**Imported Fill  
Validation Report**  
Proposed Residential  
Development  
Herbert Road  
Newport

Keepmoat

**October 2016**

**Report No. 12032/VR1**

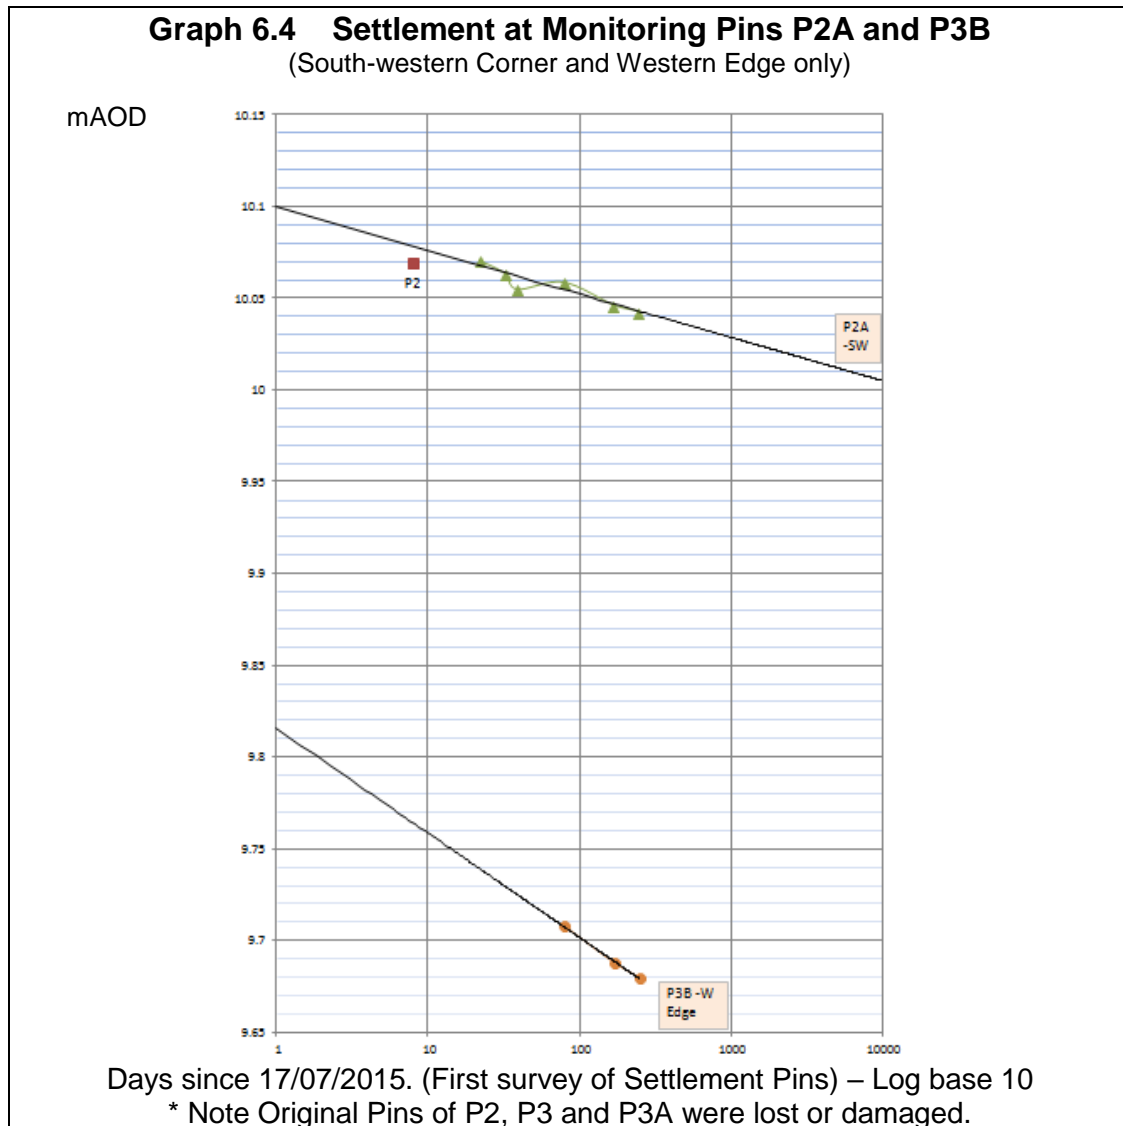
### Monitoring Pin 2

Unfortunately baseline conditions for Monitoring Pin 2 (located within the south-western corner of the site) were lost as the pin was destroyed following the placement of fill. Monitoring Pin 2A however recorded ~28mm of settlement over 7 months. Whilst the initial readings may be lost it may be possible to conjecture future settlement from the data obtained.

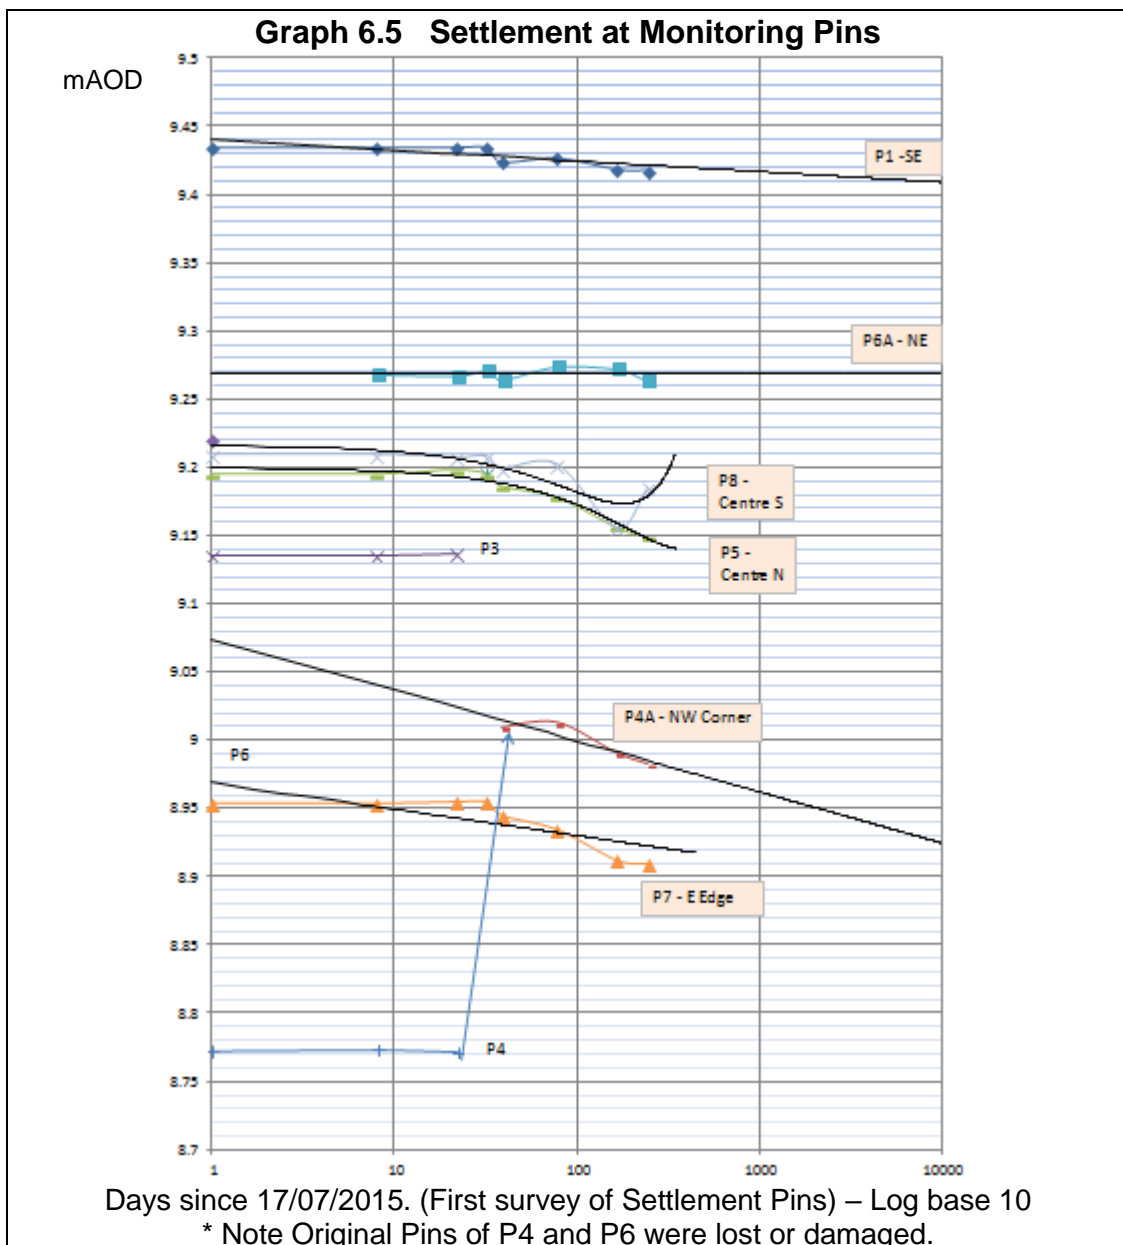
### Monitoring Pin 1

Data for Monitoring Pin 1 (located near the South-eastern Corner of the site) is complete and to date indicates settlement of ~10mm over 8 months. Conjecturing future settlement from the data obtained indicates that levels may settle to 9.41mAOD after 10<sup>4</sup> days (~30years or 2045). With the last survey indicating levels of 9.42m a further 0.010m (10mm) should be anticipated under the current surcharge by 2045.
