## SUPPORTING INFORMATION

PHOTOGRAPHY DOCUMENTING INVESTIGATIVE WORKS TO EXISTING FLOOR / CEILING AND JOIST POSITION

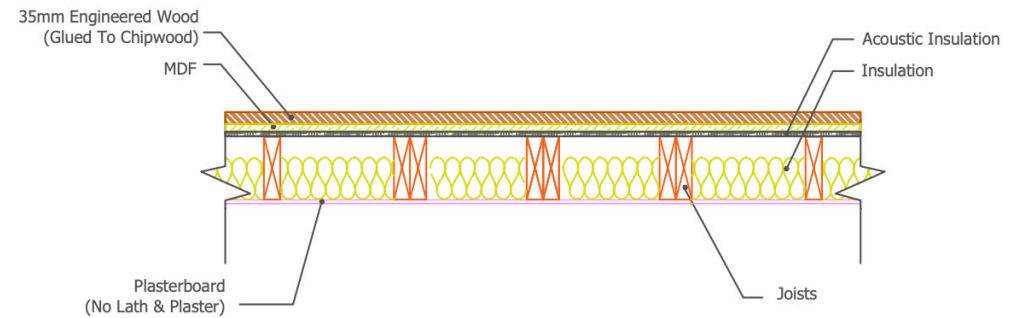
### EXISTING FLOOR FINISH:

35MM ENGINEERED TIMBER BOARDS  
GLUED TO CHIPBOARD, SITTING ON MDF BOARDS.

ENGINEERED TIMBER PLANKS HAVE BEEN RETAINED  
FOR RE-USE IN ORDER TO MAKE AREA GOOD POST  
DUCTWORK INSTALLATION.

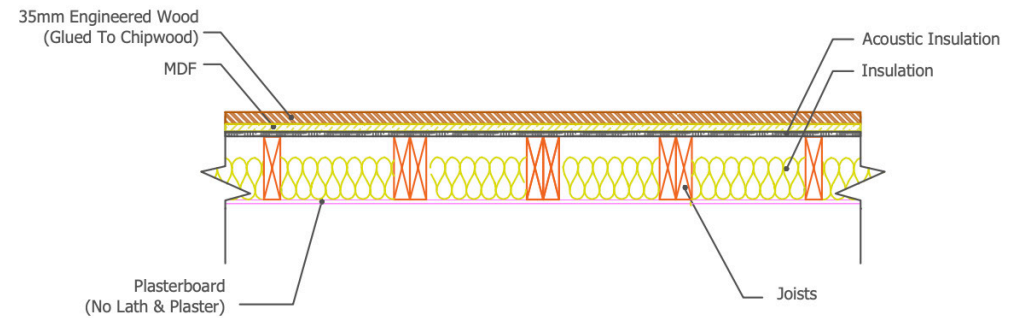
### EXISTING CEILING FINISH BELOW:

PLASTERBOARD.  
(NO LATH & PLASTER PRESENT)
