# NEWPORT CIVIC CENTRE: ROOF WORKS BELOW THE TOWER

## HERITAGE IMPACT STATEMENT

Newport City Council

05/08/26

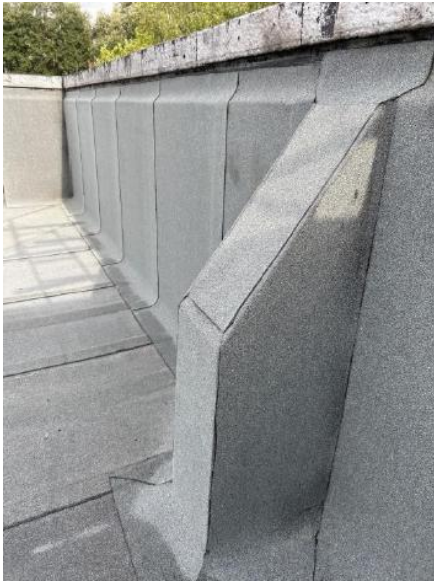
*The proposed detailing is considered appropriate given the generally poor condition of the parapet brickwork, which has, at some stage, been coated with a proprietary coating system that is now peeling and breaking down. Extending the Derbigum Olivine membrane further up the parapet walls will improve the integrity of the waterproofing detail and facilitate the continuation of the roofing system warranty.*

**Left:** indicative image of completed parapets from phase I (above level 4 west) works.

*Robust and durable materials have been specified throughout, including preservative-treated timber battens, 18mm plywood to BS EN 636-3 and stainless-steel fixings. A treated timber fillet will also be included at the head of the boarding to promote positive water run-off where the new lining projects beyond the line of the existing copings. The waterproofing membrane will be secured beneath the copings using a GRP termination bar sealed with a compatible polyurethane sealant to provide a durable and weather-tight finish.*

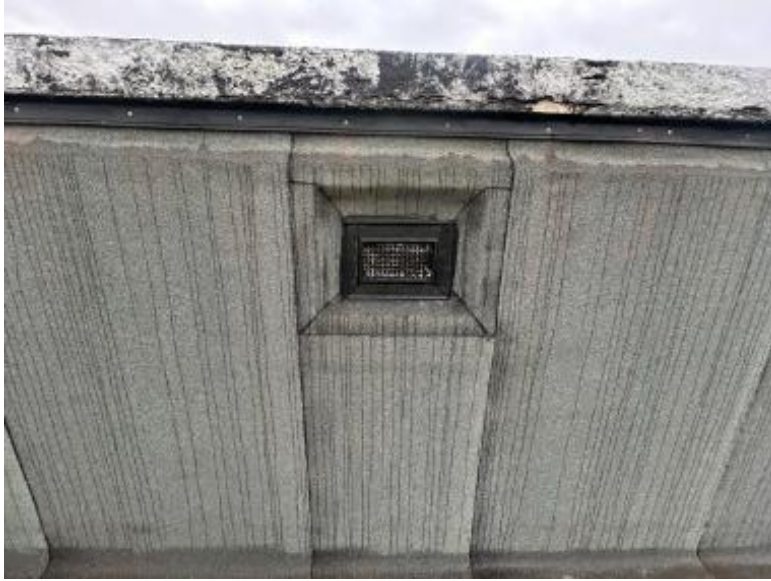
**Left:** indicative image of completed vent detail from phase I (above level 4 west) works.

3.2.2. Existing cavity vents are to be carefully cleaned and retained in situ.

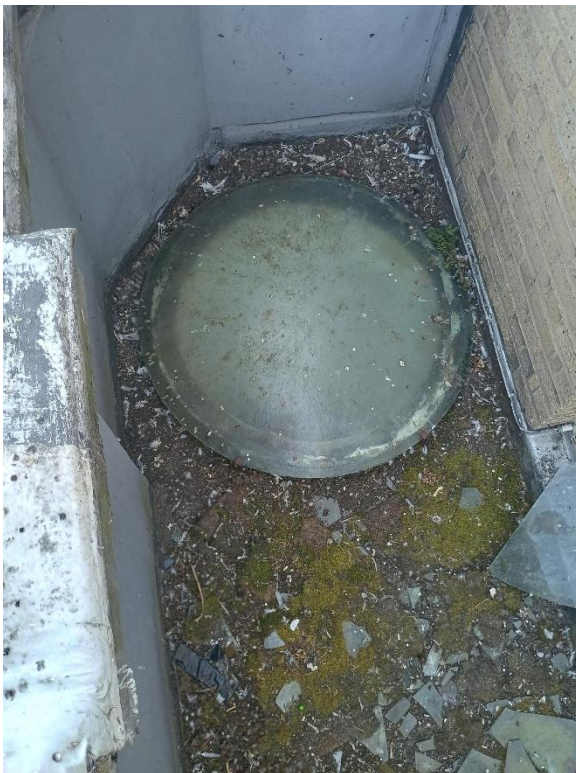
**Left:** original rooflight to be removed.

### 3.7. Replacement of rooflight:
