## Single site survey

**Client:** St Thomas' Church

**Address:** 3 Church Row, Redwick, Caldicot NP26 3DE

**Location description:** Tree located to the "Cider Press" building in the village centre

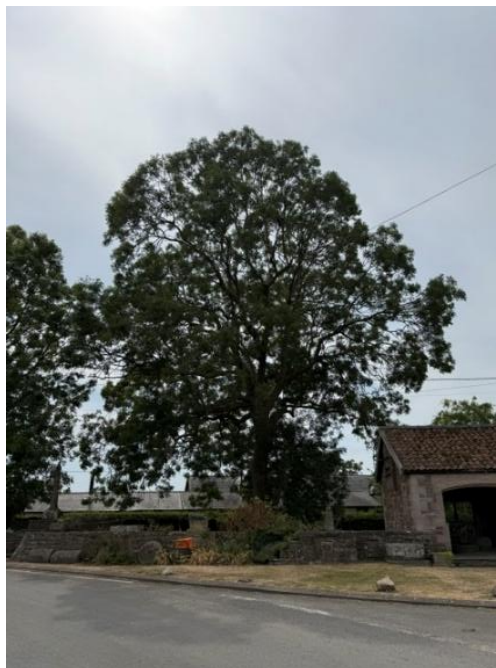
- Mature open crown ash tree
- Height 26m
- Spreads average 11m
- Stem diameter 950mm
- Fair physiological condition
- Characteristic structural condition
- High target area

- Semi-mature low stem epicormic shoots.
- Stem epicormic shoots show no Hymenoscyphus fraxineus infection.
- Open stem cavity wound at historical limb removal wound 2.2m to west of stem.
- Further occluded limb removal wound at 5m west side of stem.
- Potential for the stem to be hollow between the two points noted above.
- Dead wood throughout crown averaging 80mm diameter.
- Some dead wood as a result of natural cladoptosis but other sections most likely due to Hymenoscyphus fraxineus infection.
- Outer crown Hymenoscyphus fraxineus infection appears stabilised.
- Wide and spreading crown.

- Buildings within the vicinity of the tree are likely to alter aerodynamic loads and potentially affect the spreading limbs that may have become more brittle due to *Hymenoscyphus fraxineus* (stabilised) infection and current 2026 drought.
- Evidence of historical storm damage.
- Recent drought stress failed 90mm diameter branch from north crown.

I have considered the tree's overall condition and location and have written a management prescription below. The dead wood removal is the most important factor but some degree of crown pruning could reduce sail area and limb tip mobility in high winds. Maintaining the tree's overall silhouette will however be important so that the tree's crown will continue to develop in the best way possible.

1. Remove semi mature stem epicormic shoots using natural target pruning.
2. Remove dead wood from crown greater than 15-20mm diameter.
3. Prune out storm damage stubs.
4. Lift low crown foliage to a uniform 4m height.
5. Consider crown reduction of crown (2-3m) to reduce limb breakage potential.
6. All pruning work to be in accordance with BS3998 2010.
7. Review tree's condition in summer 2029.
