**CONCRETE STRUCTURE ASSESSMENT REPORT  
NEWPORT CENTRAL LIBRARY  
NEWPORT**

**Date: 20<sup>TH</sup> JULY 2016**  
**Ref: BH.DB/16027.01.D001**

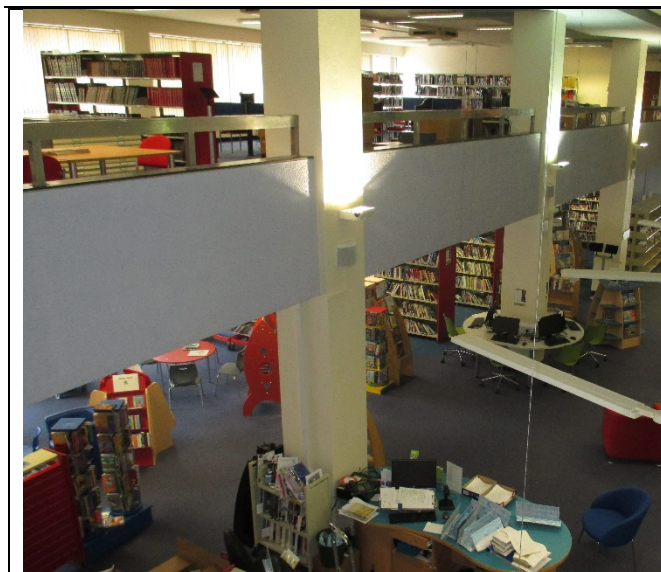
PHOTOGRAPH 1

2.2 Shear design began the survey by inspecting the internal building space currently used as an active public library ([Photographs 1](#) to [4](#)).

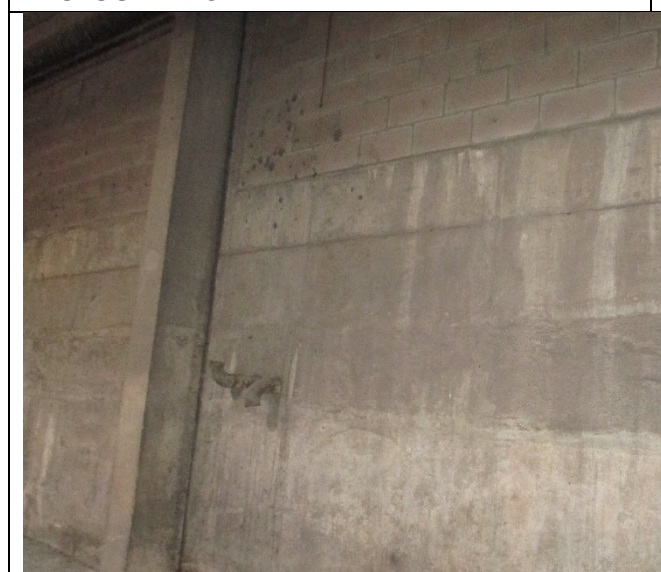
PHOTOGRAPH 5

2.3 The next area of the building to be inspected was the basement carpark. The structural frame within the car park was not finished and therefore it was possible to confirm the construction as being mostly concrete frame ([Photographs 5](#) to [8](#)) however a hot rolled steel braced bay was also captured ([Photograph 9](#)) along with some masonry wall panels ([Photographs 10](#) to [12](#)).

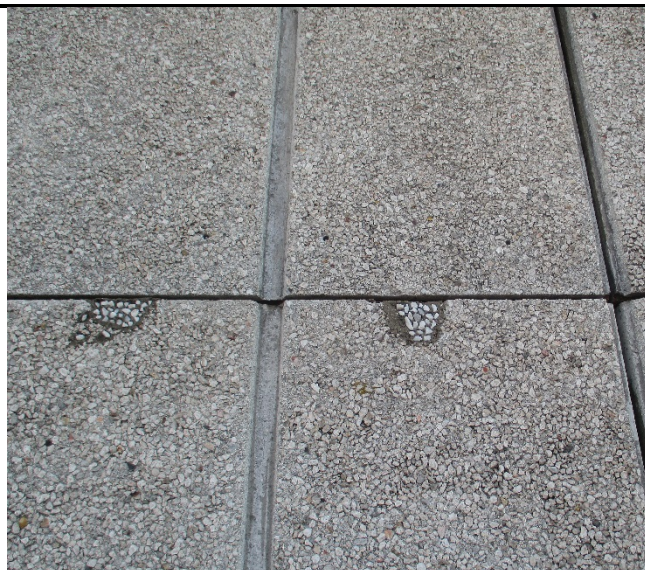
PHOTOGRAPH 13

[Photograph 13](#) shows patches of spalling to two of the rough aggregate finished panels on the north elevation. Moving along the elevation, further spalling of the same kind, along with extensive staining was observed below the window openings, [Photograph 14](#) and [15](#).

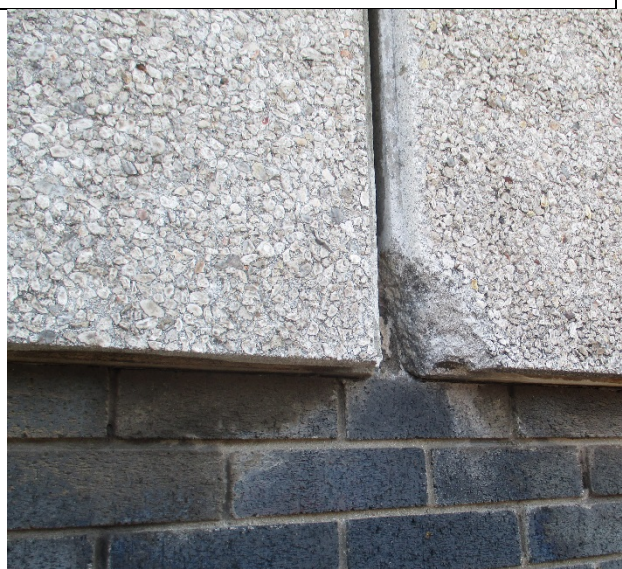
PHOTOGRAPH 16

[Photograph 16](#) demonstrates how the entire corner of one of the rough coated panels has broken away from the remaining panel.

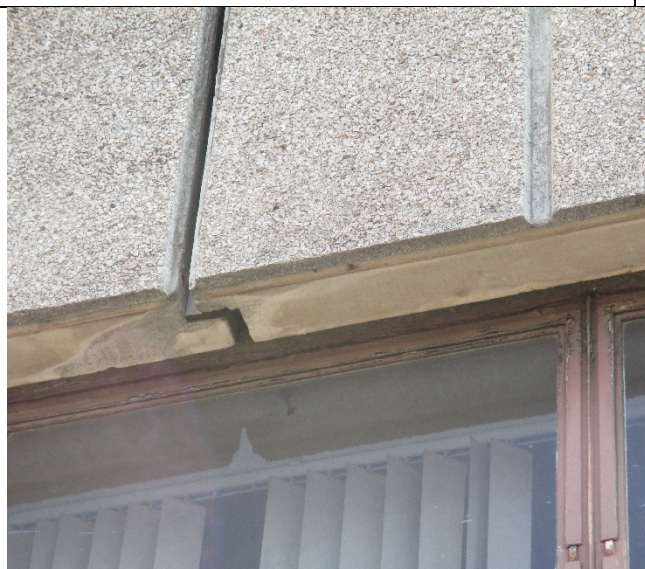
PHOTOGRAPH 17

Upon inspecting the underside of a window opening further, it was observed that the concrete forming the main body of the concrete wall panels showed evidence of patch spalling and staining ([Photographs 17](#) and [18](#)) whilst the corner of the exposed rough aggregate face of another particular panel has almost all broken away, leaving the main concrete body of the panel almost exposed from the front ([Photograph 19](#)).

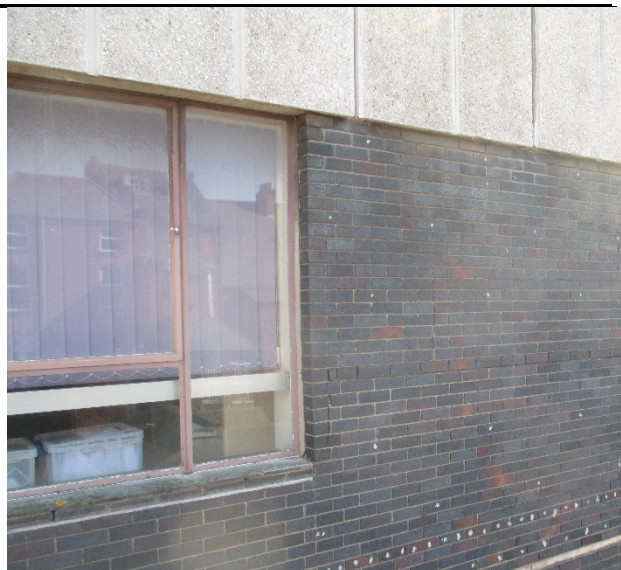
PHOTOGRAPH 20

[Photograph 20](#) shows extensive cracking to the masonry brick slip, whilst moving further down again, a length of brick slip in line with the top of a window opening had moved away from the concrete behind ([Photograph 21](#)).

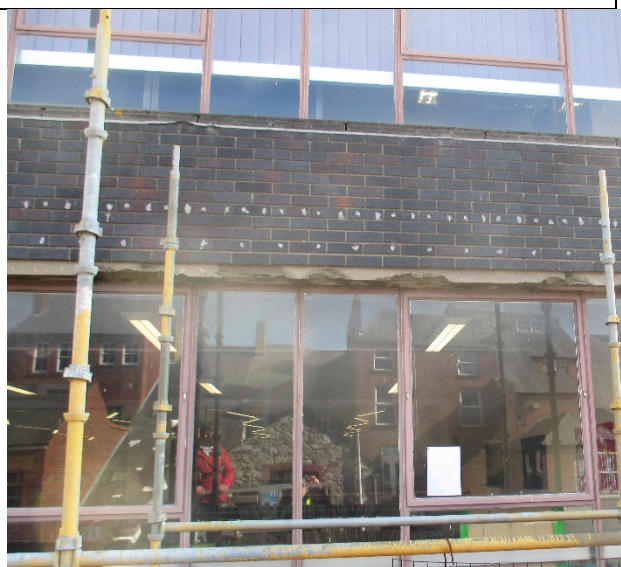
PHOTOGRAPH 22

[Photographs 22](#) to [25](#) show how large portions of the concrete had completely sprawled away from the main structural elements to the extent where the steel reinforcement within the concrete was becoming exposed ([Photograph 25](#)).

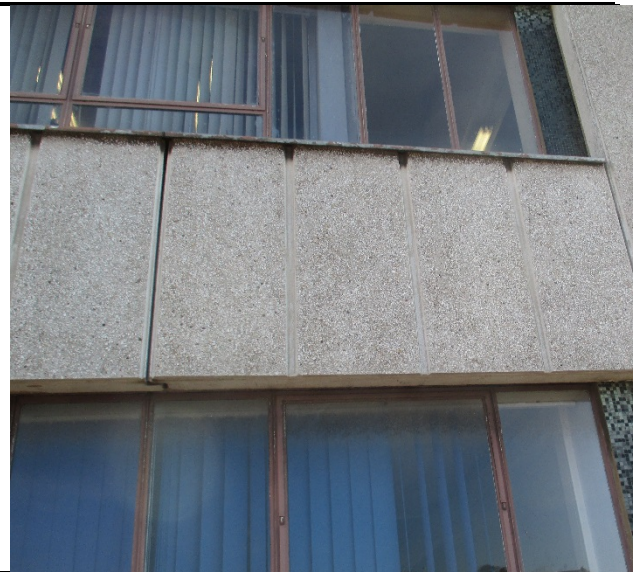
**PHOTOGRAPH 26**

[Photograph 26](#) shows further severe concrete decay with the entire strand of steel reinforcement exposed and almost separated from the main body of the concrete beam behind. A further number of instances of concrete decay and spalling are highlighted on [Photograph 27](#).

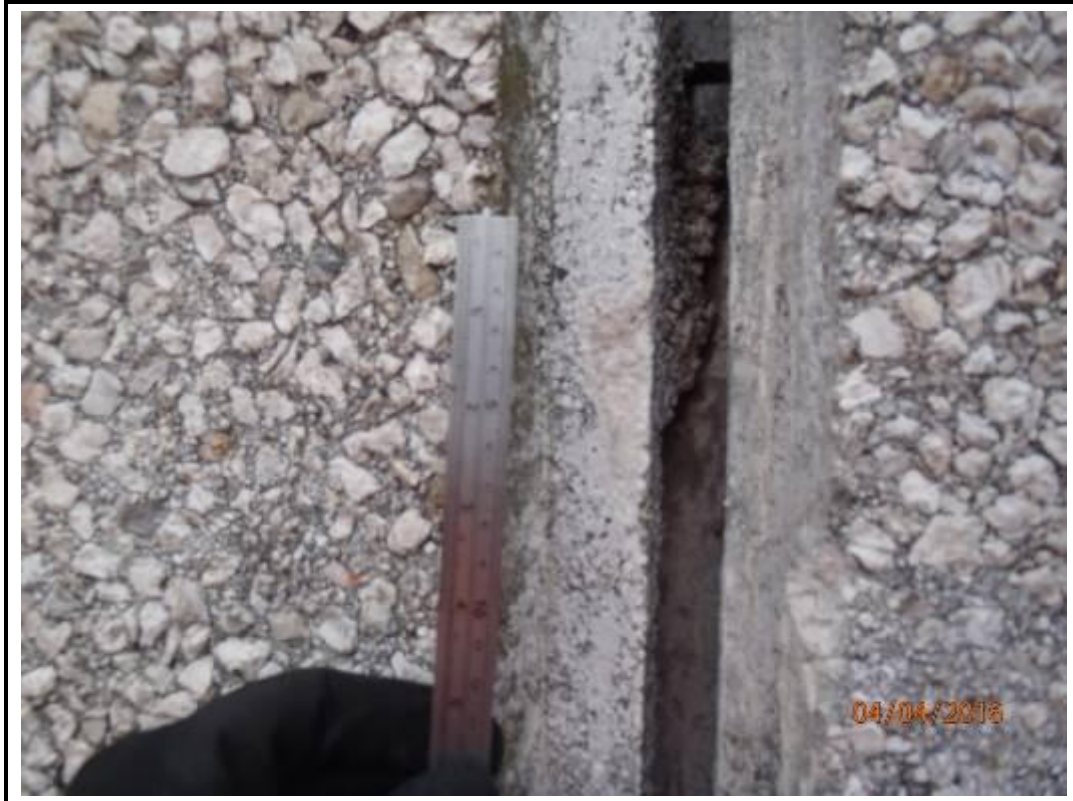
**Photo 1. Drop 1 – East Elevation**

| Photo 1 | Spalling to the north edge of T4 = 50mm H x 15mm W x 5mm D |

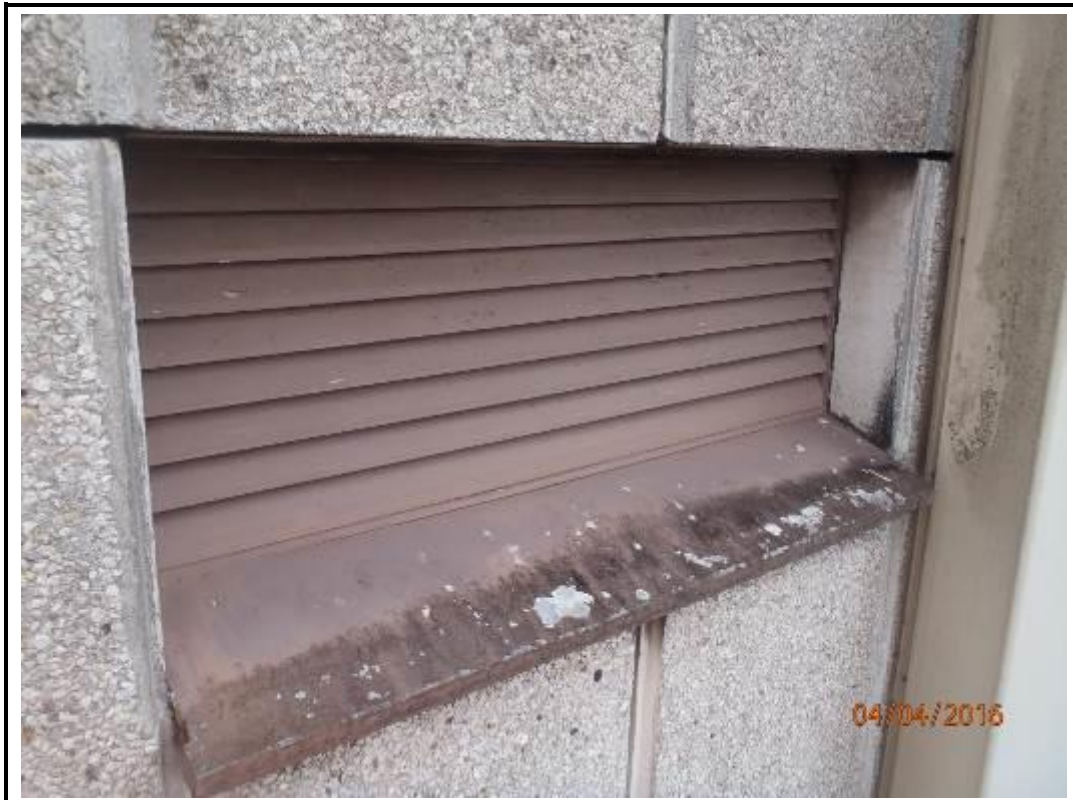
**Photo 2. Drop 1 – East Elevation**

| Photo 2 | General feature – air vent top of M1 & M2 |

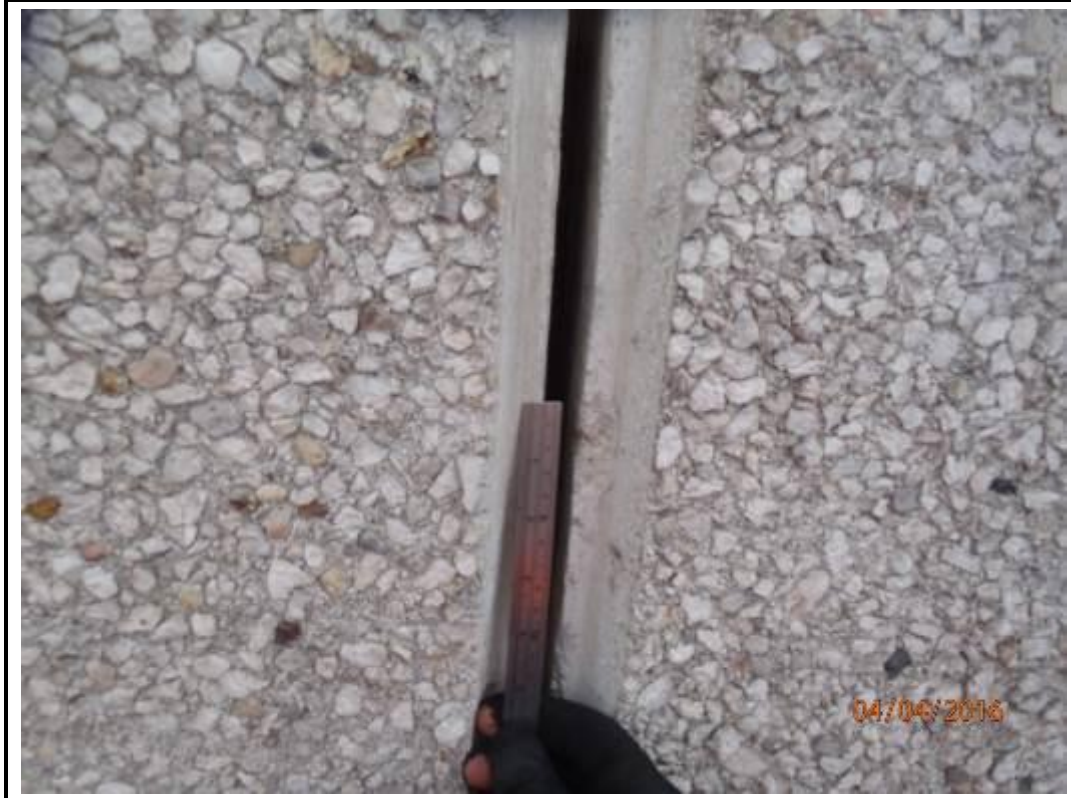
**Photo 3. Drop 1 – East Elevation**

| Photo 3 | Spalling to the south edge of M1 = 50mm H x 15mm W x 10mm D |

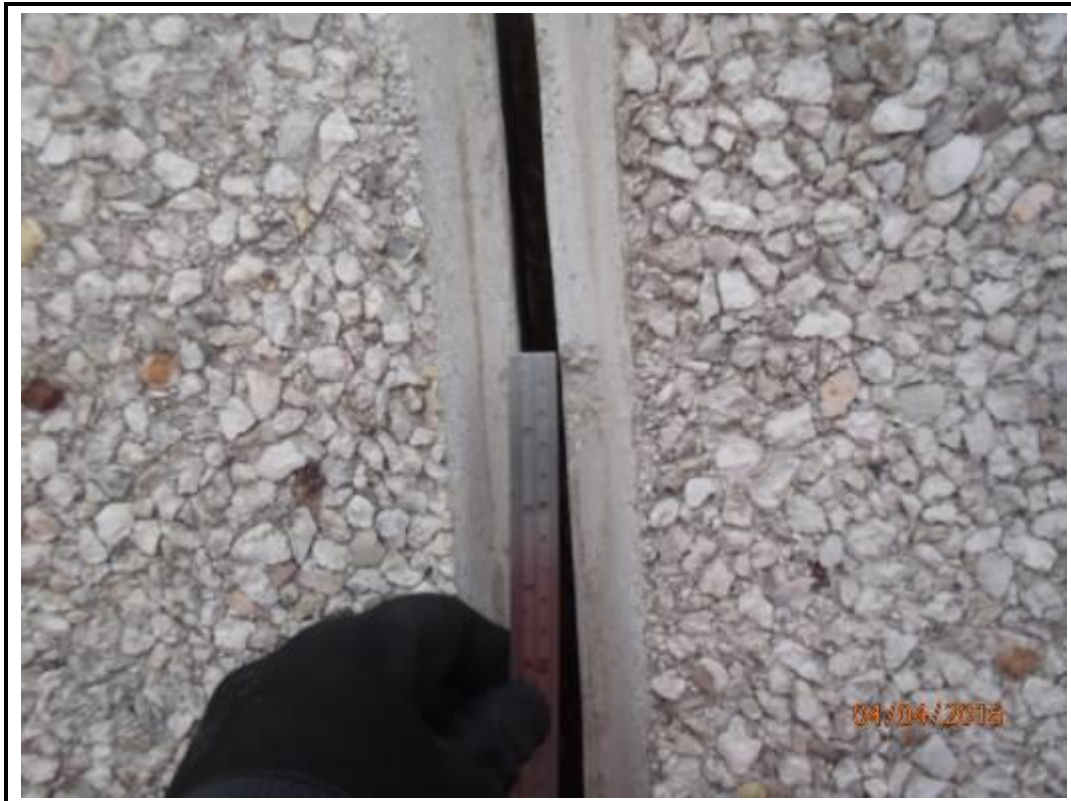
**Photo 4. Drop 1 – East Elevation**

| Photo 4 | Spalling to the south edge of M1 = 30mm H x 15mm W x 10mm D |

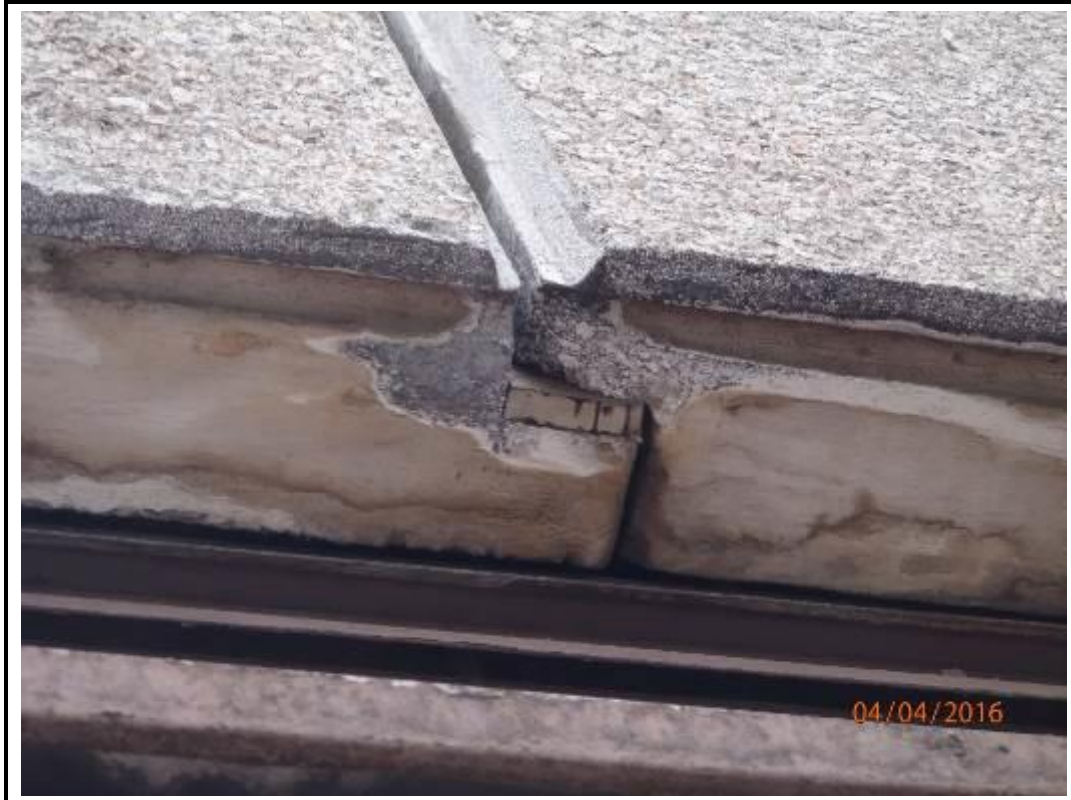
**Photo 5. Drop 1 – East Elevation**

| Photo 5 | Spalling to the underside of T1 & T2 = 10mm H x 150mm W x 100mm D |

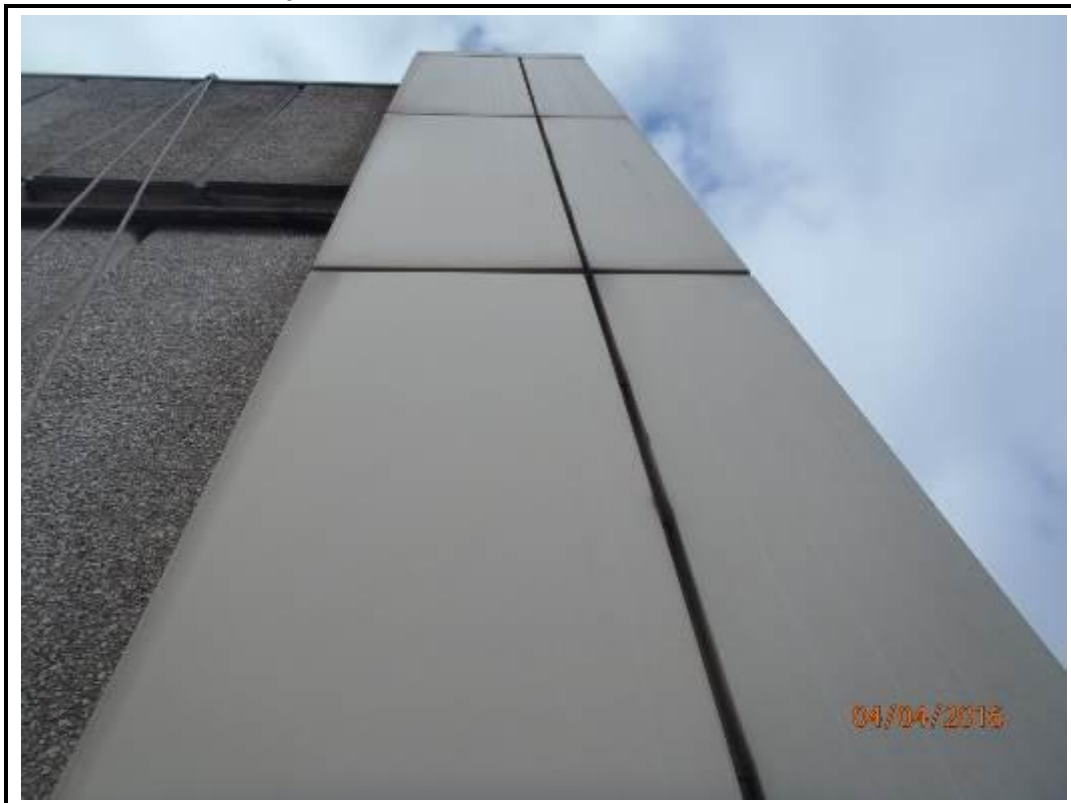
**Photo 6. Drop 1 – East Elevation**

| Photo 6 | General view of the aluminium cladding just north of drop 1 |

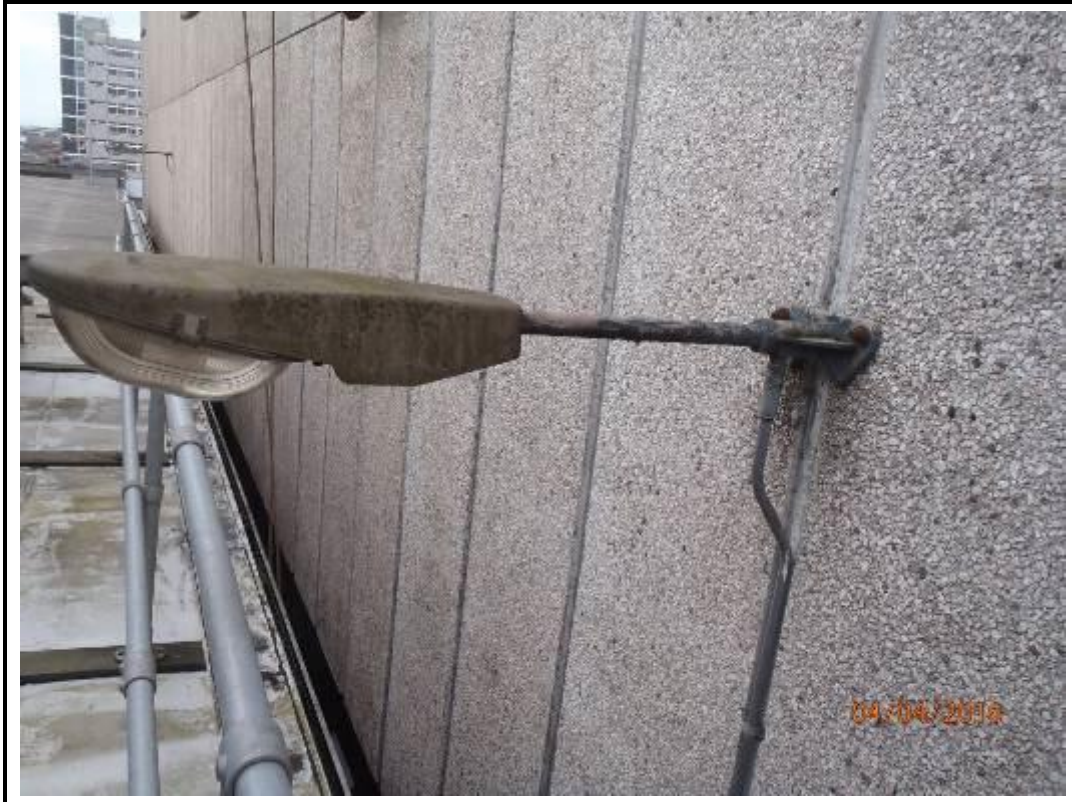
**Photo 7. Drop 1 – East Elevation**

| Photo 7 | General feature – light fitted between B2 & B3 |

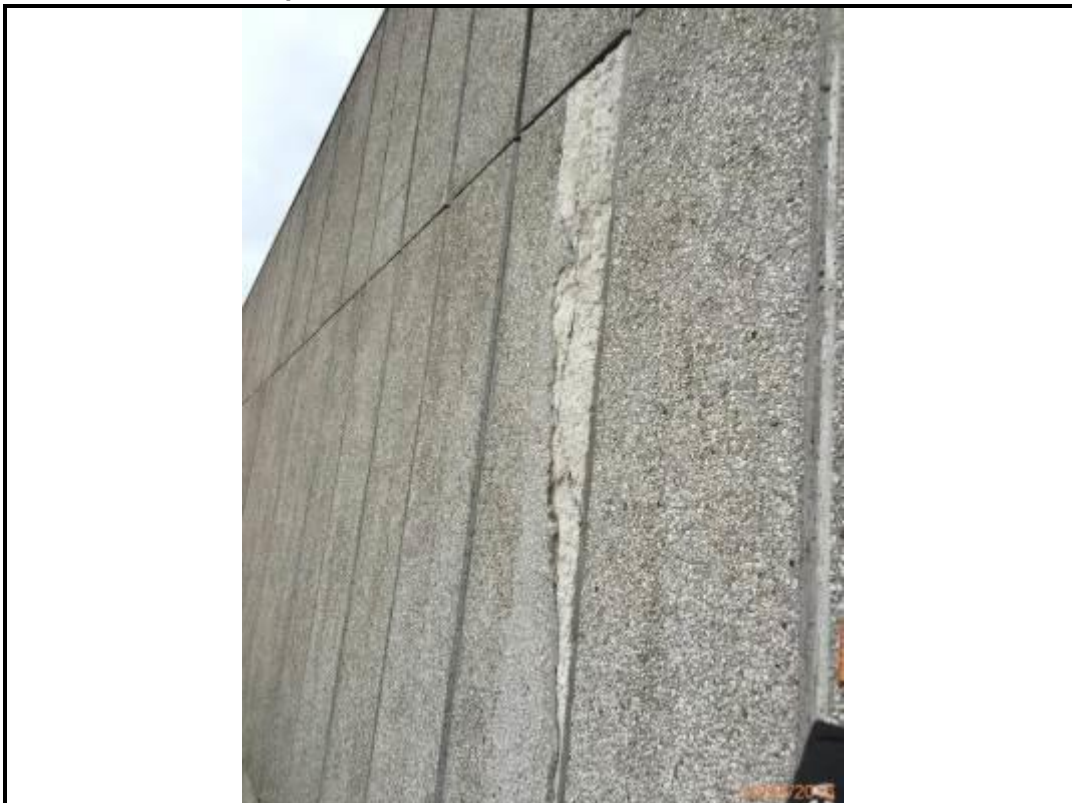
**Photo 8. Drop 2 – East Elevation**

| Photo 8 | Spalling to the top north half of M4 = 2.2m H x 320mm W x 5-25mm D |

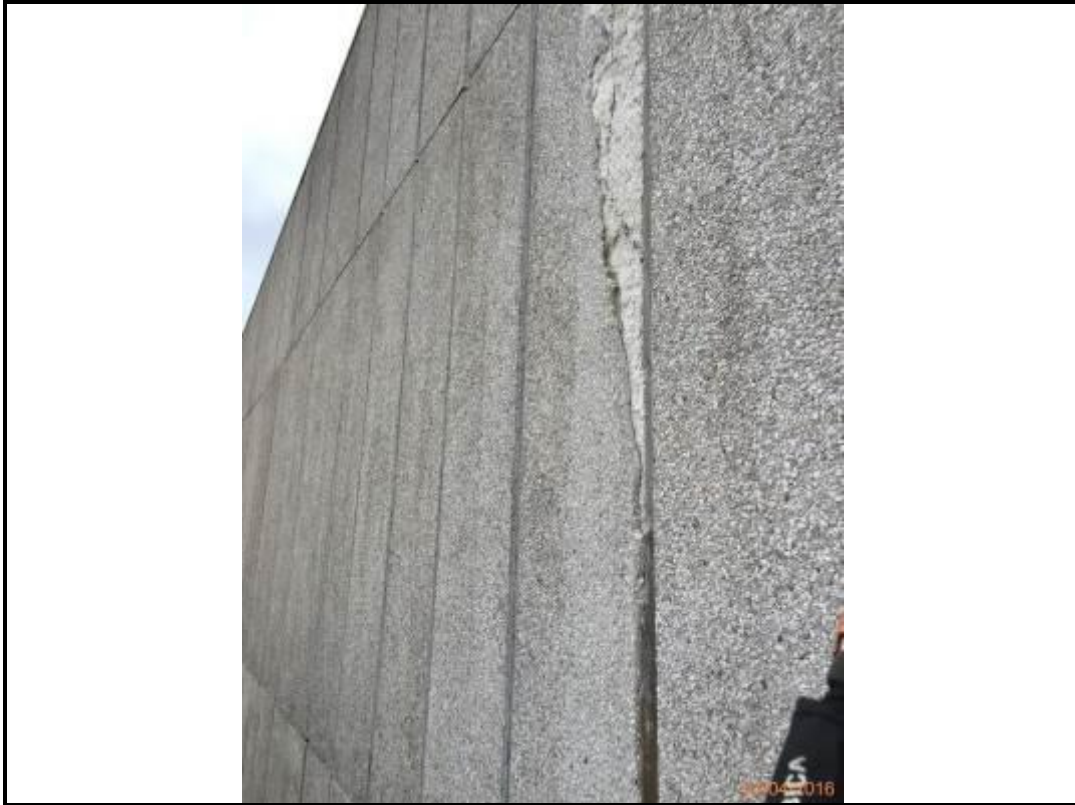
**Photo 9. Drop 2 – East Elevation**

| Photo 9 | Imminent spalling to the bottom north half of M4 = 2.5m H x 320mm W |

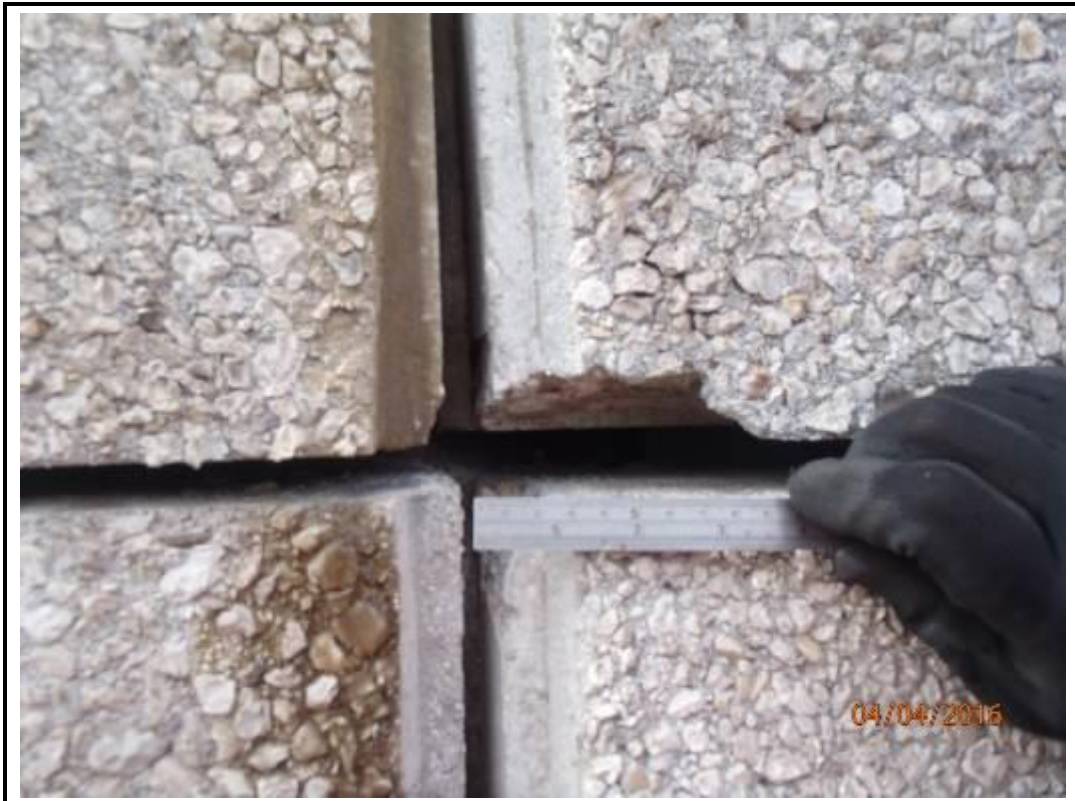
**Photo 10. Drop 2 – East Elevation**

| Photo 10 | Spalling to the bottom south corner of M3 = 30mm H x 80mm W x 60mm D |

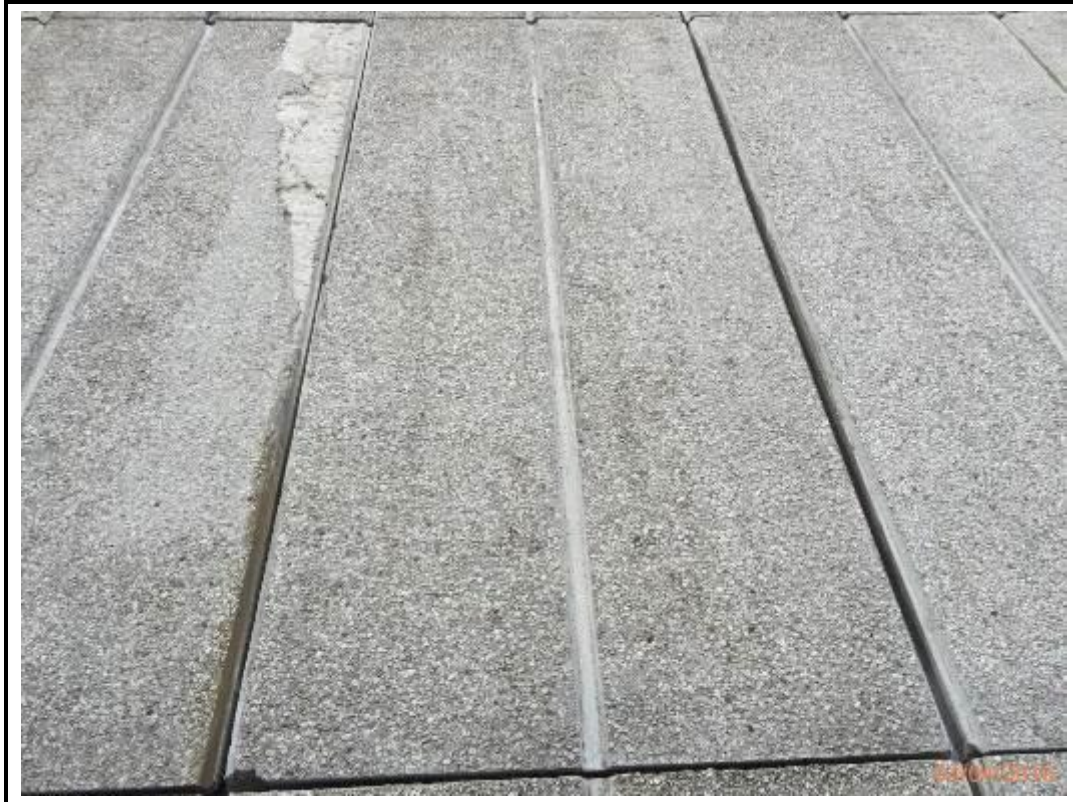
**Photo 11. Drop 2 – East Elevation**

| Photo 11 | General view of drop 2 |

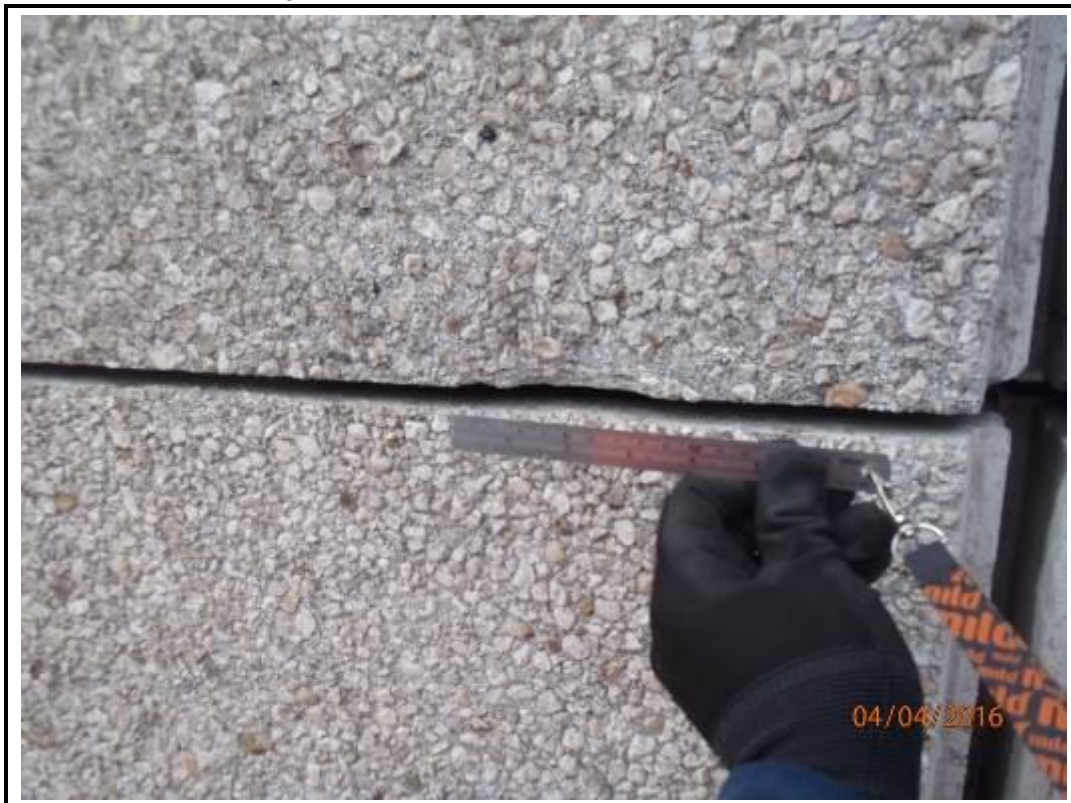
**Photo 13. Drop 3 – East Elevation**

| Photo 13 | Spalling to the north edge of T2 = 500mm H x 50mm W x 50mm D (exposed reinforcement subsequently corroded) |

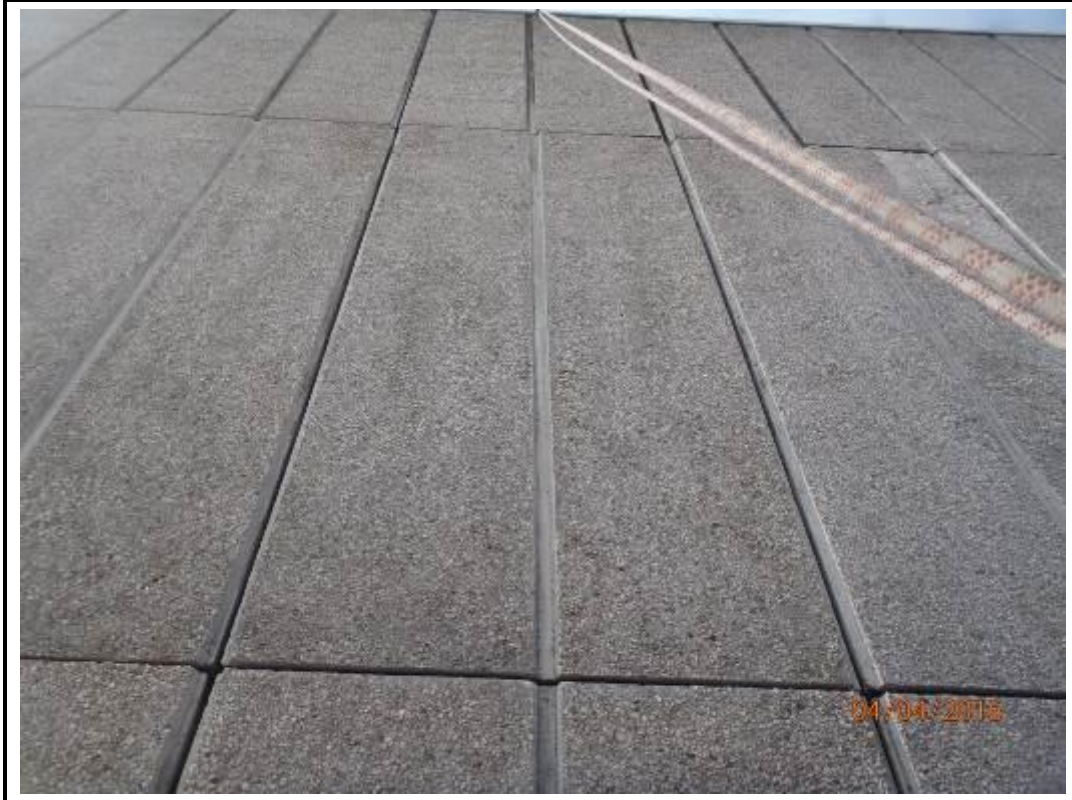
**Photo 14. Drop 3 – East Elevation**

| Photo 14 | Spalling to the bottom edge of M4 = 30mm H x 100mm W x 10mm D |

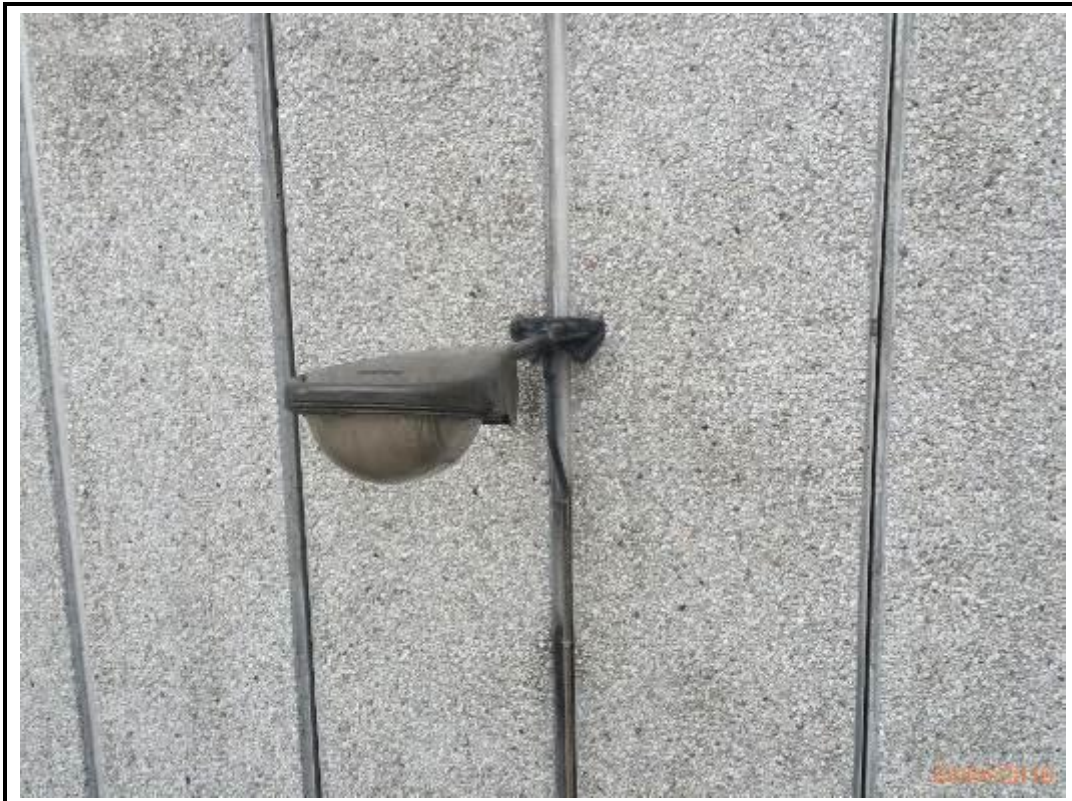
**Photo 21. Drop 7 – East Elevation**

| Photo 21 | Spalling to the top north corner of M3 = 90mm H x 70mm W x 5-30mm D |

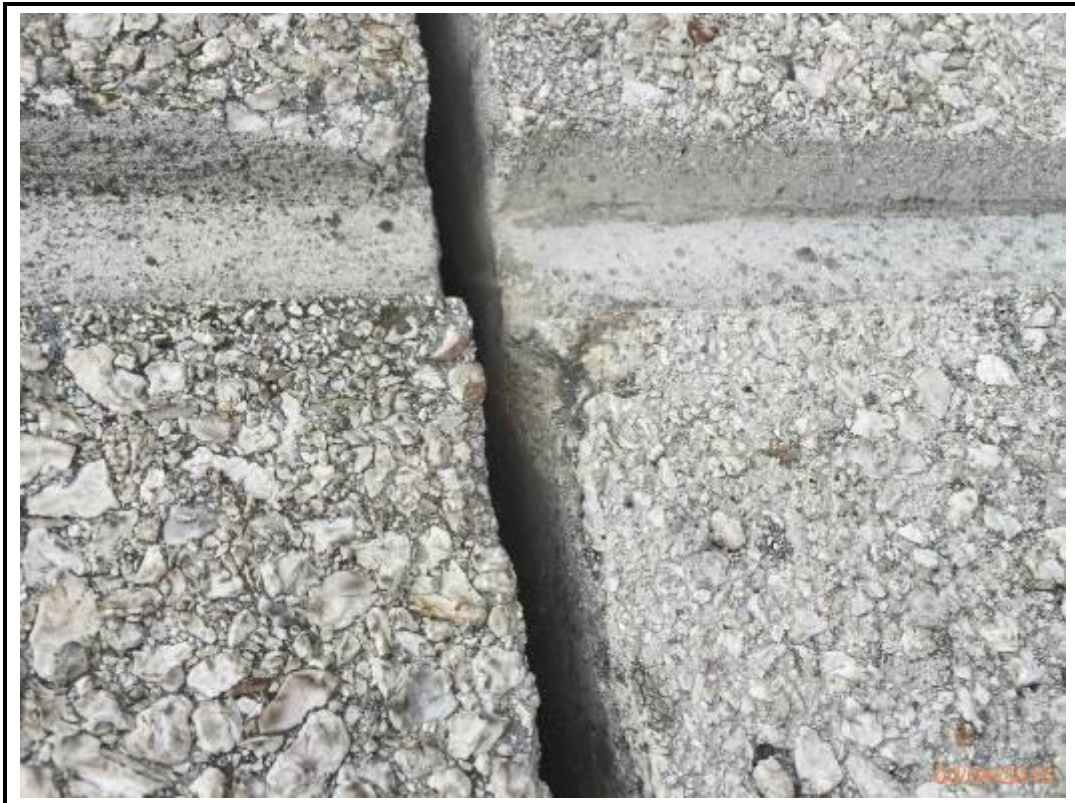
**Photo 25. Drop 8 – East Elevation**

| Photo 25 | Spalling to the top south corner of M3 = 30mm H x 30mm W x 20mm D |

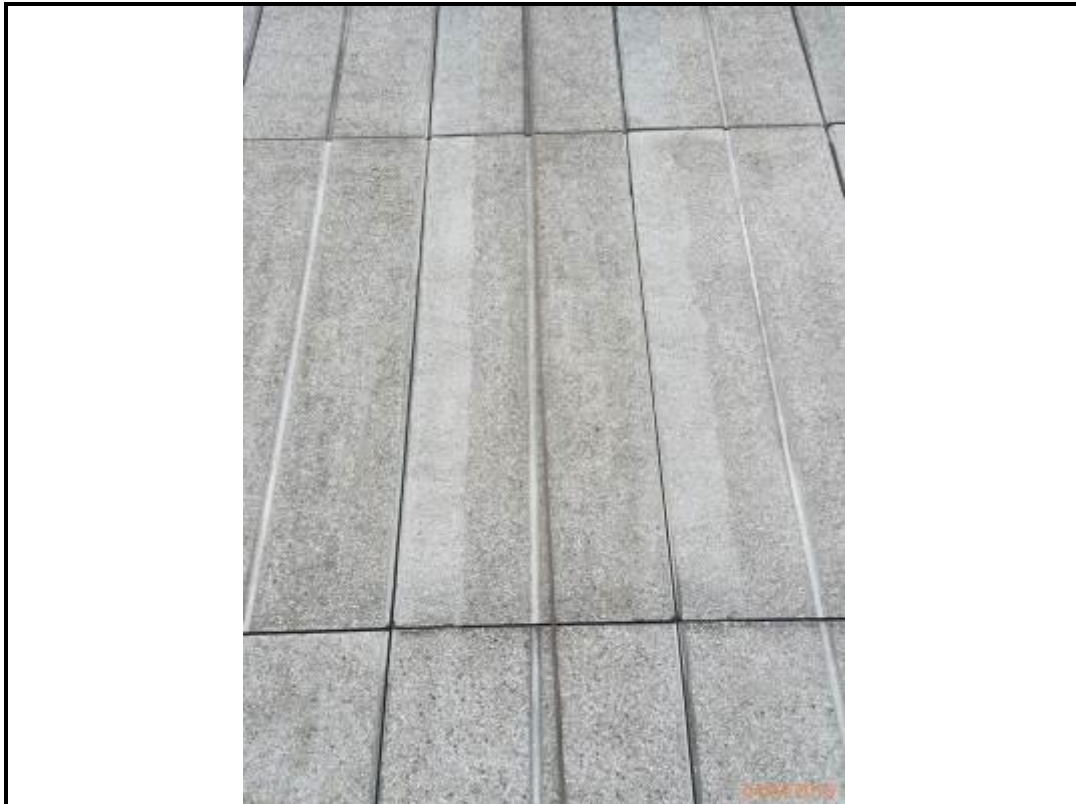
**Photo 26. Drop 8 – East Elevation**

| Photo 26 | Spalling to the top south corner of M1 = 30mm H x 20mm W x 20mm D |

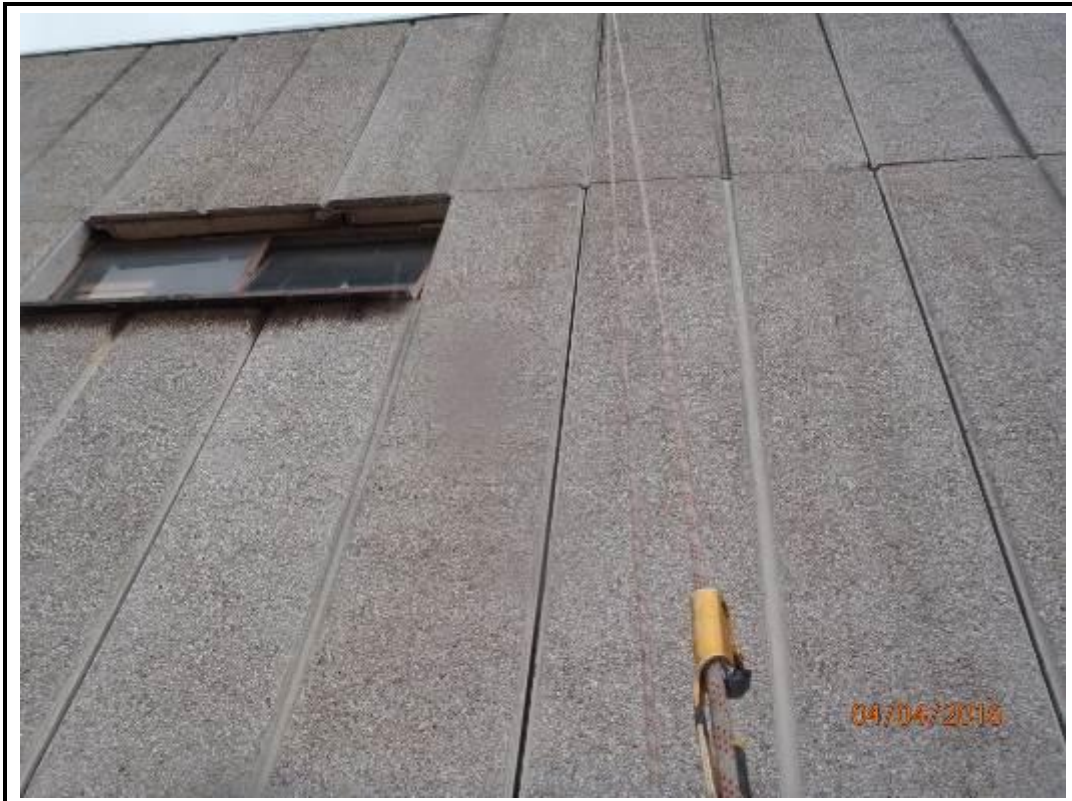
**Photo 35. Drop 11 – East Elevation**

| Photo 35 | Typical paint loss to window elements |

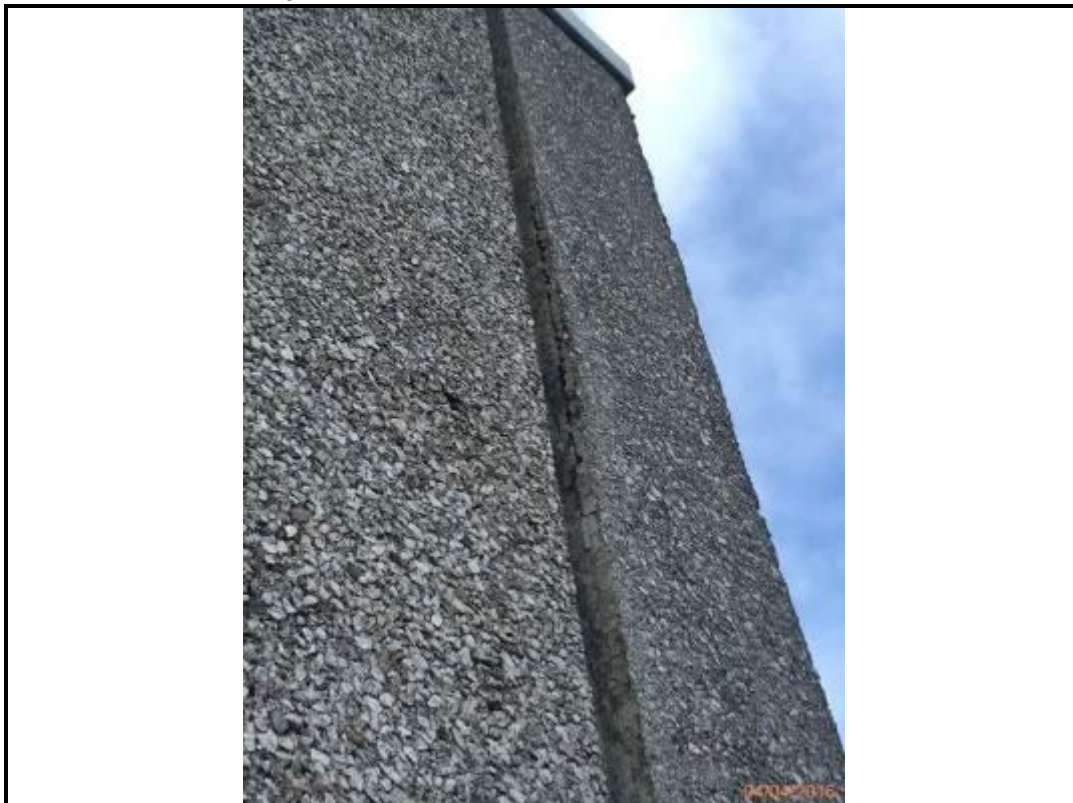
**Photo 47. Drop 13 – East Elevation**

| Photo 47 | General view of brickwork cladding beneath drop 13 showing vertical fracture, located 900mm in from the south edge of east elevation = 2.2m H x HL-2mm W |

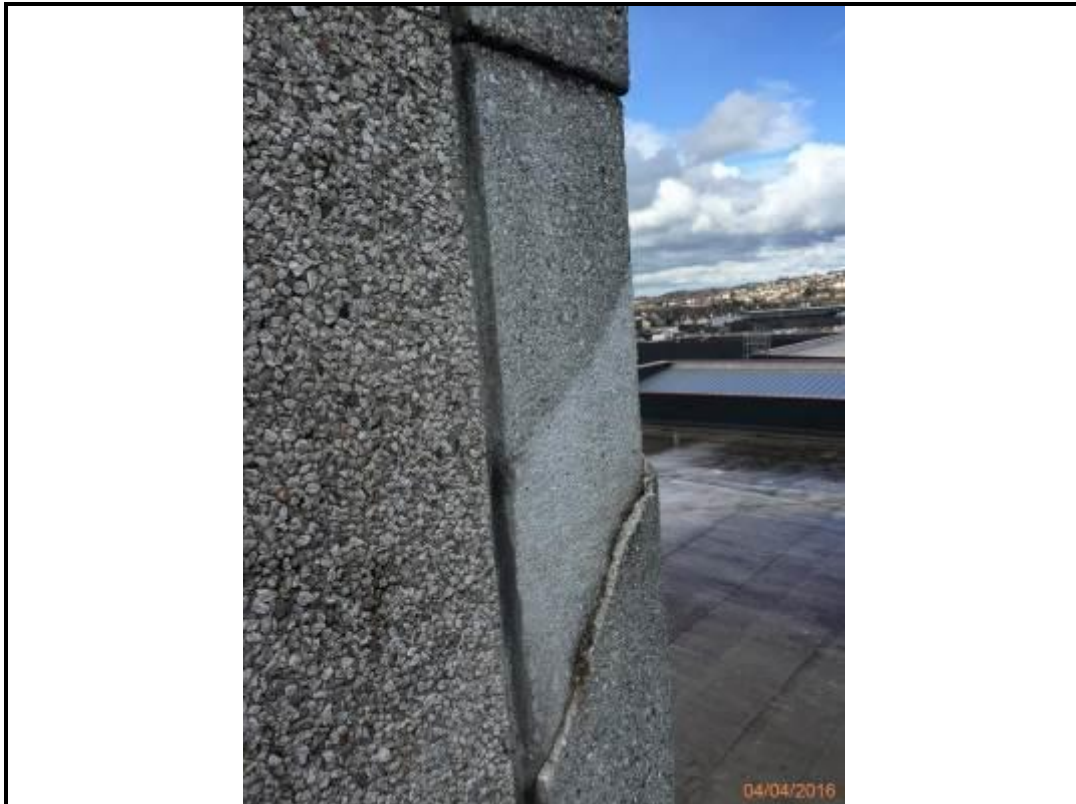
**Photo 48. Drop 1 – South Elevation**

| Photo 48 | Vertical fracture to the west edge of T1 = 2m H x HL-3mm wide |

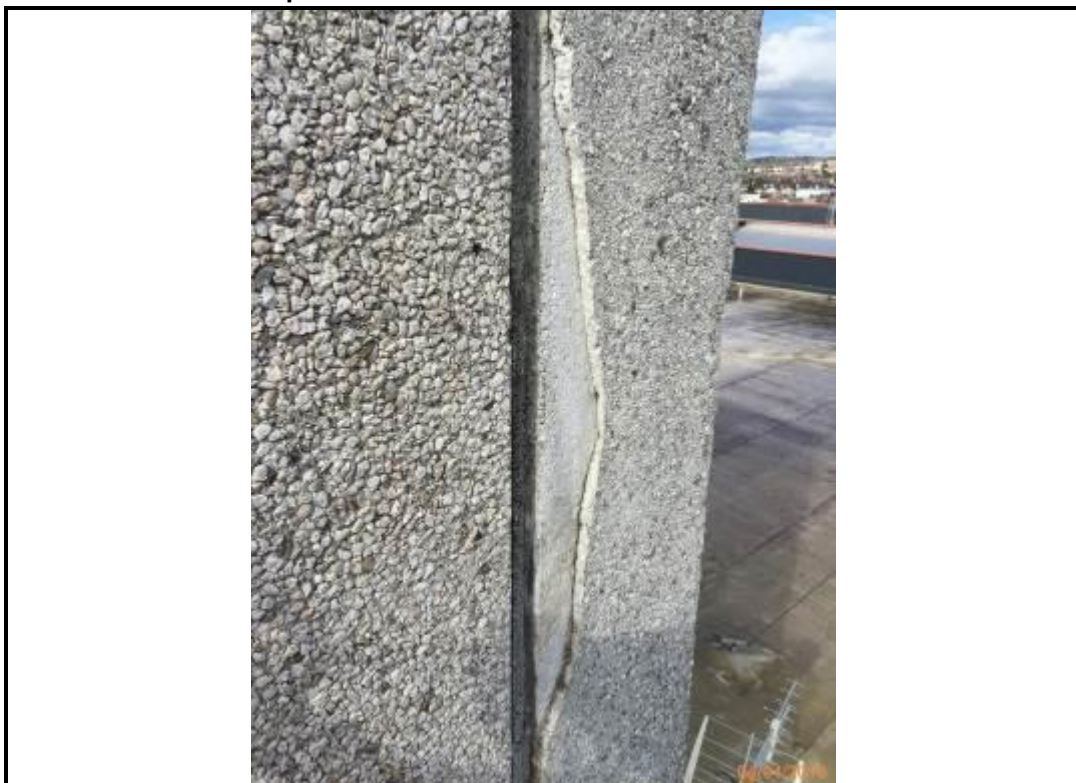
**Photo 49. Drop 1 – South Elevation**

| Photo 49 | Spalling to the top half of M1 = 920mm H x 320mm W x 25mm D |

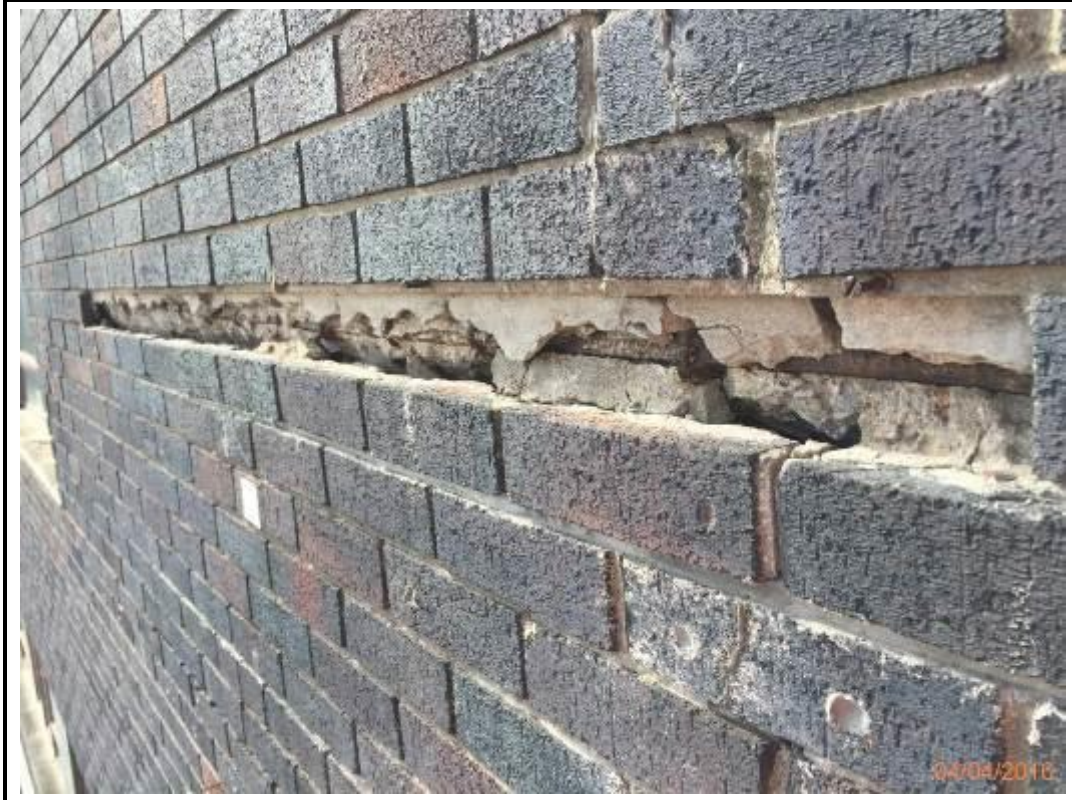
**Photo 50. Drop 1 – South Elevation**

| Photo 50 | Spalling to the west side of M1 = 820mm H x 90mm W x 25mm D |

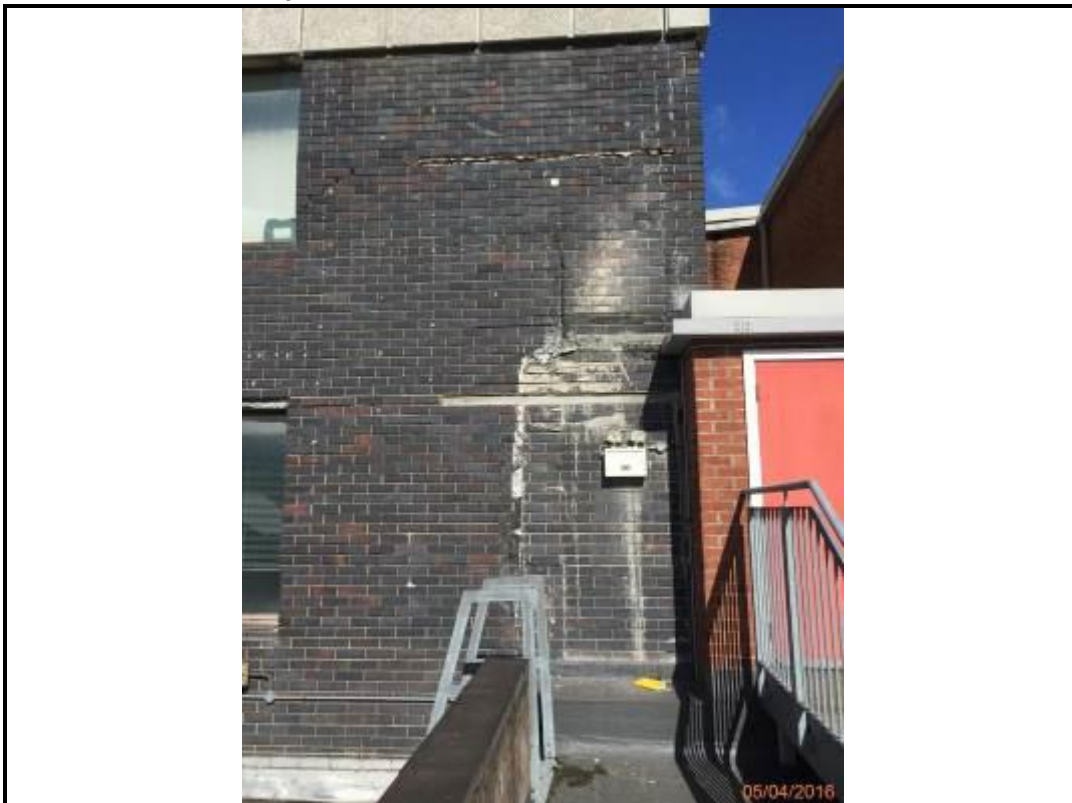
**Photo 55. Drop 1 – South Elevation**

| Photo 55 | Line of missing brickwork located in line with window row 4 lintel, 8No bricks missing. Area of missing brickwork has been filled with mortar. |
