**CONCRETE STRUCTURE ASSESSMENT REPORT  
NEWPORT CENTRAL LIBRARY  
NEWPORT**

**Date: 20<sup>TH</sup> JULY 2016**  
**Ref: BH.DB/16027.01.D001**

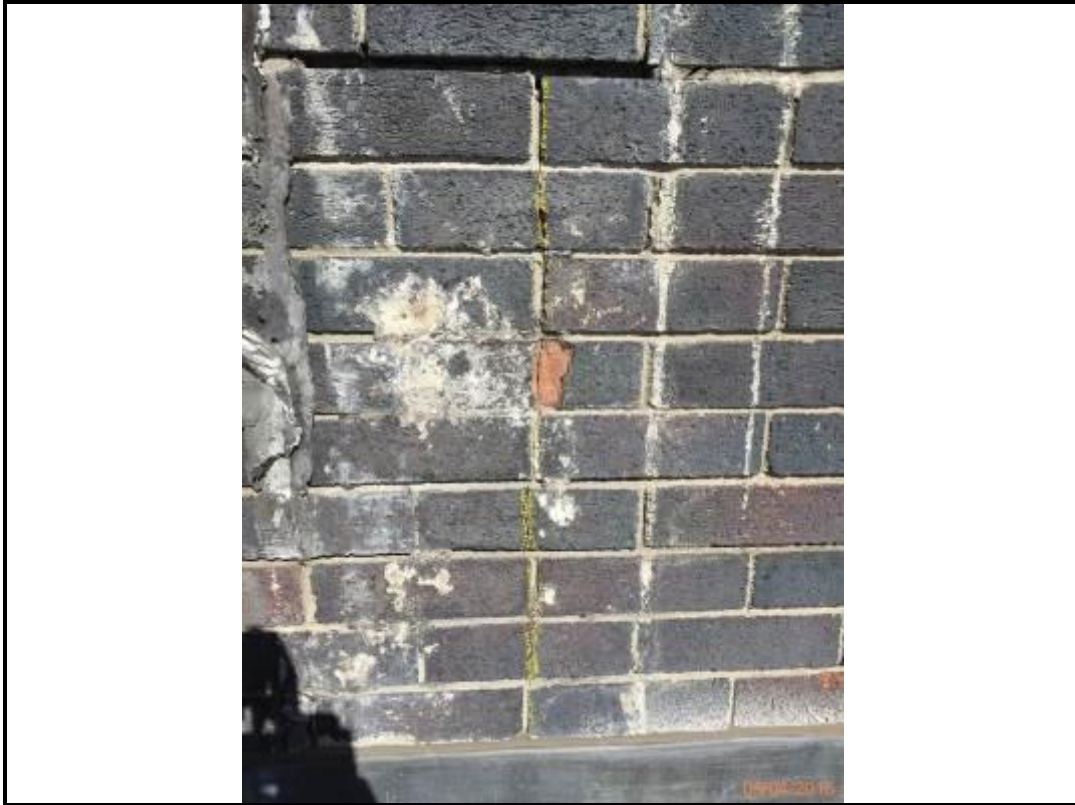
**Photo 56. Drop 1 – South Elevation**

| Photo 56 | Areas of calcite staining to brickwork cladding beneath concrete cladding = approximately 3m <sup>2</sup> . |

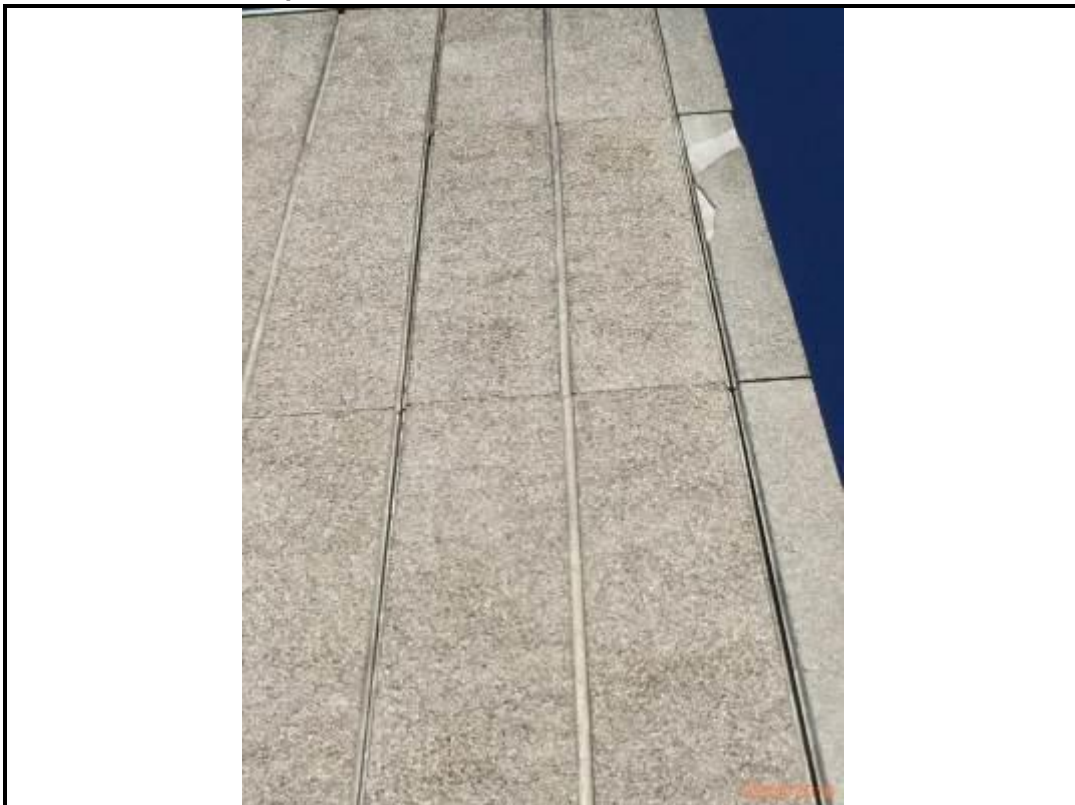
**Photo 57. Drop 1 – South Elevation**

| Photo 57 | Vertical fracture to the base of brickwork cladding beneath B2 = 670mm H x 2mm W, associated spalling mid height of the fracture = 70mm H x 40mm W x 15mm D |

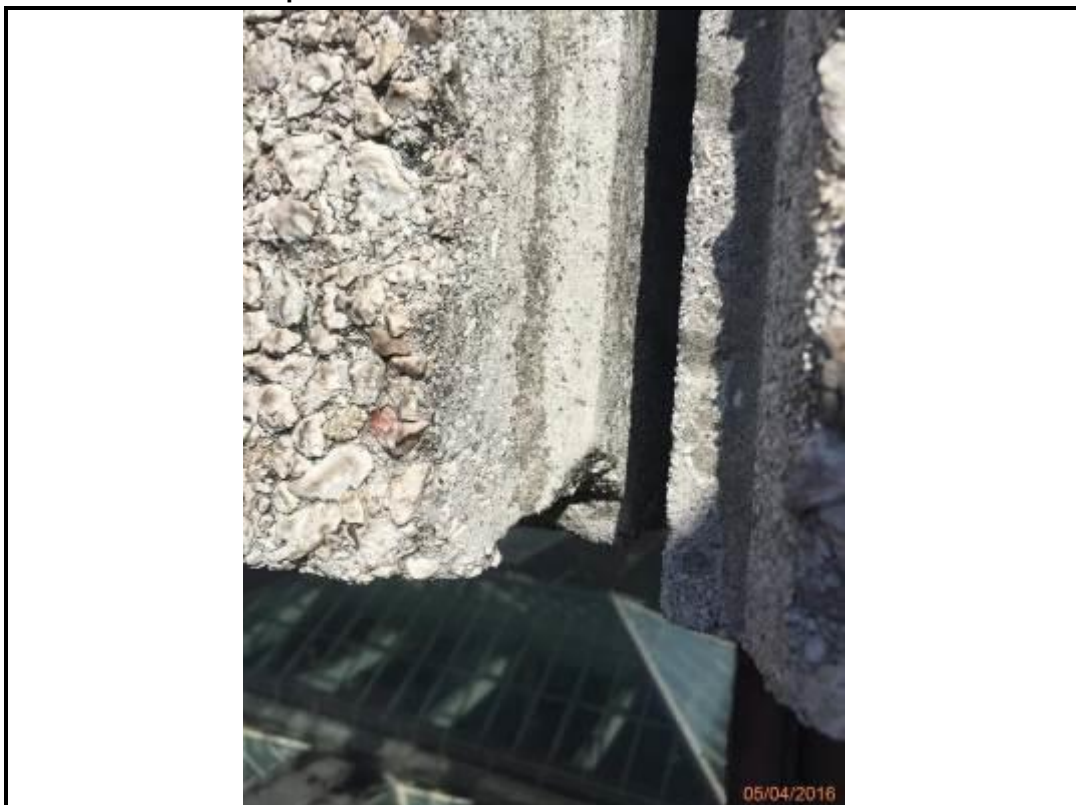
**Photo 59. Drop 2 – South Elevation**

| Photo 59 | Spalling to the bottom east corner of T2 = 70mm H x 50mm W x 40mm D |

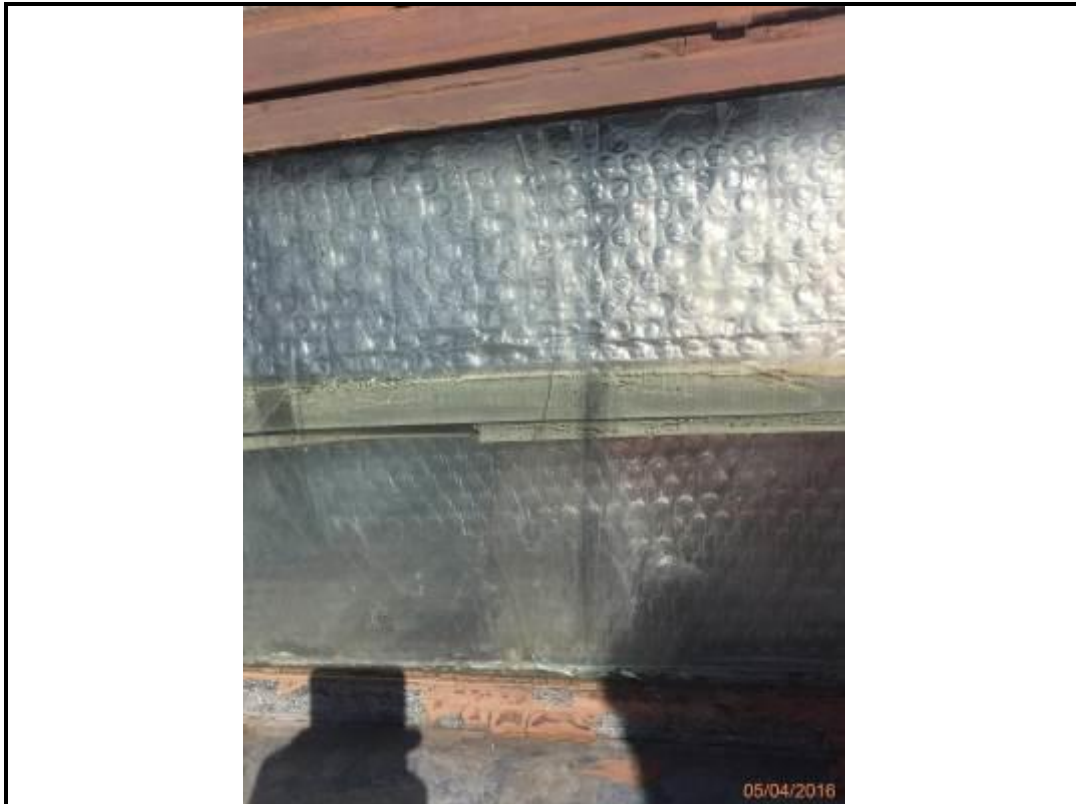
**Photo 60. Drop 2 – South Elevation**

| Photo 60 | Spalling to the bottom east corner of T2 = 30mm H x 20mm W x 5-10mm D |

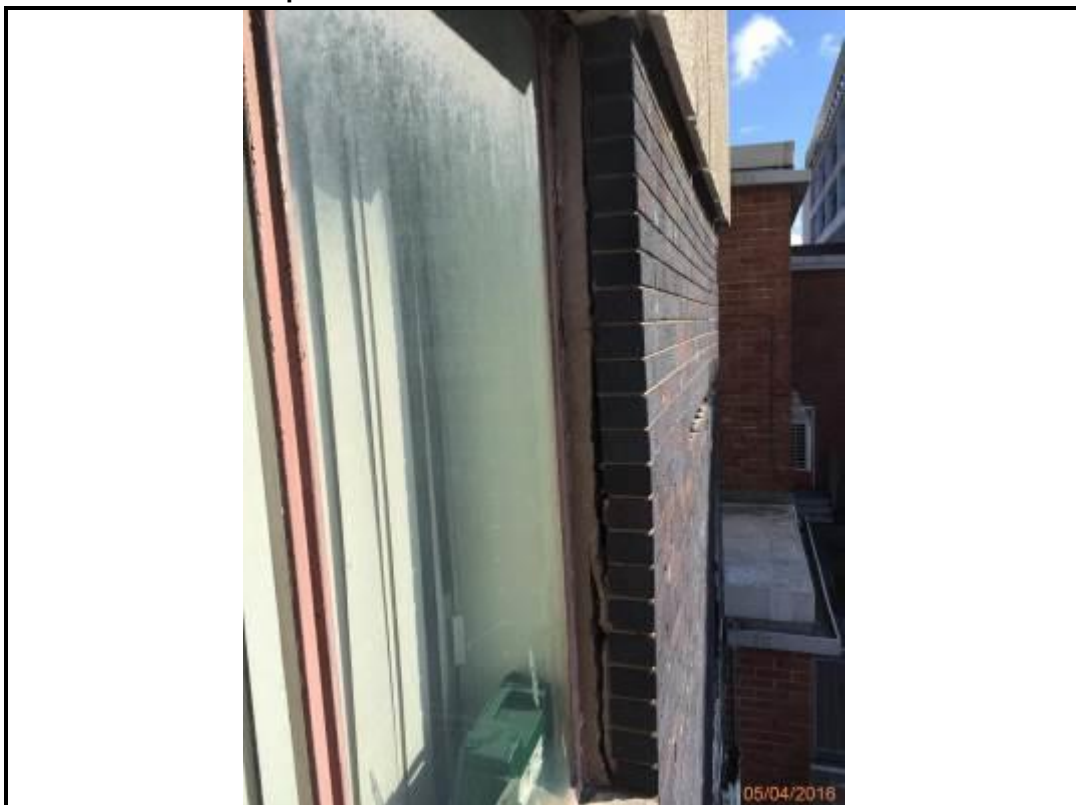
**Photo 61. Drop 2 – South Elevation**

| Photo 61 | Vertical fracture through glass, low levels of window row 1, beneath T4 = 340mm H x HL W |

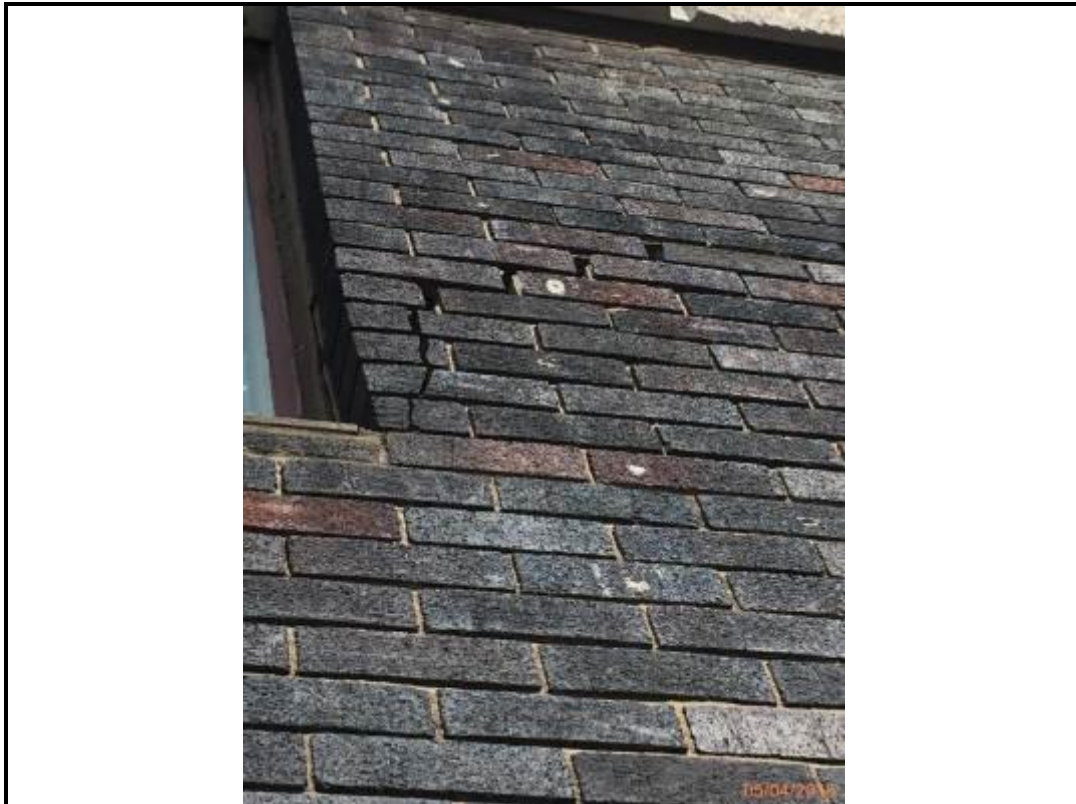
**Photo 62. Drop 2 – South Elevation**

| Photo 62 | Vertical separation of brickwork cladding, in line with window row 3 beneath B1 = 1.7m H x 5-35mm wide |

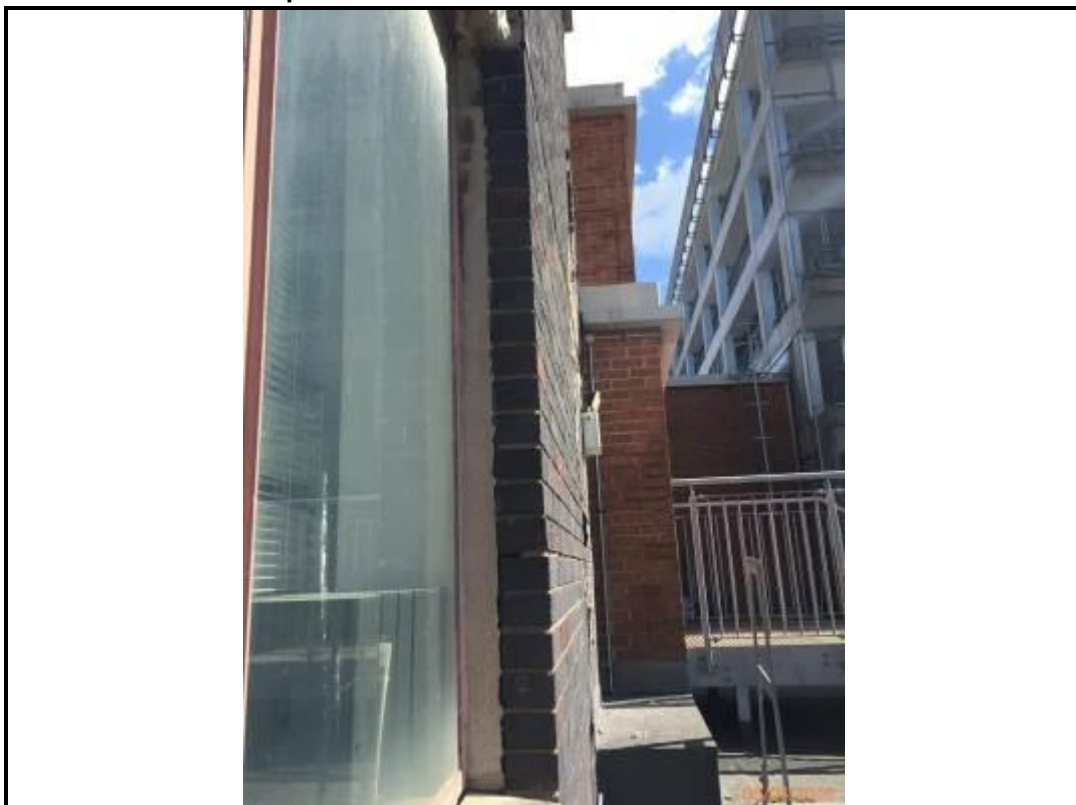
**Photo 63. Drop 2 – South Elevation**

| Photo 63 | Vertical stepped fracture through brickwork, located in line with the lower half of window row 3 = 700mm H x 5 – 25mm |

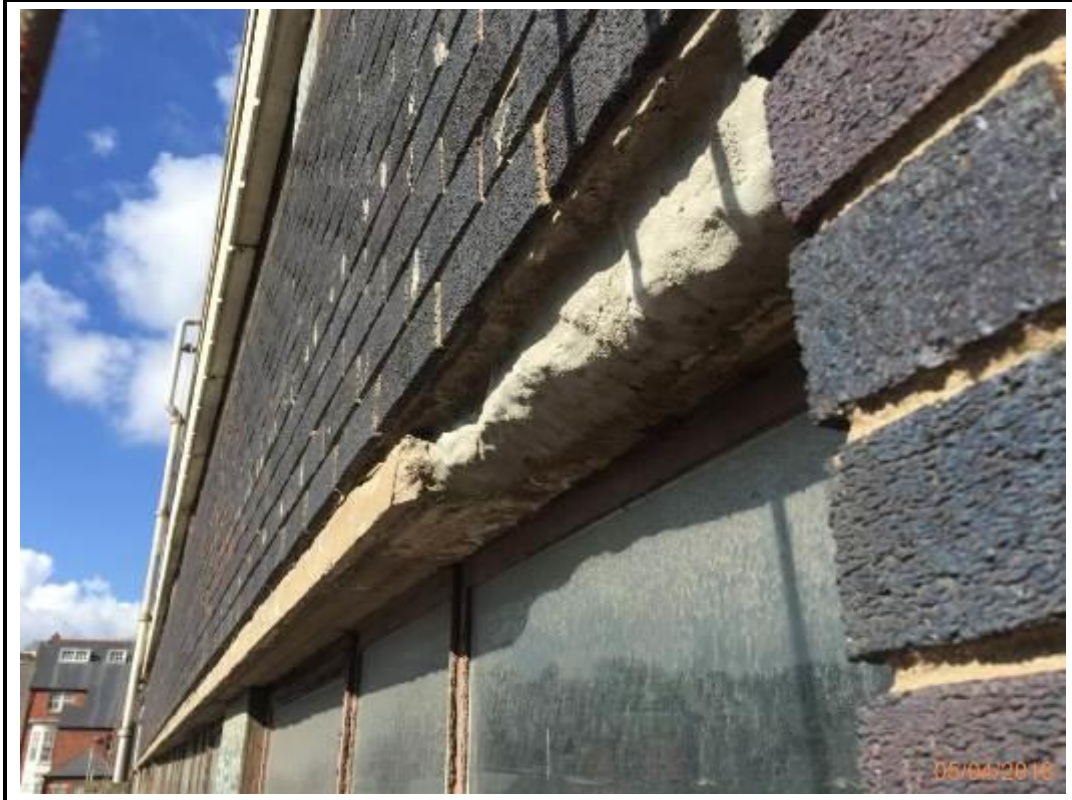
**Photo 64. Drop 2 – South Elevation**

| Photo 64 | Vertical separation of brickwork cladding, in line with window row 4 beneath B1 = 1.7m H x HL-4mm wide |

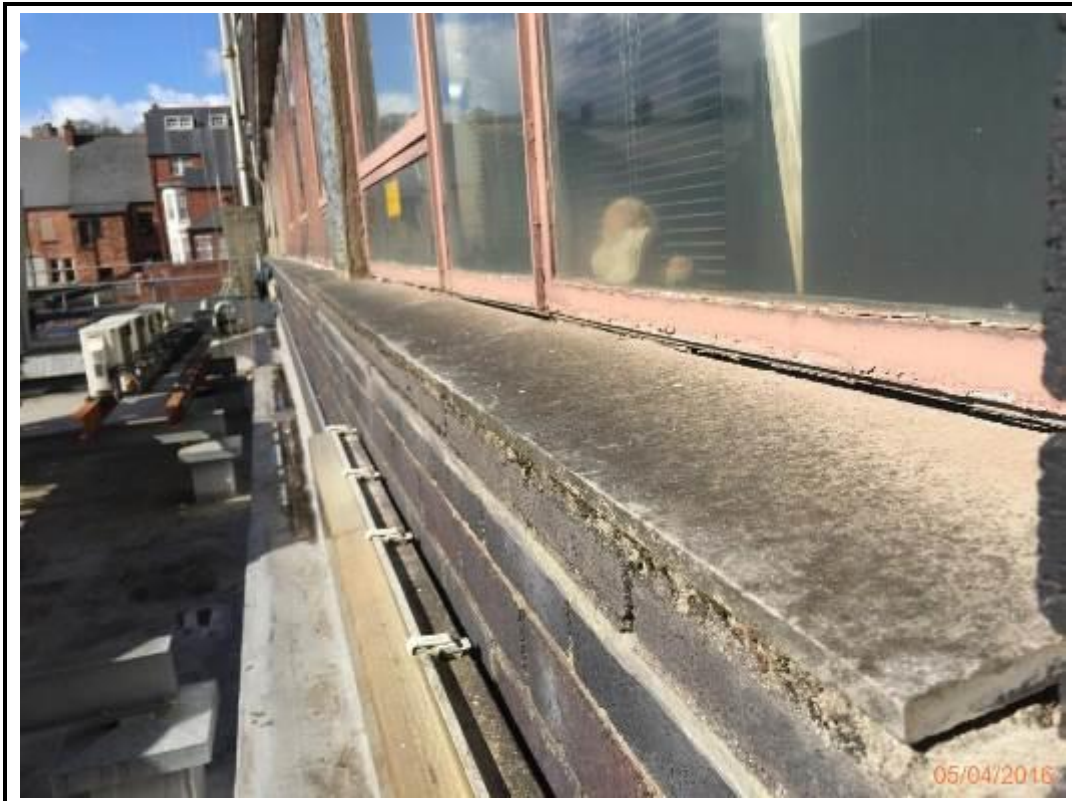
**Photo 65. Drop 2 – South Elevation**

| Photo 65 | Immanent intermittent spalling throughout full length of window row 4 lintel, between drops 2 and 13 |

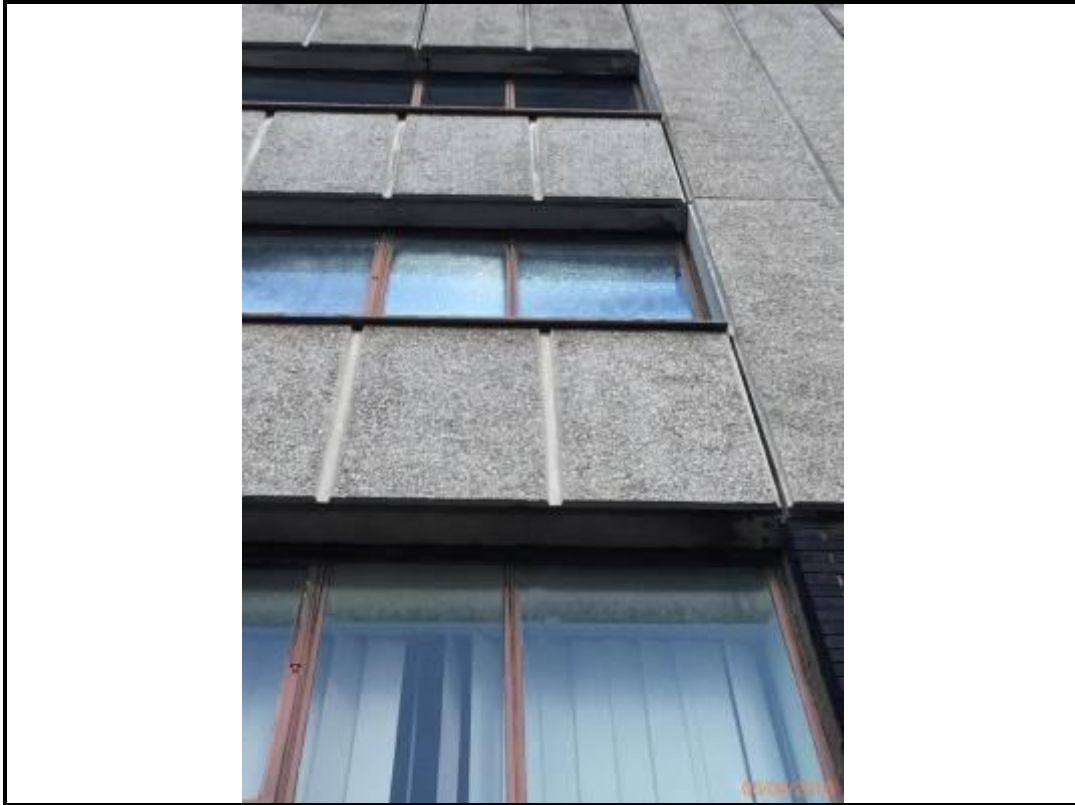
**Photo 66. Drop 2 – South Elevation**

| Photo 66 | Window row 4 cill loose intermittently throughout full length between drops 2 and 13 |

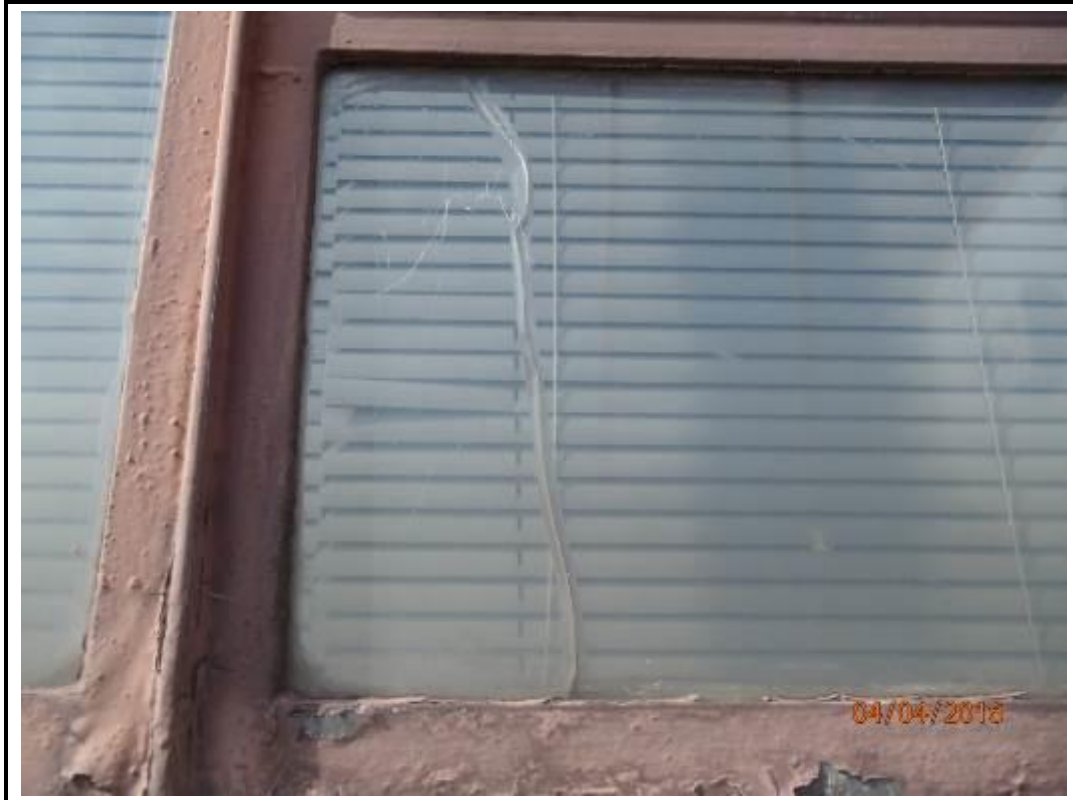
**Photo 72. Drop 3 – South Elevation**

| Photo 72 | Horizontal fracture through glass, centre of window row 4, beneath B4 = 550mm L x HL W |

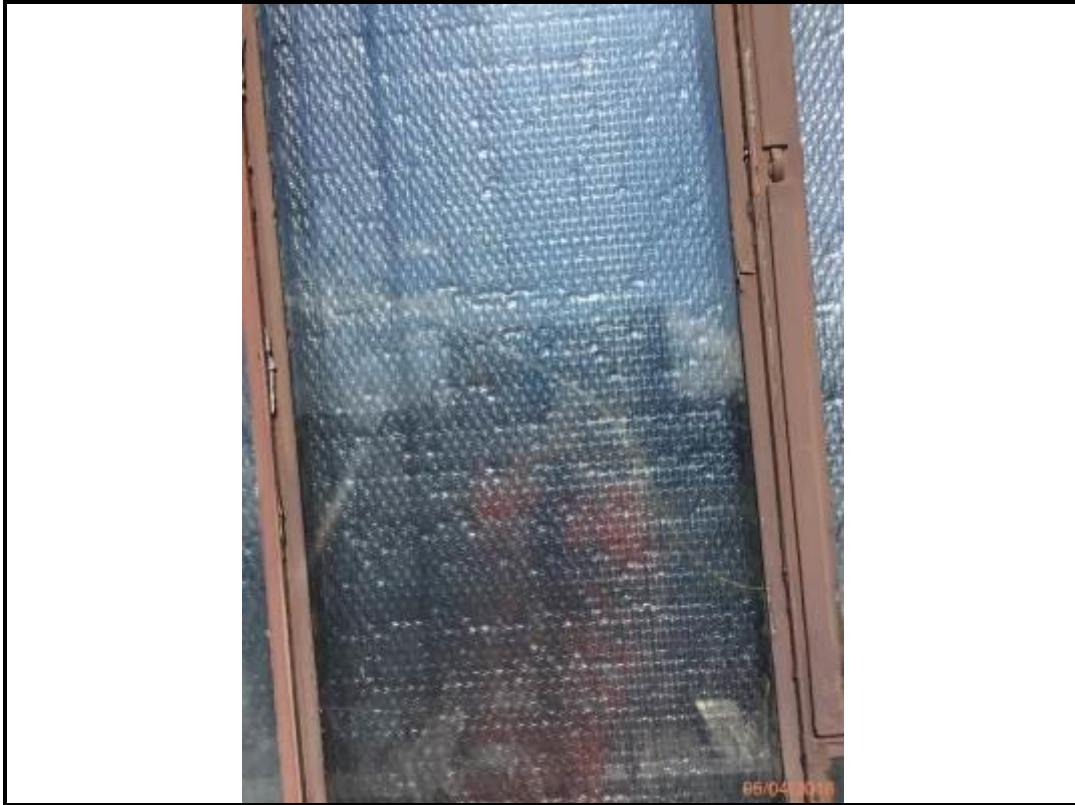
**Photo 78. Drop 5 – South Elevation**

| Photo 78 | Vertical fracture through glass, bottom half of window row 1, beneath T1 = 335mm H x HL W |

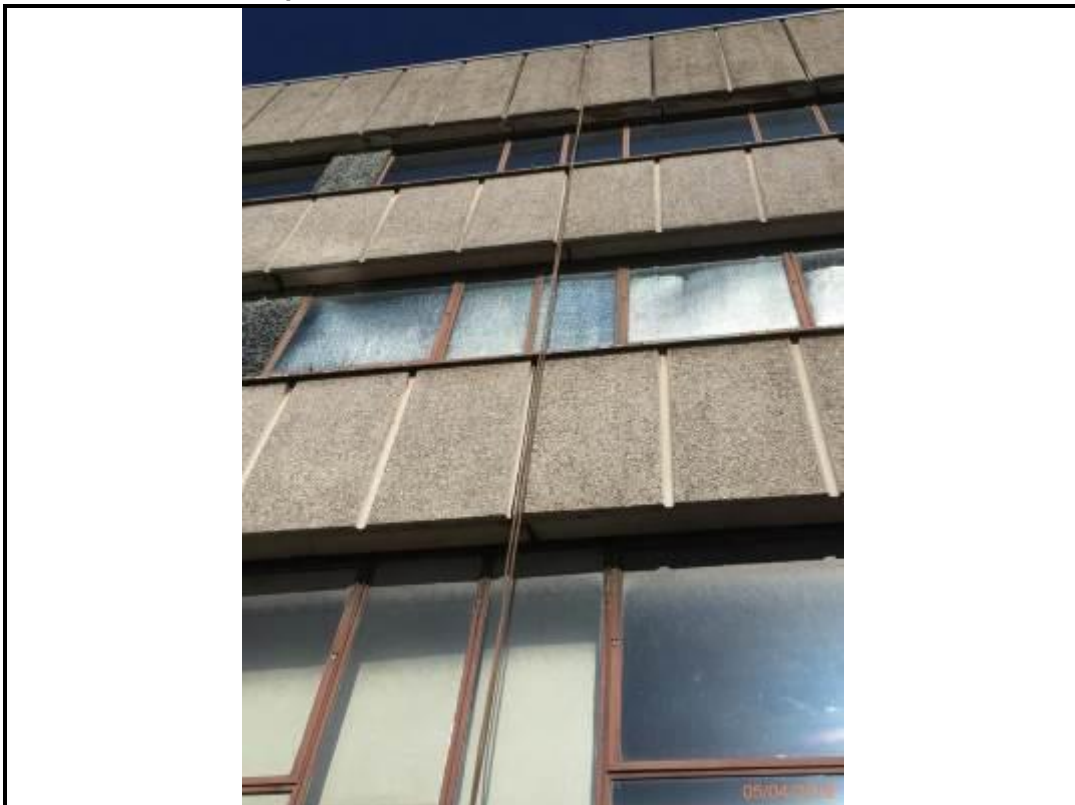
**Photo 79. Drop 5 – South Elevation**

| Photo 79 | Diagonal fracture through glass, centre of window row 2, beneath M2 & 3 = 700mm L x HL W |

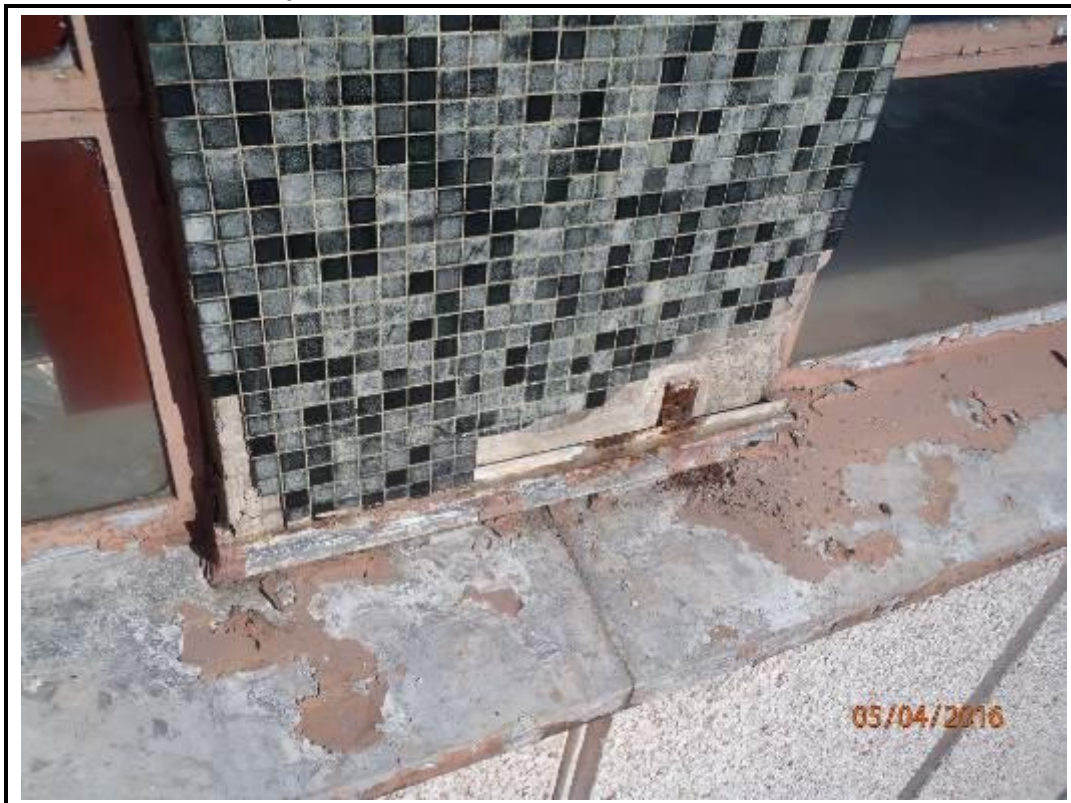
Photo 81. Drop 6 –South Elevation

| Photo 81 | Spalling to the underside T1 = 20mm H x 130mm W x 40mm D |

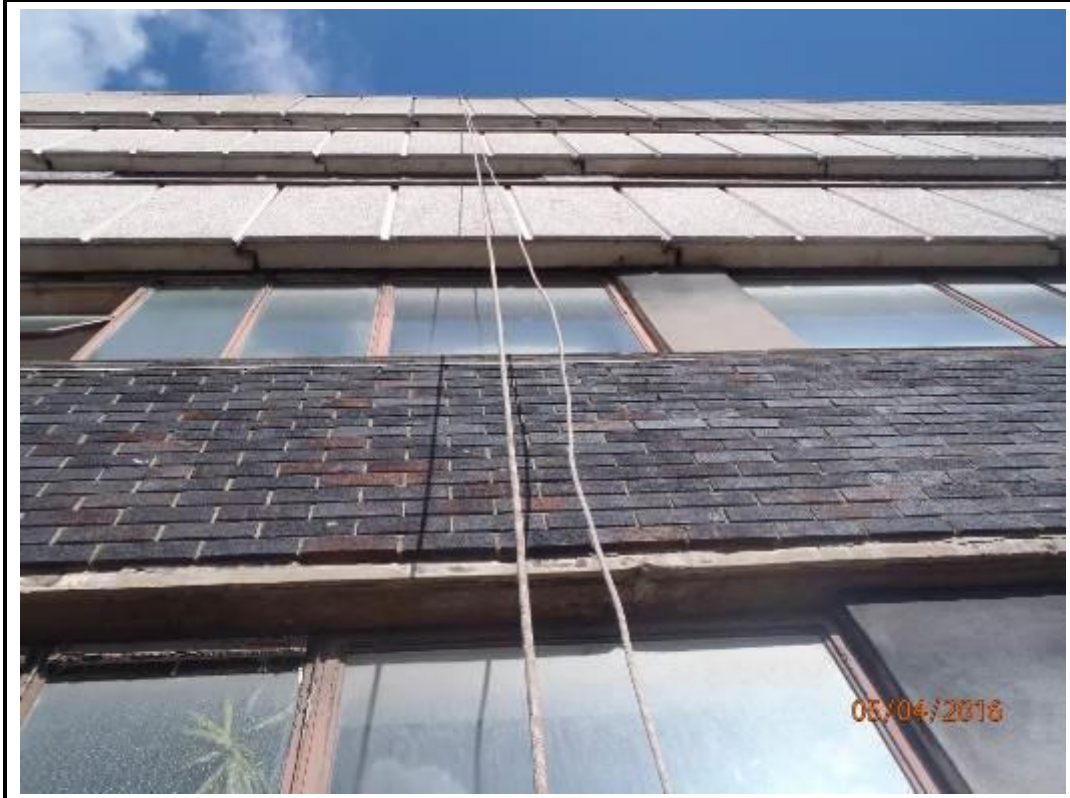
Photo 82. Drop 6 – South Elevation

| Photo 82 | Spalling to the bottom east corner of the window row 1 column beneath T1 & 2 = 20mm |

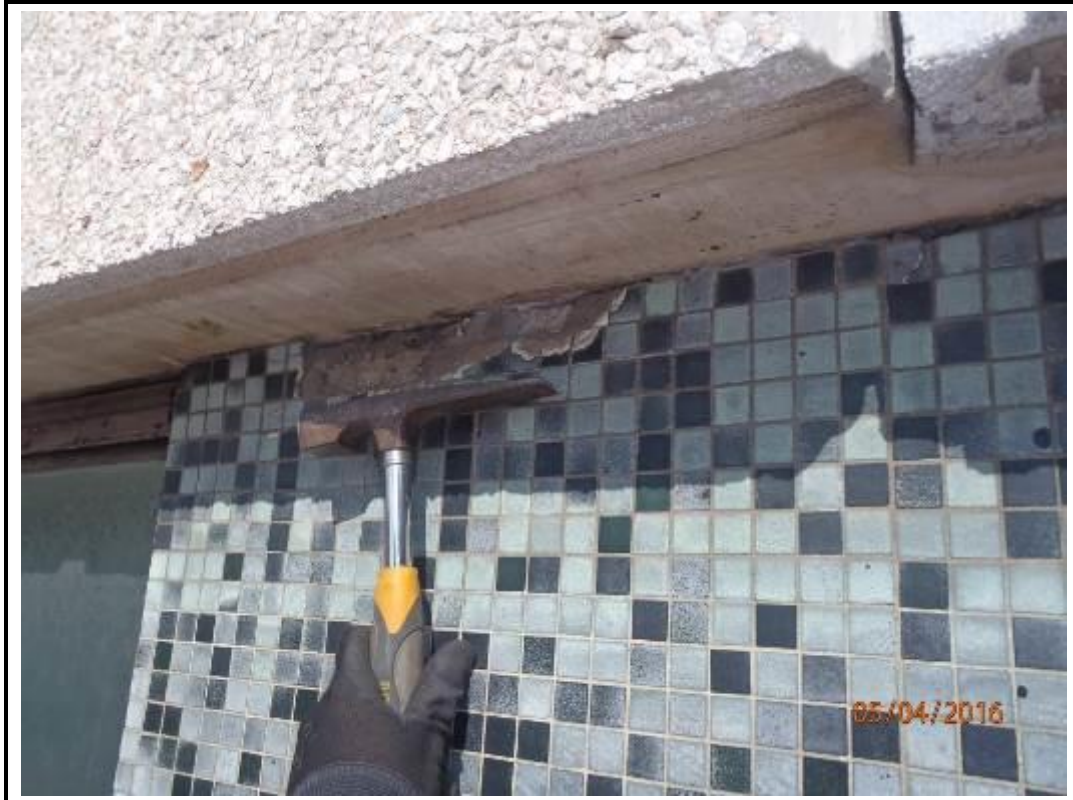
**Photo 84. Drop 7 – South Elevation**

| Photo 84 | Spalling to the bottom west corner of the window row 1 column beneath T3 & 4 = 360mm H x 25mm W x 40mm D |

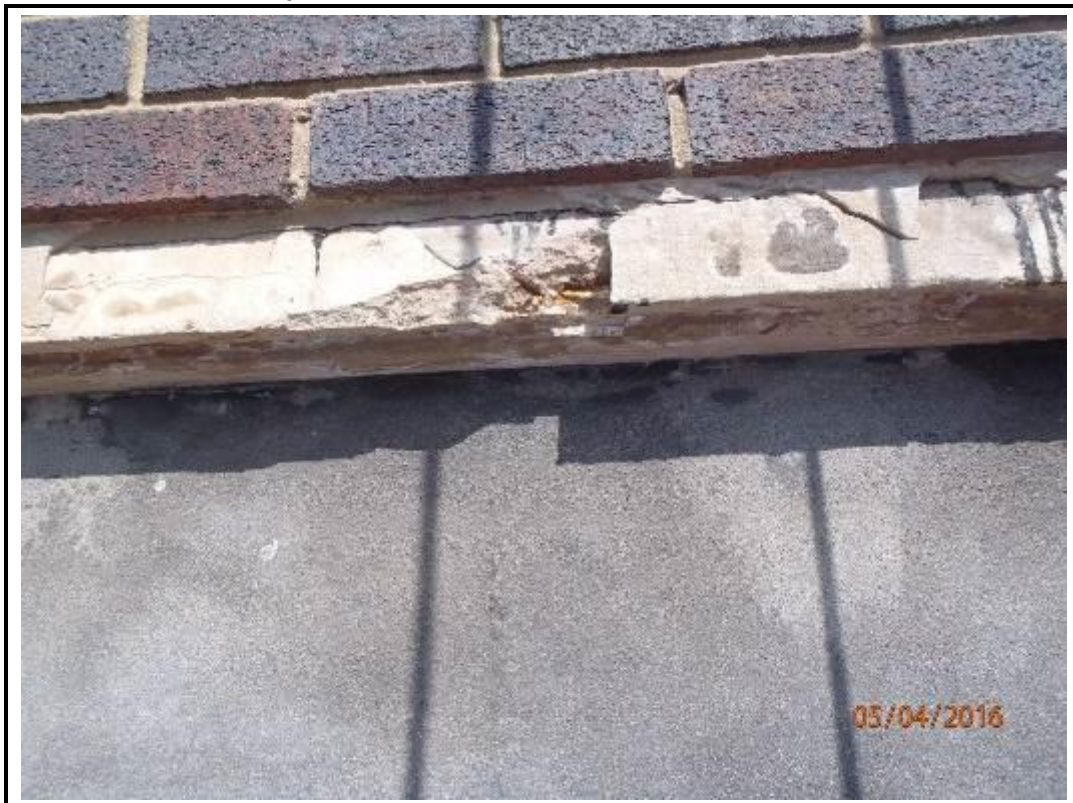
Photo 85. Drop 7 – South Elevation

| Photo 85 | Spalling to the top west corner of the window row 2 column beneath M3 & 4 = 50mm H x 270mm W x 20mm D |

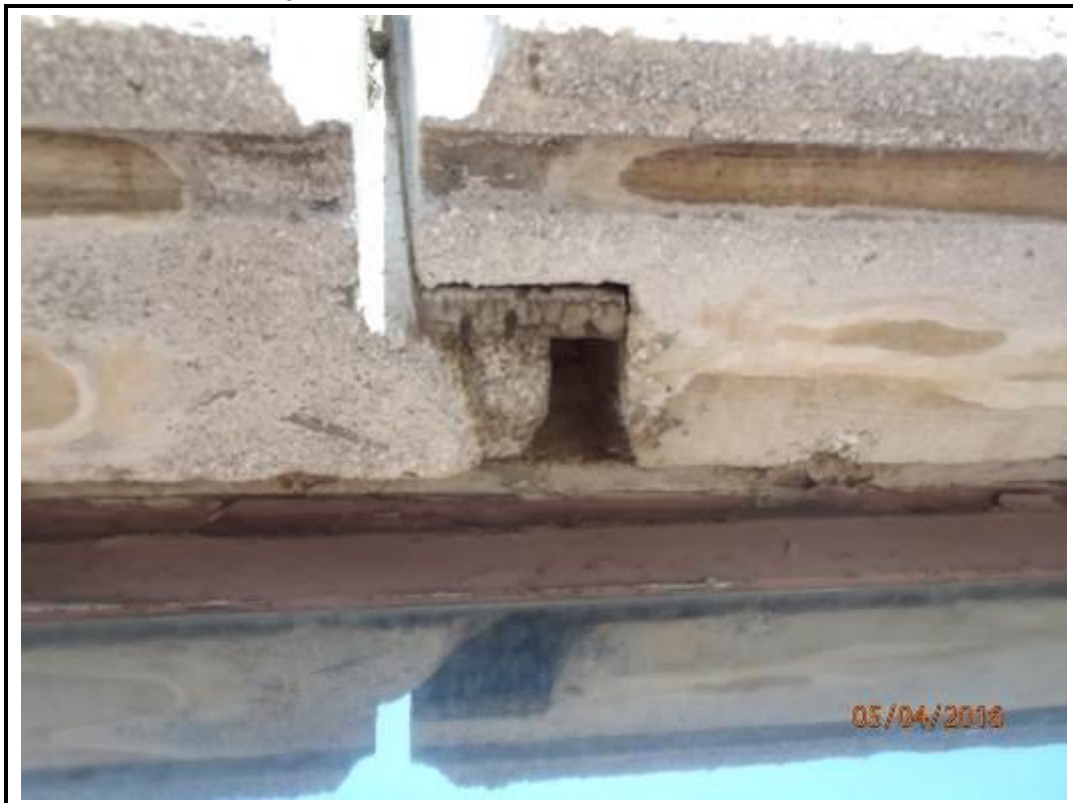
**Photo 89. Drop 8 – South Elevation**

| Photo 89 | Intermittent spalling along the east edge of T2 = 1m H (total linear height) x 20mm W x 70mm D, exposed reinforcement subsequently corroded |

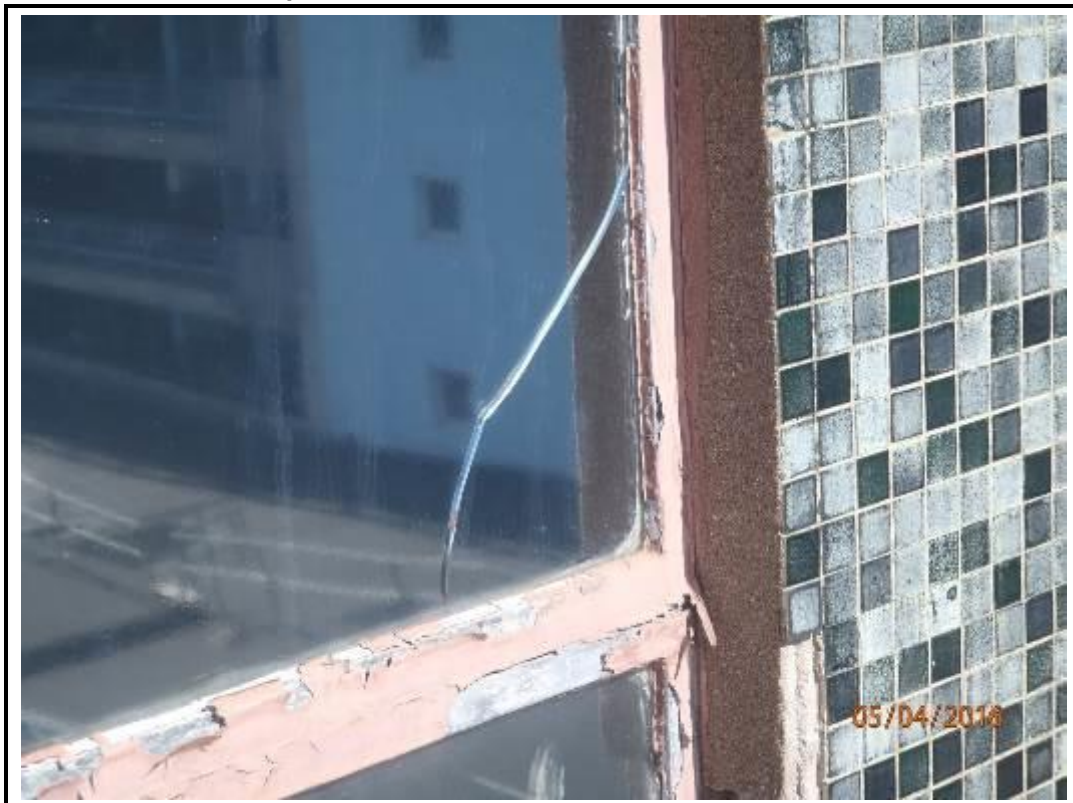
Photo 91. Drop 8 – South Elevation

| Photo 91 | Horizontal fracture through glass, centre line of window row 1, beneath T3 = 530mm L x HL W |

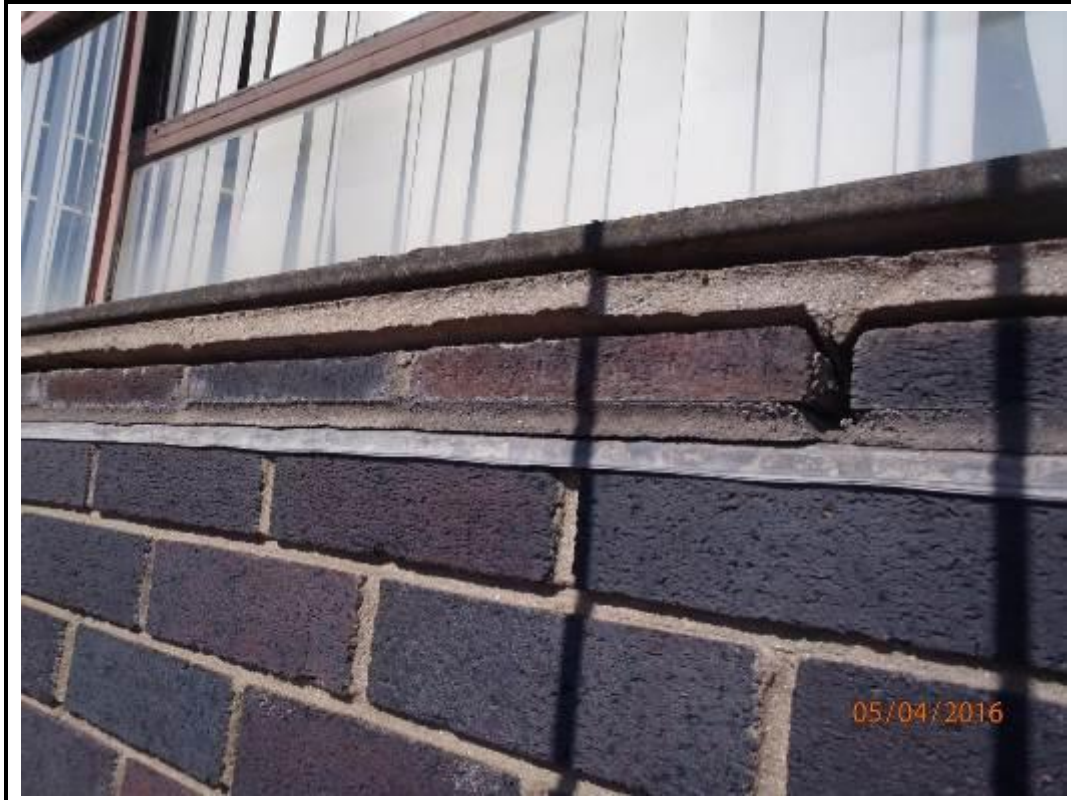
**Photo 96. Drop 9 – South Elevation**

| Photo 96 | Missing facing tiles to the bottom half of the window row 2 column beneath M1 & 2 = 700mm H x 610mm W x 20mm D |

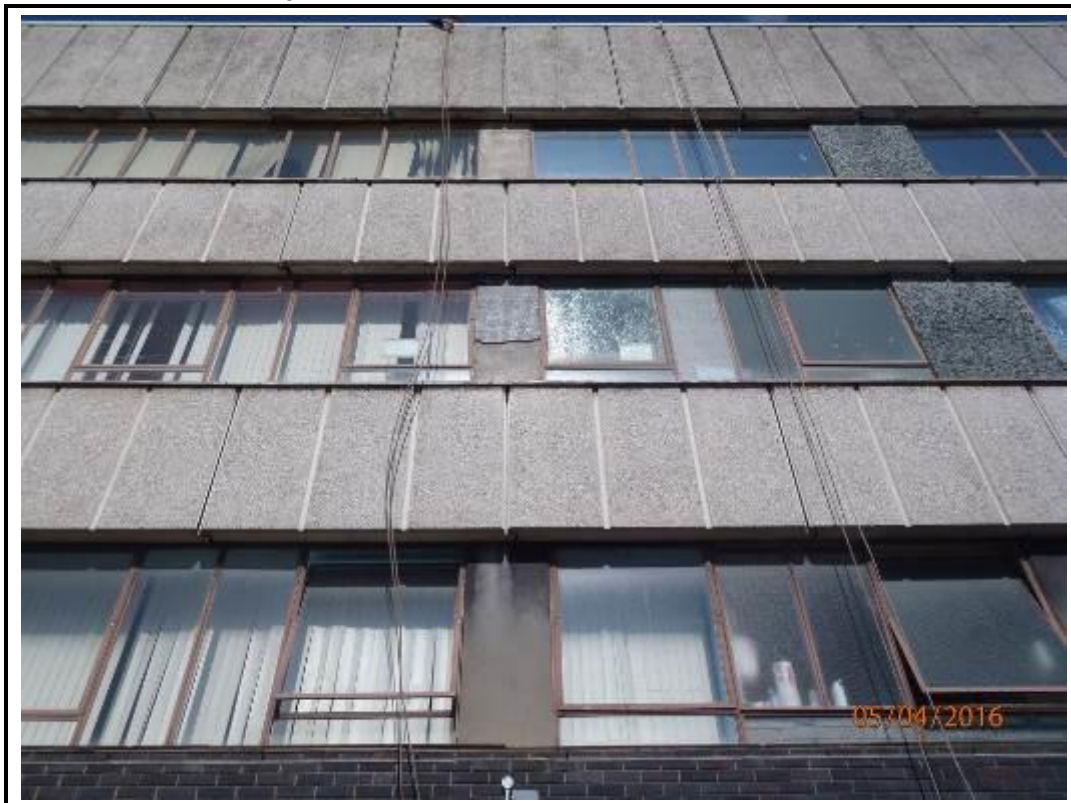
**Photo 97. Drop 9 – South Elevation**

| Photo 97 | Typical displacement and loose window row 4 cill (defect extend intermittently full span of window row 4 between drops 2 and 13) |

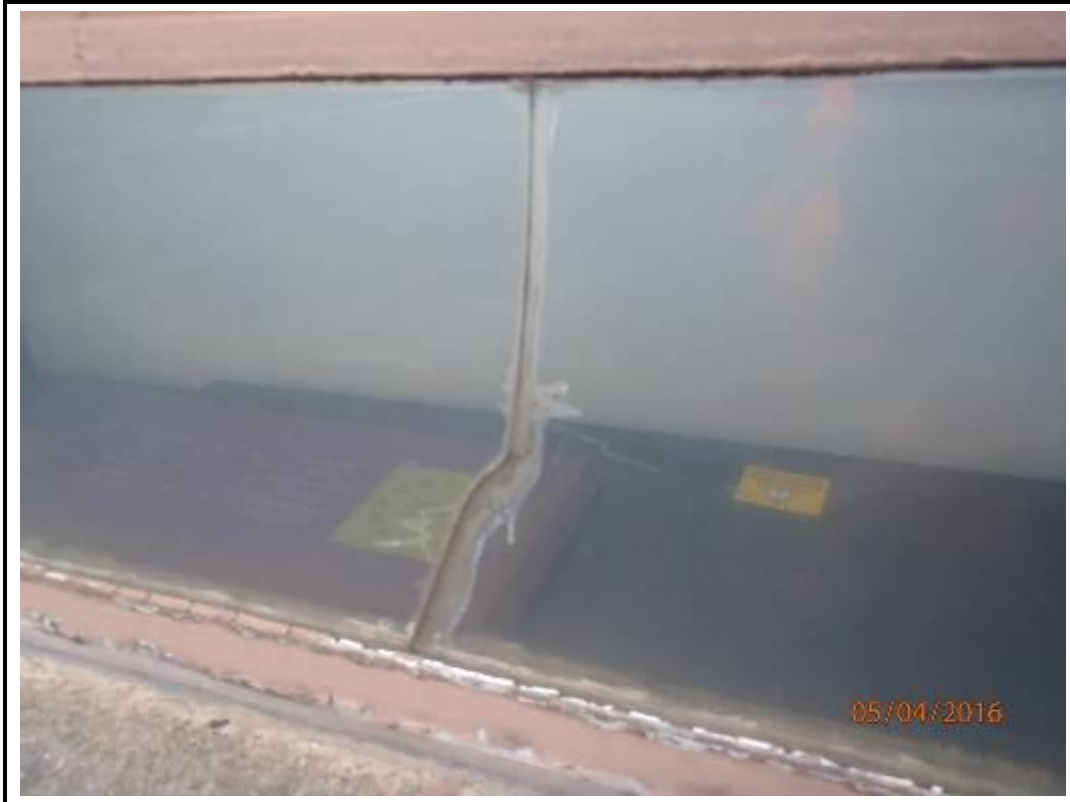
Photo 100. Drop 10 – South Elevation

| Photo 100 | Vertical fracture through glass, bottom half of window row 1, beneath T2 = 400mm L x HL W |

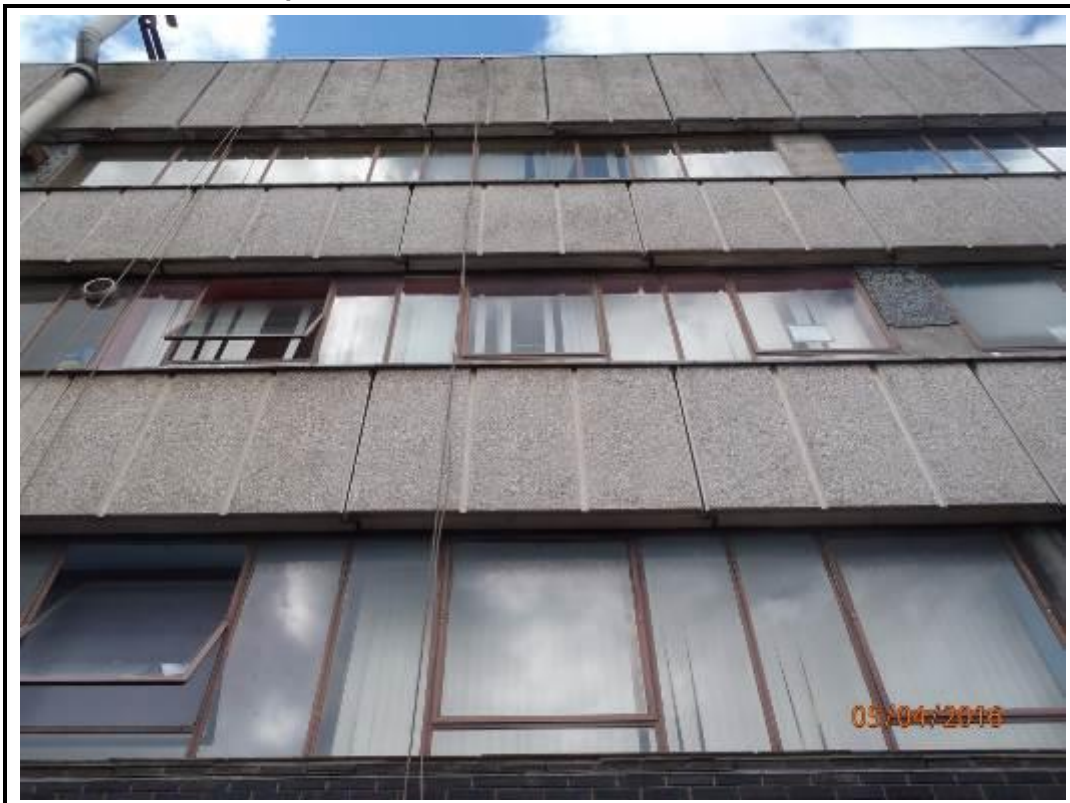
**Photo 101. Drop 10 – South Elevation**

| Photo 101 | Vertical fracture through glass, bottom half of window row 4, beneath B2 = 220mm L x HL W |

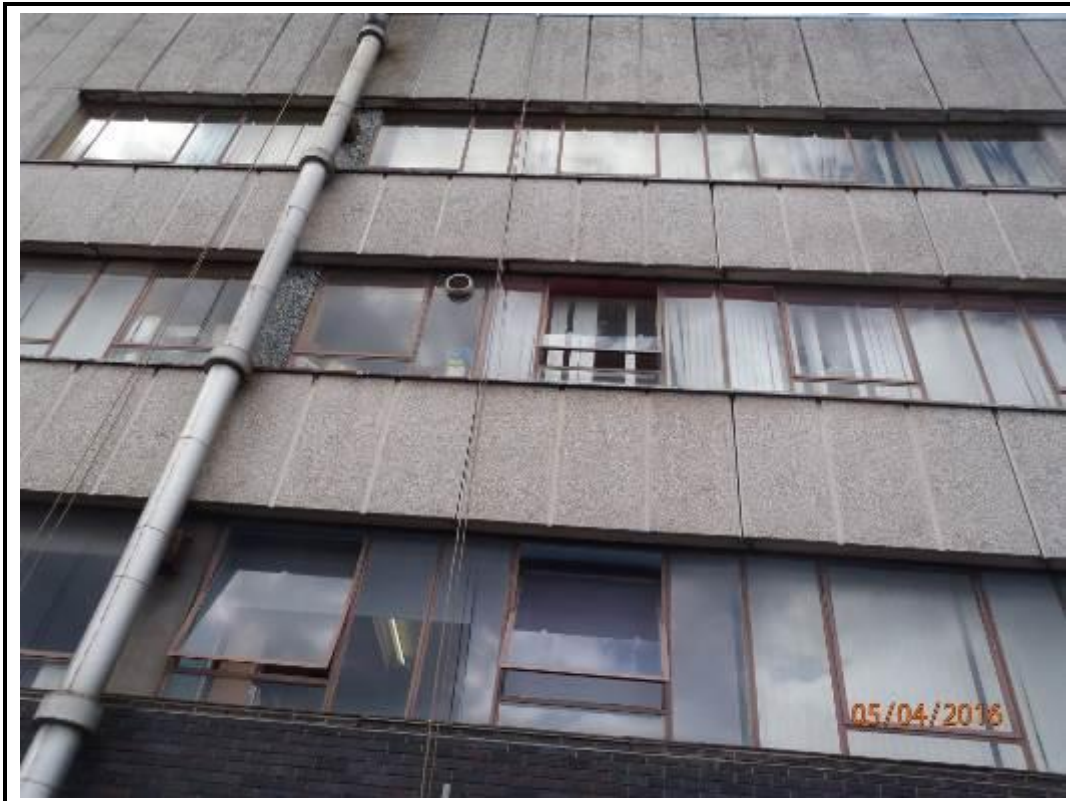
**Photo 103. Drop 11 – South Elevation**

| Photo 103 | General remark – 250mm diameter air vent in glass, window row 2 beneath M3 |

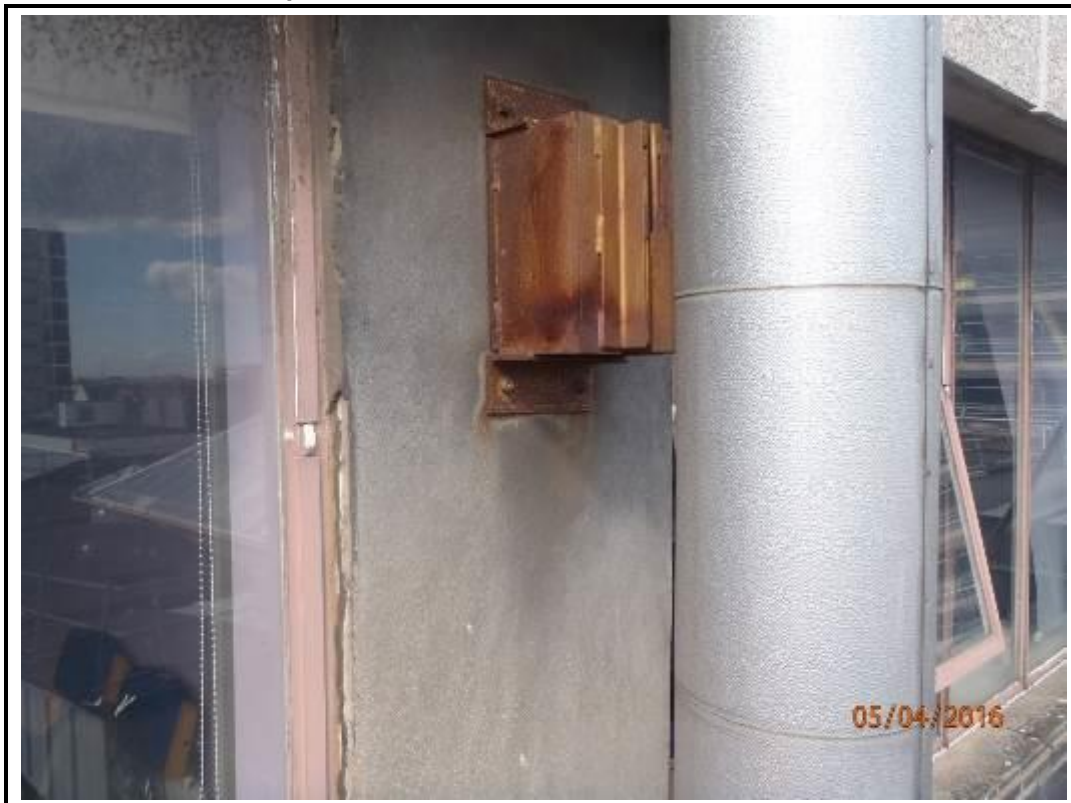
Photo 105. Drop 12 – South Elevation

| Photo 105 | General feature – external duct fitting fixed to the column in window row 1 beneath T1 and 2 |
