**CONCRETE STRUCTURE ASSESSMENT REPORT  
NEWPORT CENTRAL LIBRARY  
NEWPORT**

**Date: 20<sup>TH</sup> JULY 2016**  
**Ref: BH.DB/16027.01.D001**

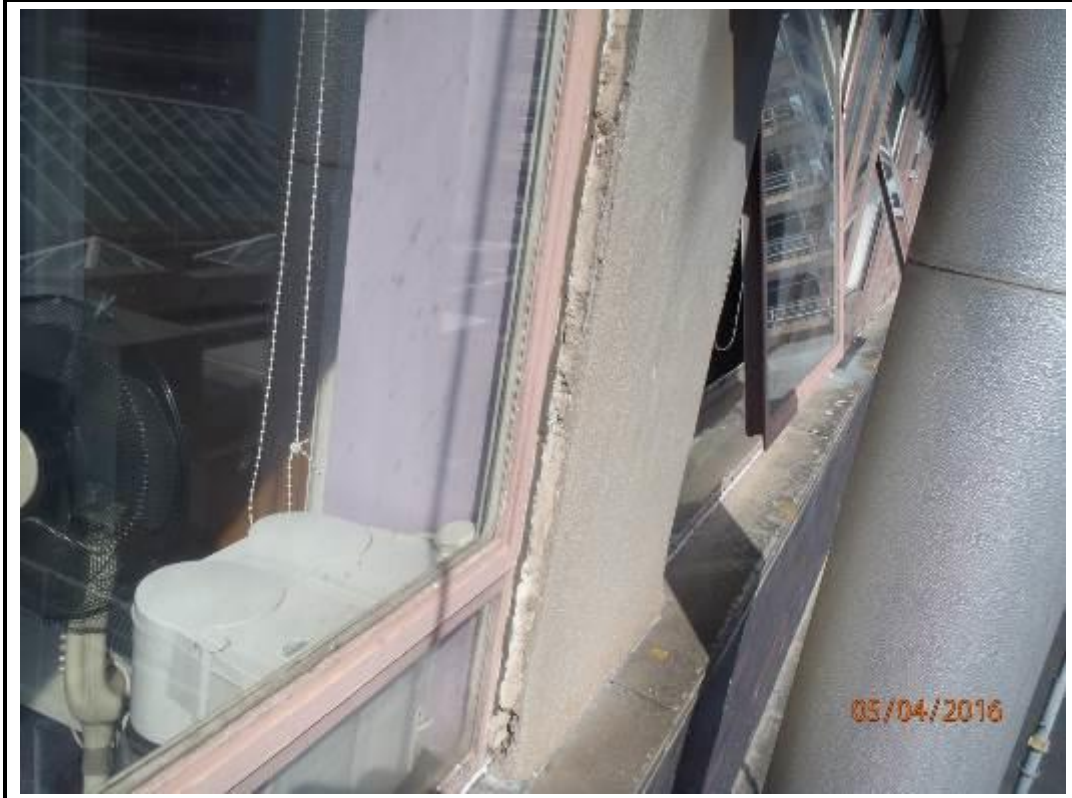
Photo 106. Drop 12 – South Elevation

| Photo 106 | General feature – external duct fitting fixed to the column in window row 3 beneath B1 and 2 |

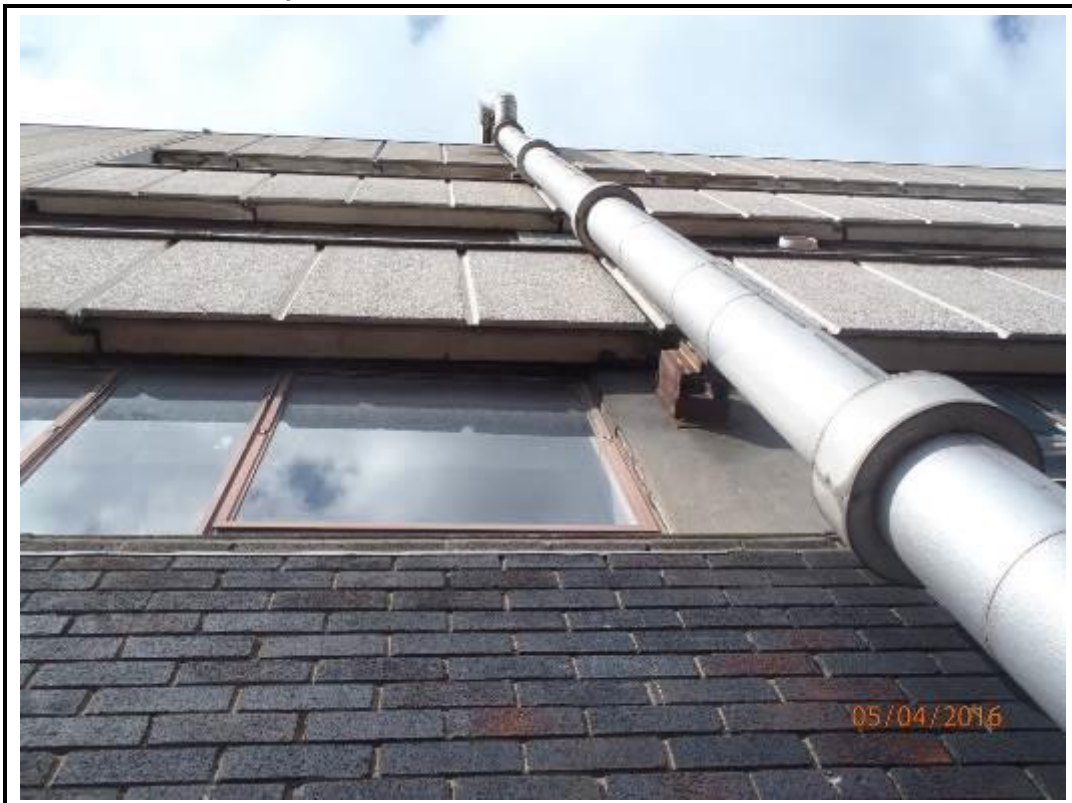
**Photo 107. Drop 12 – South Elevation**

| Photo 107 | Sporadic spalling to the east edge of column in window row 4 beneath B1 and 2 <0.1m <sup>2</sup> x 10mm D |

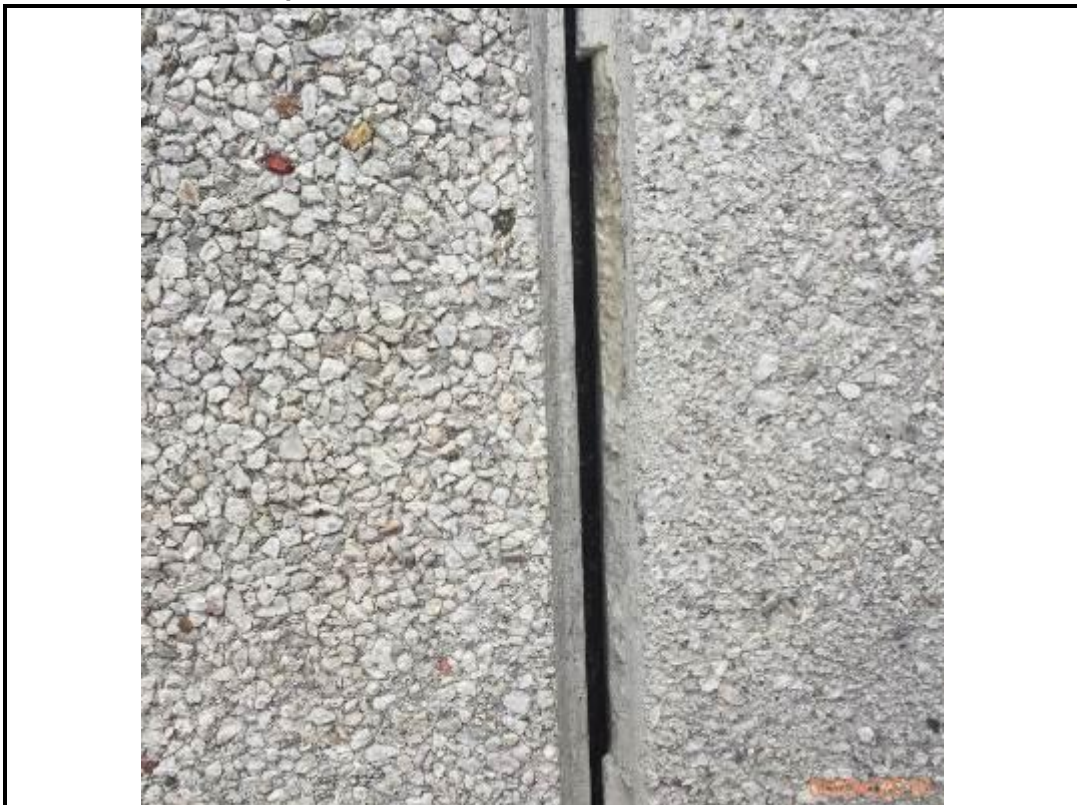
**Photo 109. Drop 13 – South Elevation**

| Photo 109 | Spalling to the top of west edge of T3 = 130mm H x 15mm W x 20mm D |

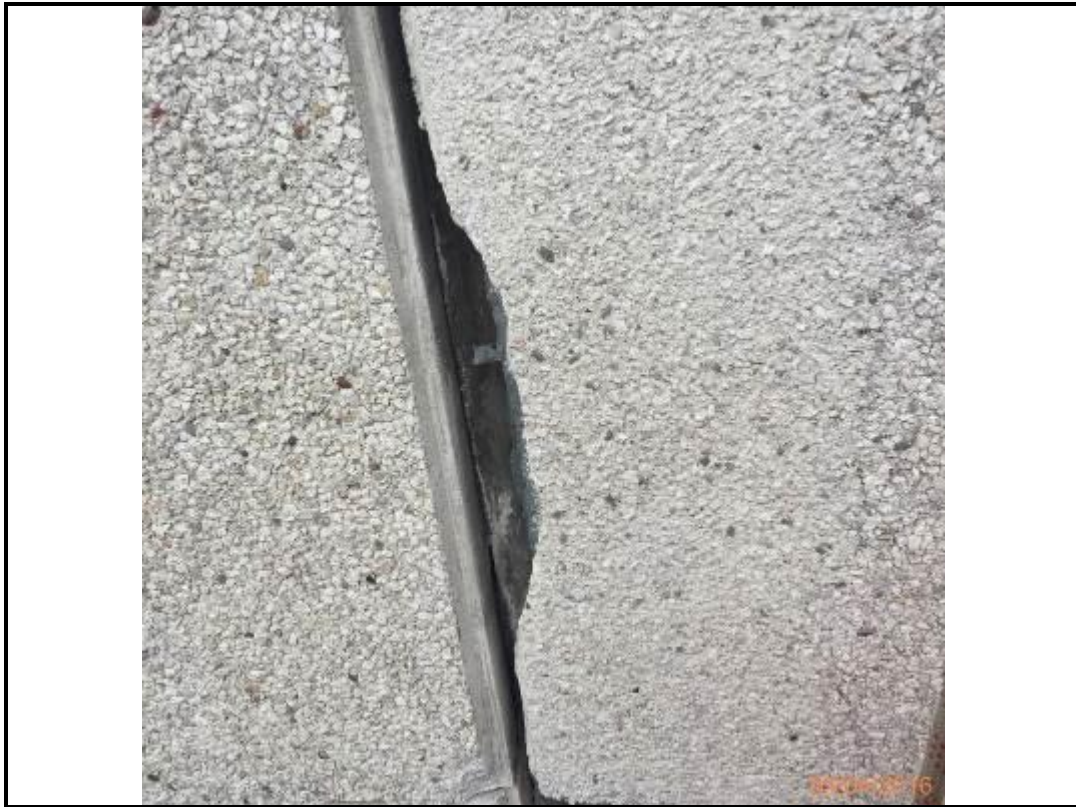
**Photo 110. Drop 13 – South Elevation**

| Photo 110 | Spalling to the west edge of M3 = 440mm H x 30mm W x 15mm D |

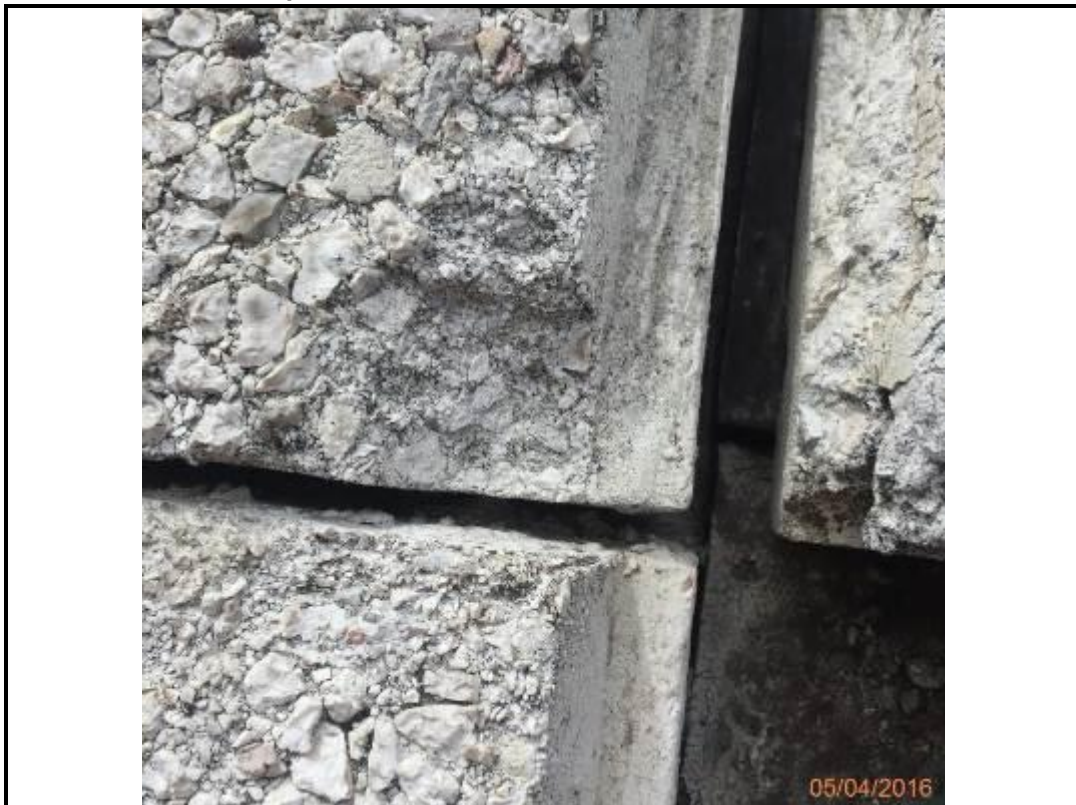
**Photo 111. Drop 13 – South Elevation**

| Photo 111 | Spalling to the west edge of M3 = 1.1m H x 60mm W x 80mm D |

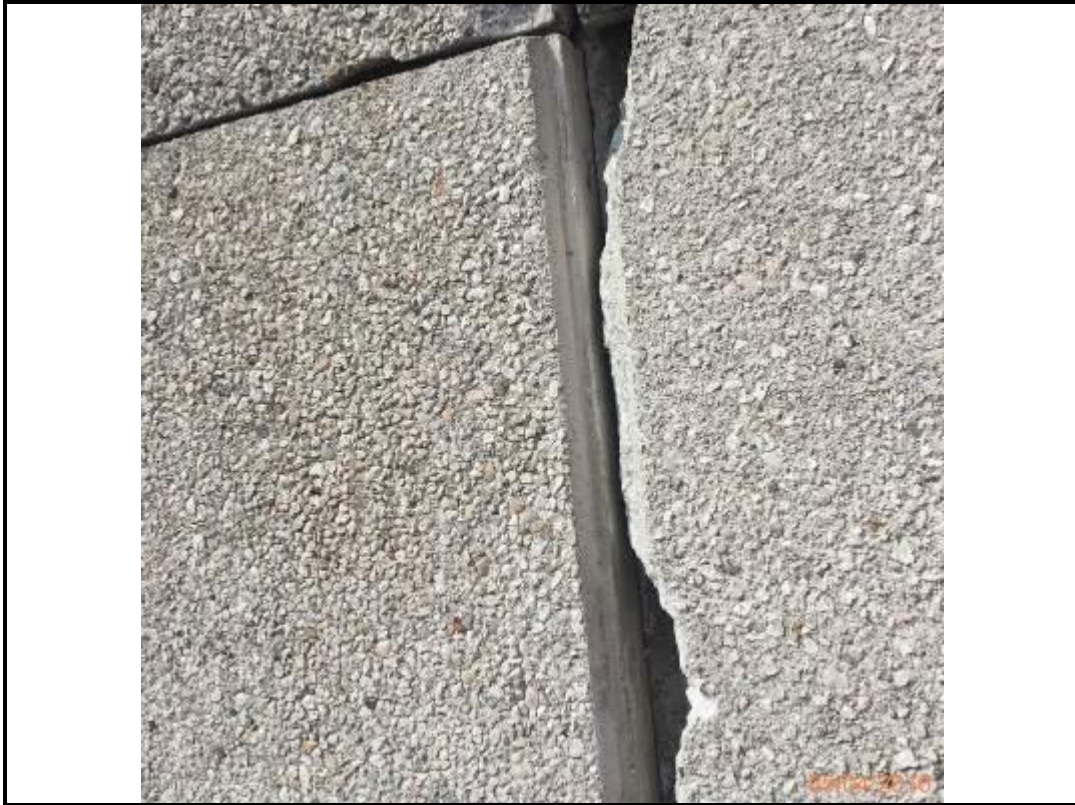
**Photo 112. Drop 13 – South Elevation**

| Photo 112 | Spalling to the bottom east corner of M4 = 40mm H x 50mm W x 15mm D |

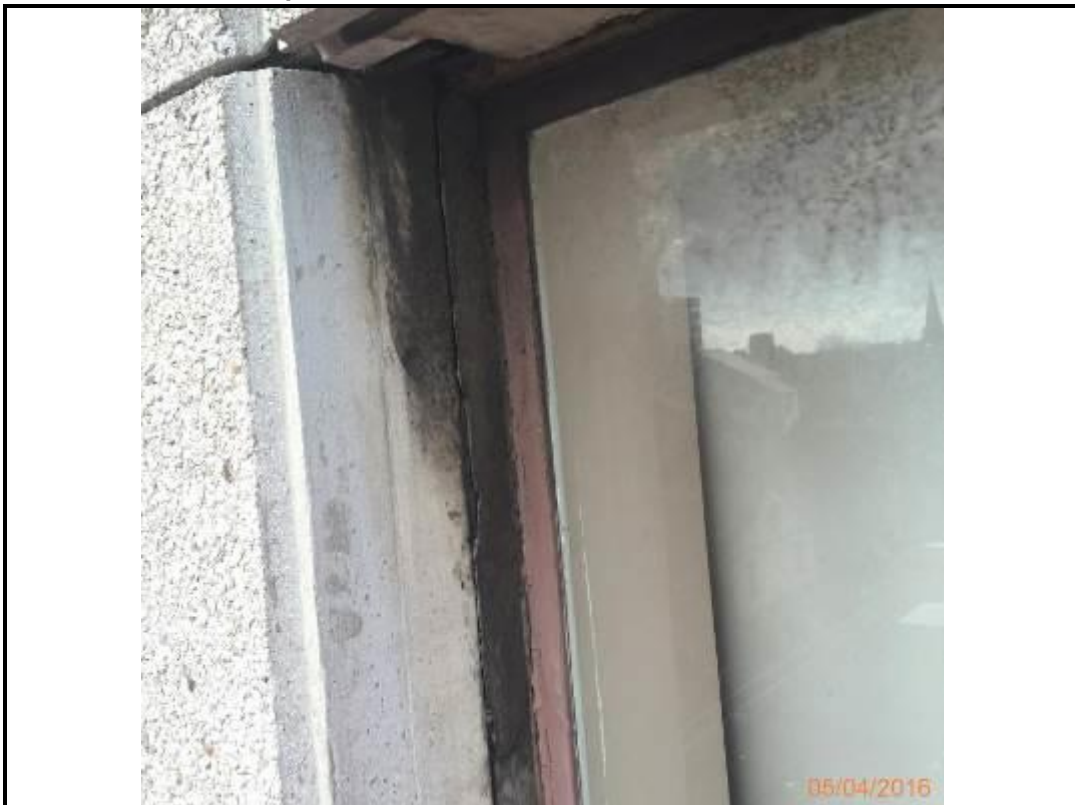
**Photo 113. Drop 13 – South Elevation**

| Photo 113 | Spalling to the top of west edge of B3 = 760mm H x 70mm W x 80mm D |

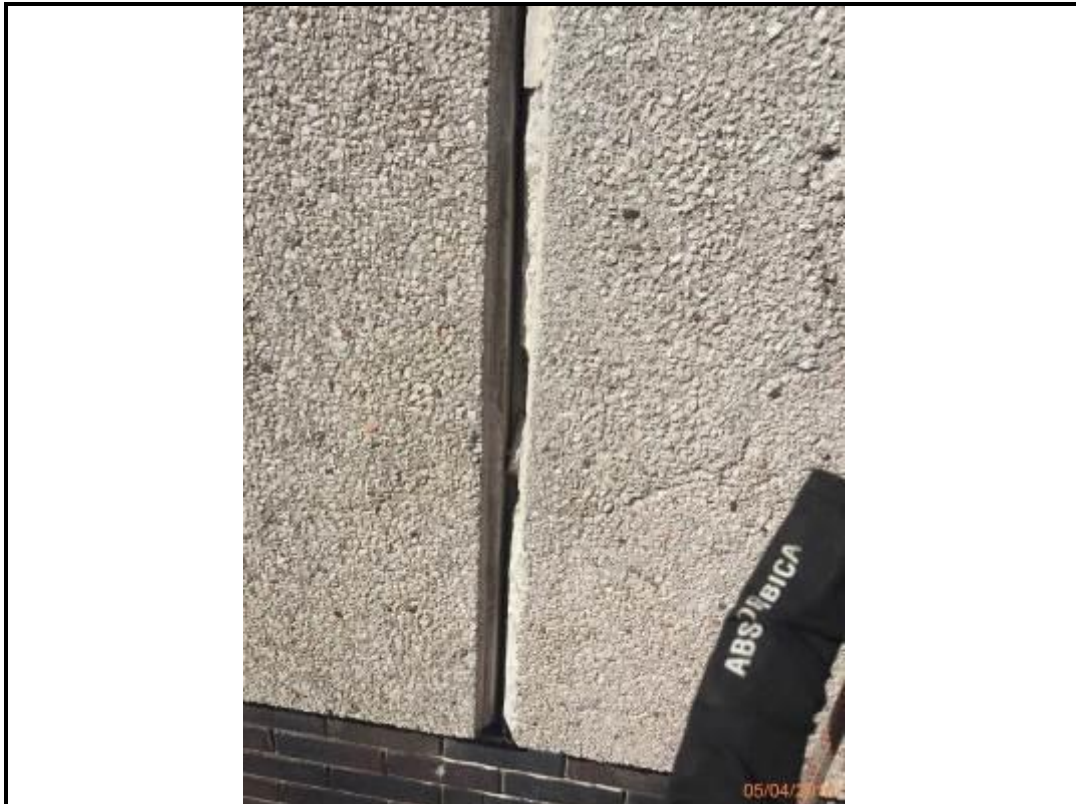
**Photo 114. Drop 13 – South Elevation**

| Photo 114 | Imminent spalling to the top of east edge of B3 = 550mm H x 50mm W |

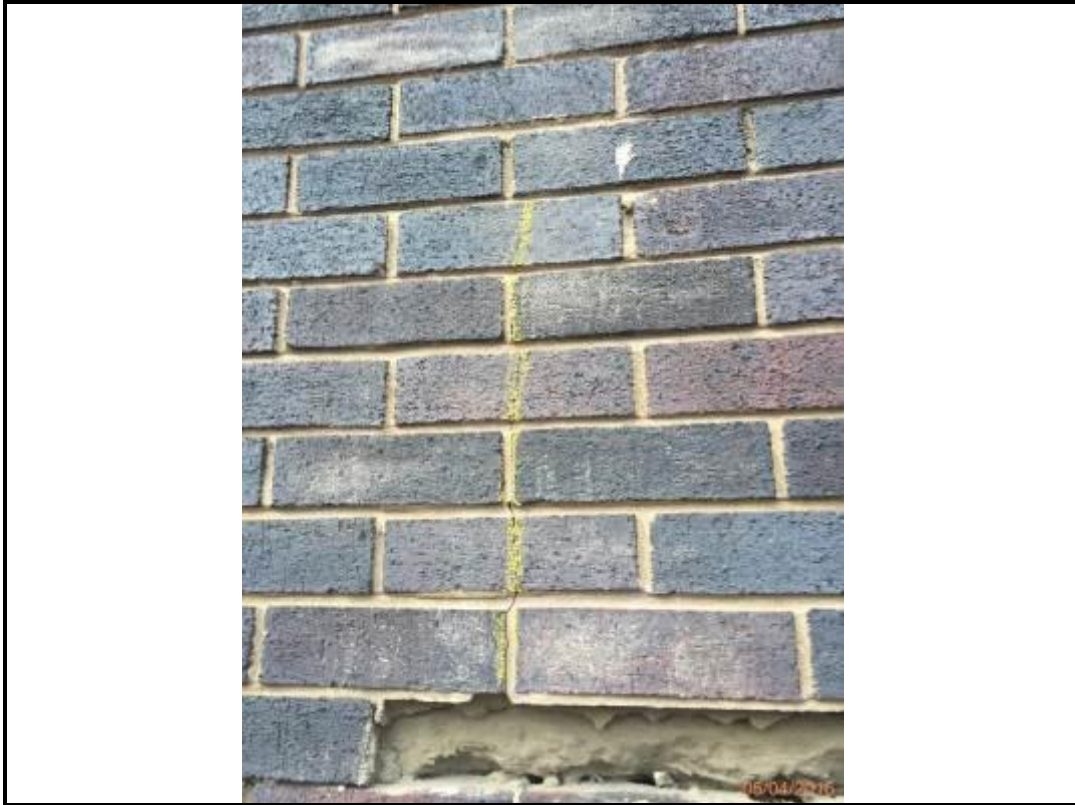
**Photo 116. Drop 13 – South Elevation**

| Photo 116 | Vertical stepped fracture through brickwork beneath window row 3 beneath B2 = 1m H x HL-2mm W |

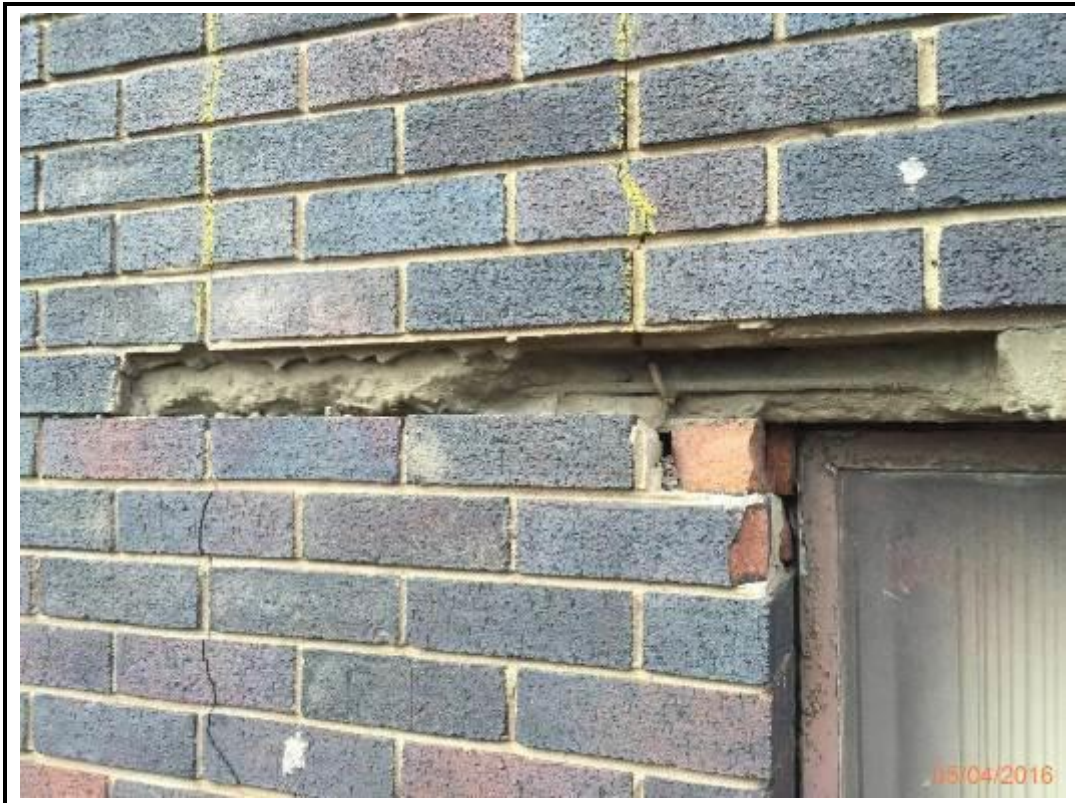
**Photo 117. Drop 13 – South Elevation**

| Photo 117 | Vertical fracture through brickwork beneath B3 = 450m H x HL-2mm W |

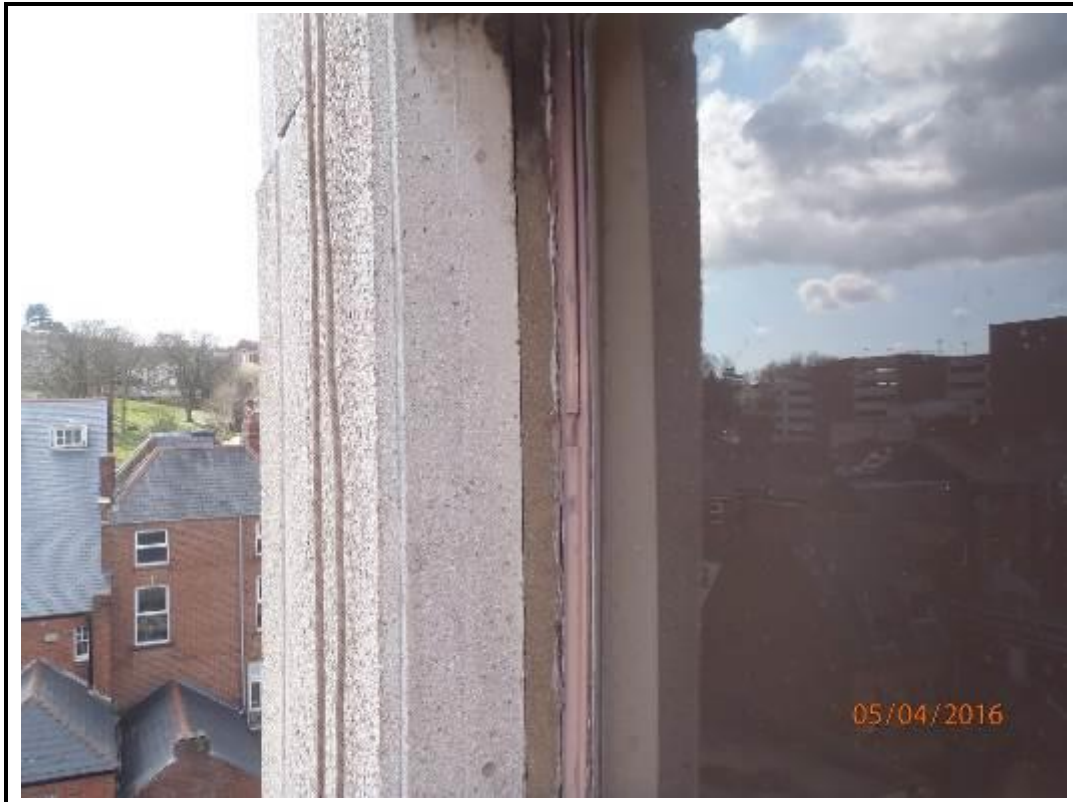
**Photo 122. Drop 14 – South Elevation**

| Photo 122 | Separation fracture to the east side of window 1 = 1.1m H x 3-4mm W |

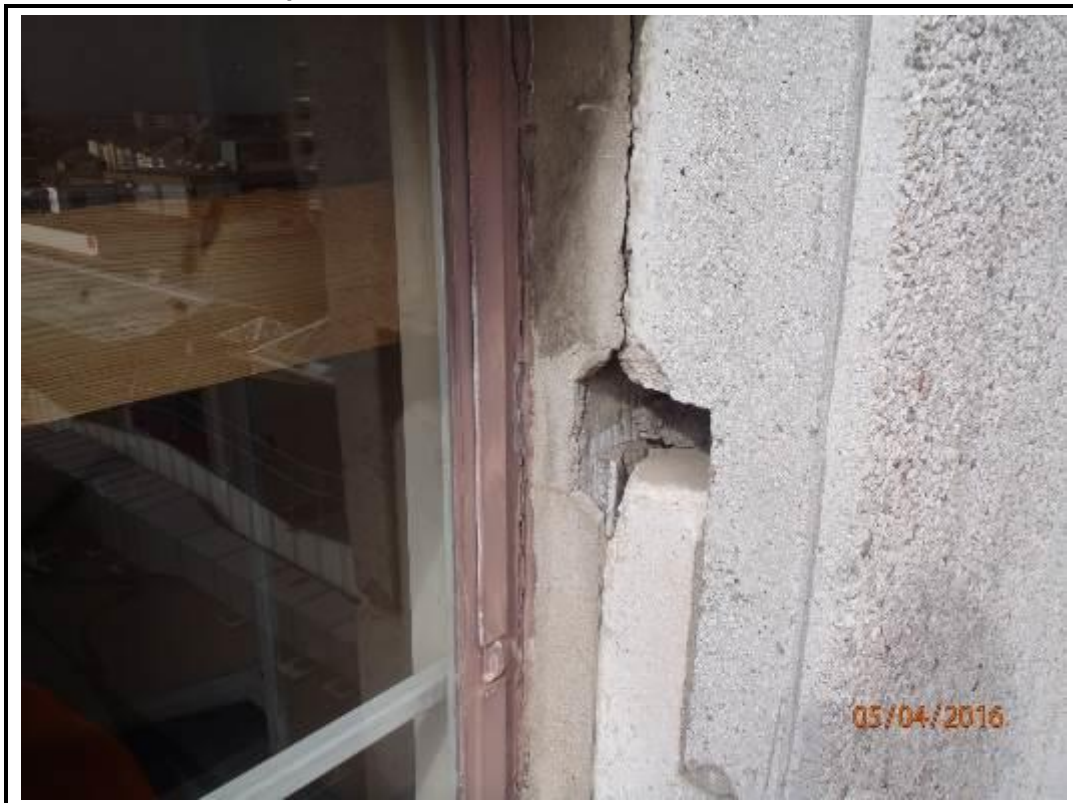
Photo 123. Drop 14 – South Elevation

| Photo 123 | Separation fracture to the west side of window 1 = 1.1m H x 1-2mm W |

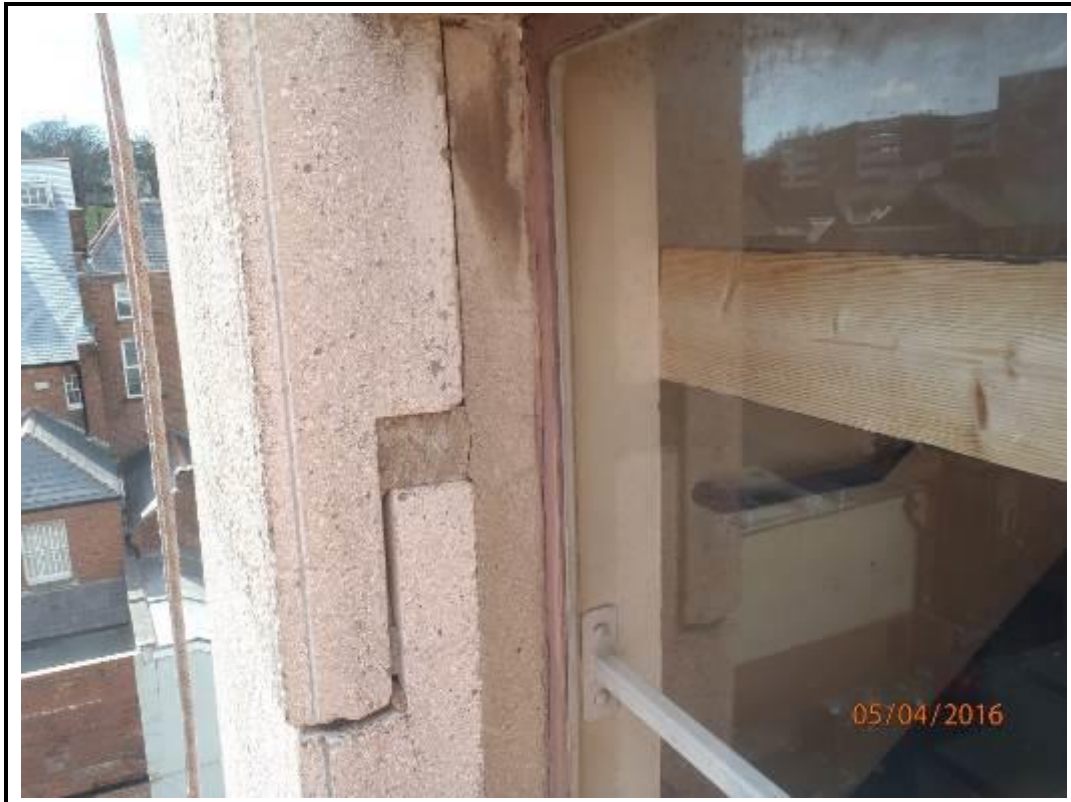
Photo 124. Drop 14 – South Elevation

| Photo 124 | Separation fracture to the east side of window 2 = 1.1m H x 2-5mm W |

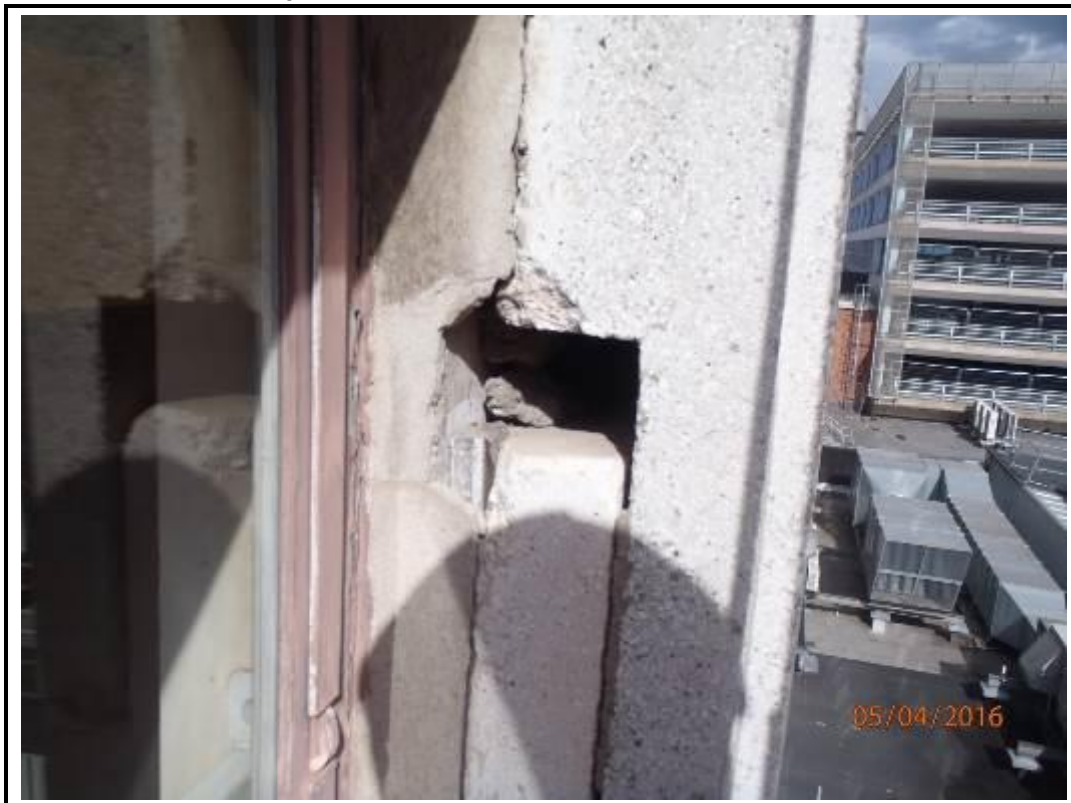
**Photo 125. Drop 14 – South Elevation**

| Photo 125 | Separation fracture to the west side of window 2 = 1.1m H x HL-2mm W |

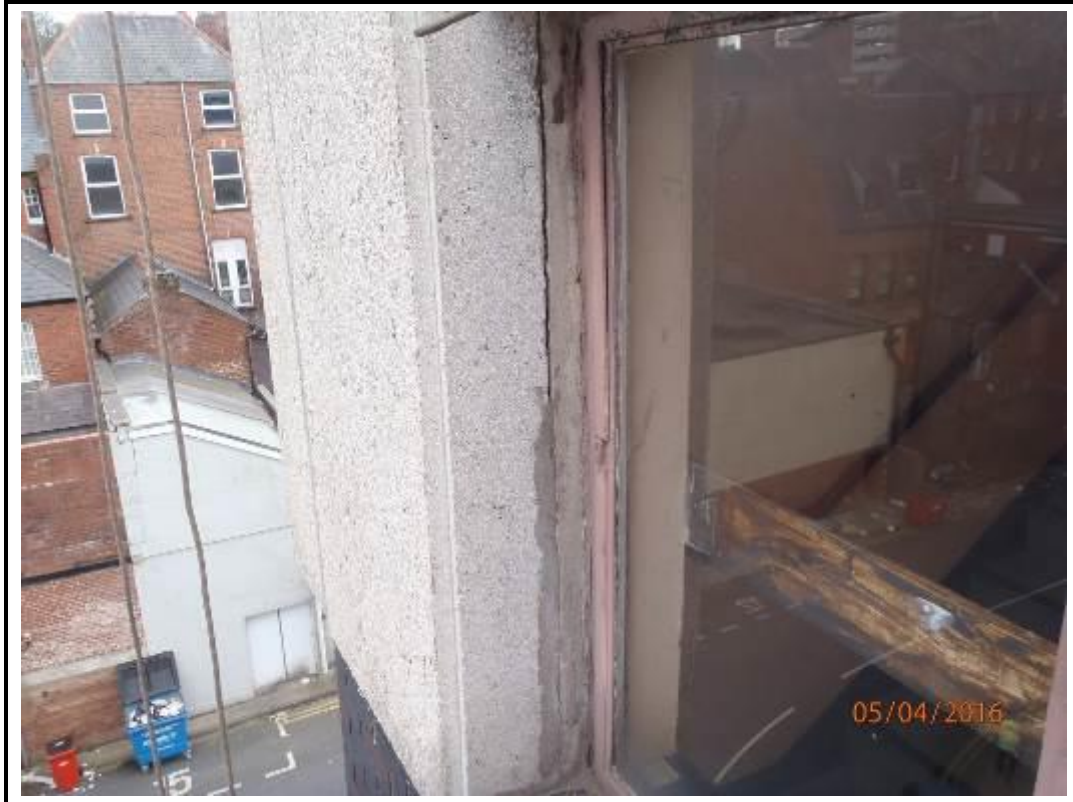
Photo 128. Drop 14 – South Elevation

| Photo 128 | Separation fracture to the east side (top half) of window 3 = 500mm H x 1mm W |

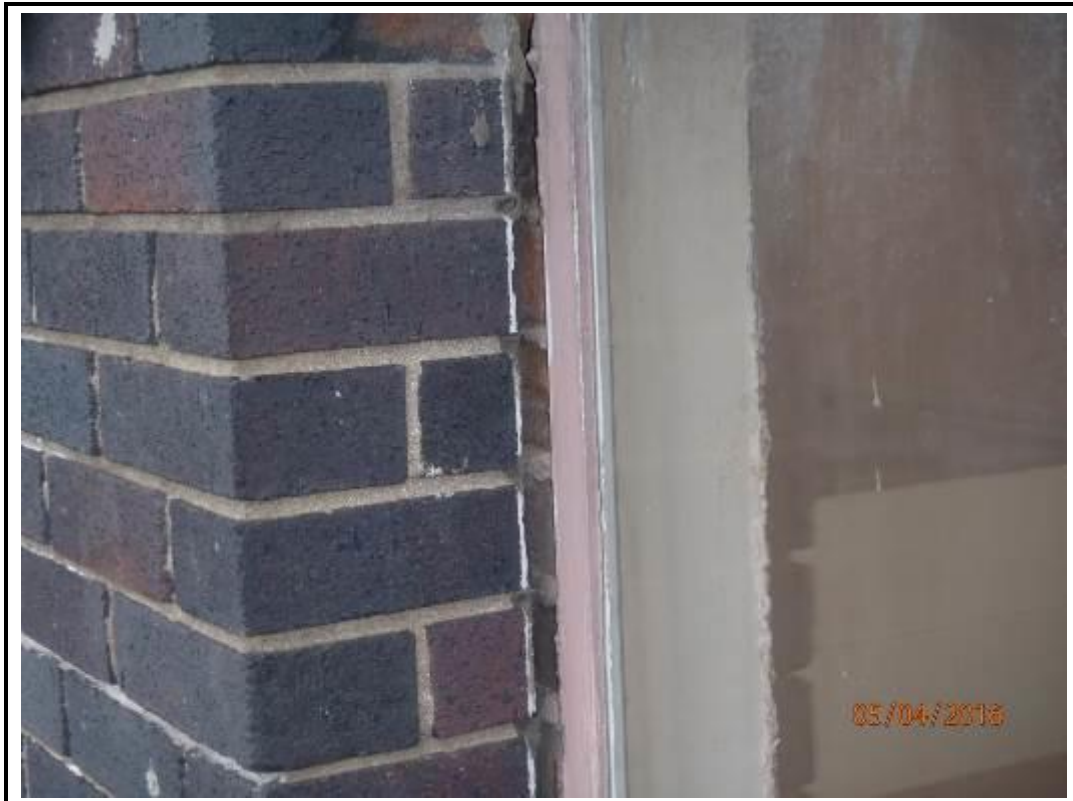
**Photo 131. Drop 14 – South Elevation**

| Photo 131 | Vertical stepped fracture through brickwork beneath B1 & 2 = 1.6m H x 1-5mm W |

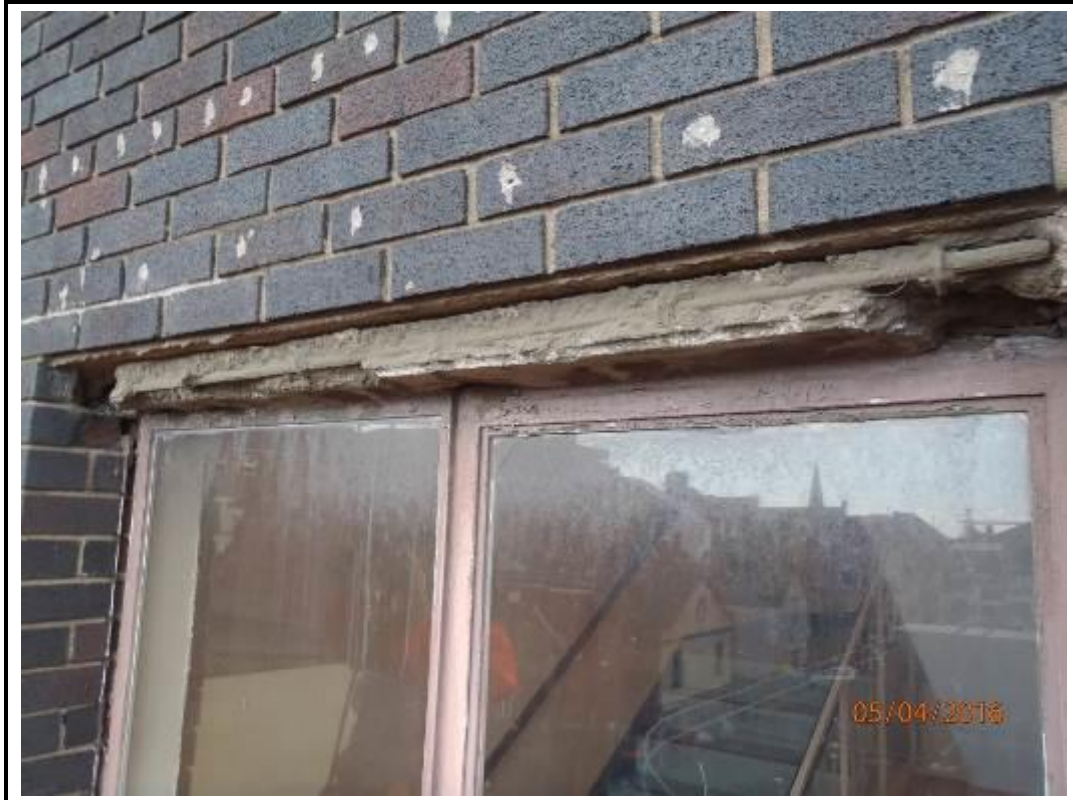
**Photo 132. Drop 14 – South Elevation**

| Photo 132 | Separation fracture to the west side of window 4 = 1.1m H x 5mm W(bottom)-20mm W(top) |

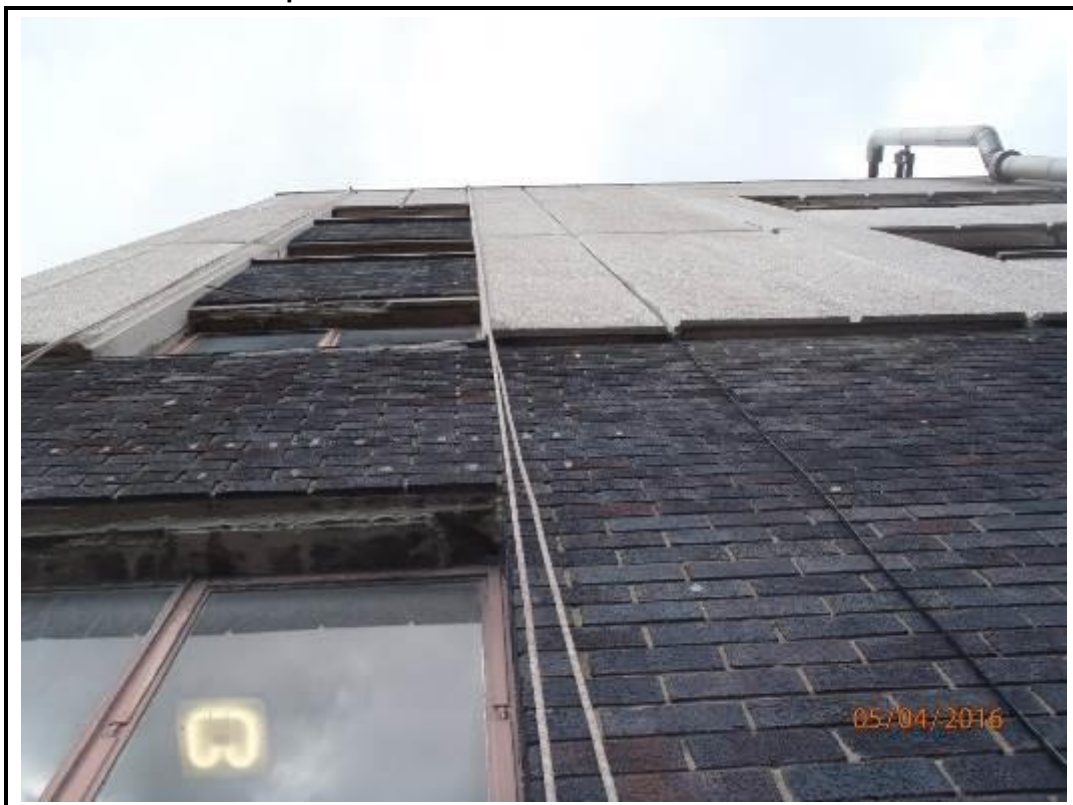
**Photo 133. Drop 14 – South Elevation**

| Photo 133 | Spalling to the window 4 lintel = 50mm H x 1.5m W x 180mm D (exposed reinforcement) |

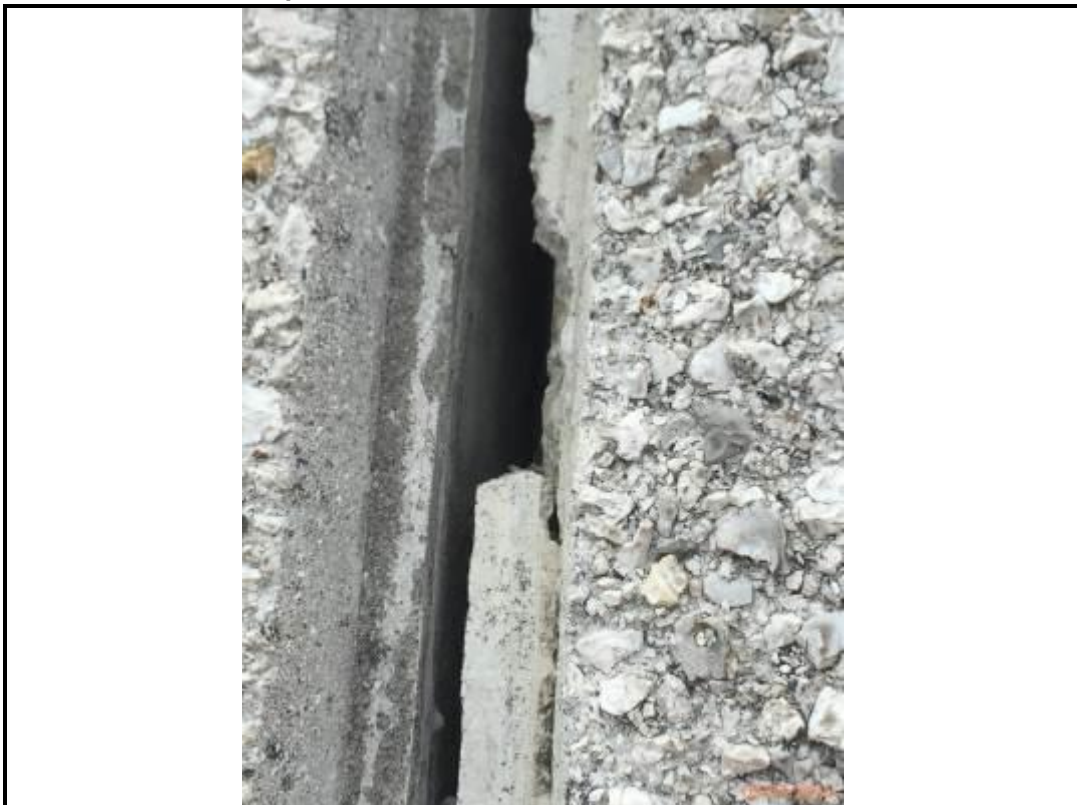
**Photo 135. Drop 15 – South Elevation**

| Photo 135 | Spalling to the west edge of M1 = 670mm H x 70mm W x 80mm D |

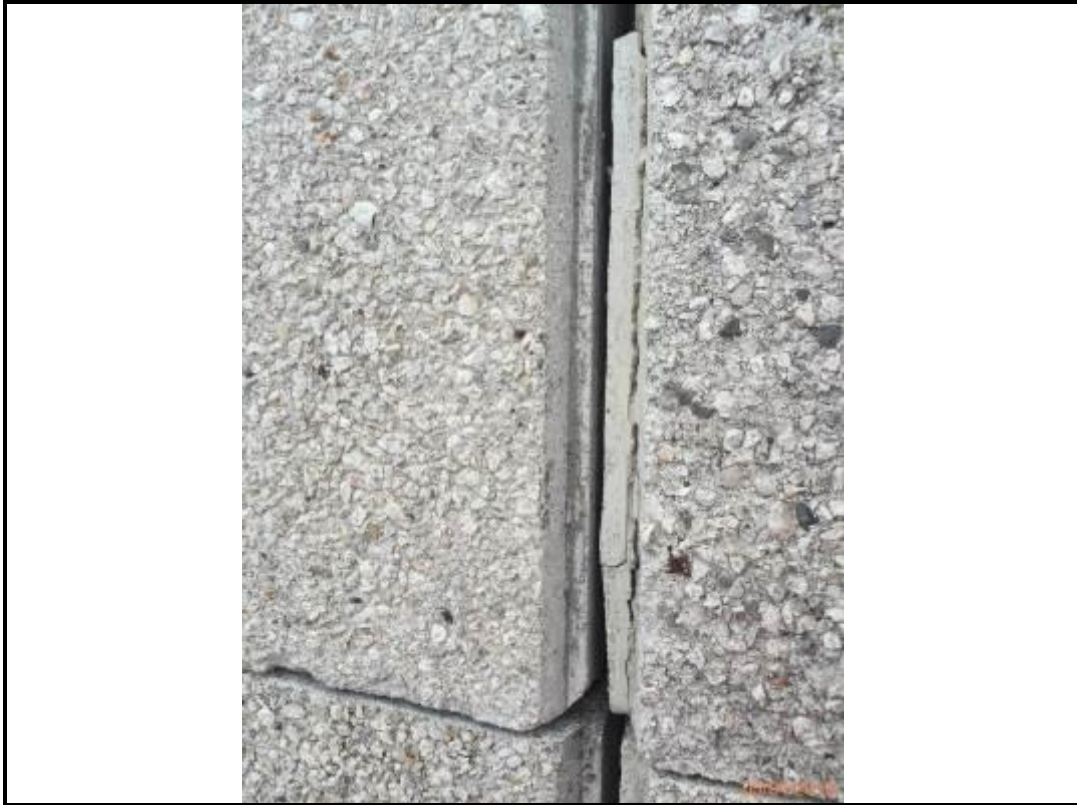
**Photo 136. Drop 15 – South Elevation**

| Photo 136 | Spalling to the west edge of M1 = 80mm H x 20mm W x 20mm D |

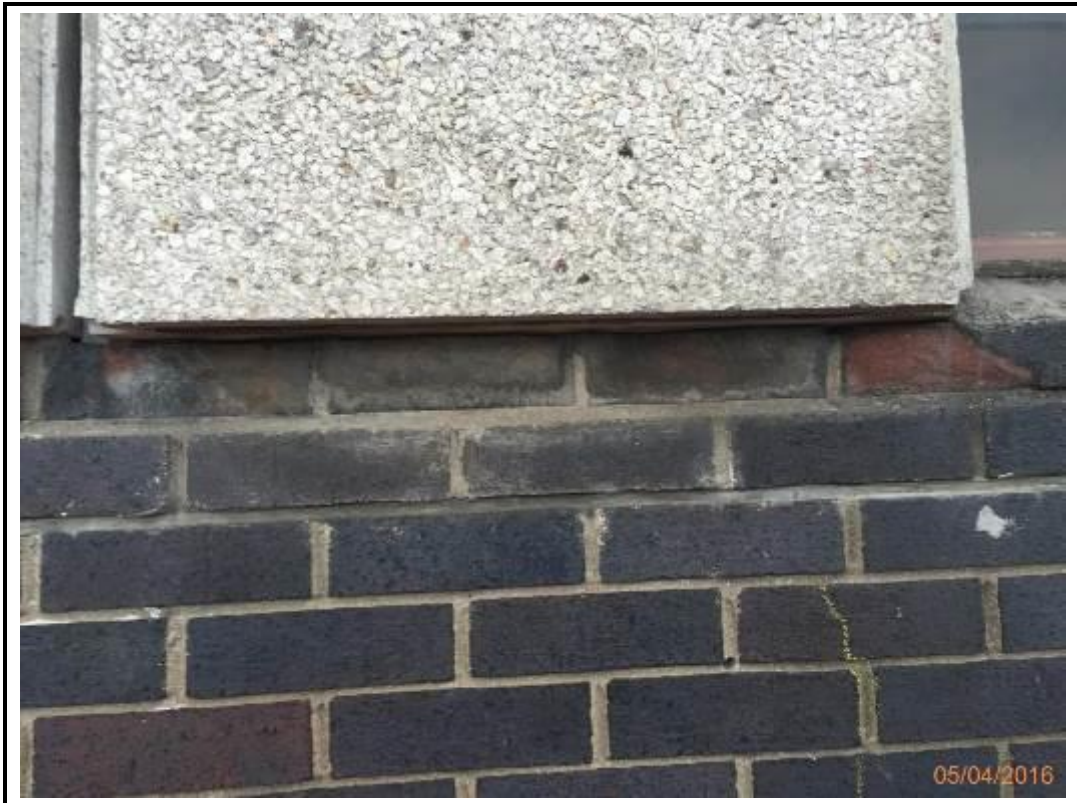
**Photo 137. Drop 15 – South Elevation**

| Photo 137 | Immanent spalling to the west edge of M1 = 400mm H x 20mm W |

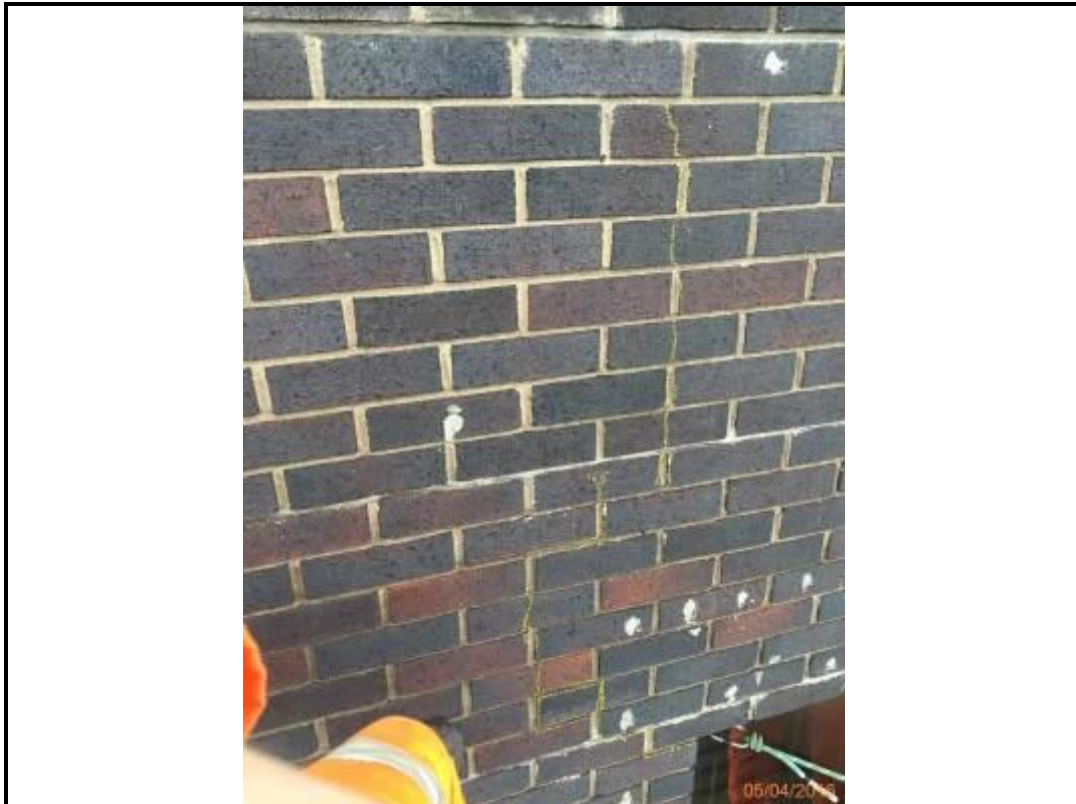
**Photo 138. Drop 15 – South Elevation**

| Photo 138 | Spalling to the brickwork beneath B1 = 70mm H x 880mm W x 20mm D |

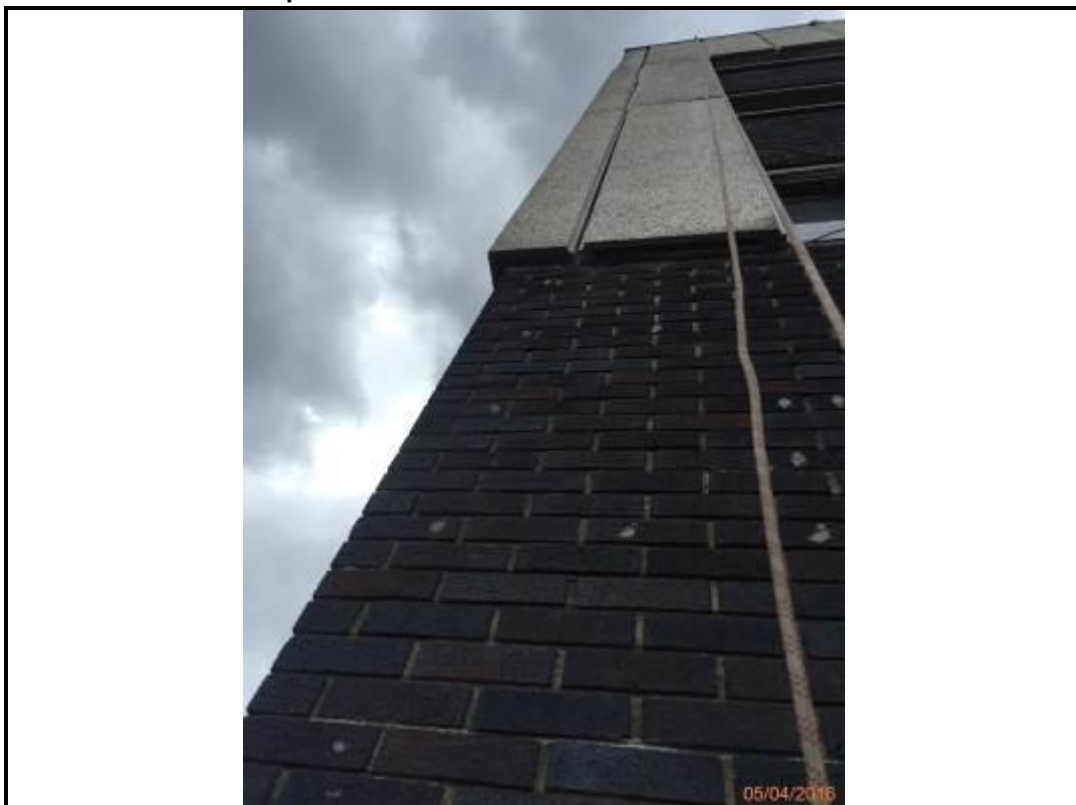
**Photo 139. Drop 15 – South Elevation**

| Photo 139 | Vertical stepped fracture through brickwork beneath B1 = 1.25m H x HL-2mm W |

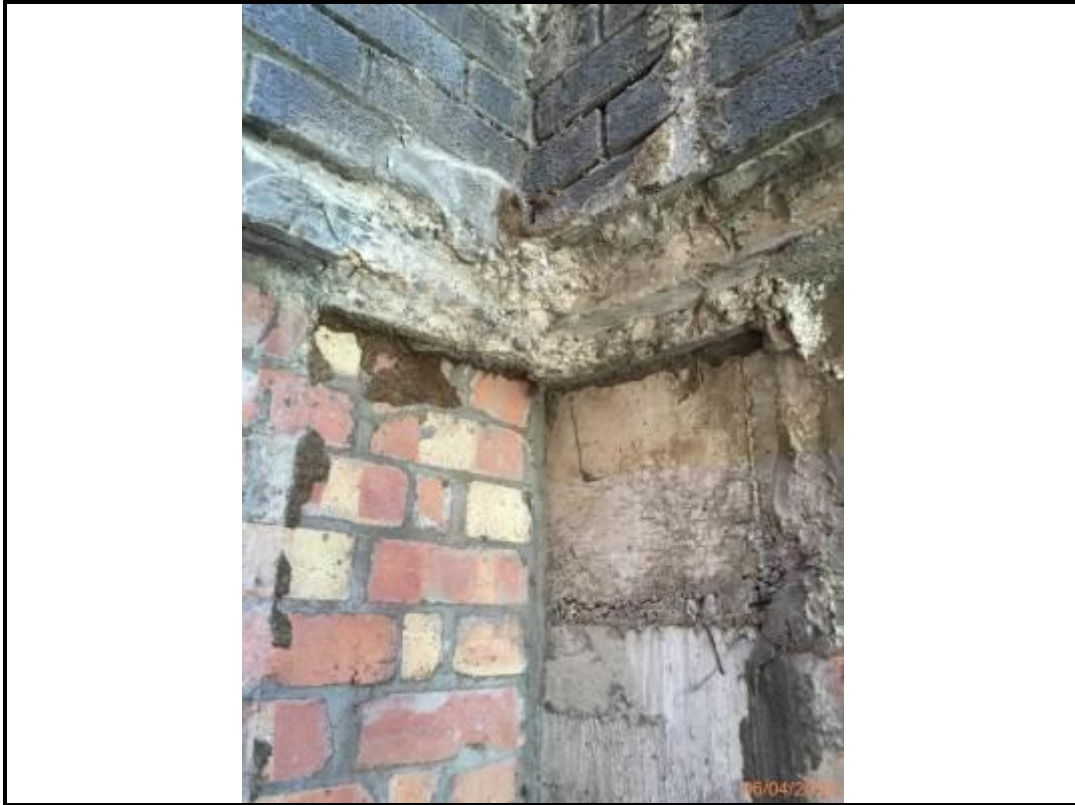
**Photo 144. East Elevation – Brickwork Cladding Beneath Overhang**

| Photo 144 | Spalling to the east edge of the south return, top of access door = 140mm H x 40mm W x 20mm D |

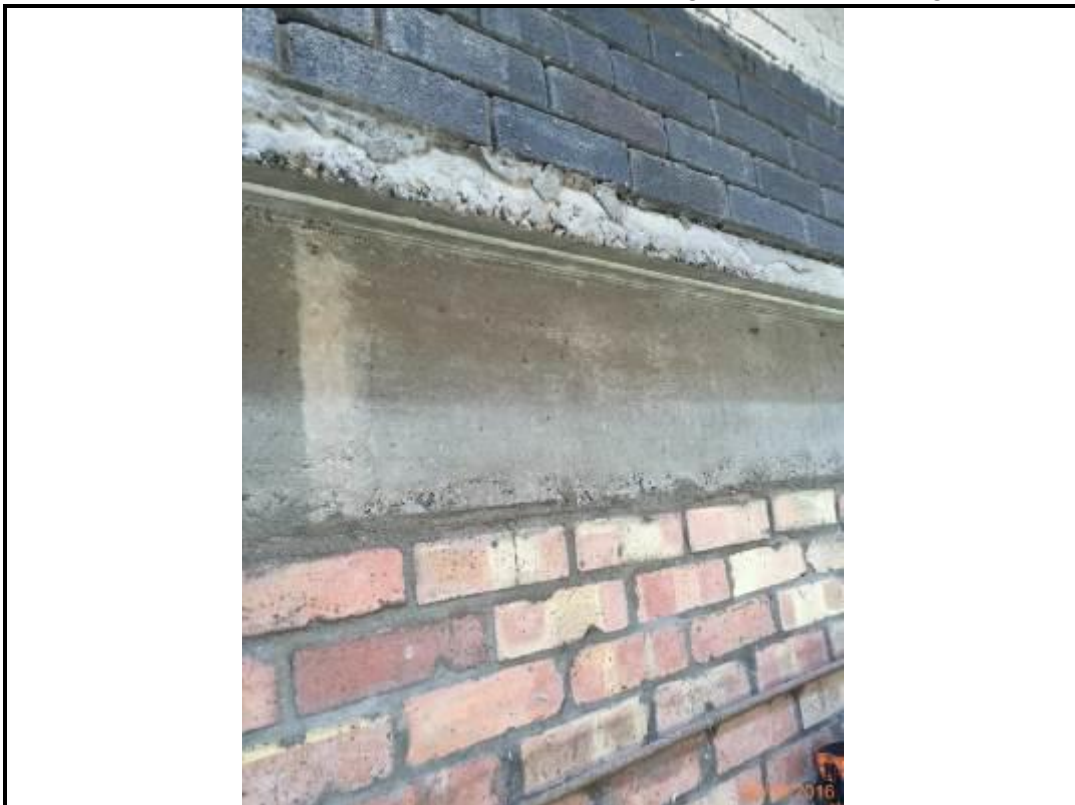
**Photo 145. East Elevation – Brickwork Cladding Beneath Overhang**

| Photo 145 | Poor concrete mix at the mitre between south return and east elevation |
