**CONCRETE STRUCTURE ASSESSMENT REPORT  
NEWPORT CENTRAL LIBRARY  
NEWPORT**

**Date: 20<sup>TH</sup> JULY 2016**  
**Ref: BH.DB/16027.01.D001**

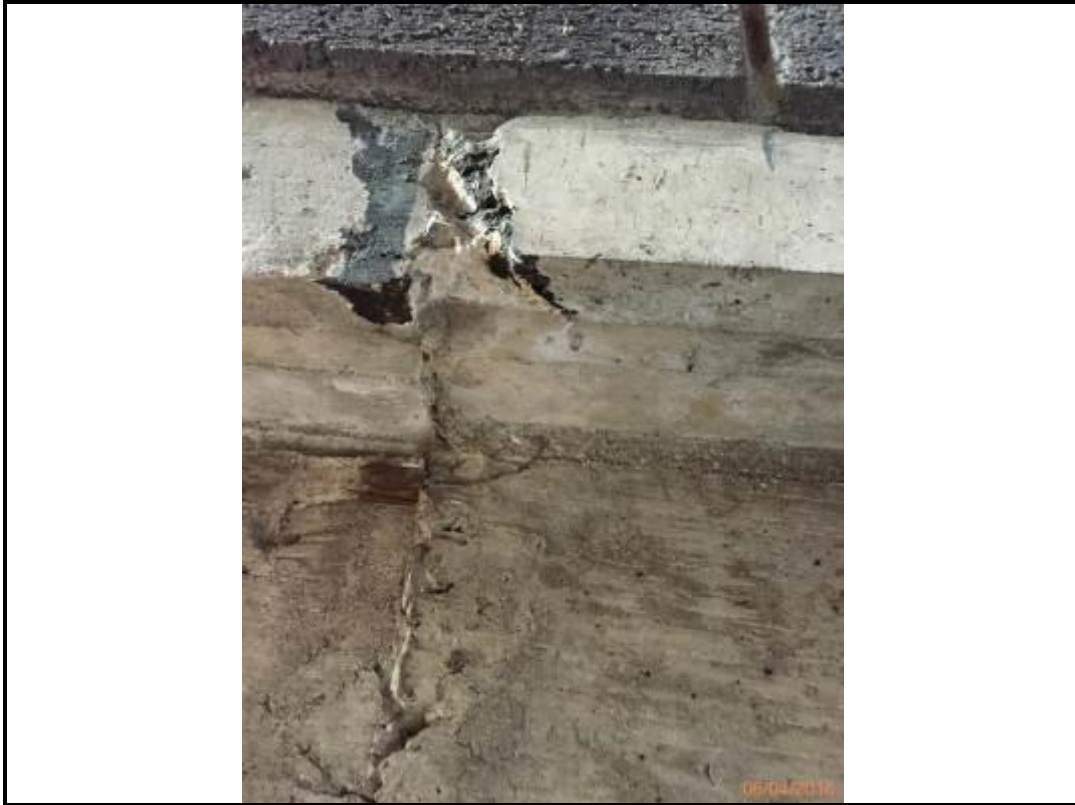
**Photo 146. East Elevation – Brickwork Cladding Beneath Overhang**

| Photo 146 | Sporadic areas of honeycombing throughout concrete section separating red and blue bricks. |

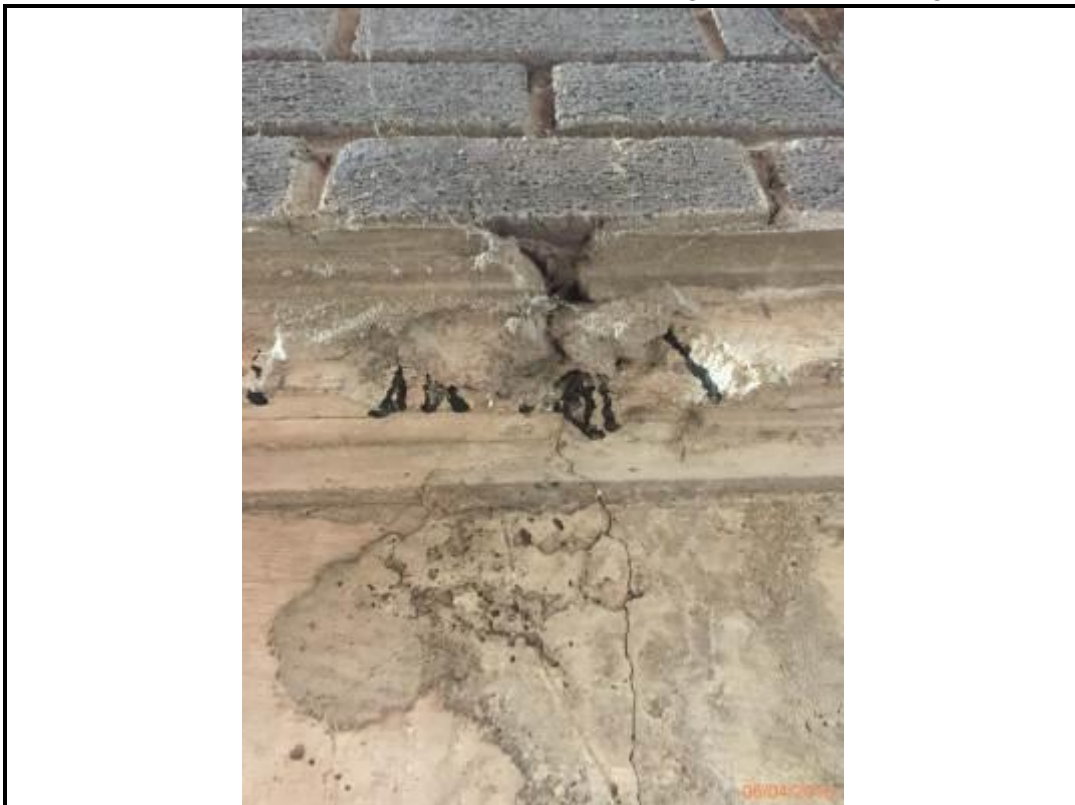
**Photo 147. East Elevation – Brickwork Cladding Beneath Overhang**

| Photo 147 | Sporadic areas of spalling throughout the line of concrete <0.5m <sup>2</sup> x 10-30mm D |

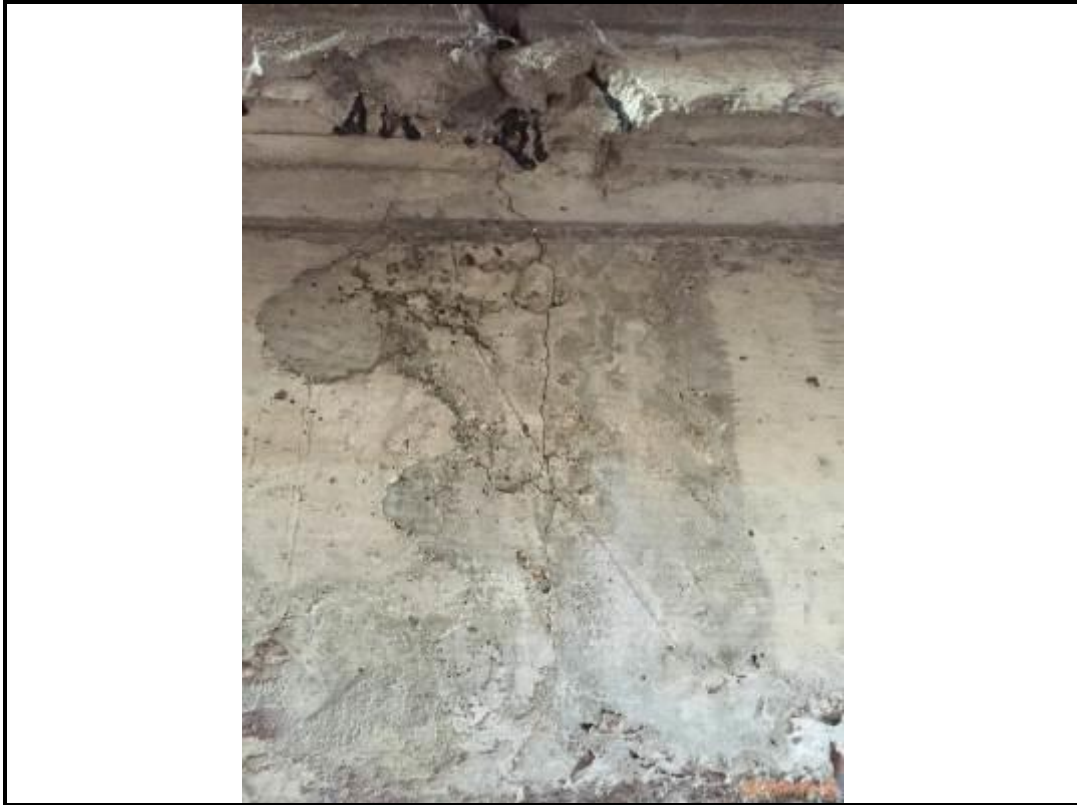
**Photo 148. East Elevation – Brickwork Cladding Beneath Overhang**

| Photo 148 | Spalling to the concrete section, located 20m from the south return, 2m above floor level = 70mm H x 180mm W x 30mm D |

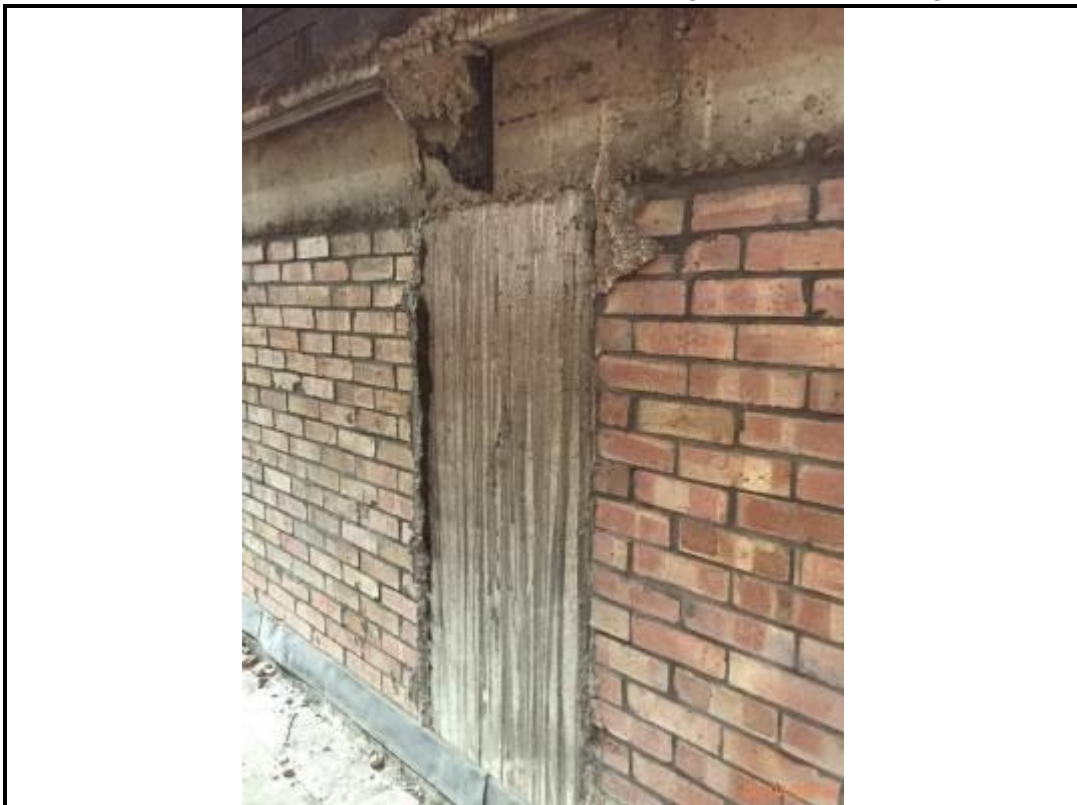
**Photo 149. East Elevation – Brickwork Cladding Beneath Overhang**

| Photo 149 | Vertical fracture through concrete section, located 19.5m from the south return, 1.8m above floor level = 360mm H x HL-2mm W |

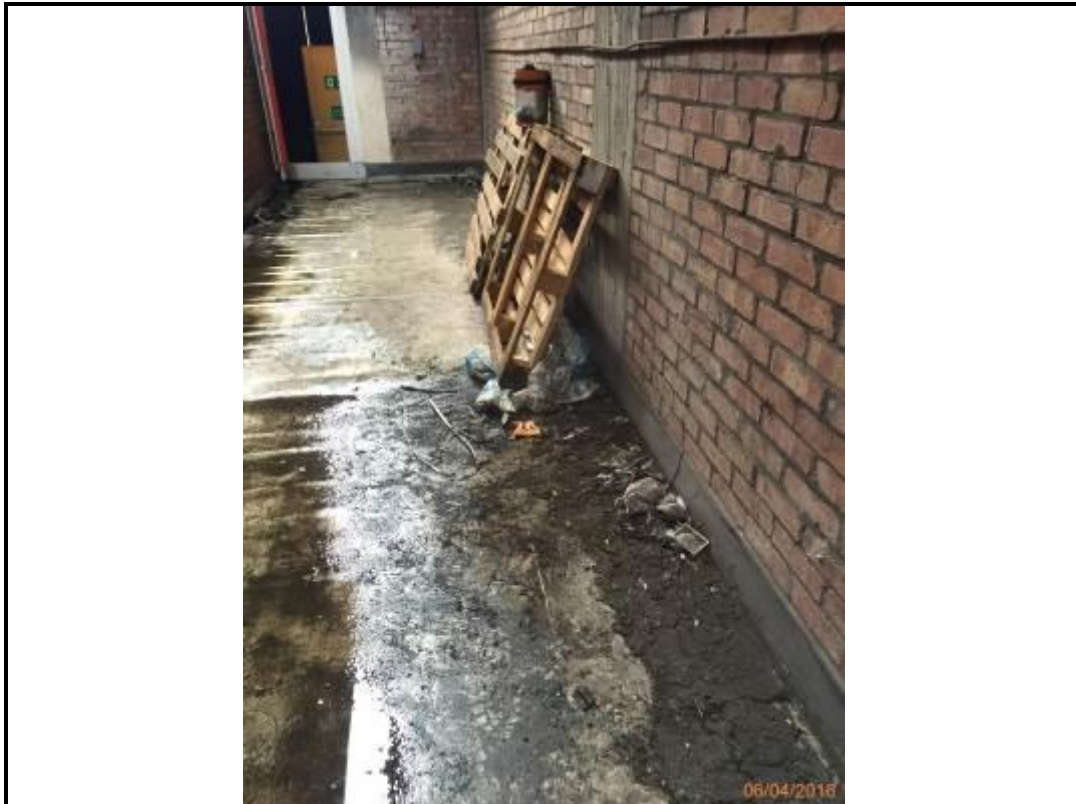
**Photo 150. East Elevation – Brickwork Cladding Beneath Overhang**

| Photo 150 | Poor concrete mix pillar located 27.9m from south return |

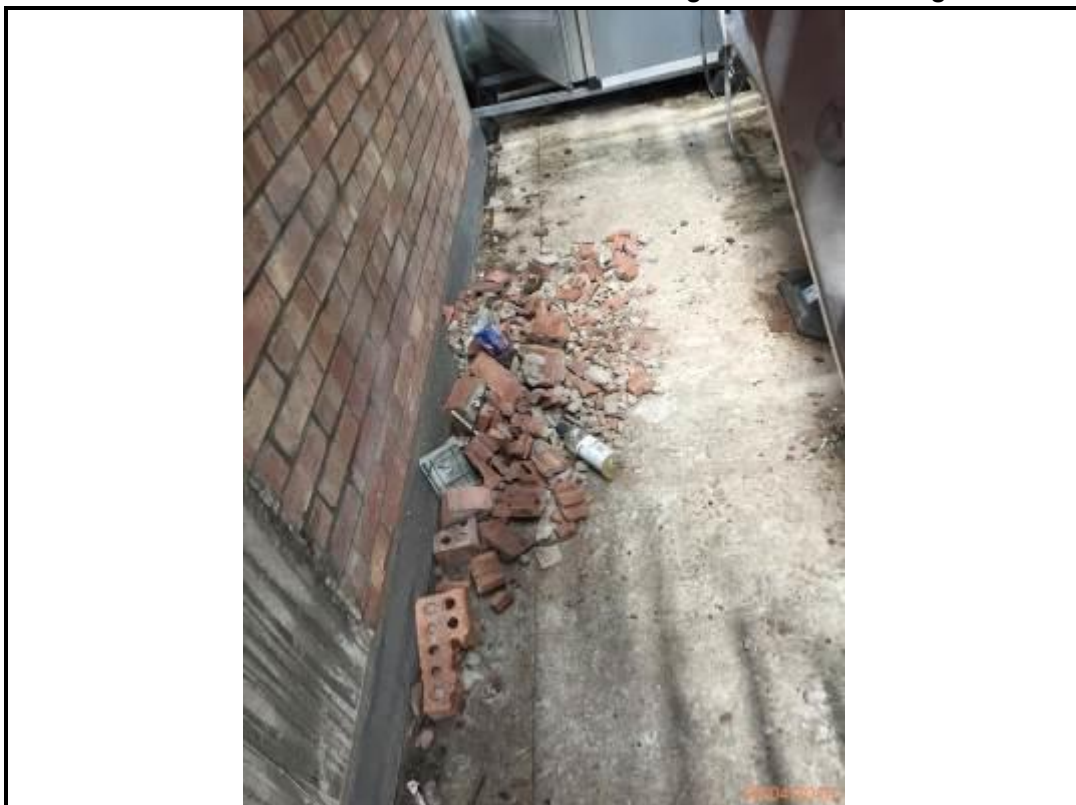
**Photo 151. East Elevation – Brickwork Cladding Beneath Overhang**

| Photo 151 | Sporadic debris on floor level |

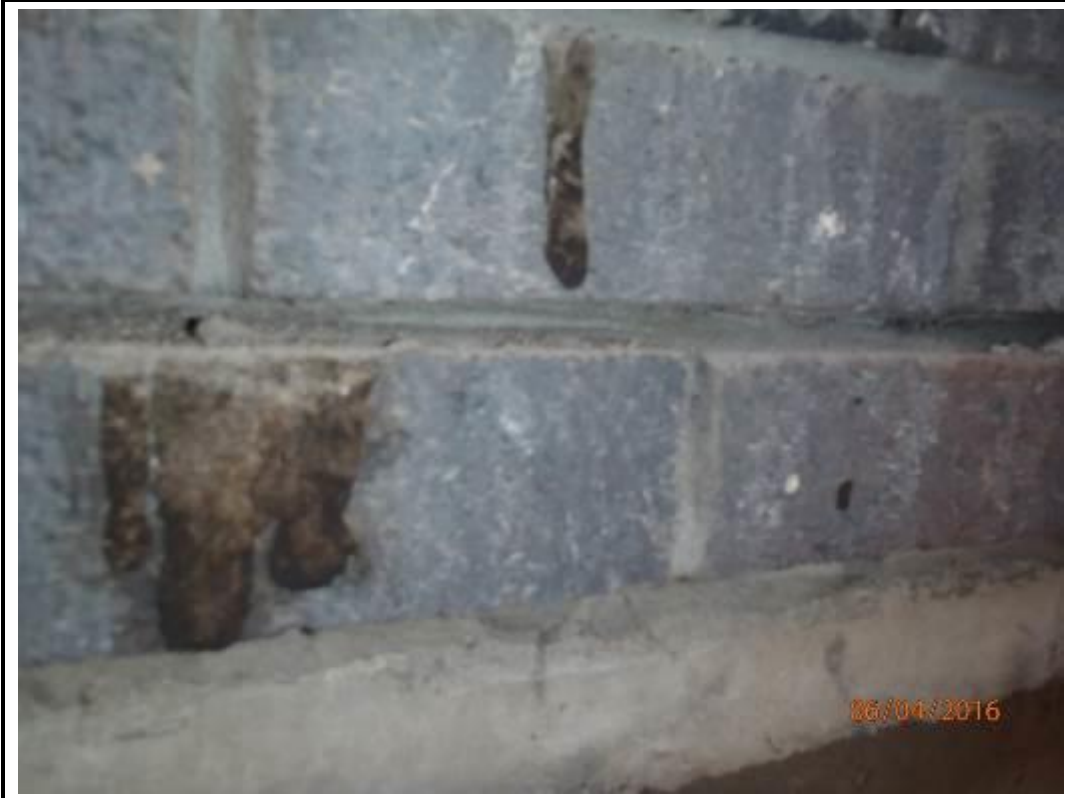
**Photo 152. East Elevation – Brickwork Cladding Beneath Overhang**

| Photo 152 | Sporadic debris on floor level |

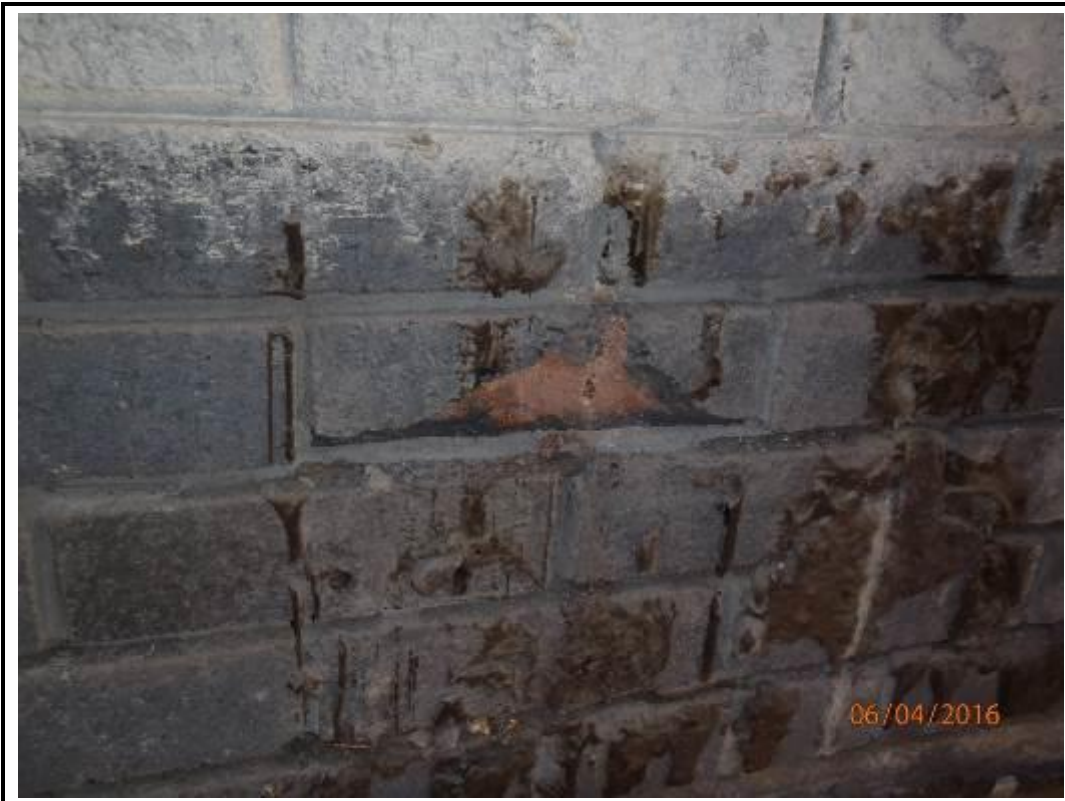
**Photo 153. East Elevation – Brickwork Cladding Beneath Overhang**

| Photo 153 | Typical joint loss throughout mid height of brickwork cladding, affecting <0.5m <sup>2</sup> in total to a maximum depth of 20mm |

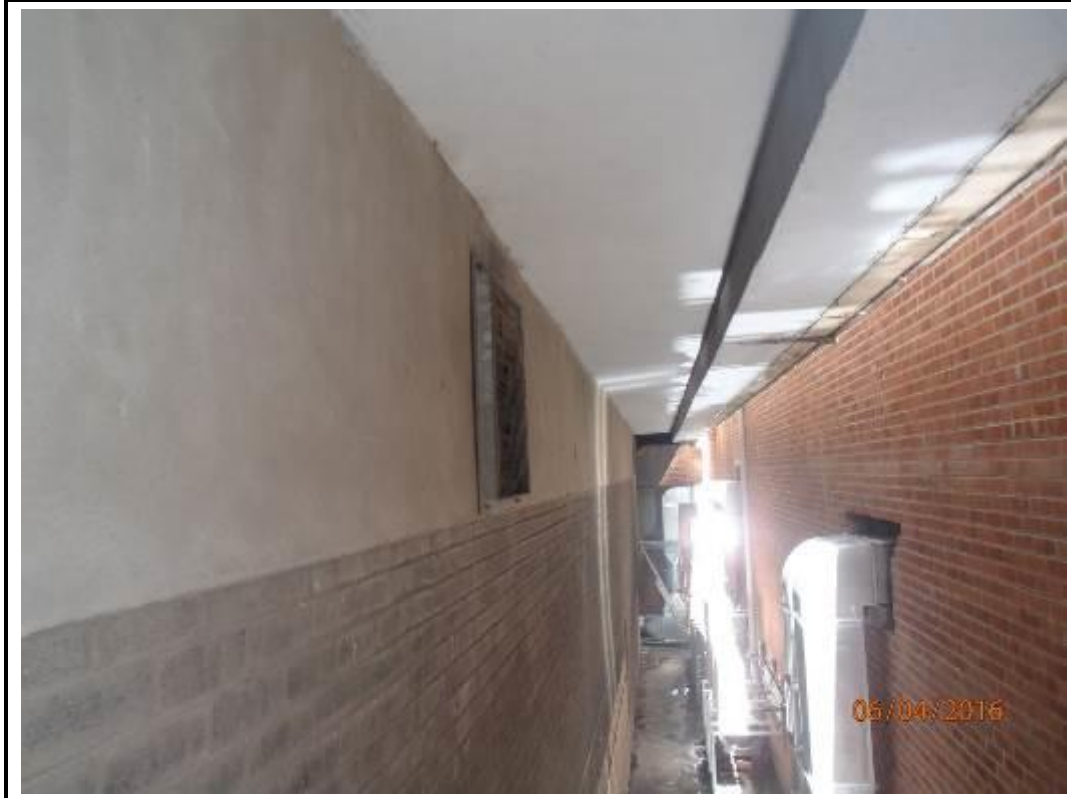
**Photo 154. East Elevation – Brickwork Cladding Beneath Overhang**

| Photo 154 | Spalling to brickwork located 2.5m from the south return, 2.3m above floor level = 60mm H x 100mm W x 10mm D |

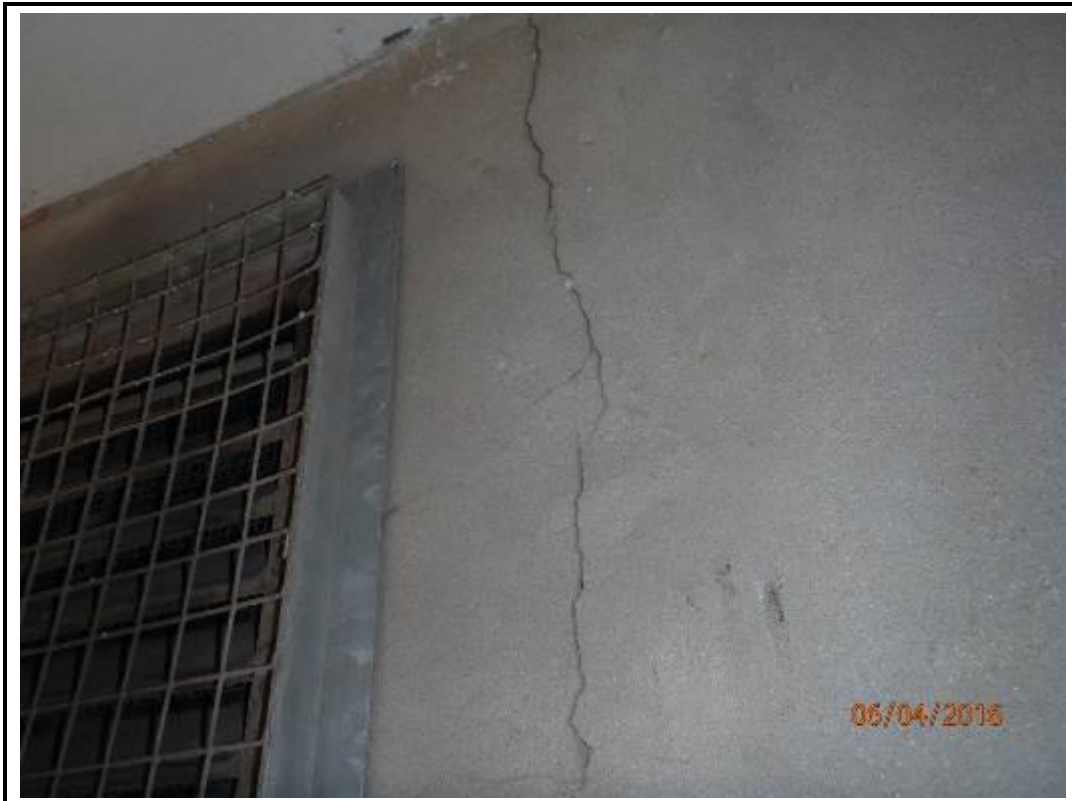
**Photo 157. East Elevation – Brickwork Cladding Beneath Overhang**

| Photo 157 | Vertical fracture through render section, located 9.9m from the south return = 200mm H x 2mm W |

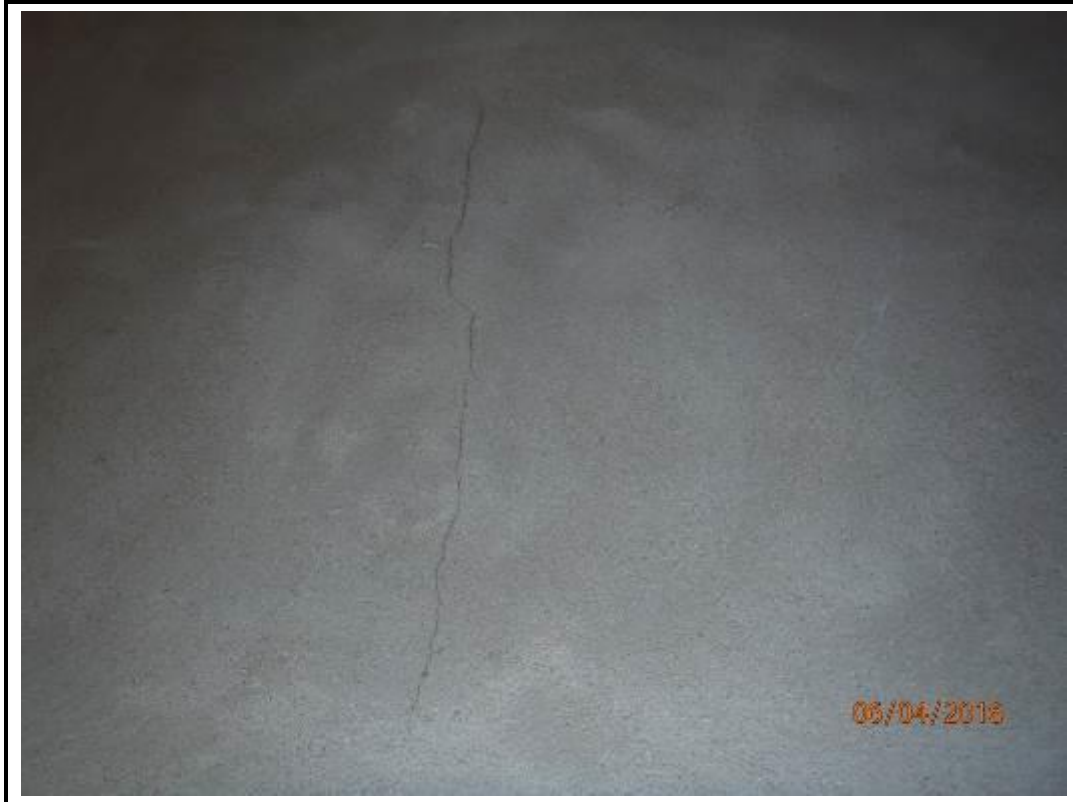
**Photo 158. East Elevation – Brickwork Cladding Beneath Overhang**

| Photo 158 | Vertical fracture through render section, located 10.7m from the south return = 1m H x HL-3mm W |

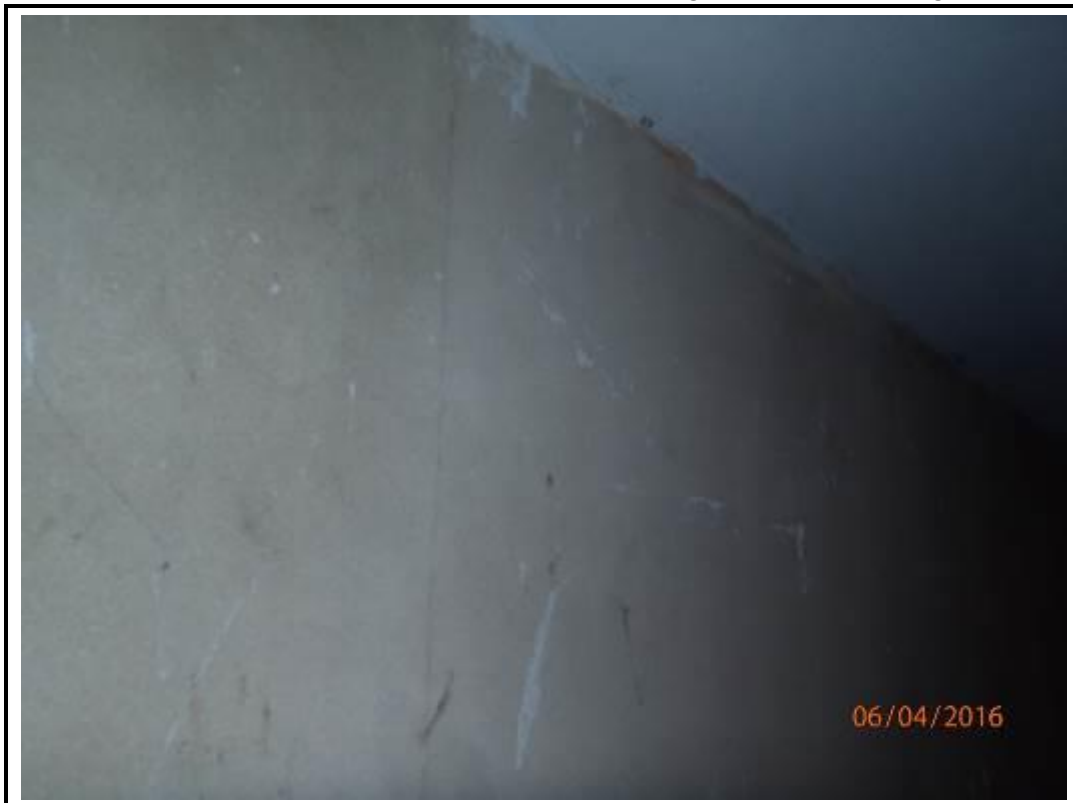
**Photo 159. East Elevation – Brickwork Cladding Beneath Overhang**

| Photo 159 | Vertical fracture through render section, located 12.8m from the south return = 1m H x HL-1mm W |

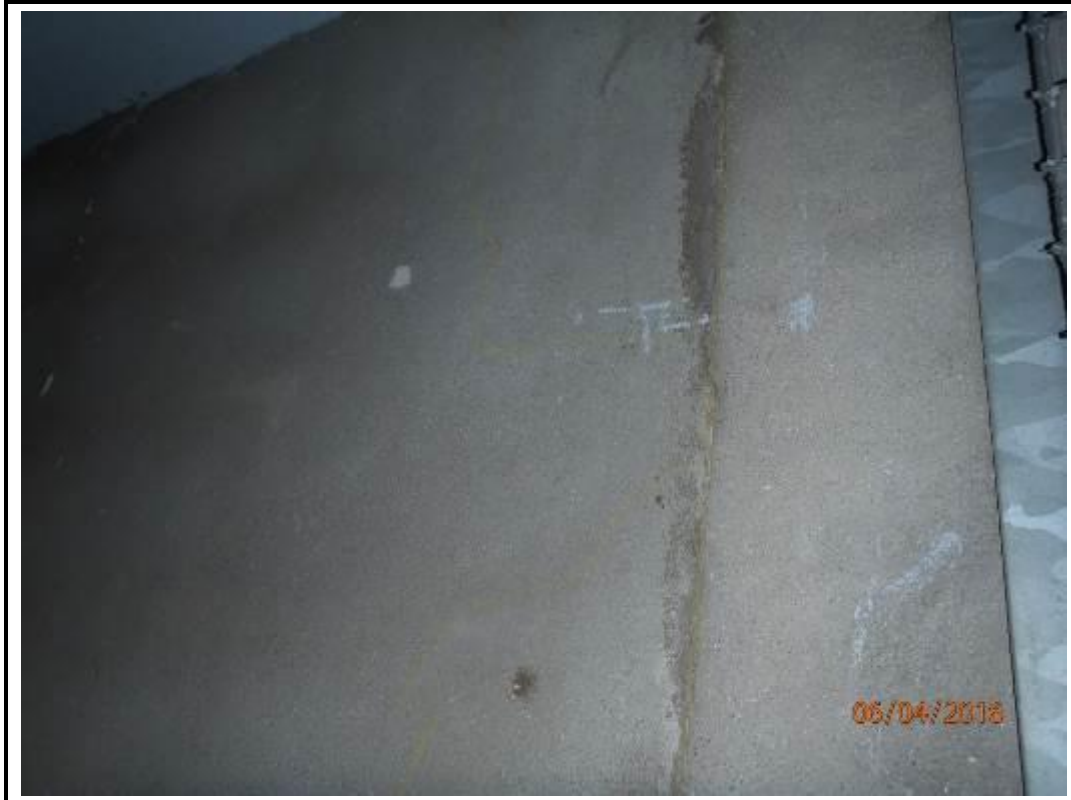
**Photo 160. East Elevation – Brickwork Cladding Beneath Overhang**

| Photo 160 | Vertical fracture through render section, located 16.5m from the south return = 1m H x HL-1mm W |

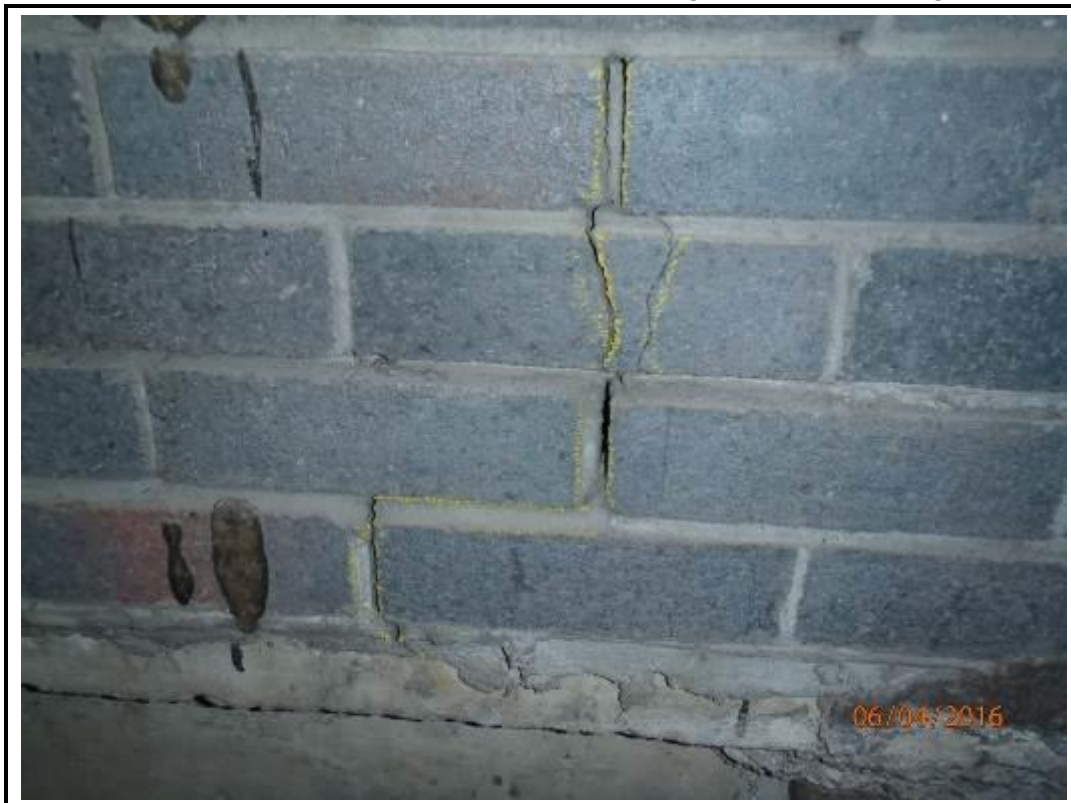
**Photo 161. East Elevation – Brickwork Cladding Beneath Overhang**

| Photo 161 | 3No fractures through render section, located 26.5m from the south return = 2m total linear length x HL-1mm W |

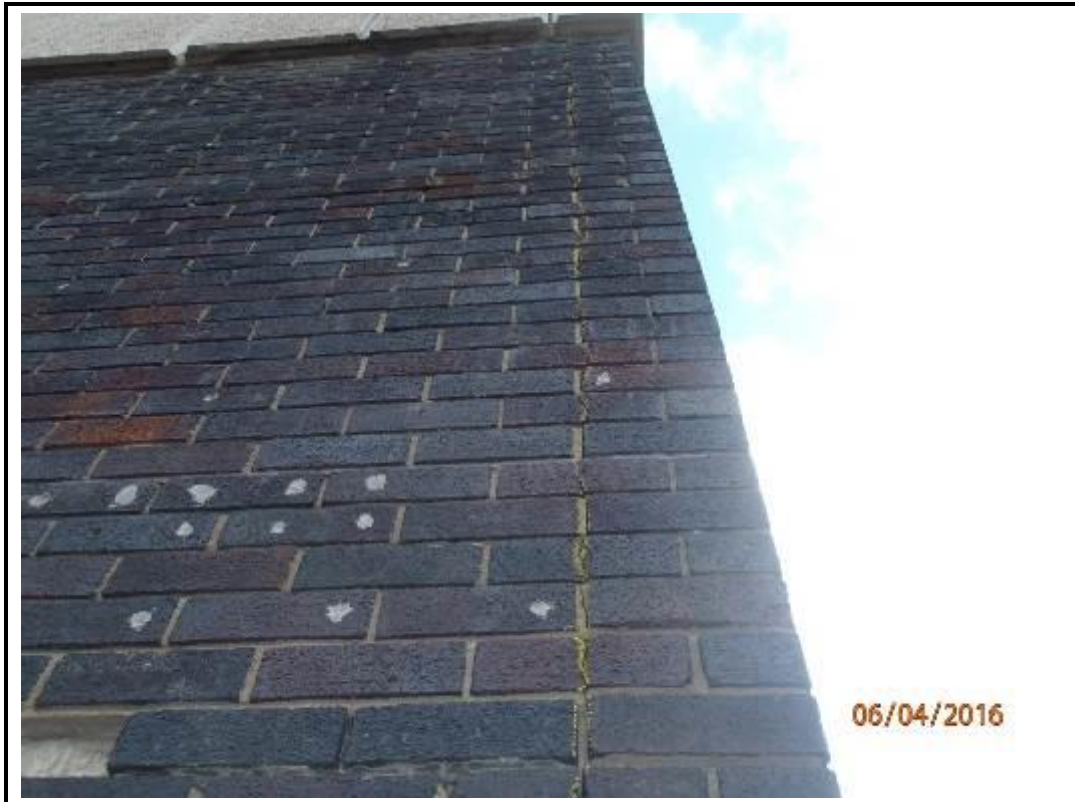
**Photo 168. Drop 1 – West Elevation**

| Photo 168 | 3No loose bricks, located 1.5m beneath B2 |

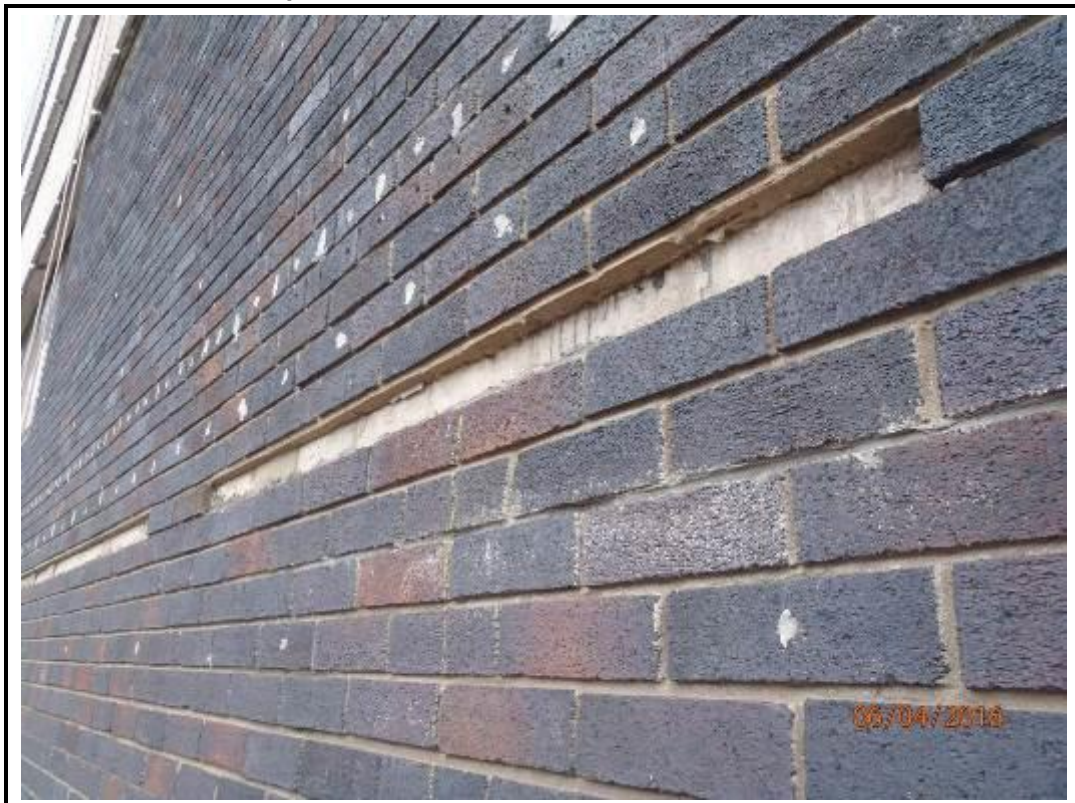
**Photo 169. Drop 1 – West Elevation**

| Photo 169 | Vertical stepped fracture through brickwork beneath B1 = 4.2m H x 1-10mm W |

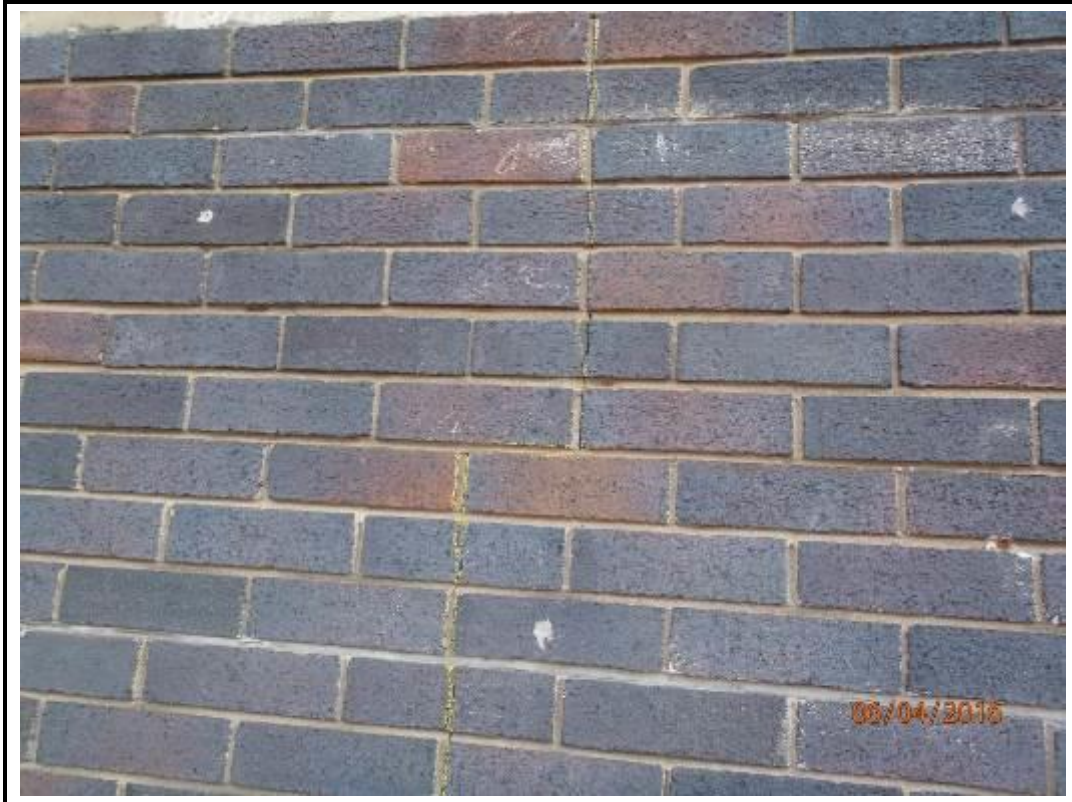
**Photo 170. Drop 1 – West Elevation**

| Photo 170 | Line of missing brickwork, starts approximately 3m beneath B2 and extends into drops 2 & 3 and into window row 4 lintel. 22No bricks missing |

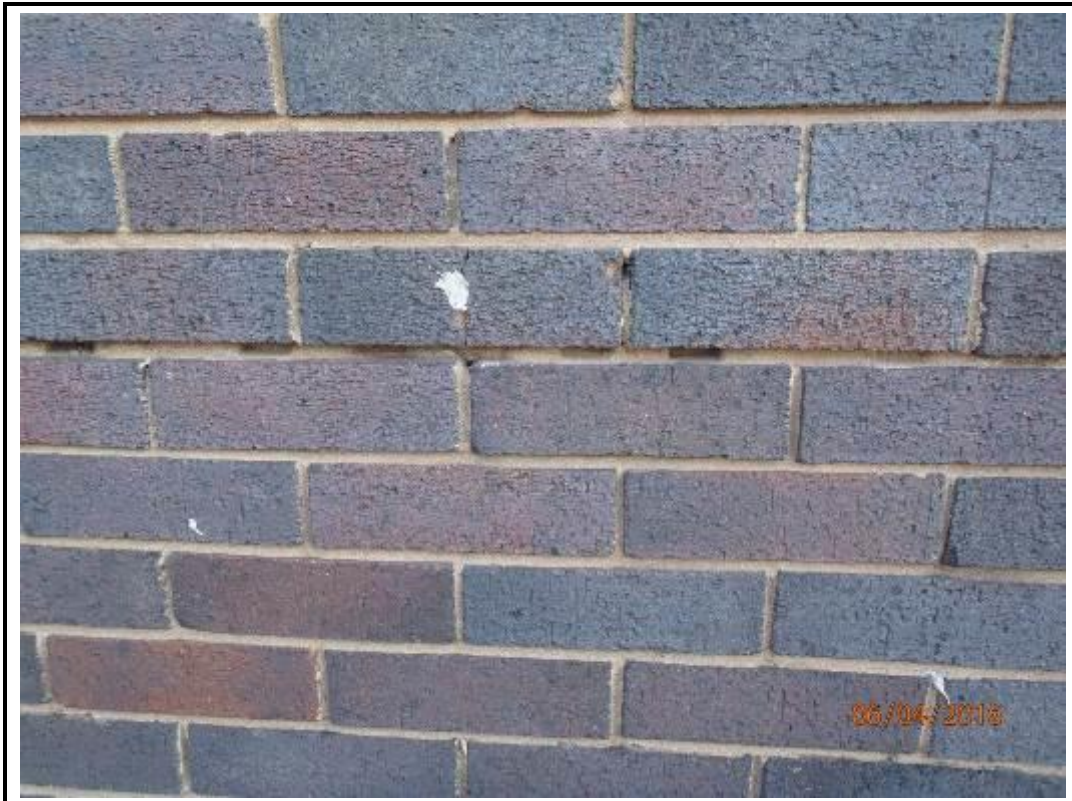
**Photo 171. Drop 1 – West Elevation**

| Photo 171 | Vertical stepped fracture through brickwork, starts 3m beneath B3 and extends down = 1.7m H x 1-5mm W |

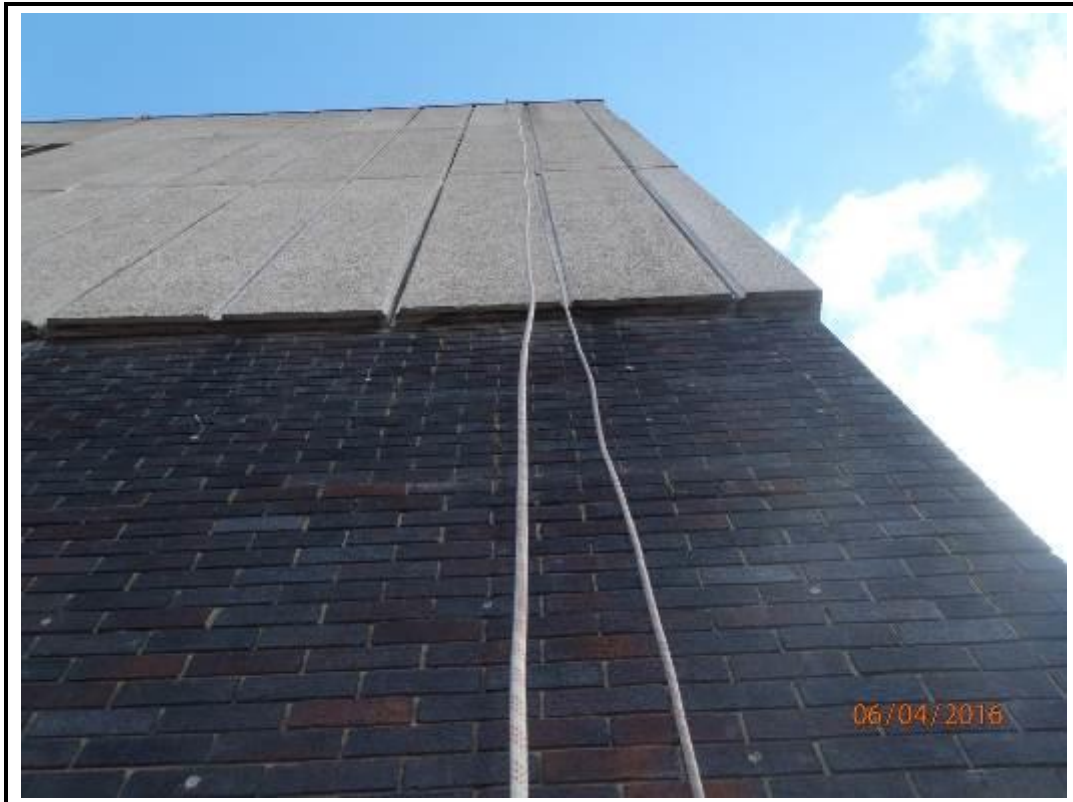
**Photo 172. Drop 1 – West Elevation**

| Photo 172 | Typical sporadic joint loss, mainly to lower levels of brickwork in line with window row 4 between drops 1-3 <0.5m <sup>2</sup> x30mm D |

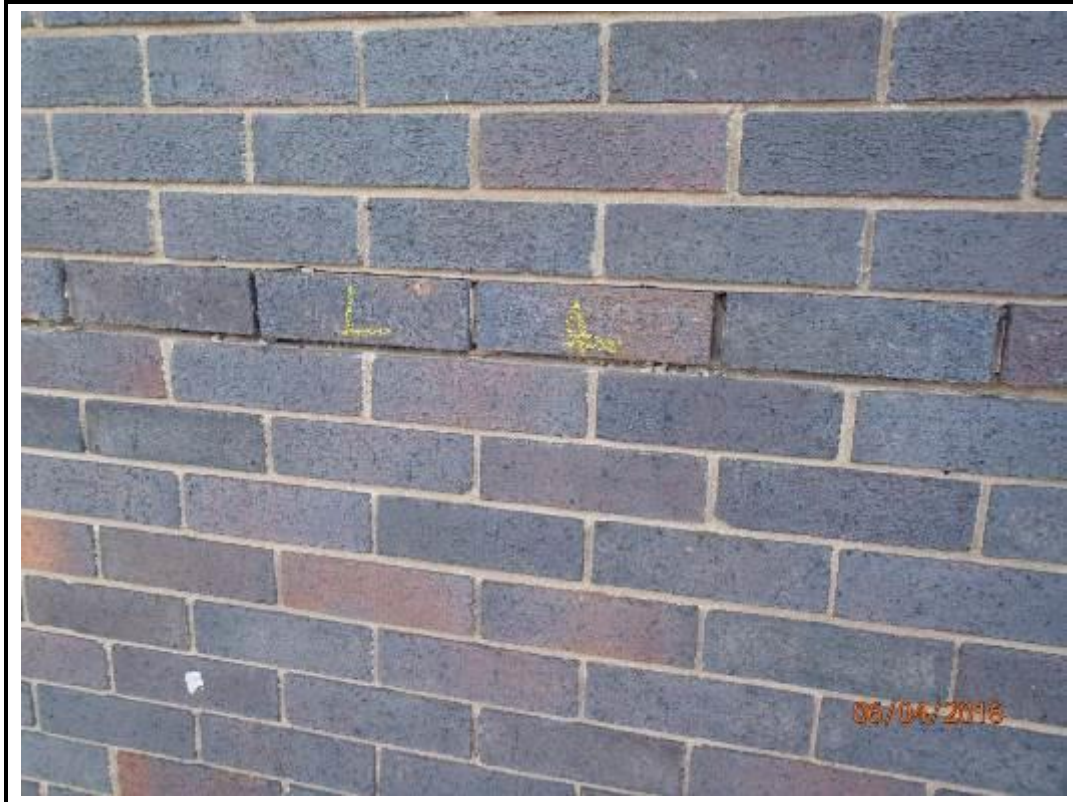
**Photo 174. Drop 2 – West Elevation**

| Photo 174 | Spalling to the south edge of T4 = 100mm H x 10mm W x 40mm D |

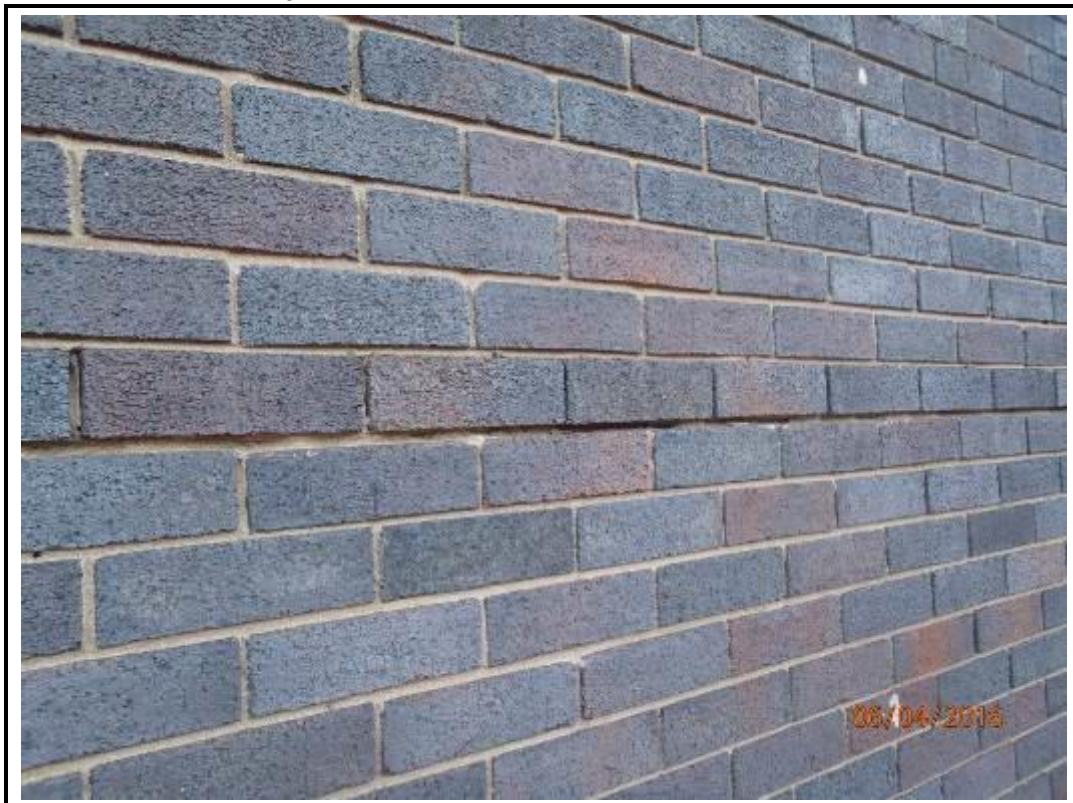
**Photo 175. Drop 2 – West Elevation**

| Photo 175 | 2No loose bricks, located 1.5m beneath B3 & 4 |

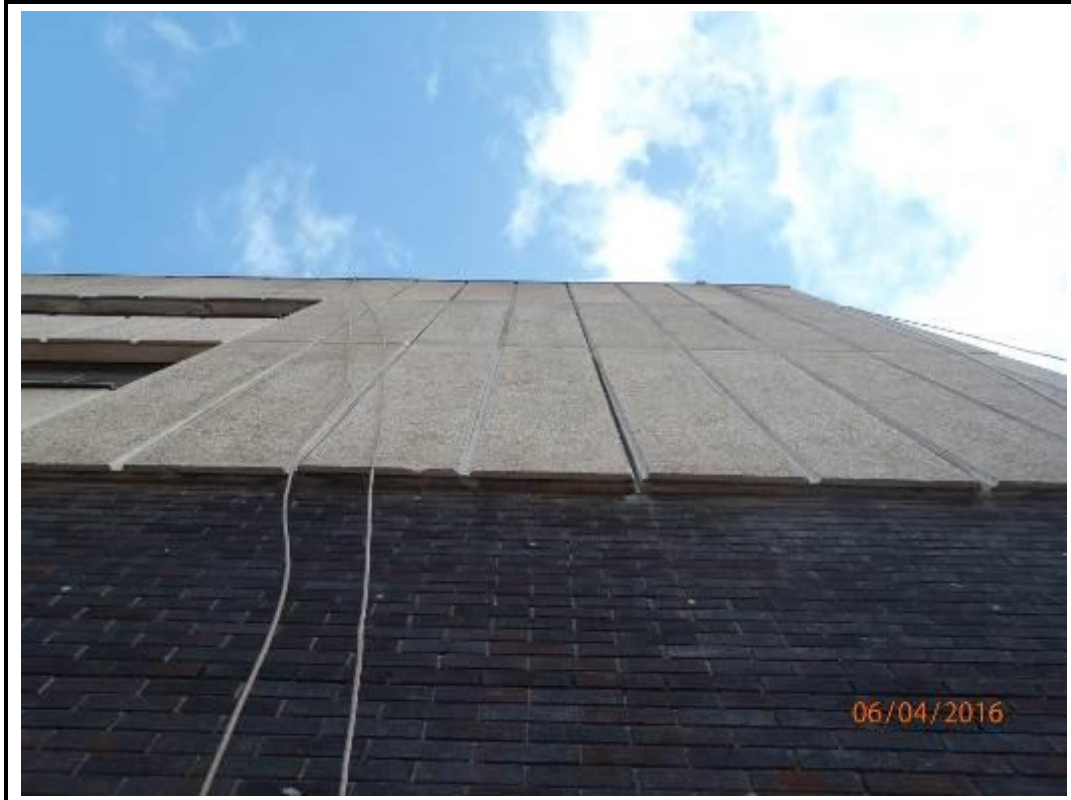
**Photo 176. Drop 2 – West Elevation**

| Photo 176 | Line of joint loss to brickwork 1.5m beneath B1-4, extends into drop 1 and 3 <1m <sup>2</sup> x30mm D |

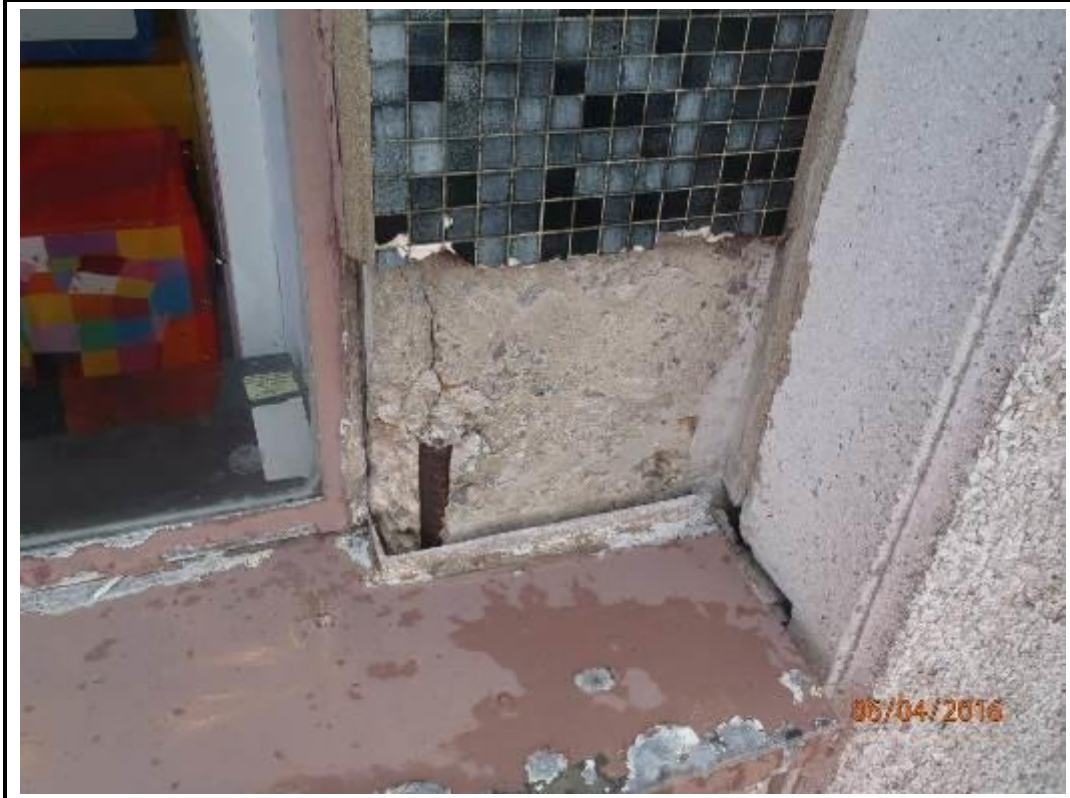
**Photo 178. Drop 3 – West Elevation**

| Photo 178 | Spalling to the bottom half of the infill between T1 and 2 = 1.1m H x 30mm W x 90mm D |

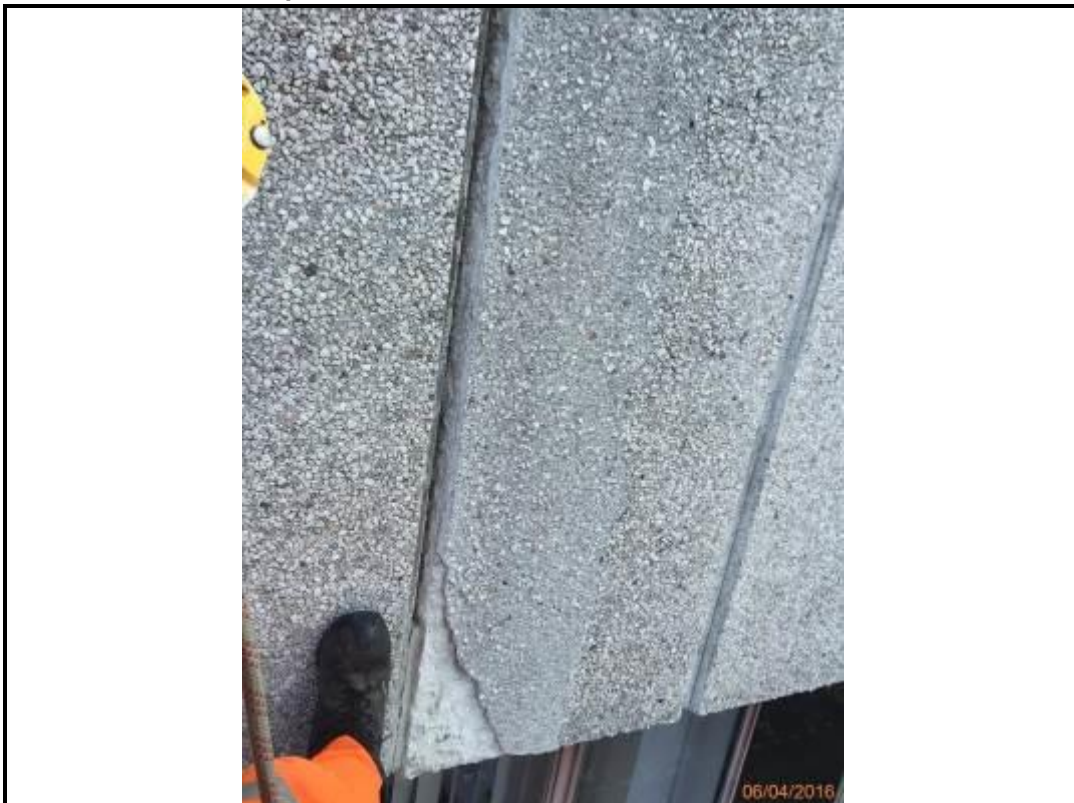
**Photo 183. Drop 4 – West Elevation**

| Photo 183 | Spalling to the top north corner of T2 = 120mm H x 200mm W x 20mm D |

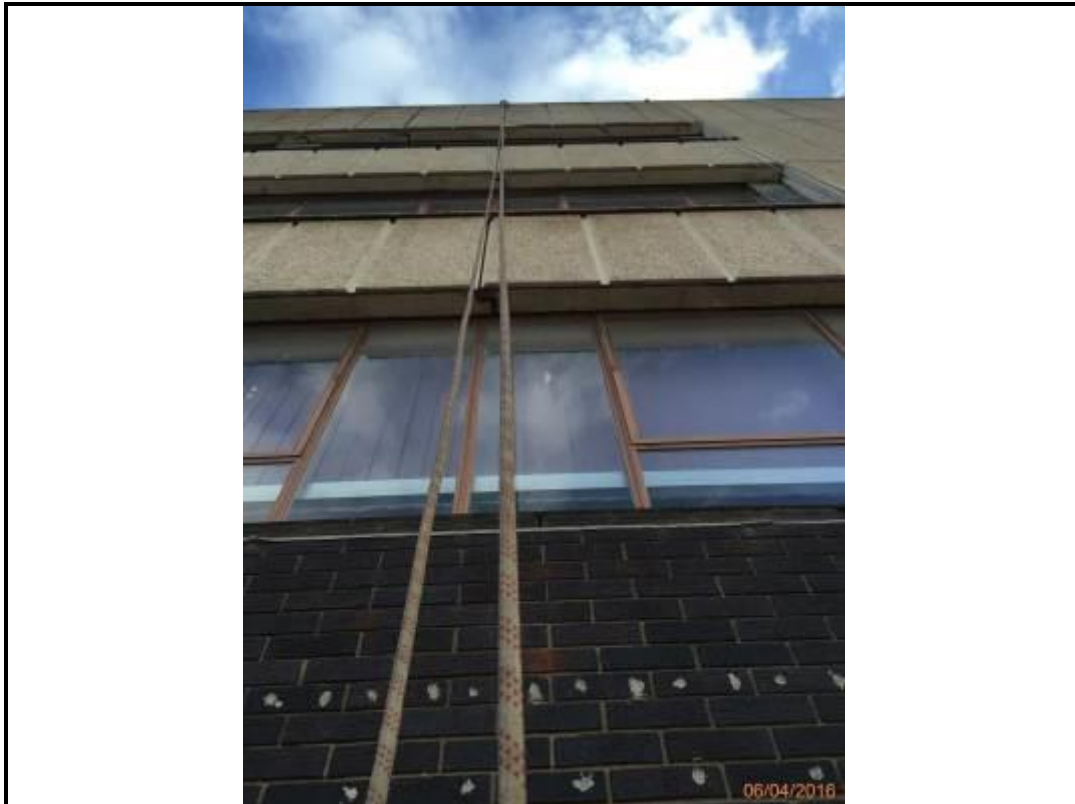
**Photo 184. Drop 4 – West Elevation**

| Photo 184 | Spalling to the bottom south corner of T2 = 1.25m H x 250mm W x 30mm D |
