**CONCRETE STRUCTURE ASSESSMENT REPORT  
NEWPORT CENTRAL LIBRARY  
NEWPORT**

**Date: 20<sup>TH</sup> JULY 2016**  
**Ref: BH.DB/16027.01.D001**

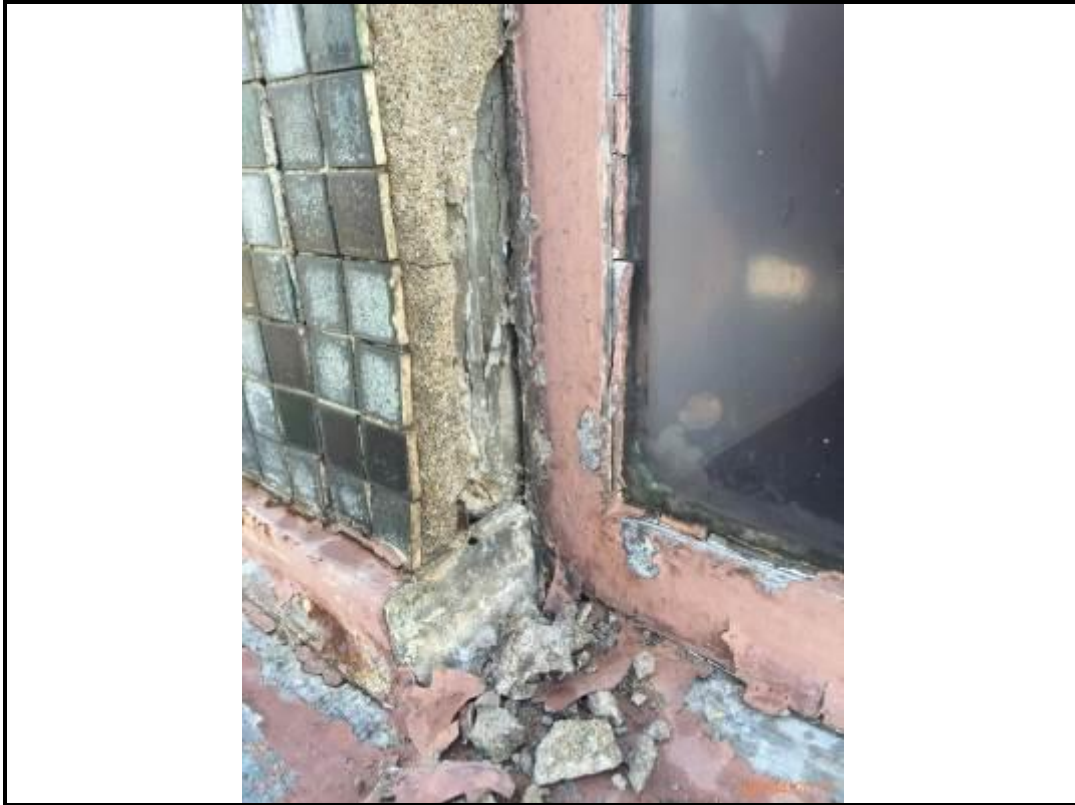
**Photo 186. Drop 5 – West Elevation**

| Photo 186 | 2No Vertical stepped fracture to window row 2 column beneath M1 and 2 = 1.15m H x HL-5mm W |

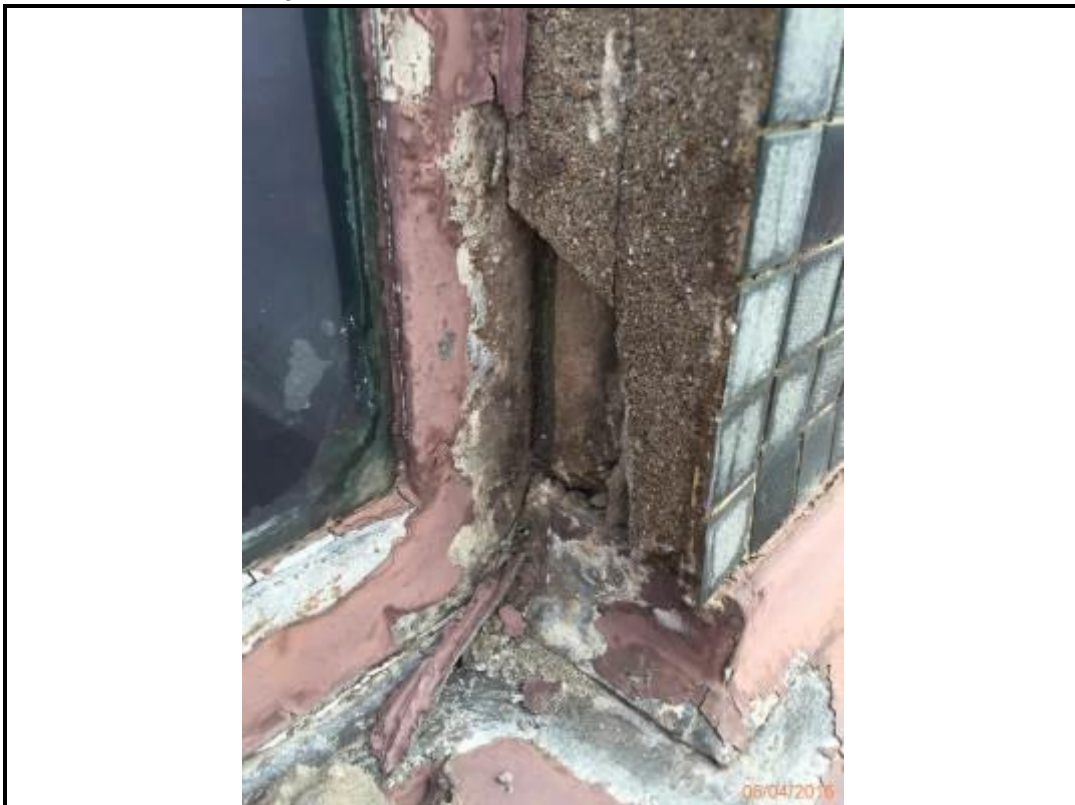
**Photo 187. Drop 5 – West Elevation**

| Photo 187 | Spalling to window row 2 column bottom south corner beneath M1 and 2 = 140mm H x 30mm W x 20mm |

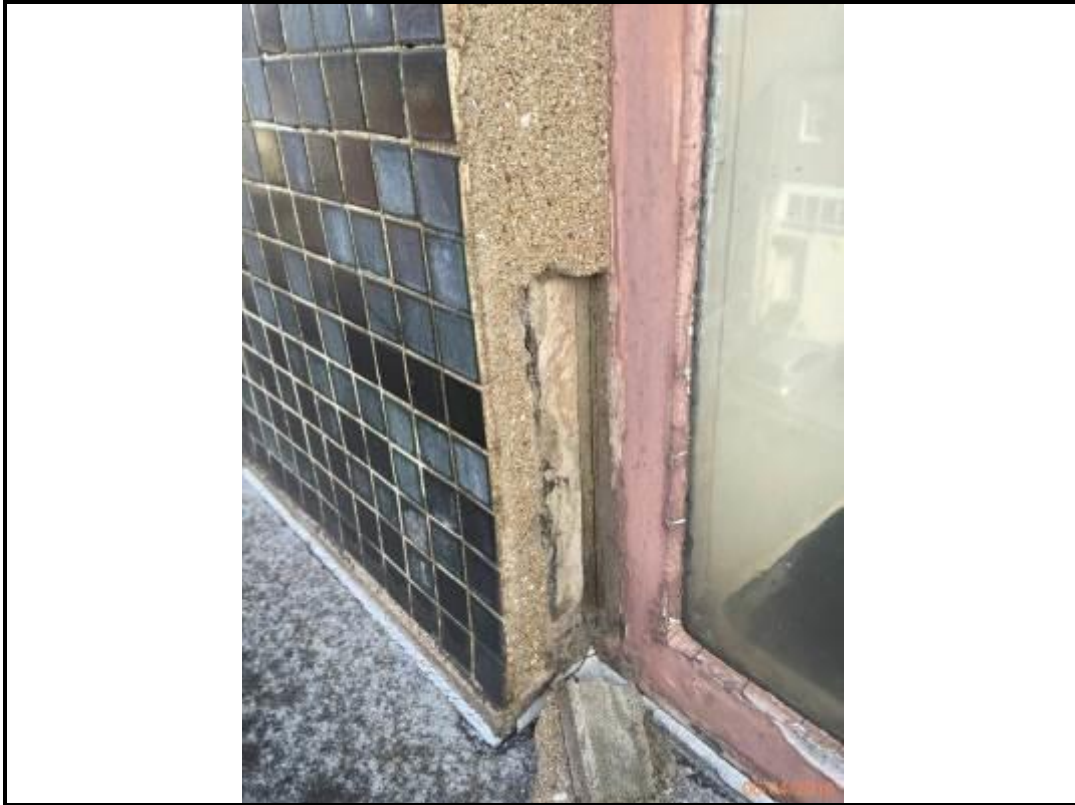
**Photo 188. Drop 5 – West Elevation**

| Photo 188 | Spalling to window row 2 column bottom north corner beneath M1 and 2 = 70mm H x 30mm W x 5mm |

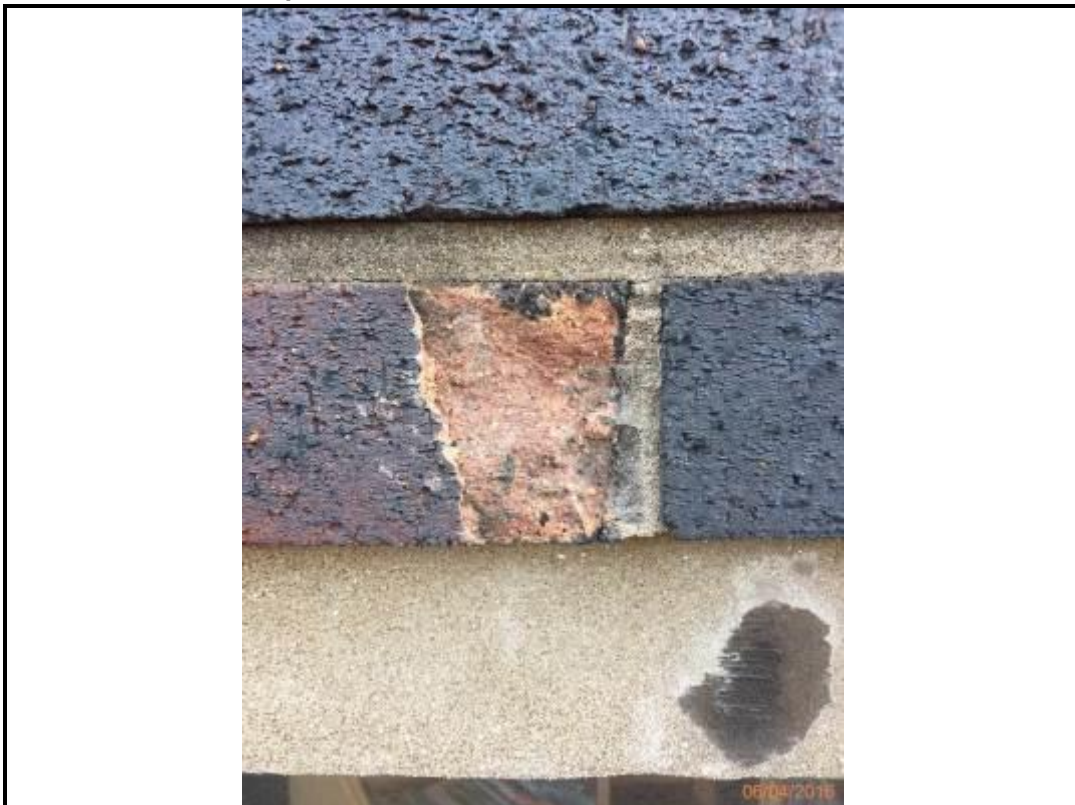
**Photo 189. Drop 5 – West Elevation**

| Photo 189 | Spalling to window row 3 column bottom south corner beneath B1 and 2 = 170mm H x 30mm W x 30mm |

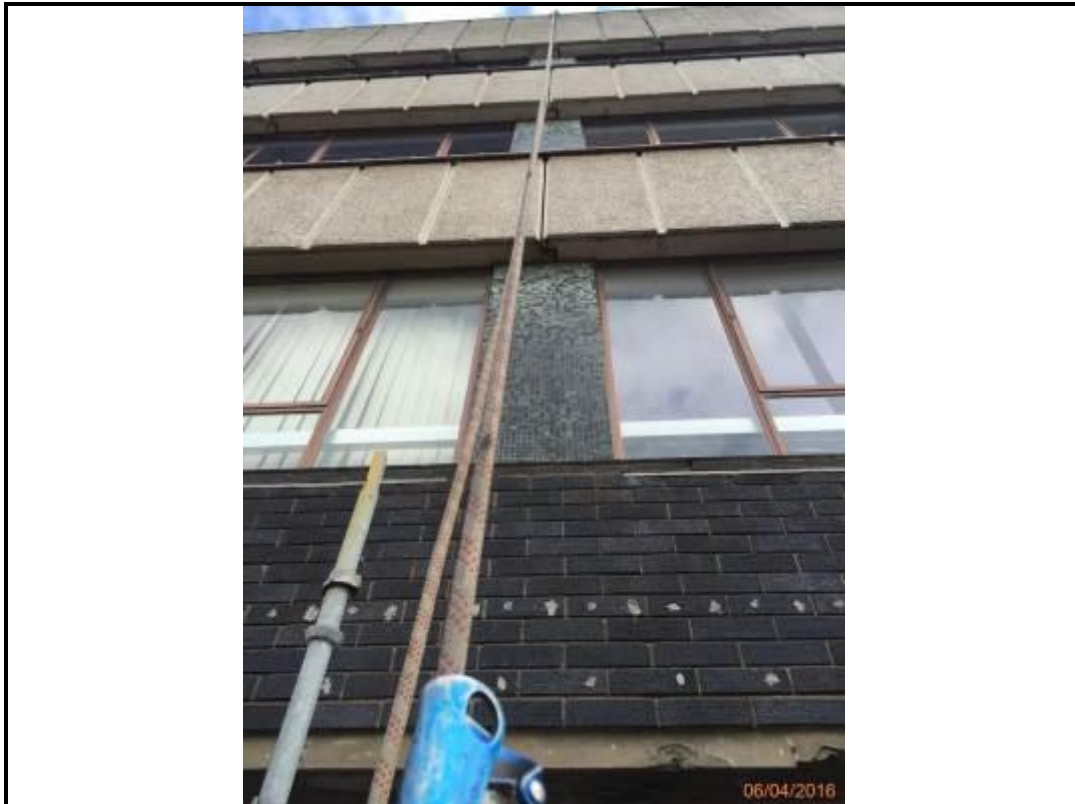
**Photo 190. Drop 5 – West Elevation**

| Photo 190 | Spalling to brickwork just above window row 4 lintel beneath B4 = 60mm H x 50mm W x 5mm |

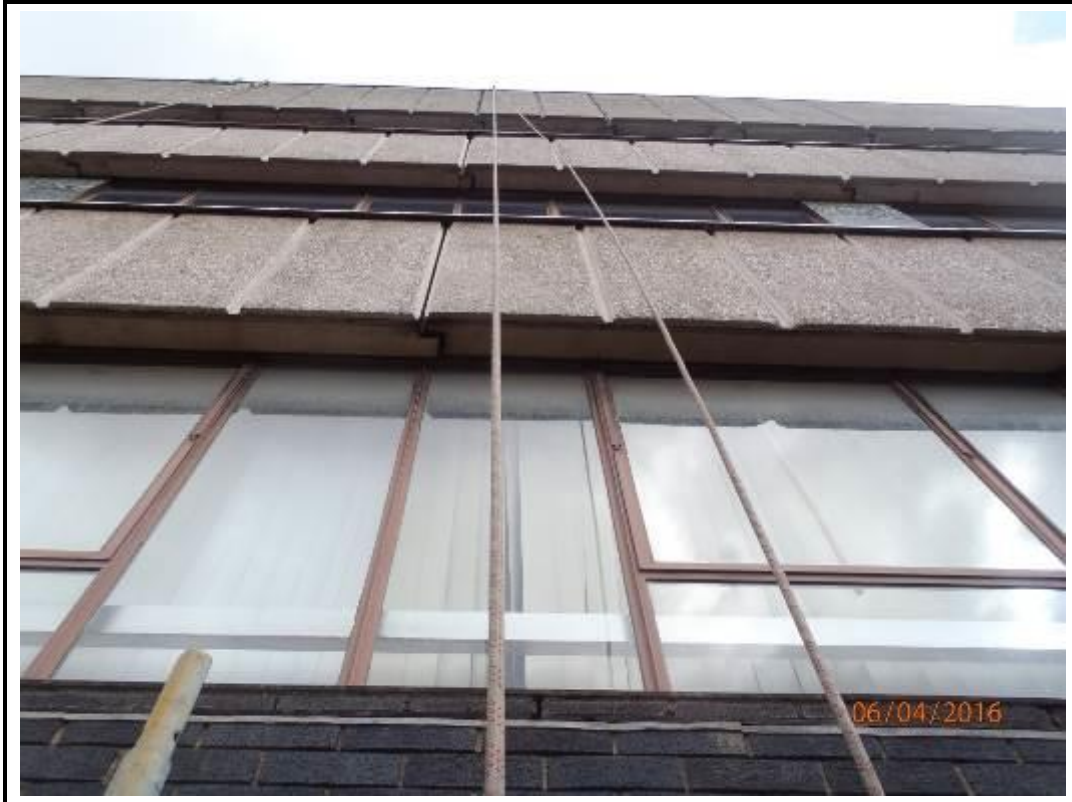
**Photo 192. Drop 6 – West Elevation**

| Photo 192 | Typical paint loss to window frame elements affecting all 4 rows of windows between drops 3 and 11 |

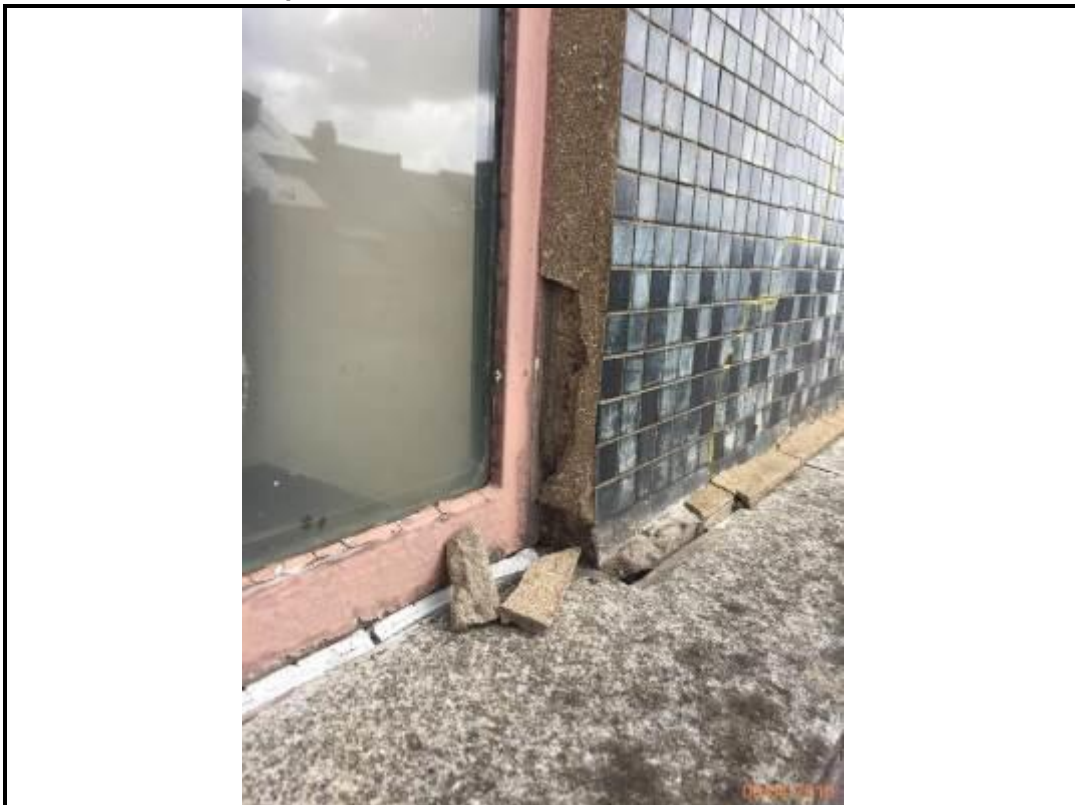
**Photo 195. Drop 7 – West Elevation**

| Photo 195 | Spalling to window row 3 column bottom south corner beneath B1 and 2 = 240mm H x 30mm W x 10mm |

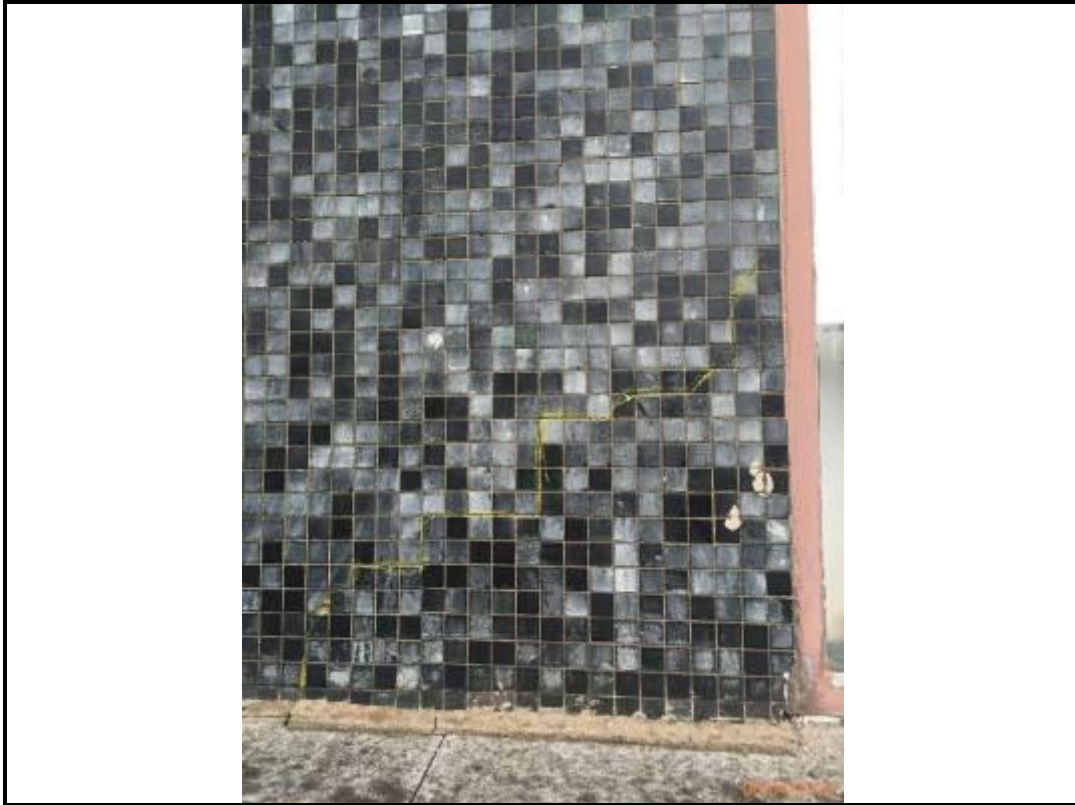
**Photo 196. Drop 7 – West Elevation**

| Photo 196 | Spalling to window row 3 column bottom north corner beneath B1 and 2 = 240mm H x 30mm W x 10mm |

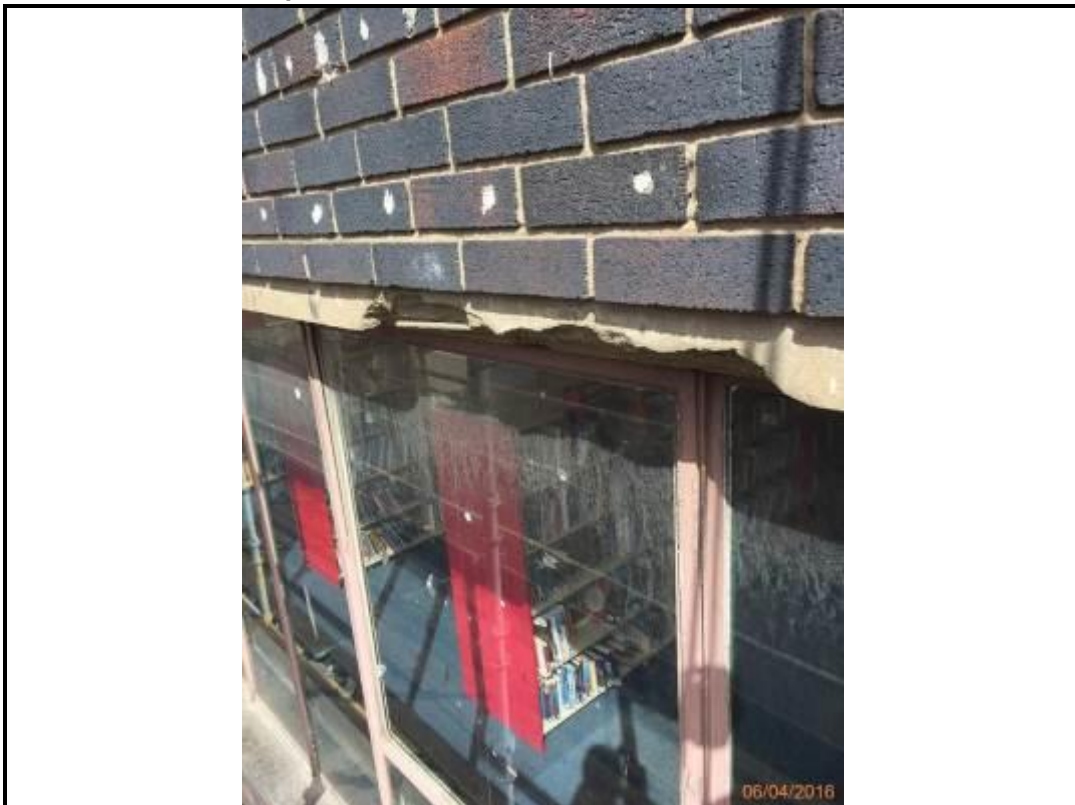
**Photo 197. Drop 7 – West Elevation**

| Photo 197 | Diagonal stepped fracture to window row 2 column beneath B1 and 2 = 600mm L x HL-2mm W |

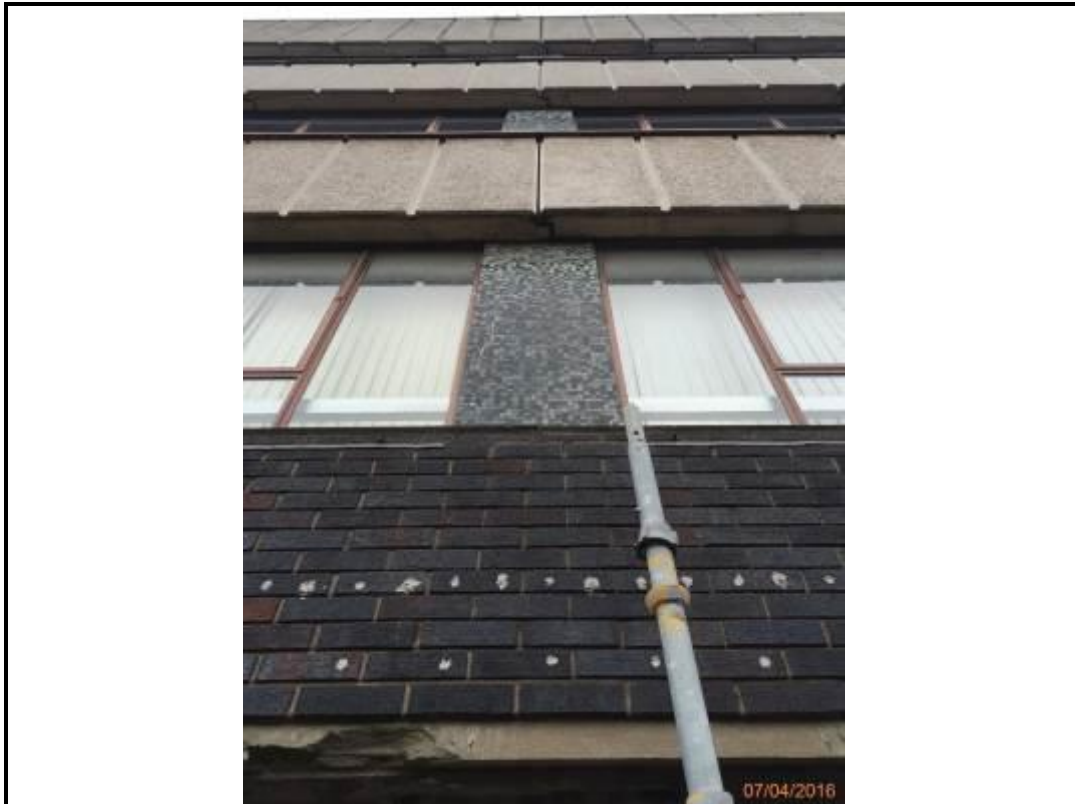
**Photo 198. Drop 7 – West Elevation**

| Photo 198 | Typical spalling to window row 4 lintel – area with exposed reinforcement (this defect extends intermittently full length of the lintel between drops 3 and 11) |

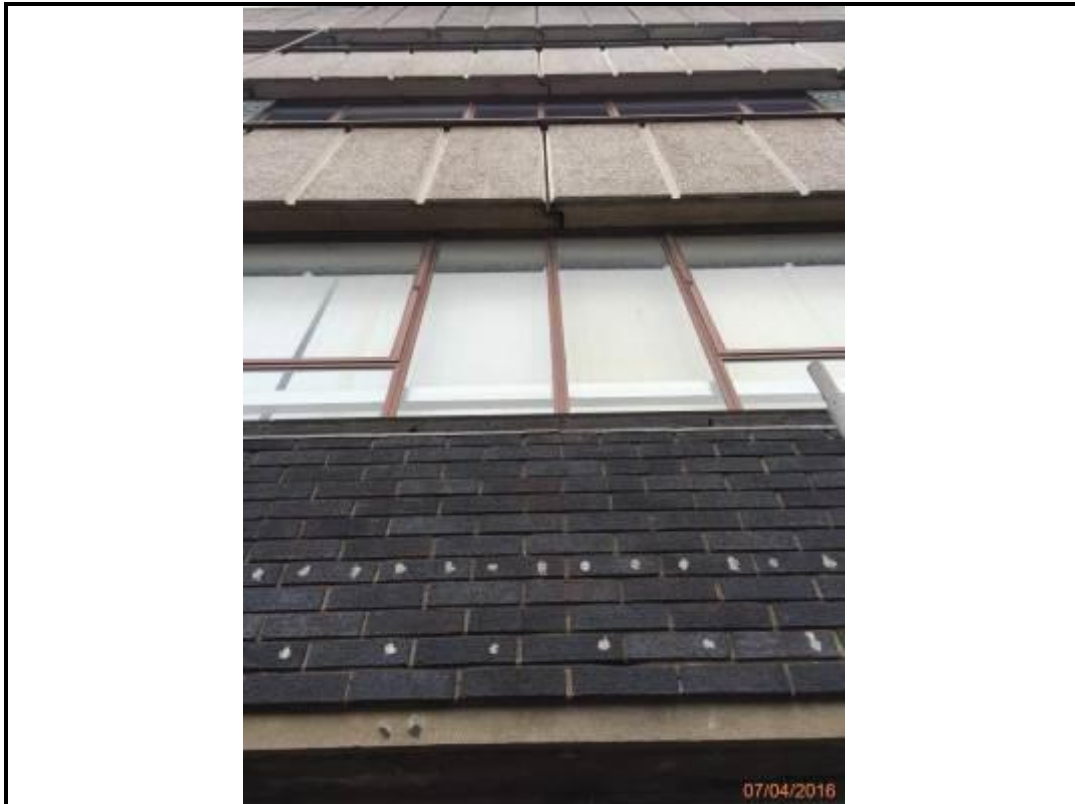
**Photo 200. Drop 8 – West Elevation**

| Photo 200 | Spalling to the north edge of T1 = 320mm H x 30mm W x 90mm D |

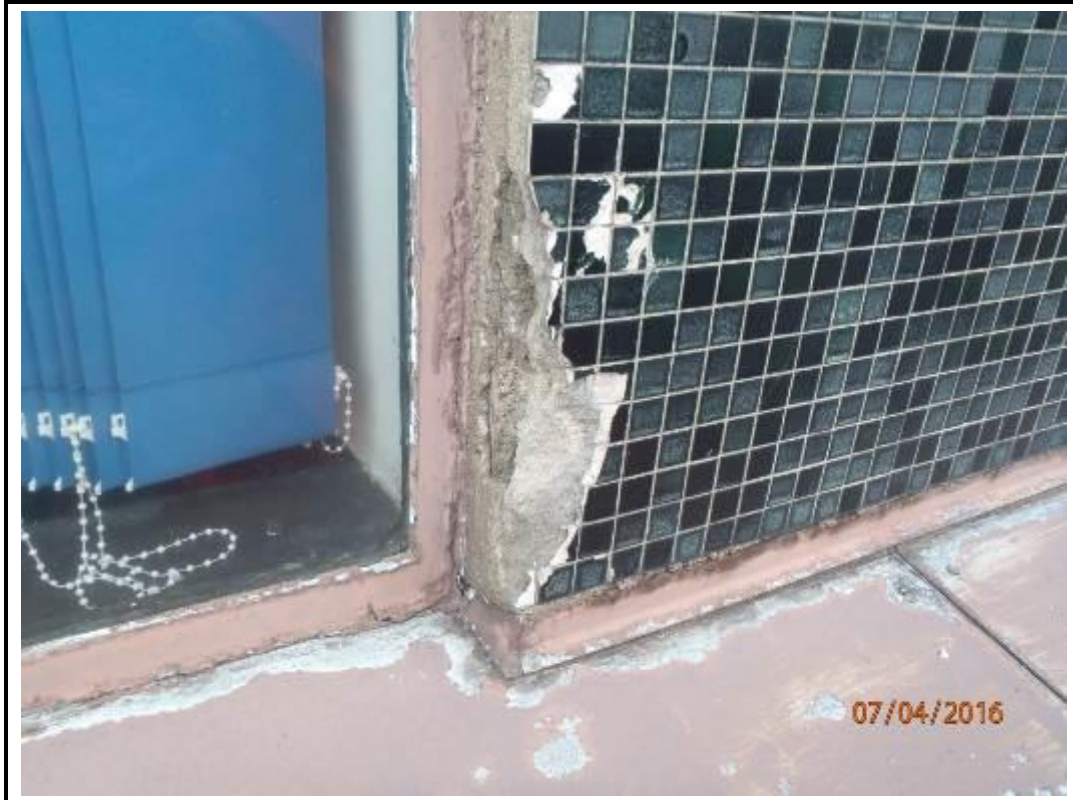
**Photo 202. Drop 9 – West Elevation**

| Photo 202 | Spalling to window row 2 column bottom south corner beneath M1 and 2 = 70mm H x 30mm W x 10mm |

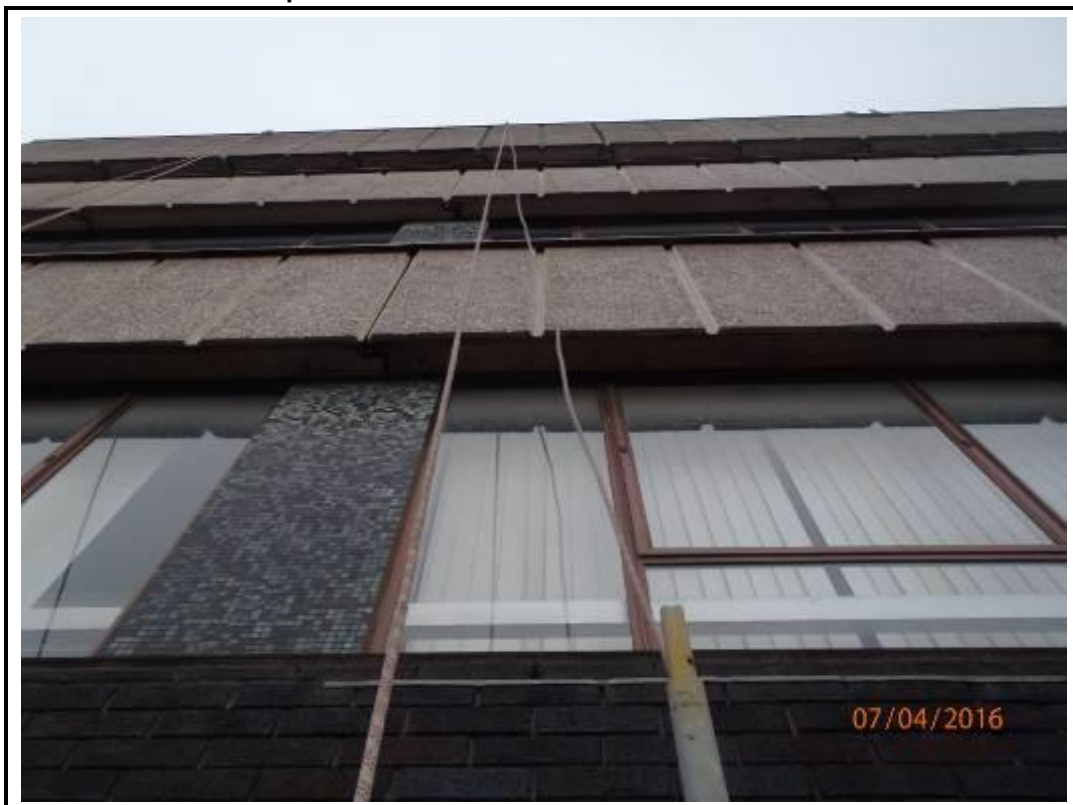
Photo 203. Drop 9 – West Elevation

| Photo 203 | Spalling to window row 2 column bottom north corner beneath M1 and 2 = 220mm H x 60mm W x 50mm |

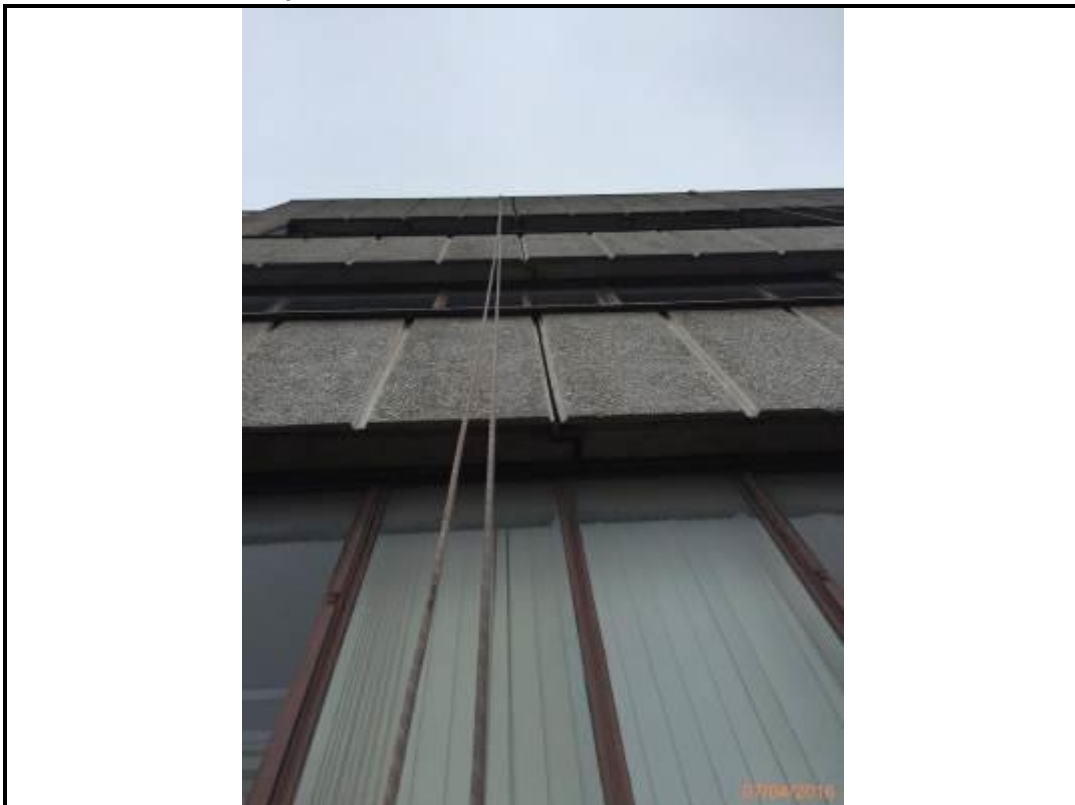
**Photo 205. Drop 10 – West Elevation**

| Photo 205 | Spalling between M3 and 4 beneath window row 2 = 20mm H x 40mm W x 2mm, exposed reinforcement |

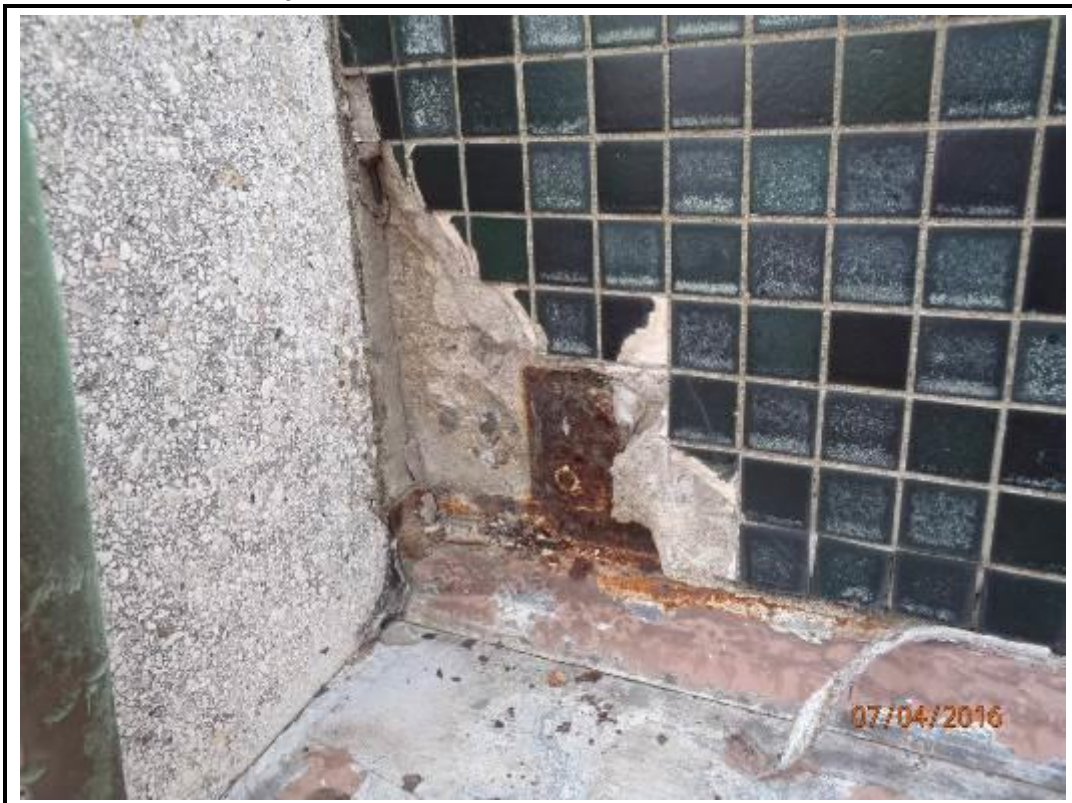
**Photo 207. Drop 11 – West Elevation**

| Photo 207 | Spalling to the top north corner of window row 1 column beneath T1 = 70mm H x 50mm W x 10mm d |

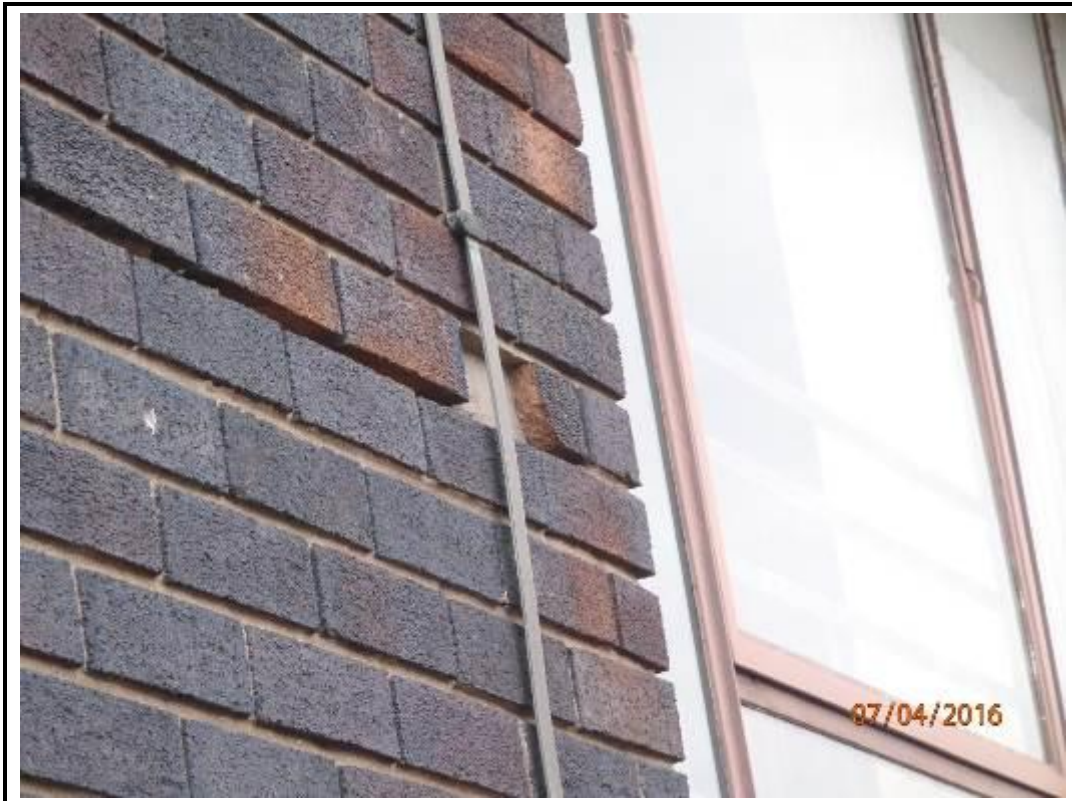
**Photo 209. Drop 11 – West Elevation**

| Photo 209 | Line of joint loss to brickwork 1.35m beneath B1 and extends into drop 12 and 13 <1m <sup>2</sup> x30mm D |

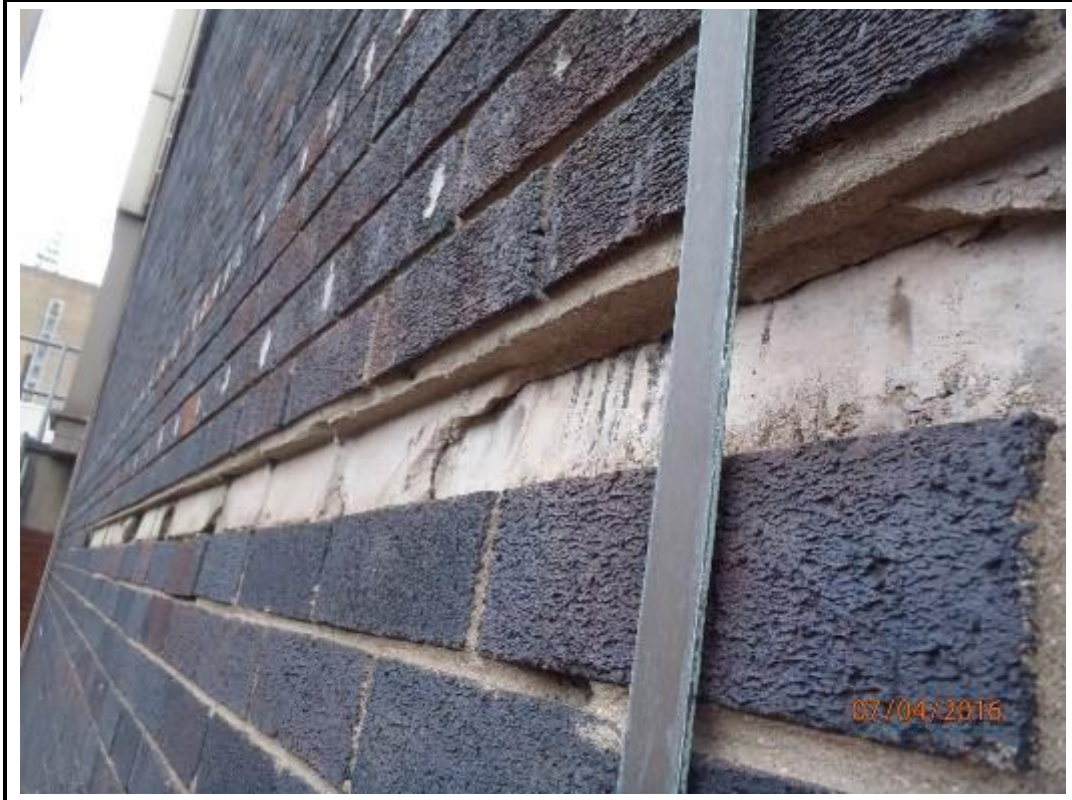
**Photo 210. Drop 11 – West Elevation**

| Photo 210 | 1No missing brick, located 1.35m beneath B1 |

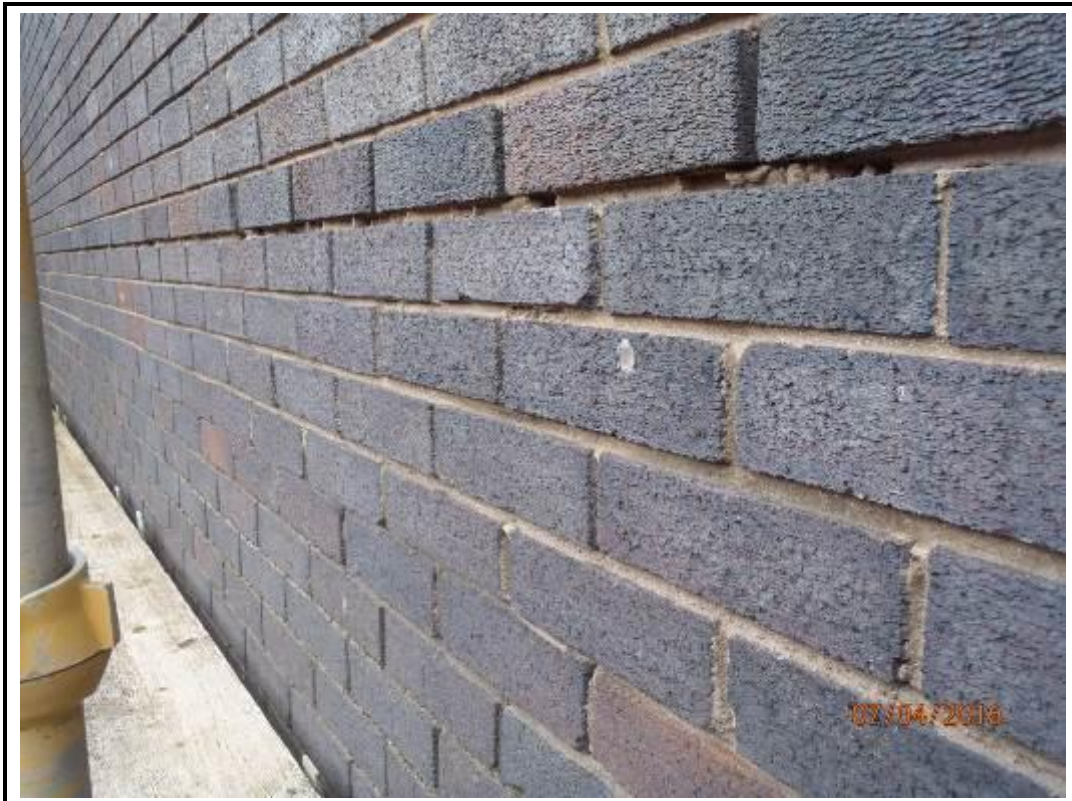
**Photo 211. Drop 11 – West Elevation**

| Photo 211 | Line of missing brickwork 1.35m beneath B1 and extends into drop 12, 17No bricks missing |

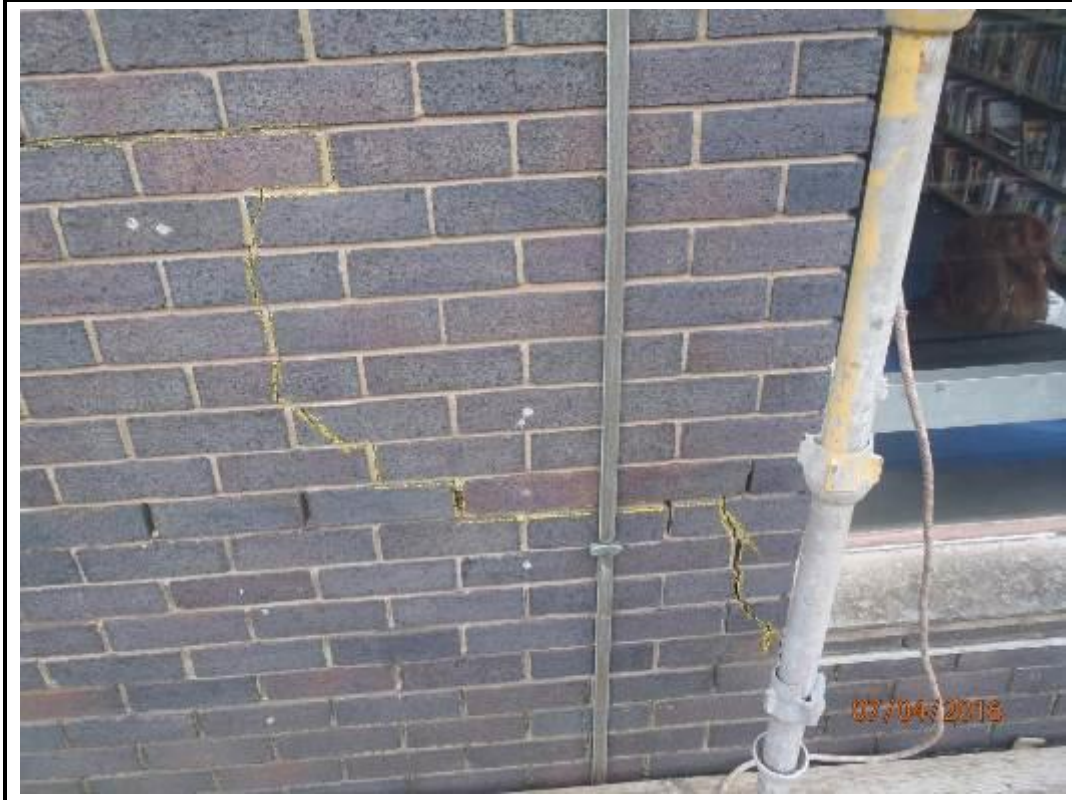
**Photo 212. Drop 11 – West Elevation**

| Photo 212 | Line of joint loss to brickwork 3.7m beneath B1 and extends into drop 12 and 13 |

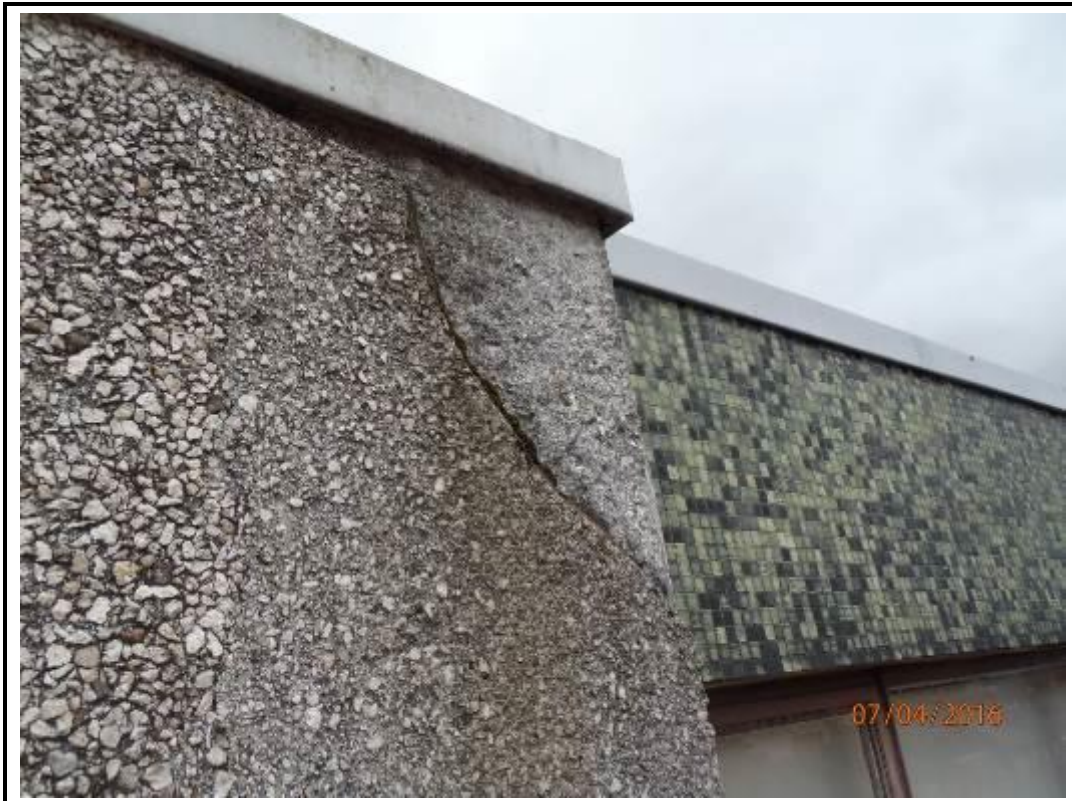
**Photo 217. Drop 12 – West Elevation**

| Photo 217 | Spalling to the bottom north corner of T1 = 30mm H x 100mm W x 50mm D |

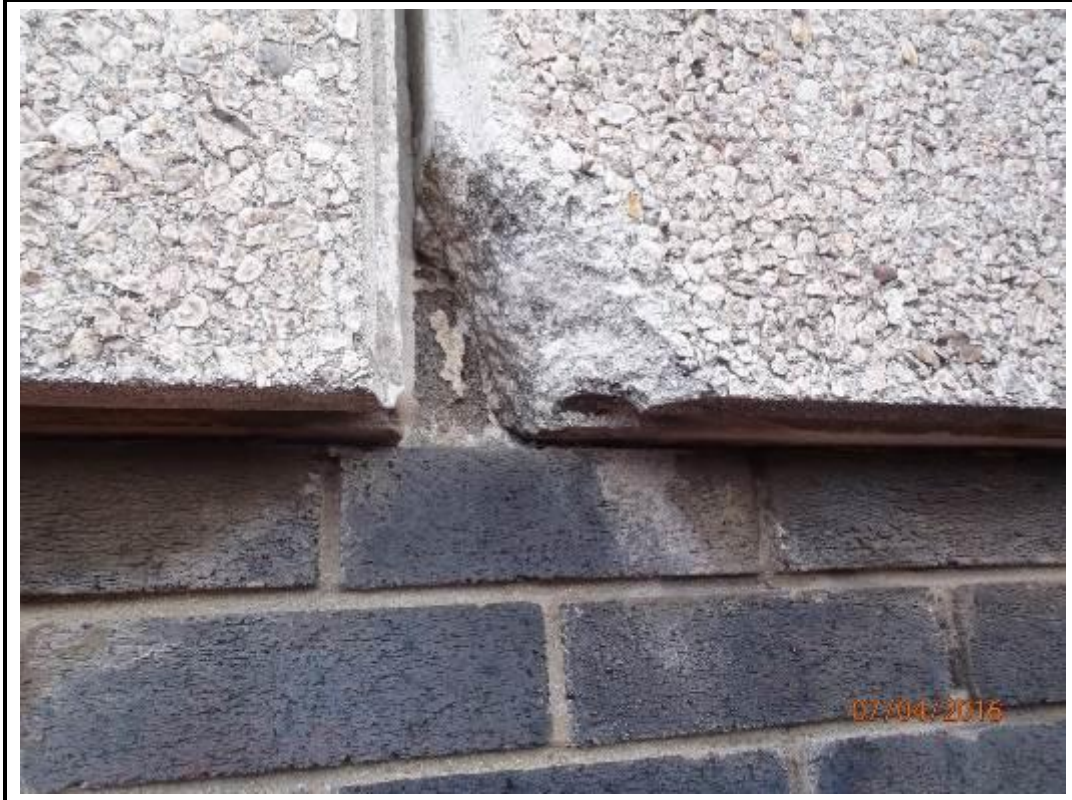
**Photo 218. Drop 12 – West Elevation**

| Photo 218 | Spalling to the top south corner of T3 = 500mm H x 450mm W x 40mm D |

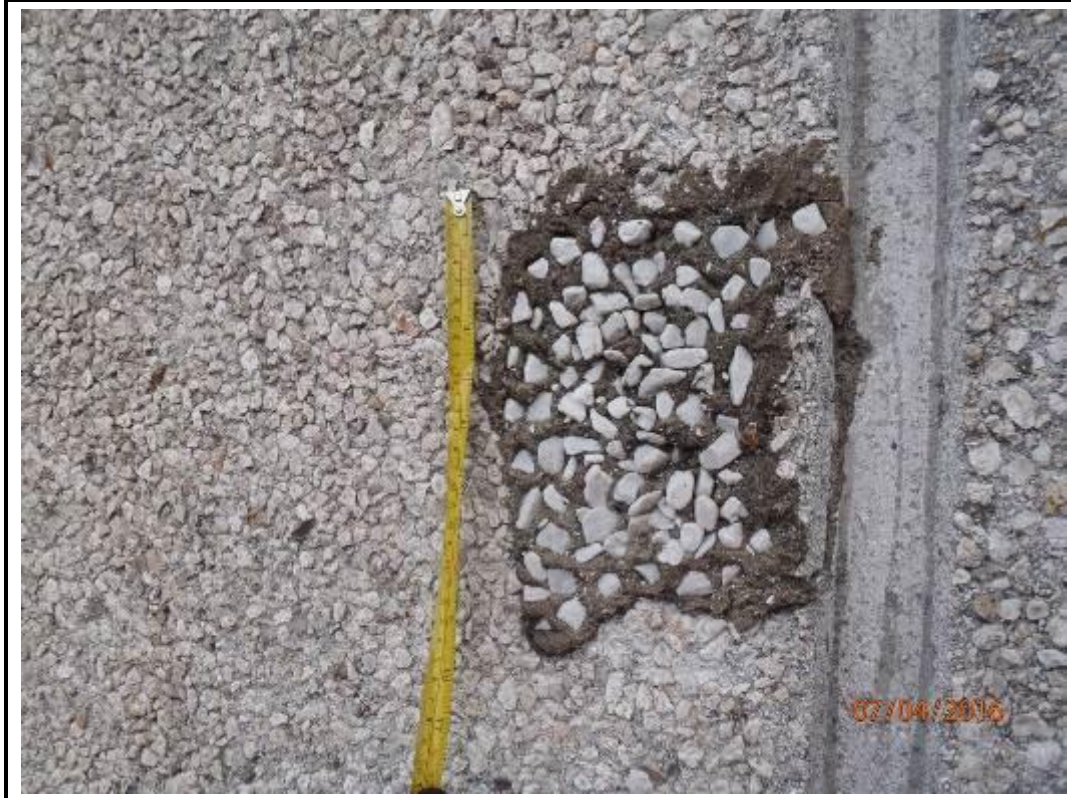
**Photo 224. Drop 13 – West Elevation**

| Photo 224 | 2No spall repairs to top of B1 and 2, each = 100mm H x 100mm W |

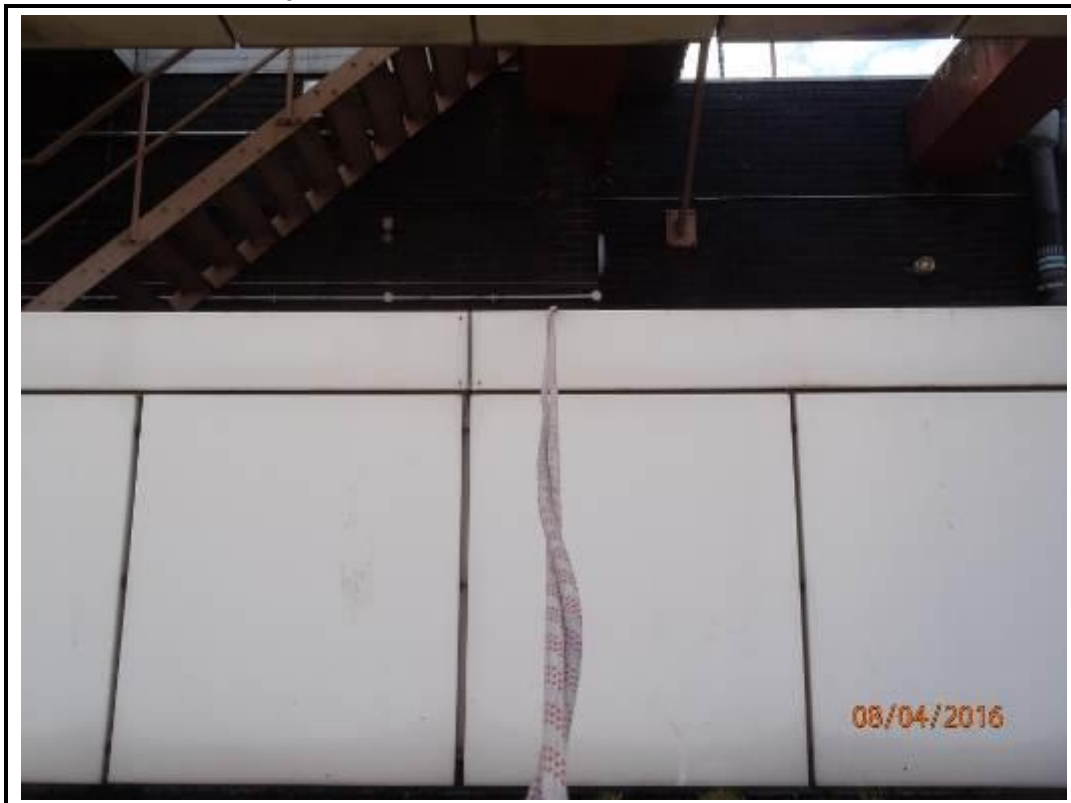
**Photo 251. Drop 8 – North Elevation**

| Photo 251 | General view looking up |

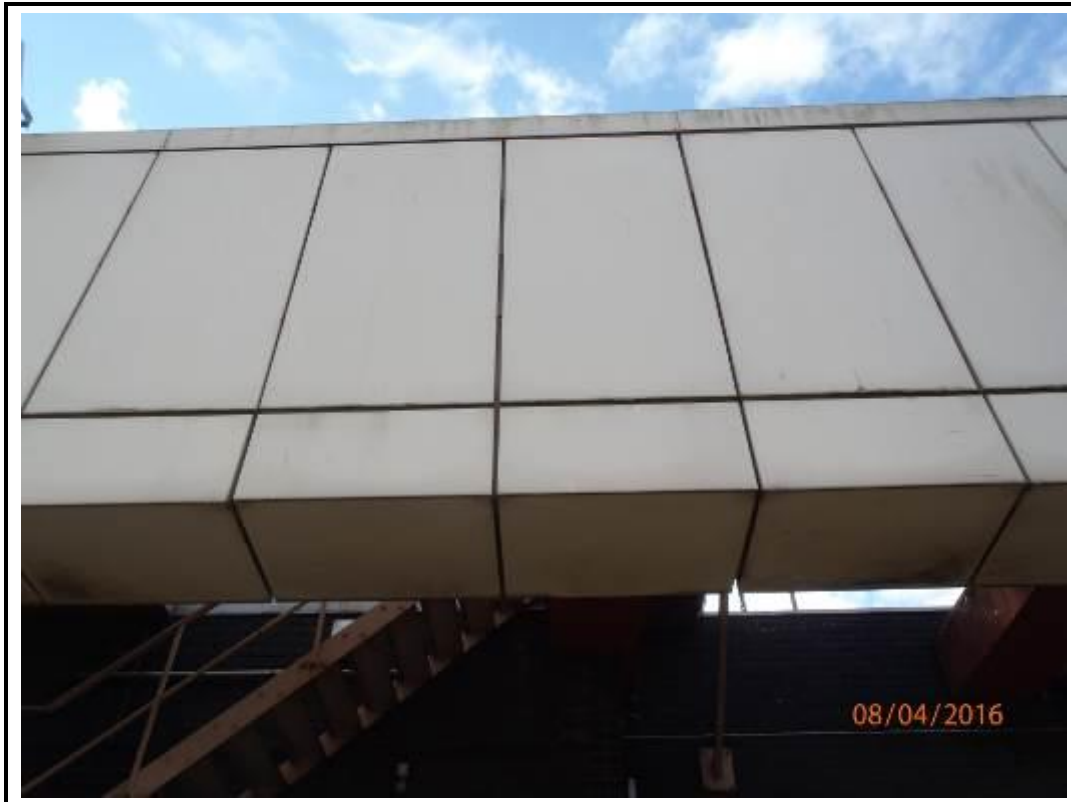
**Photo 252. Drop 8 – North Elevation**

| Photo 252 | General view looking up |

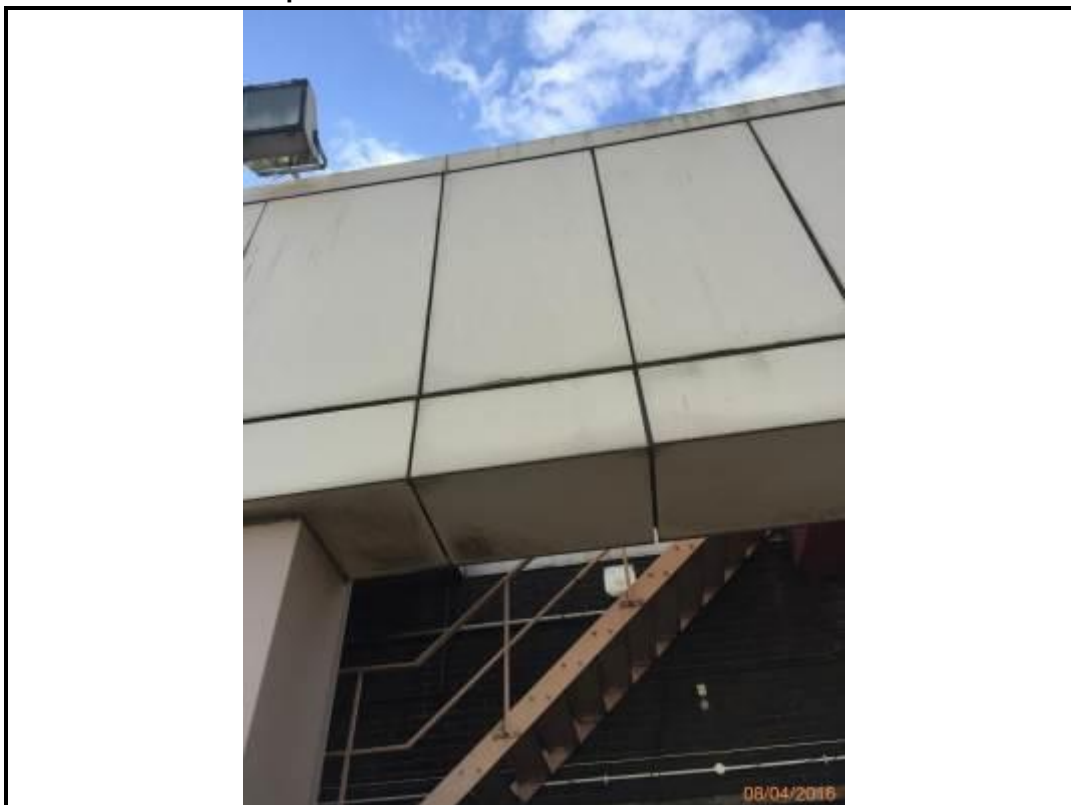
**Photo 253. Drop 8 – North Elevation**

| Photo 253 | General view looking up |
