**CONCRETE STRUCTURE ASSESSMENT REPORT  
NEWPORT CENTRAL LIBRARY  
NEWPORT**

**Date: 20<sup>TH</sup> JULY 2016**  
**Ref: BH.DB/16027.01.D001**

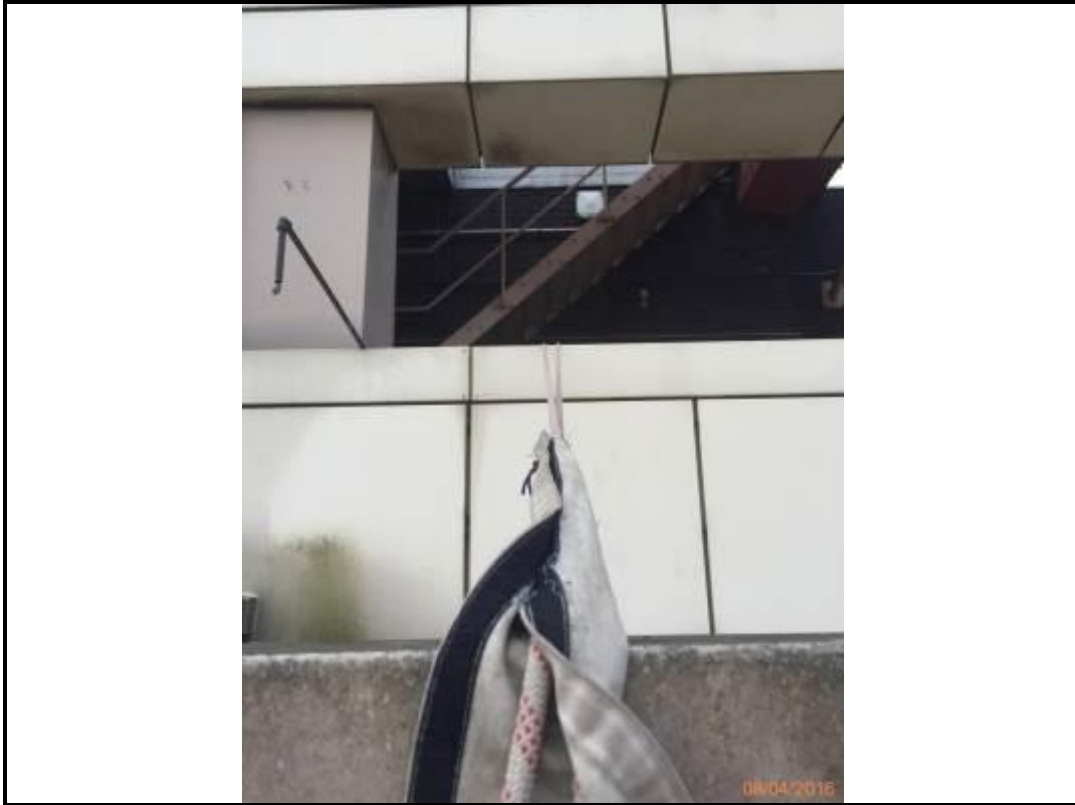
**Photo 254. Drop 9 – North Elevation**

| Photo 254 | General view looking up |

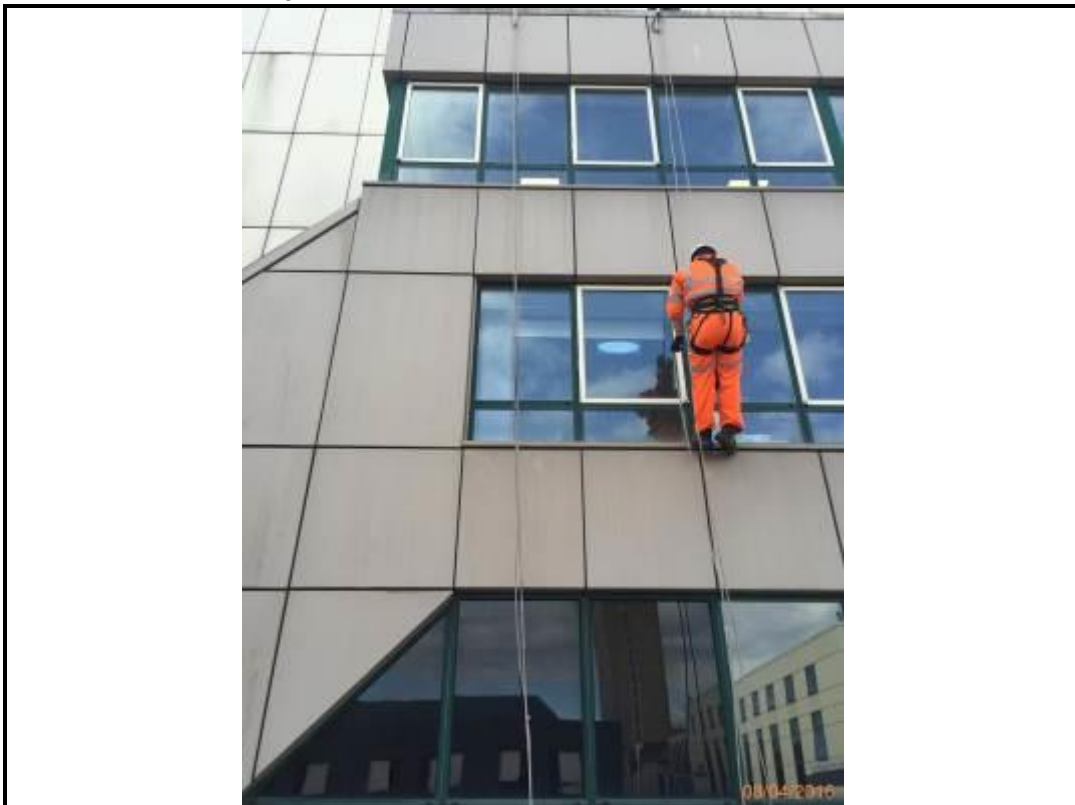
**Photo 255. Drop 9 – North Elevation**

| Photo 255 | General view looking up |

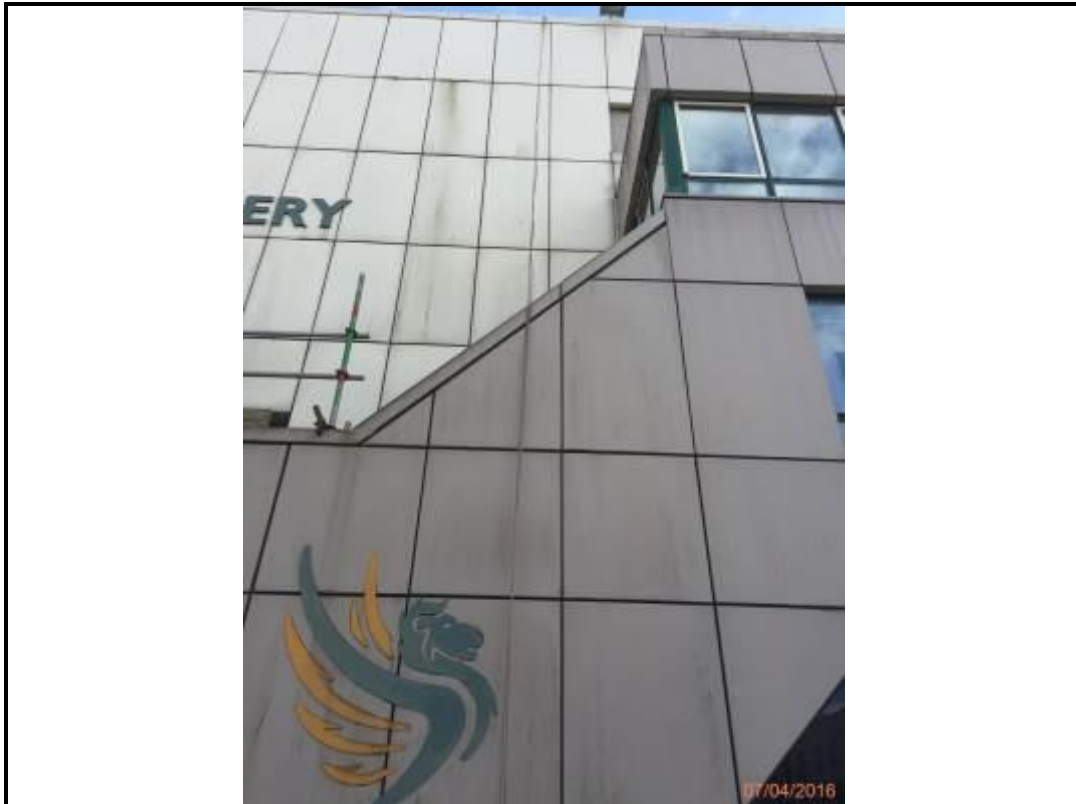
**Photo 256. Drop 9 – North Elevation**

| Photo 256 | General view looking up |

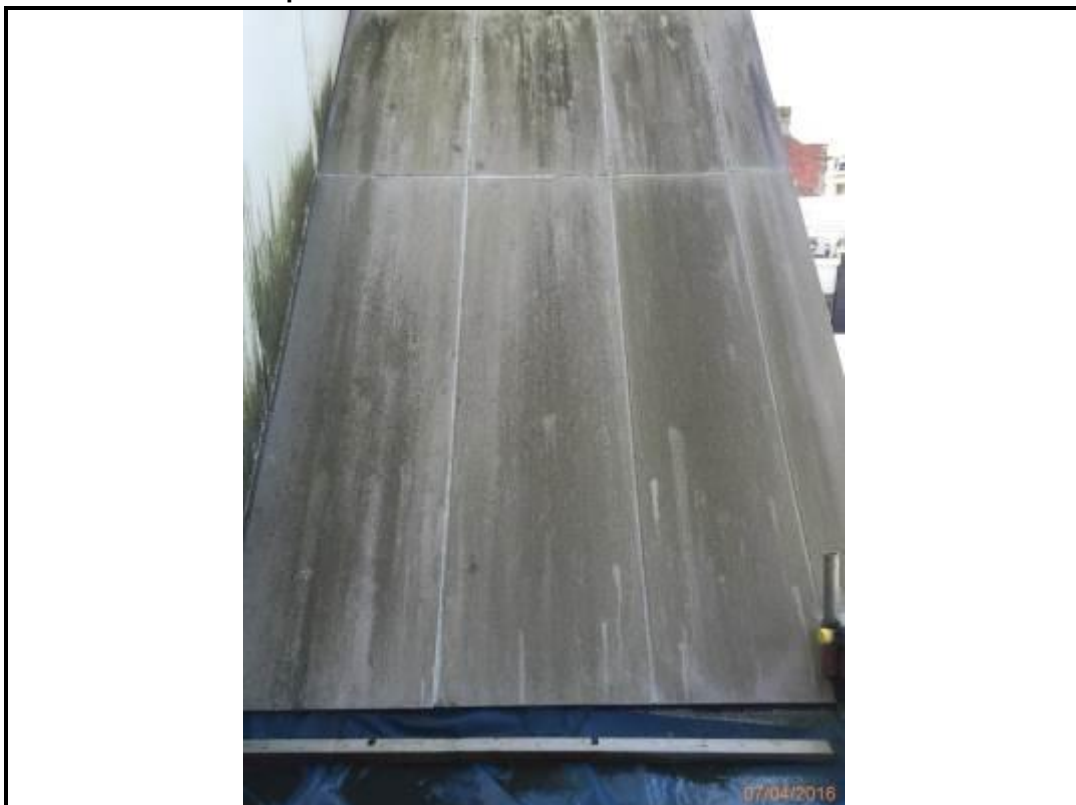
**Photo 257. Drop 10 – North Elevation**

| Photo 257 | General view looking up |

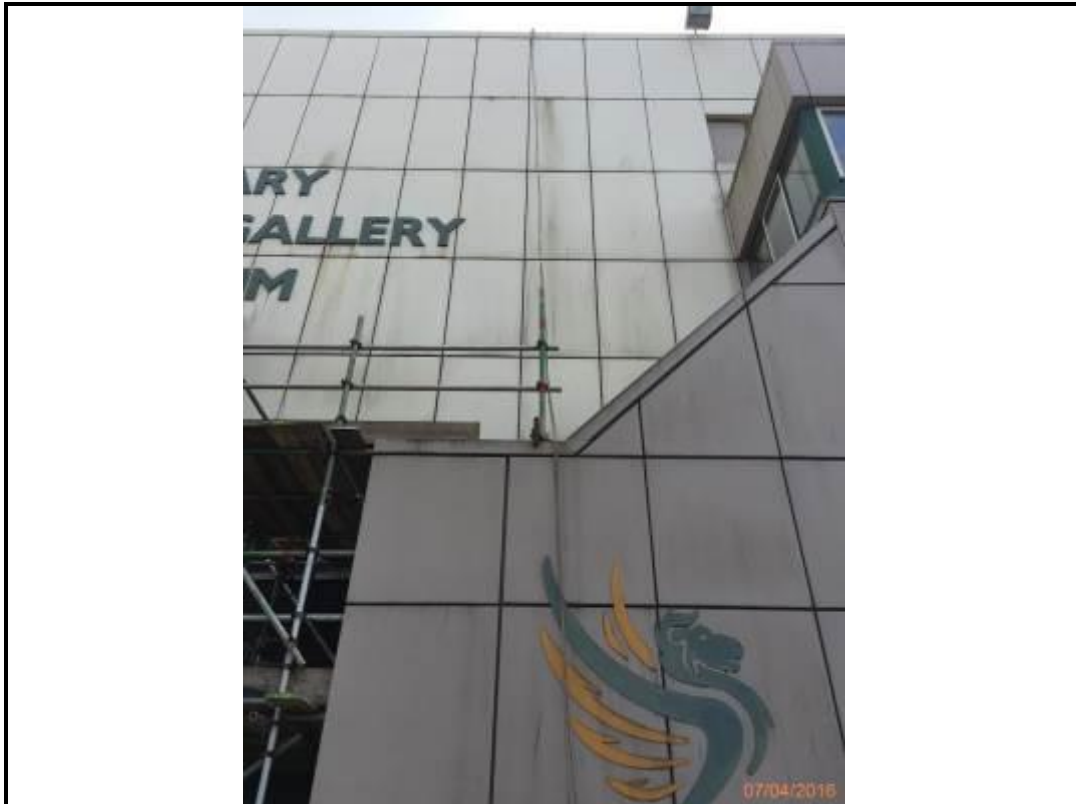
**Photo 258. Drop 10 – North Elevation**

| Photo 258 | East elevation of 2 <sup>nd</sup> and 3 <sup>rd</sup> floor level extension |

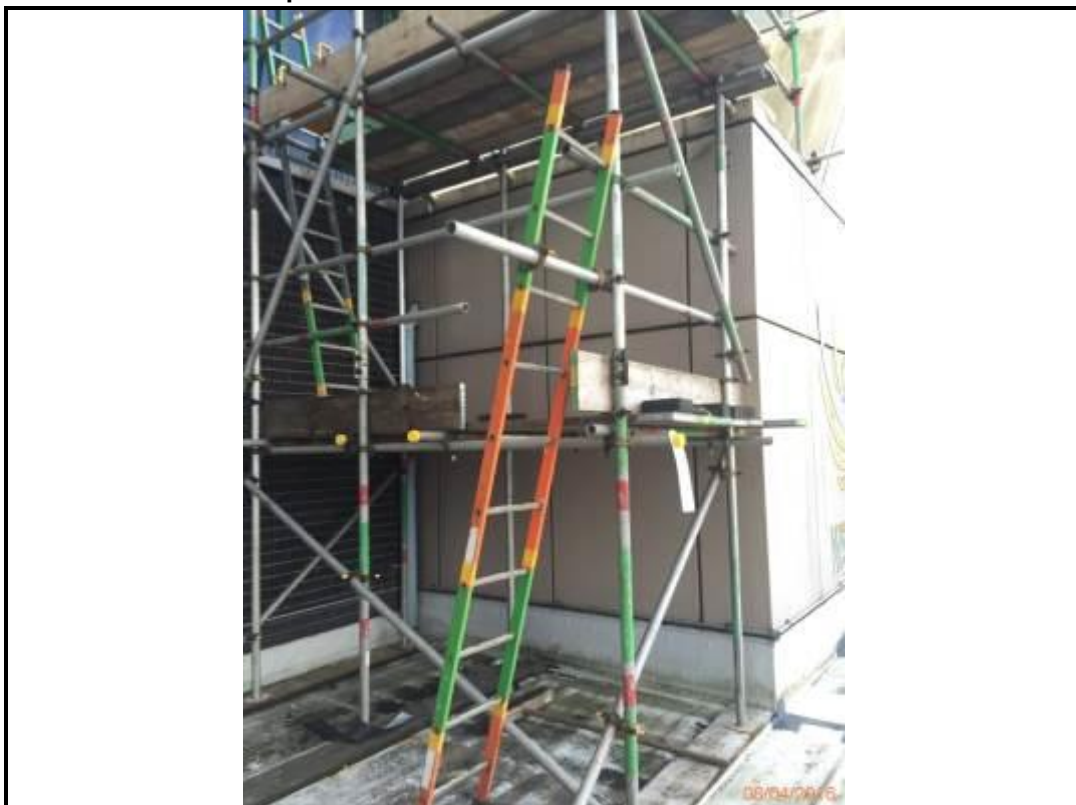
**Photo 259. Drop 11 – North Elevation**

| Photo 259 | General view looking up |

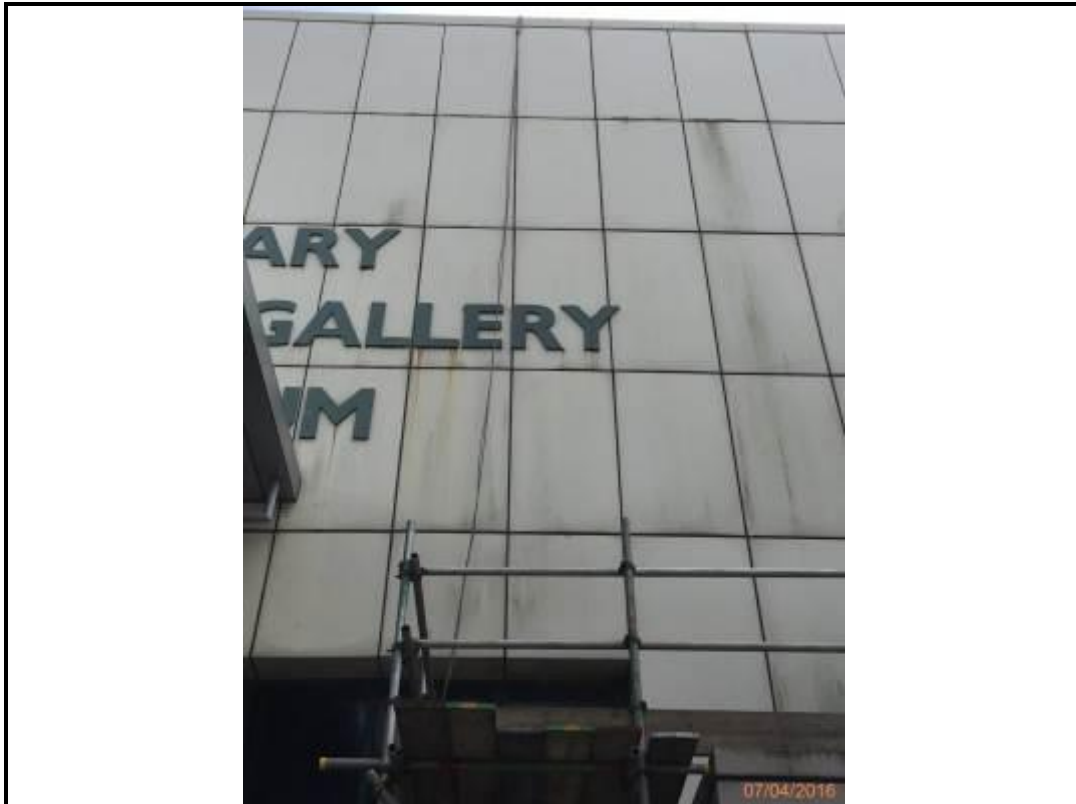
**Photo 260. Drop 11 – North Elevation**

| Photo 260 | East elevation of 1 <sup>st</sup> floor level extension |

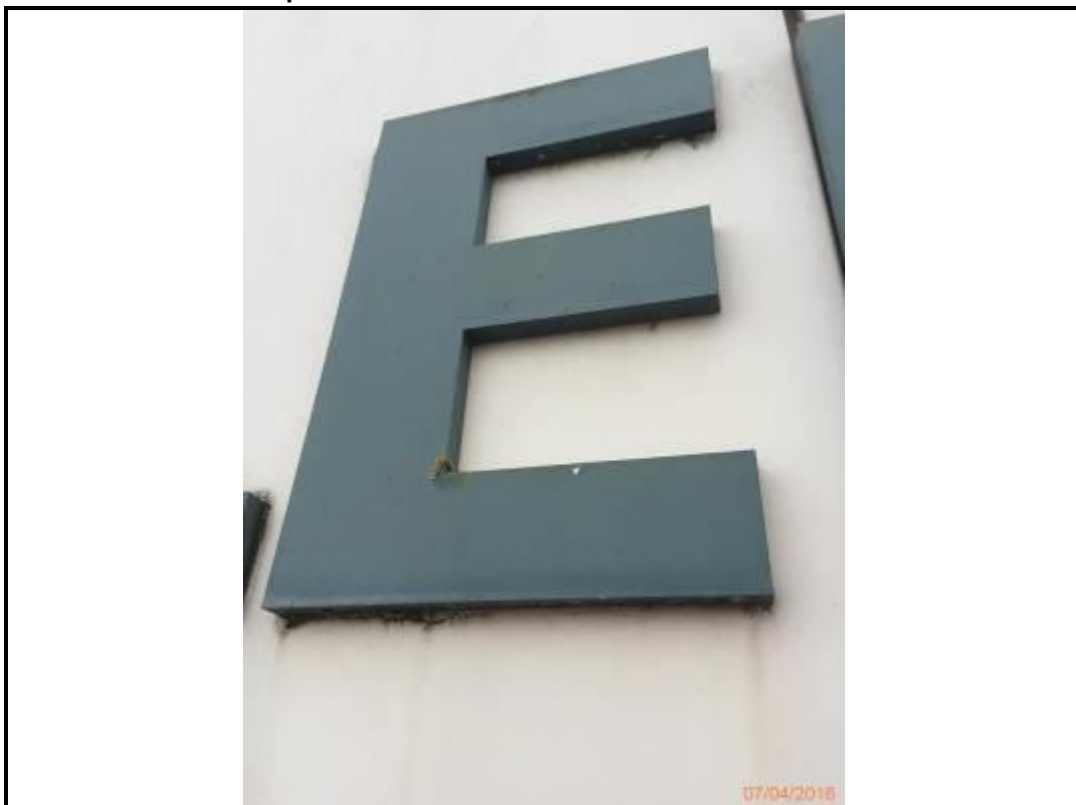
**Photo 261. Drop 12 – North Elevation**

| Photo 261 | General view looking up |

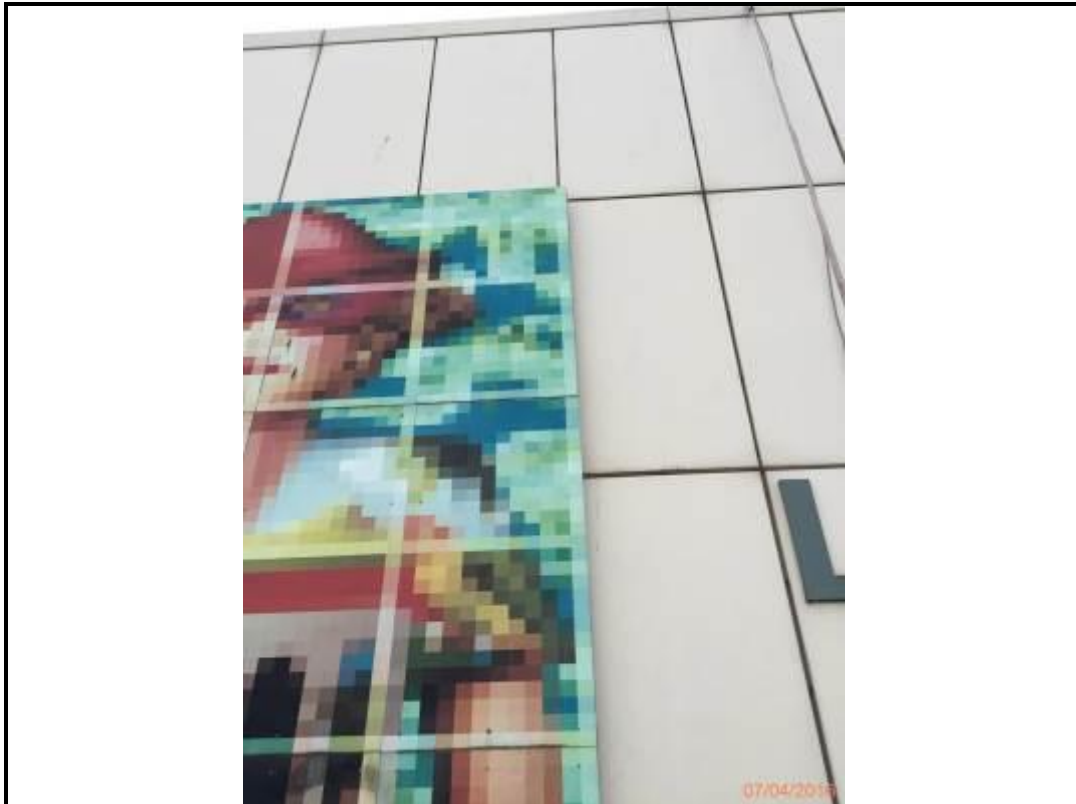
**Photo 268. Drop 14 – North Elevation**

| Photo 268 | General view looking up |

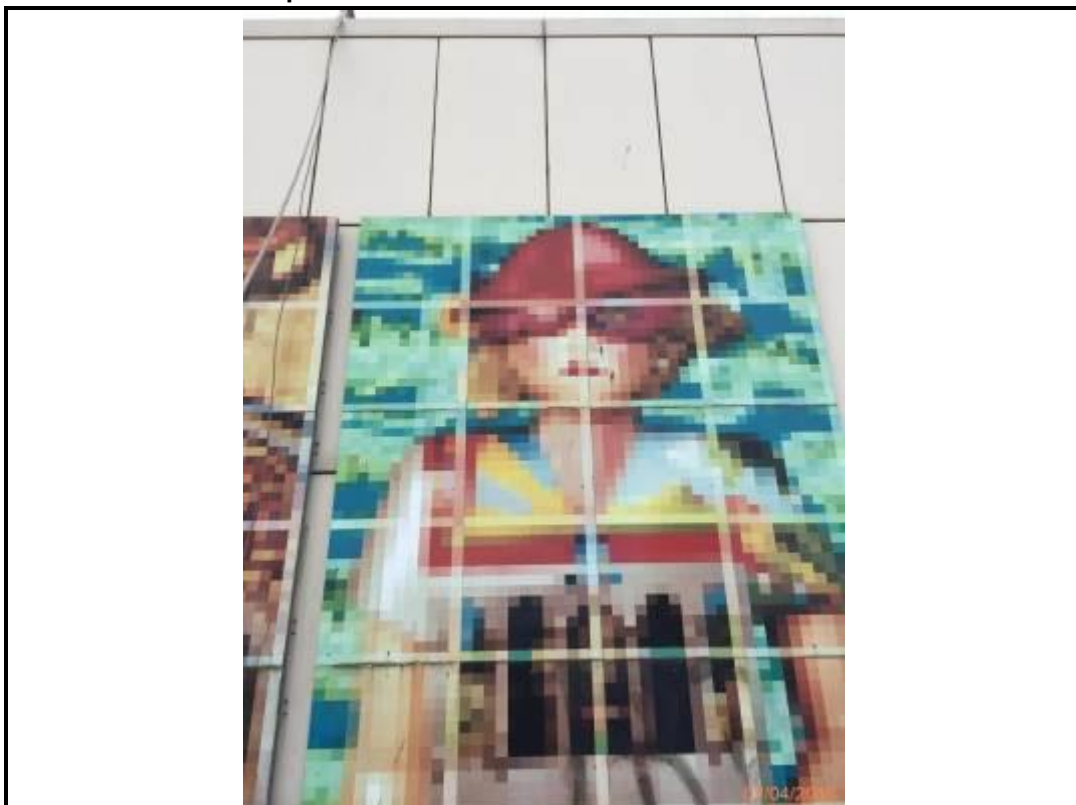
**Photo 269. Drop 15 – North Elevation**

| Photo 269 | General view looking up |

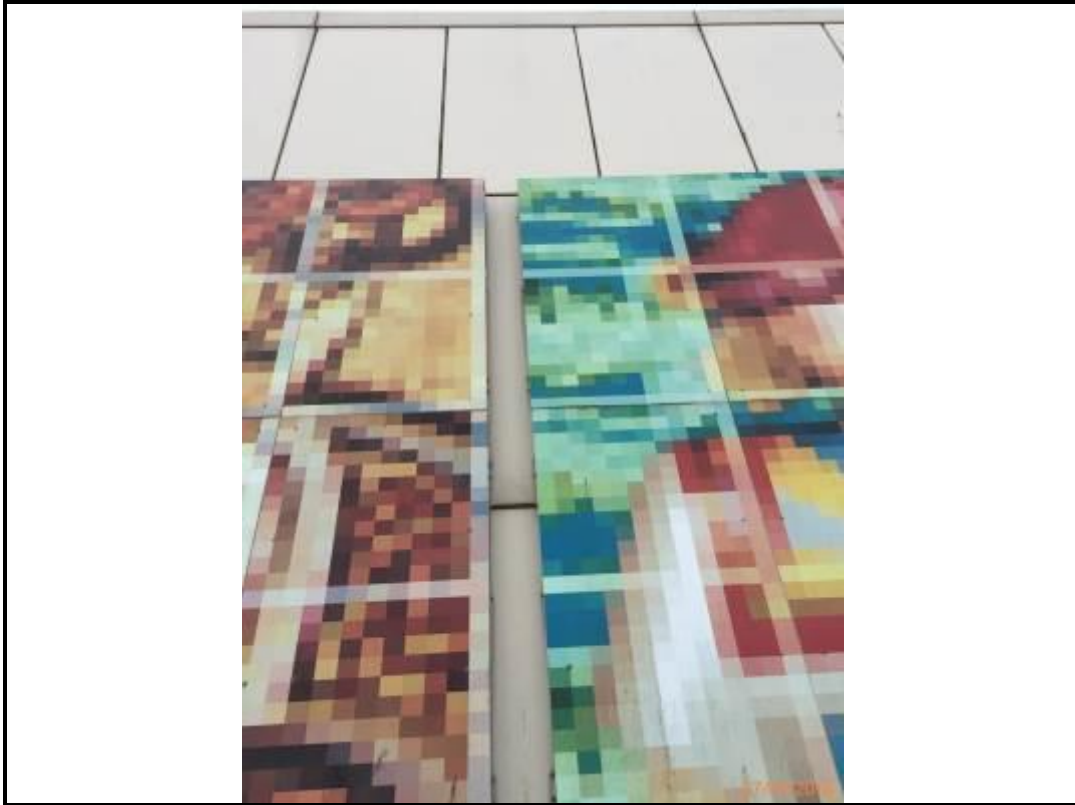
**Photo 270. Drop 16 – North Elevation**

| Photo 270 | General view looking up |

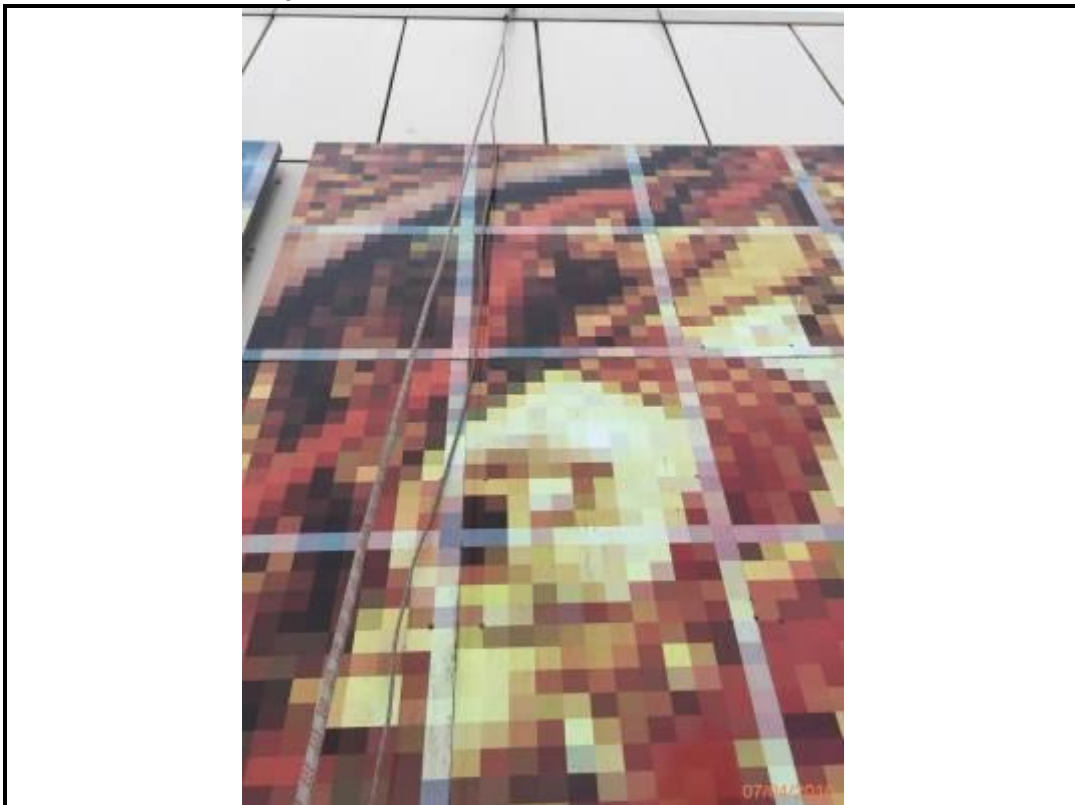
**Photo 271. Drop 17 – North Elevation**

| Photo 271 | General view looking up |

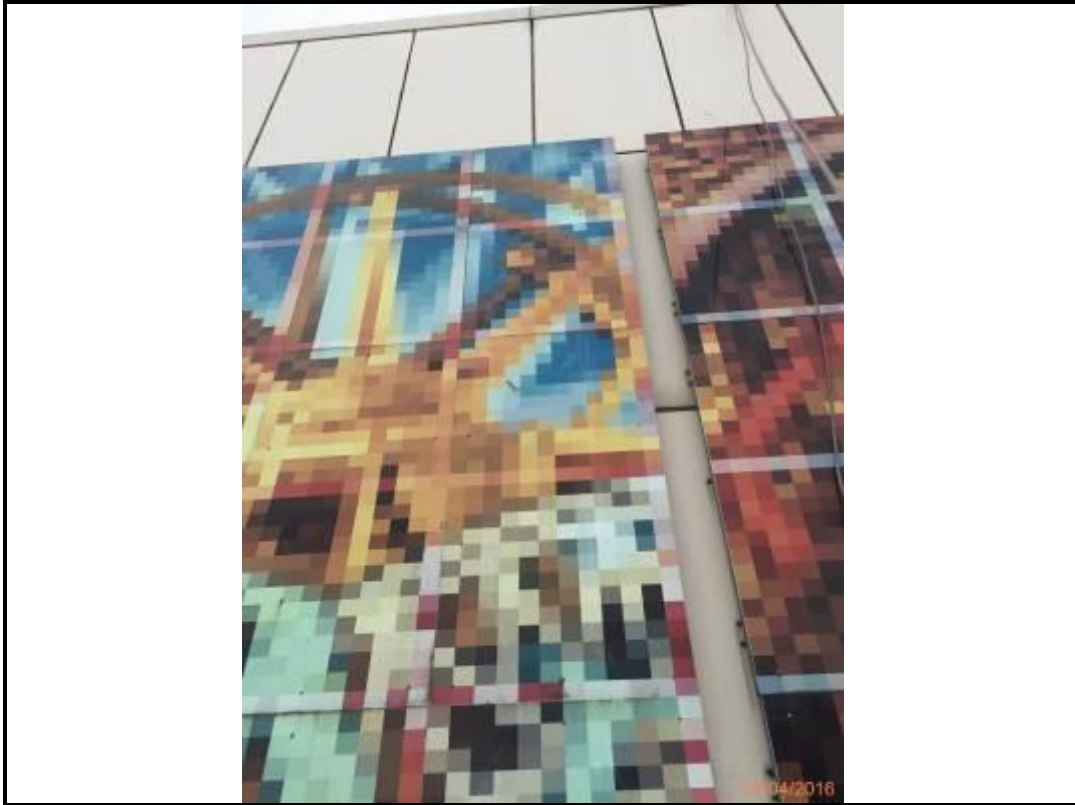
**Photo 272. Drop 18 – North Elevation**

| Photo 272 | General view looking up |

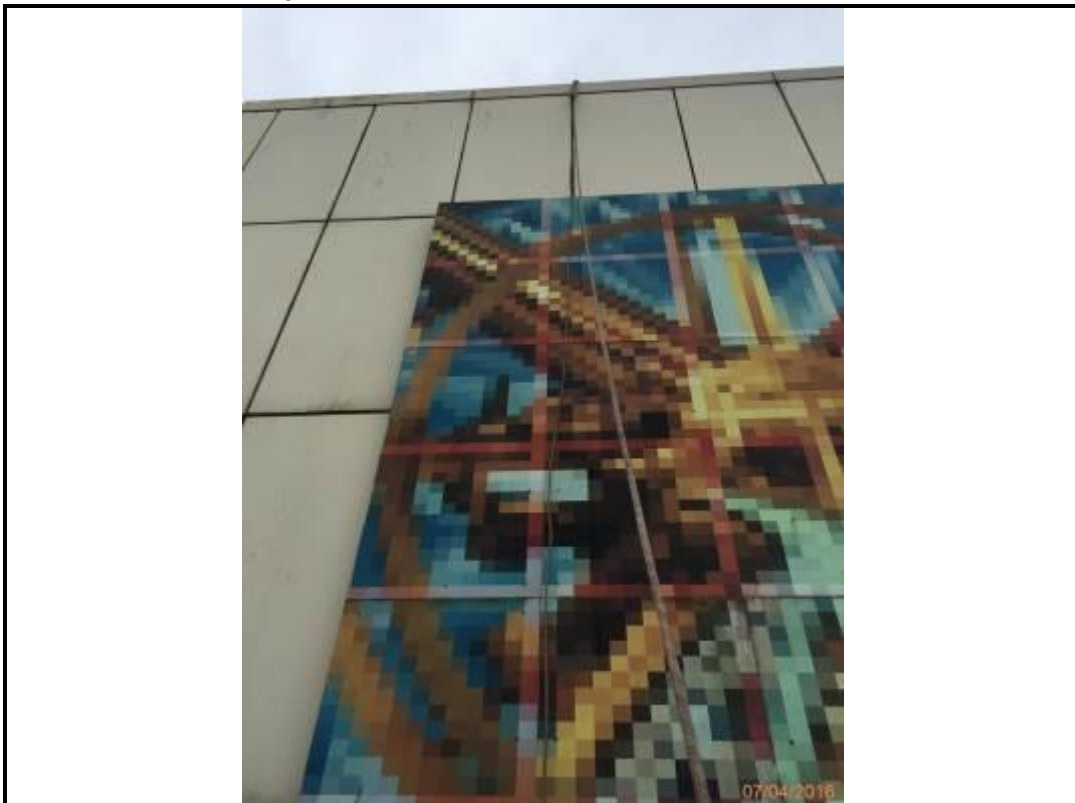
**Photo 273. Drop 19 – North Elevation**

| Photo 273 | General view looking up |

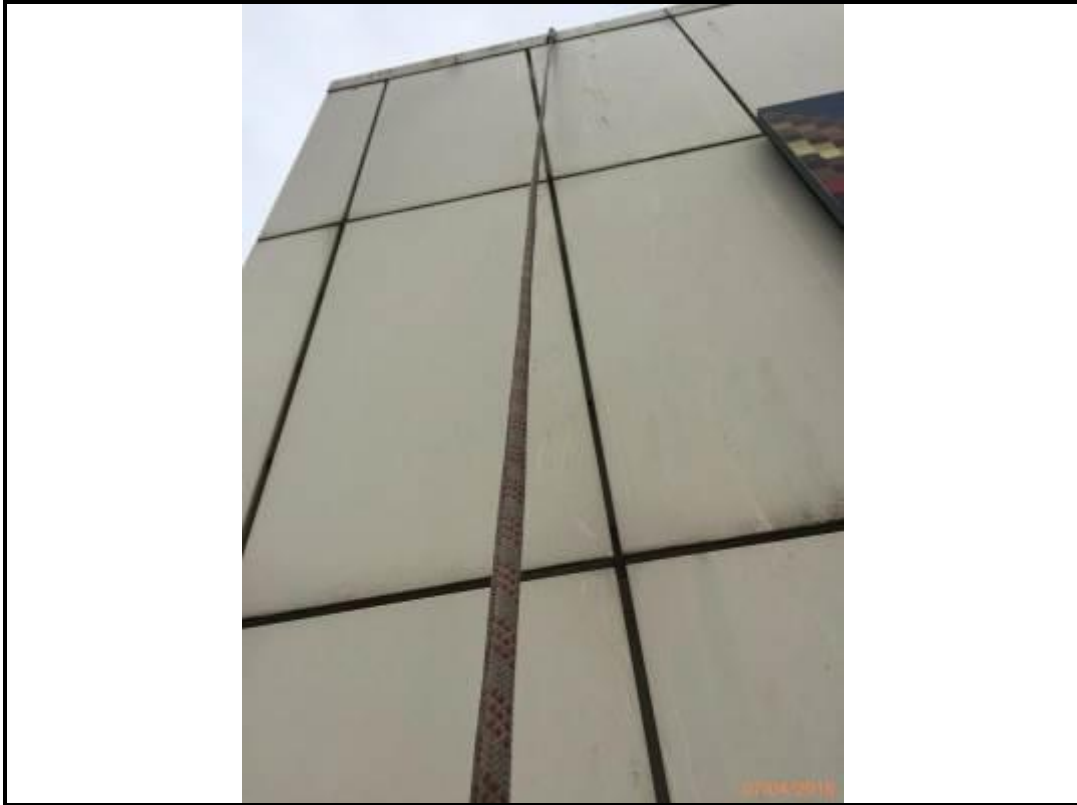
**Photo 274. Drop 20 – North Elevation**

| Photo 274 | General view looking up |

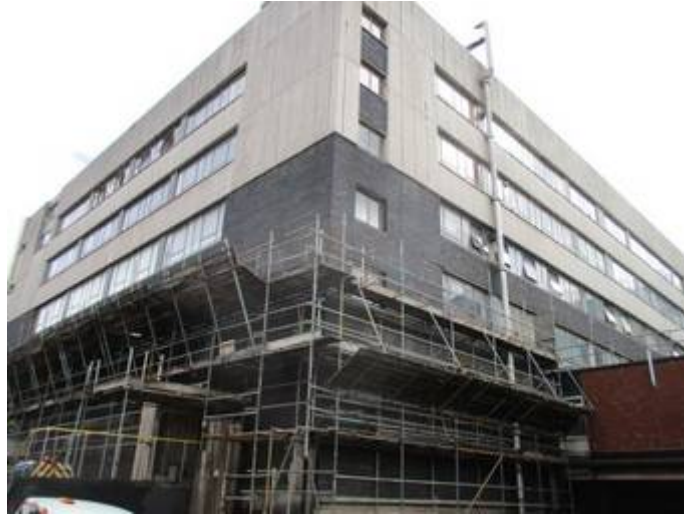
1 – View of the rear elevations to the property.

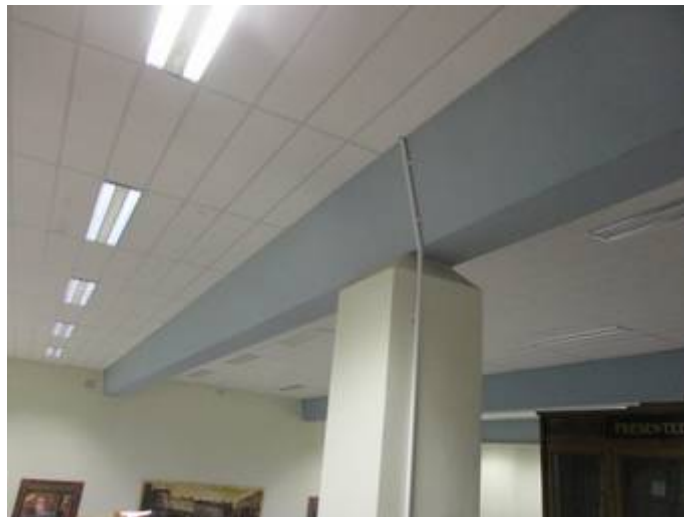
2 – Typical insitu cast concrete construction within the property.

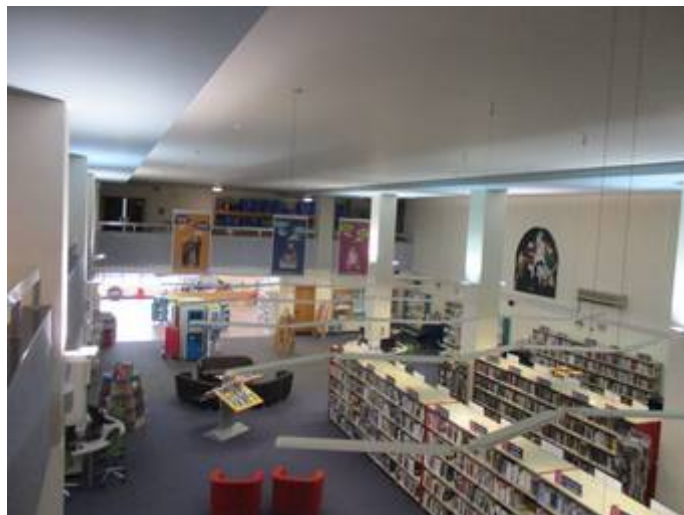
3 – As above.

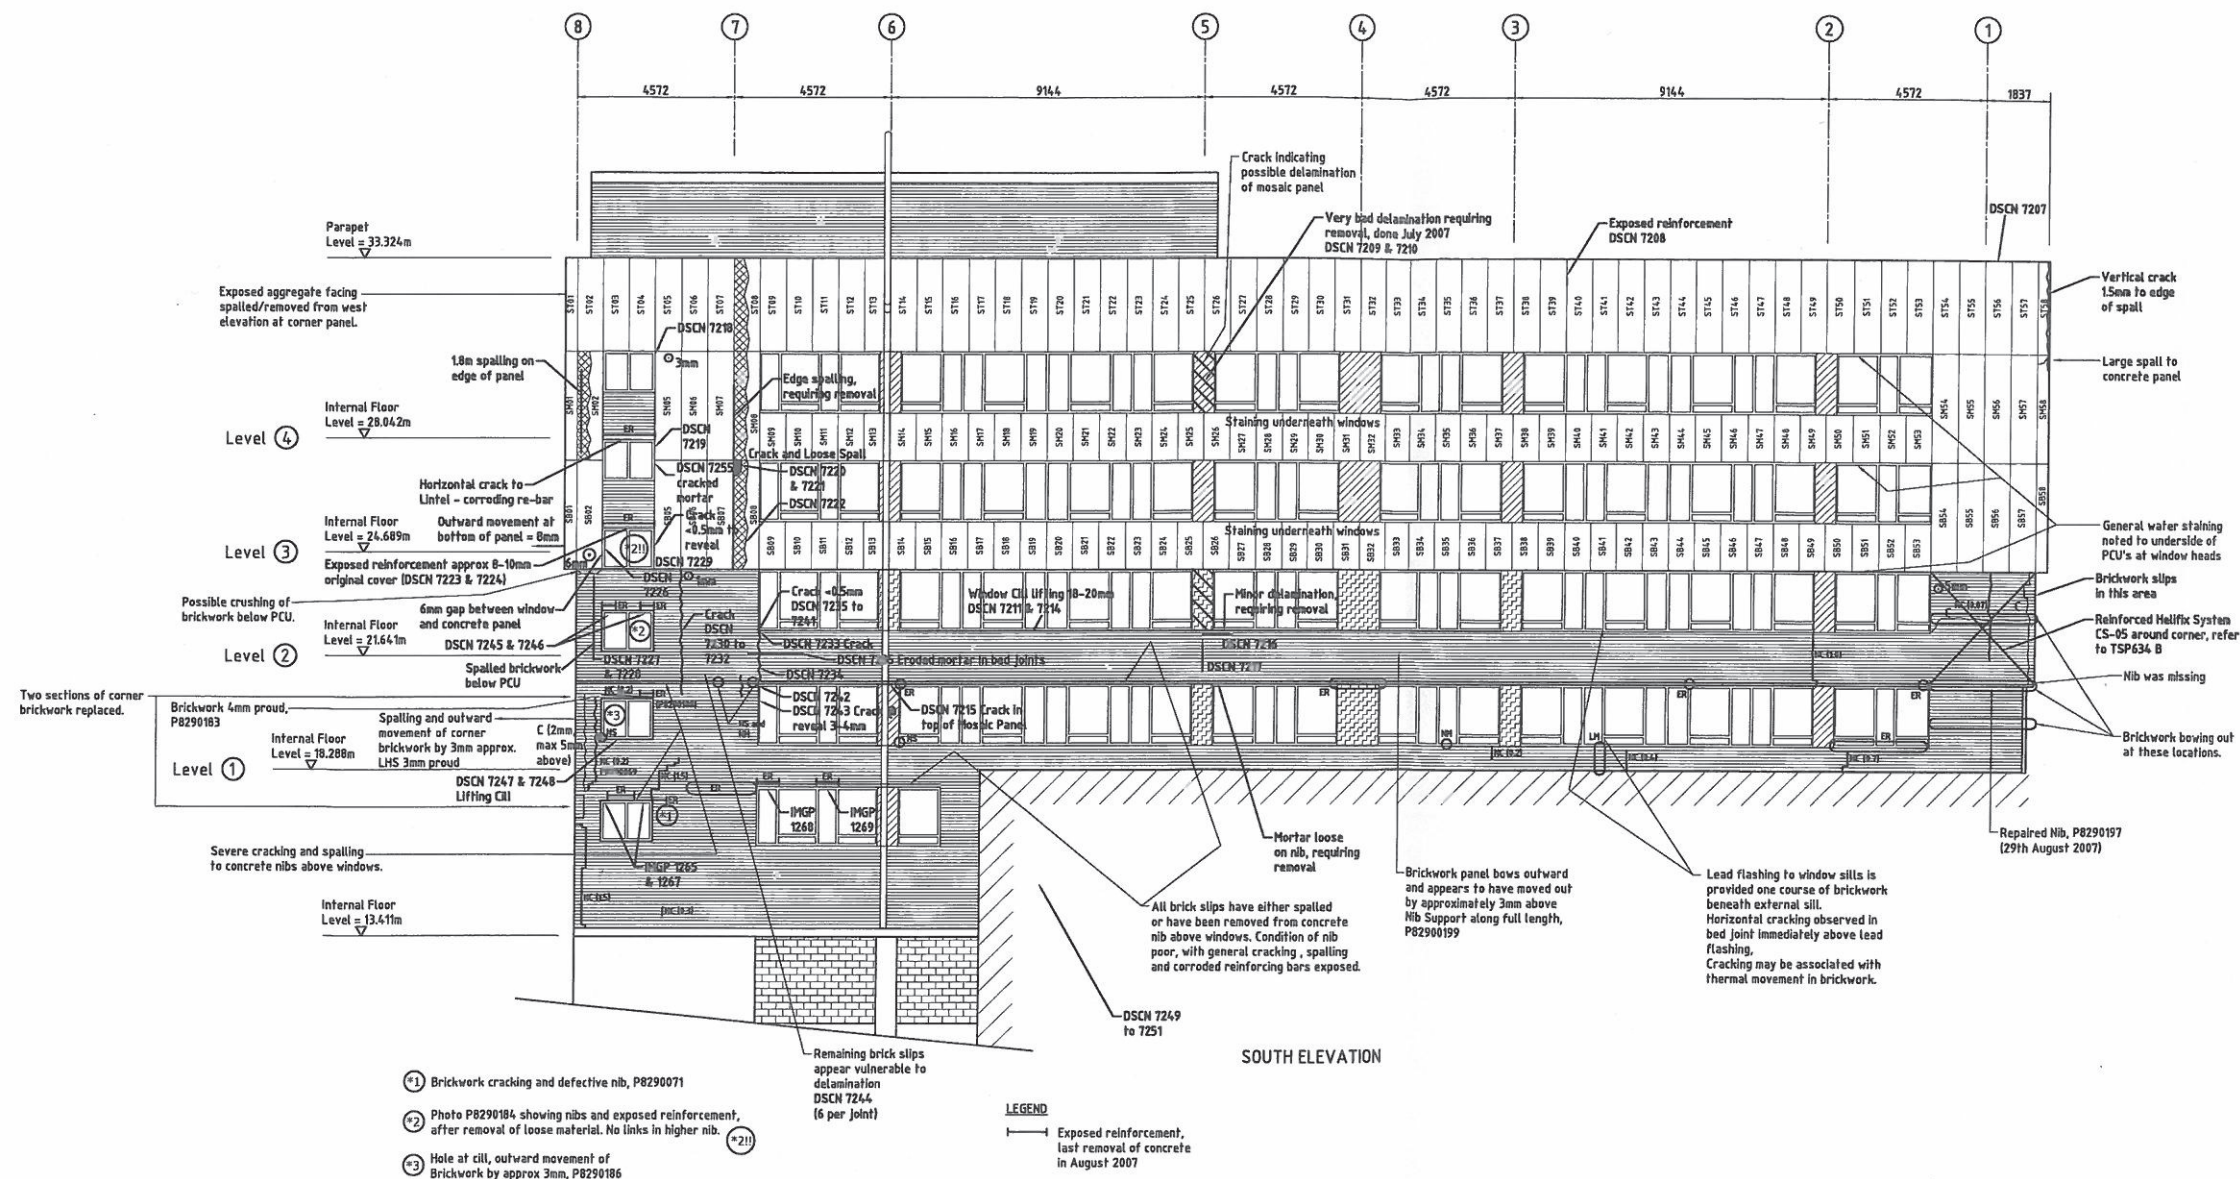
1. Defects shown on this drawing are based upon a binocular survey of the building carried out from ground level & adjacent buildings, September 2001.
2. Steel window frames require repainting. General condition of paintwork poor, peeling in places with signs of rusting to frames in some places.
3. External sills to windows within brick panels may be asbestos cement. Signs of fibrous materials in sills.
4. Levels are based on Record Drawings.
