## **ARBORICULTURAL ASSESSMENT - NORFOLK HOUSE NURSERY**

| <b>Location:</b> | Norfolk House Nursery, 9 Caerau Crescent, Newport NP20 4HG | | |
| <b>Client:</b> | Norfolk House Nursery | <b>Reference:</b> | S251113.2 |
| <b>Author:</b> | John Mitchener | <b>Report Date:</b> | 21 February 2025 |

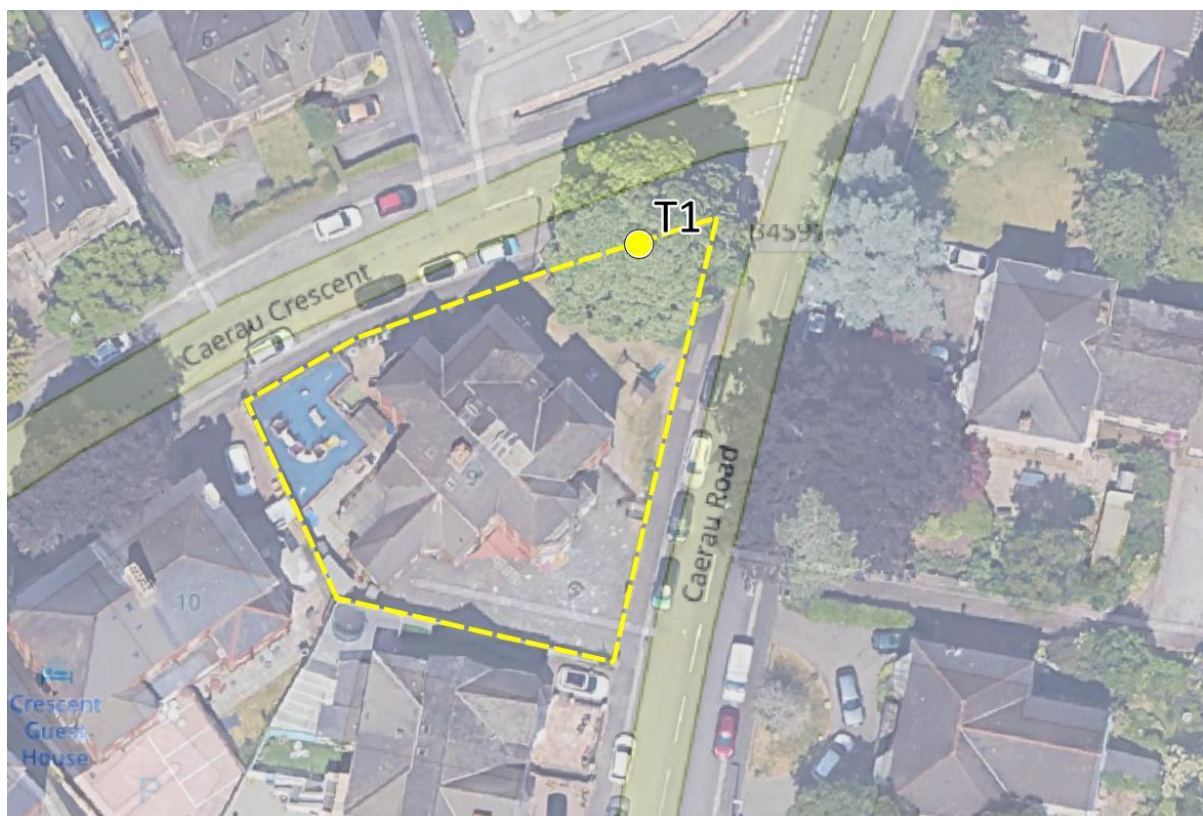
**Figure 1: Tree Location**

Tree T1 is a mature specimen with an estimated height in excess of 20m, a stem diameter in excess of 1000mm and a crown radius of between 6m and 9m. The location of tree T1 is shown in **Figure 1: Tree Location**.
