Llanwern Hot Mill

TITLE: Figure 8:  
B16 Location of Bat Boxes

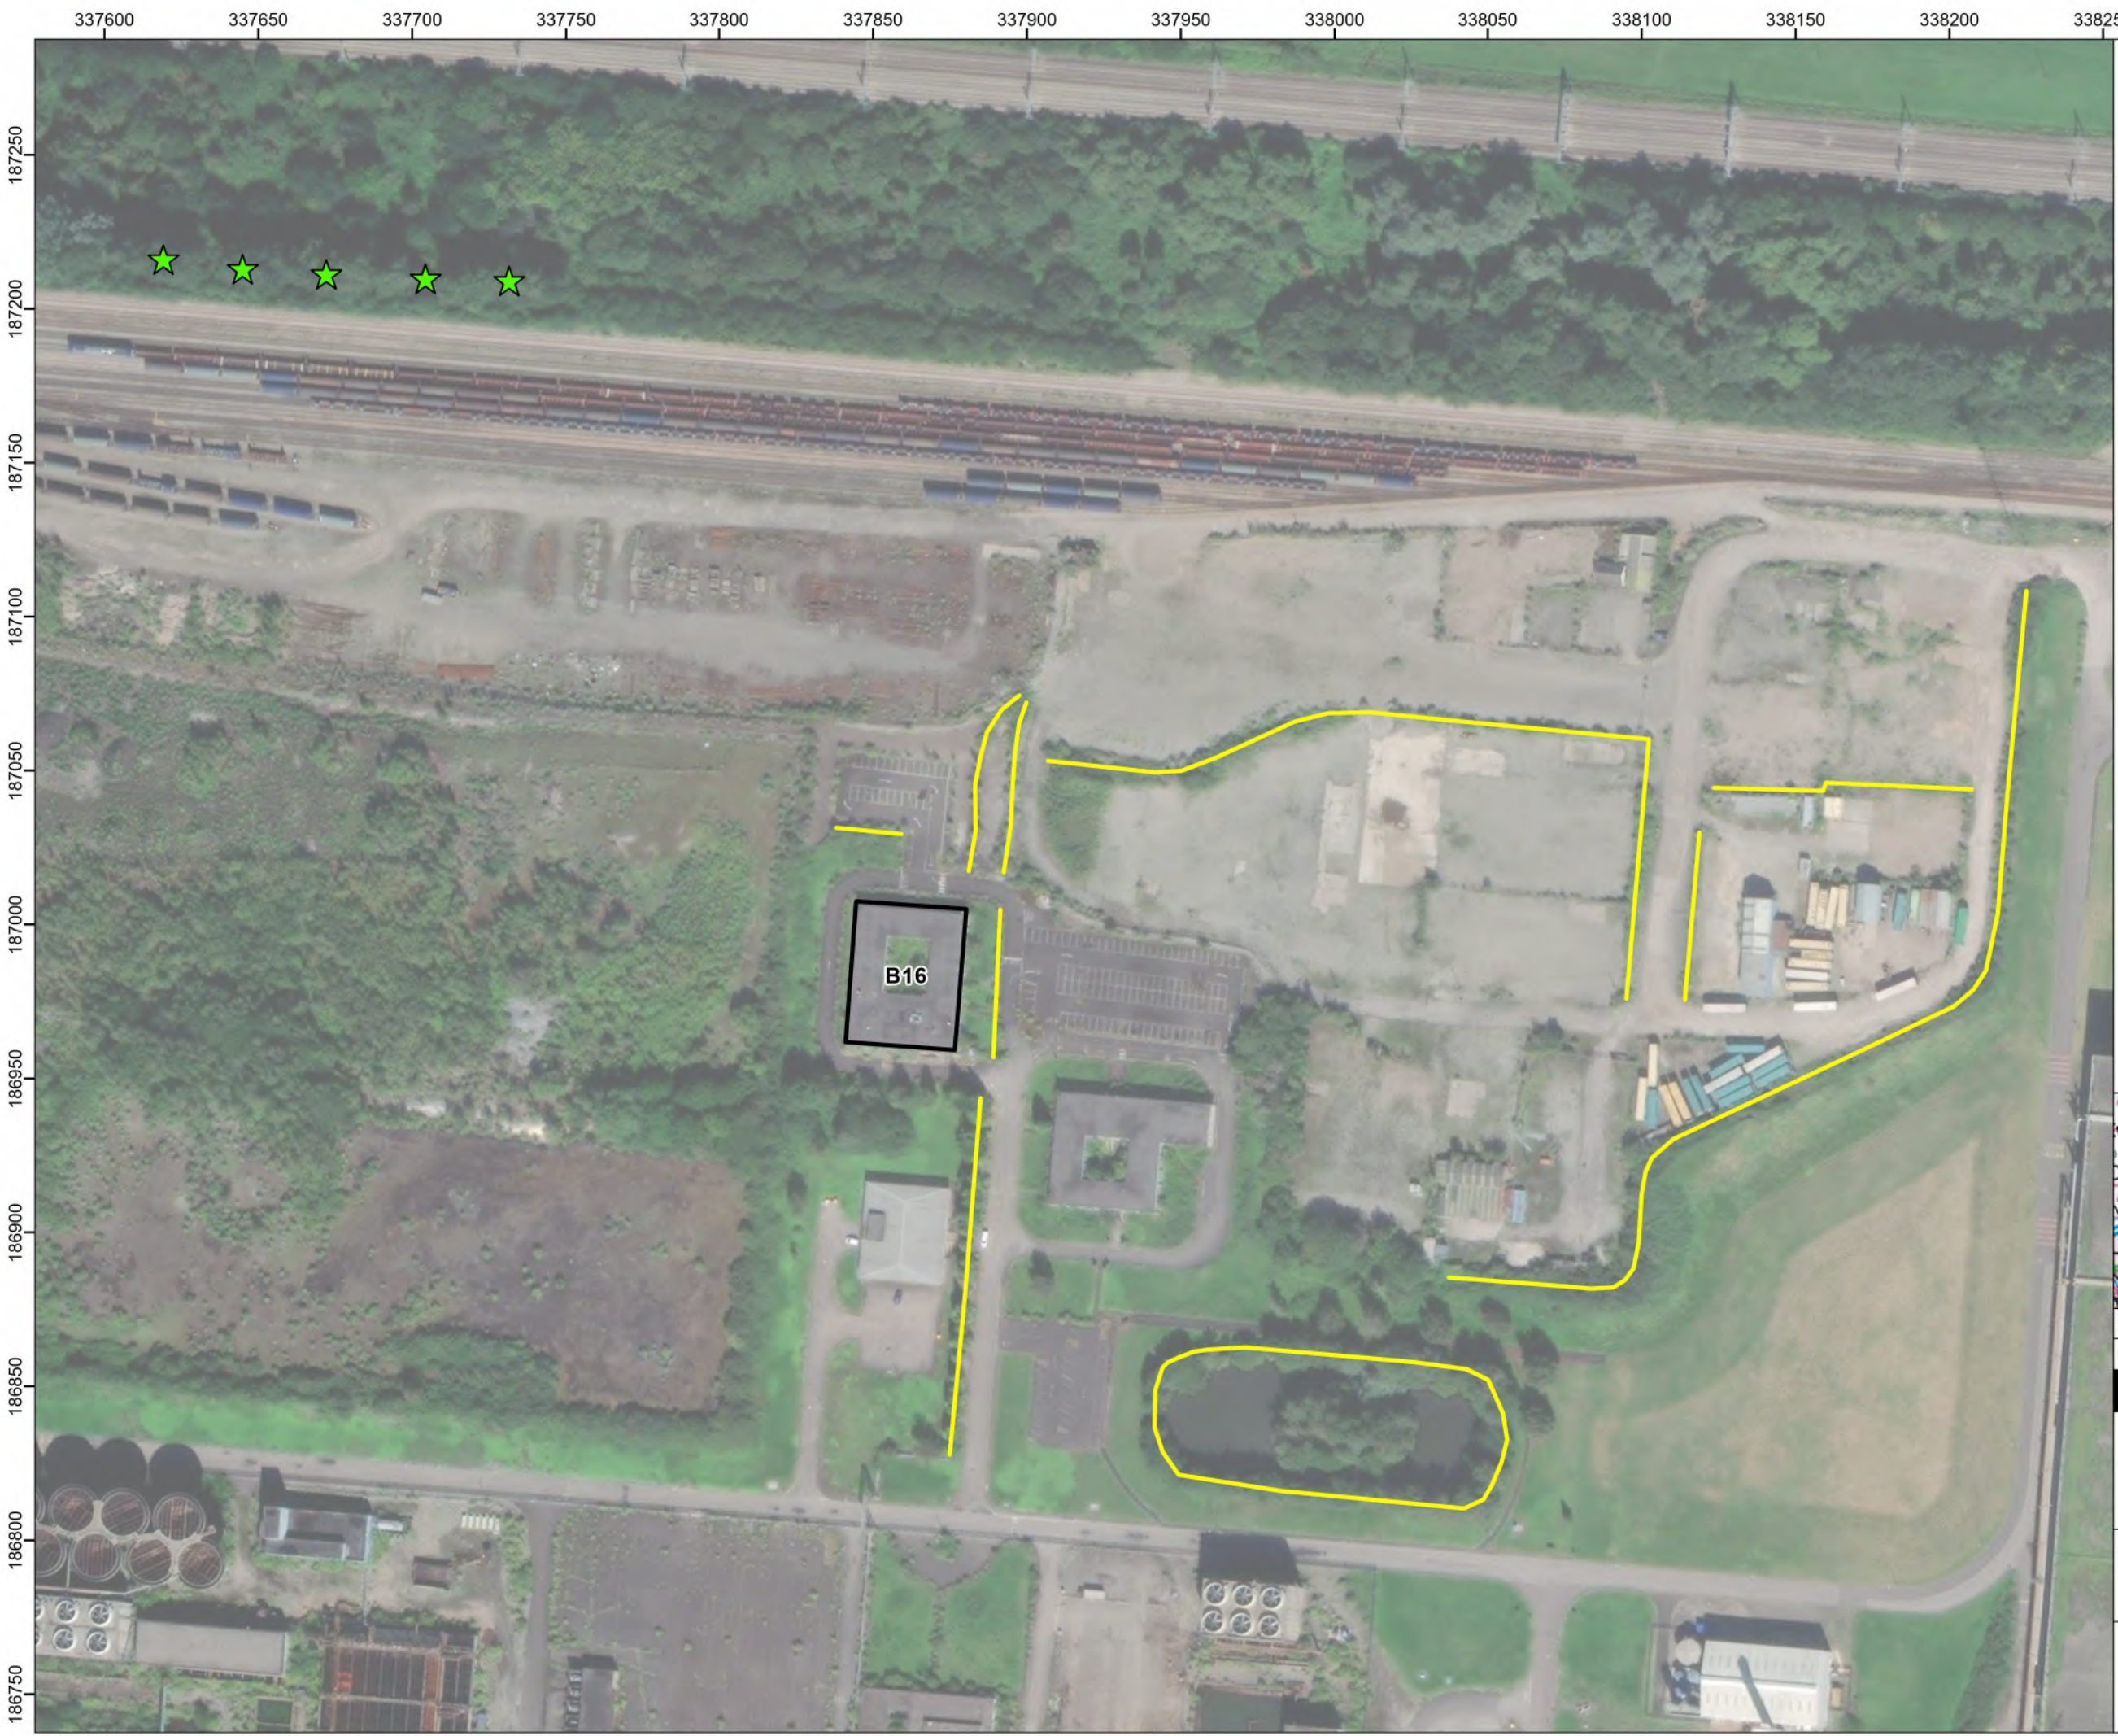
- Legend:
- Building 16
  - Retained treelines and hedges
  - Indicative location of bat box to be installed on northern tree line
