# Brynglas House

Structural Condition Survey Report

**Newport Norse**

Project Number: 11735

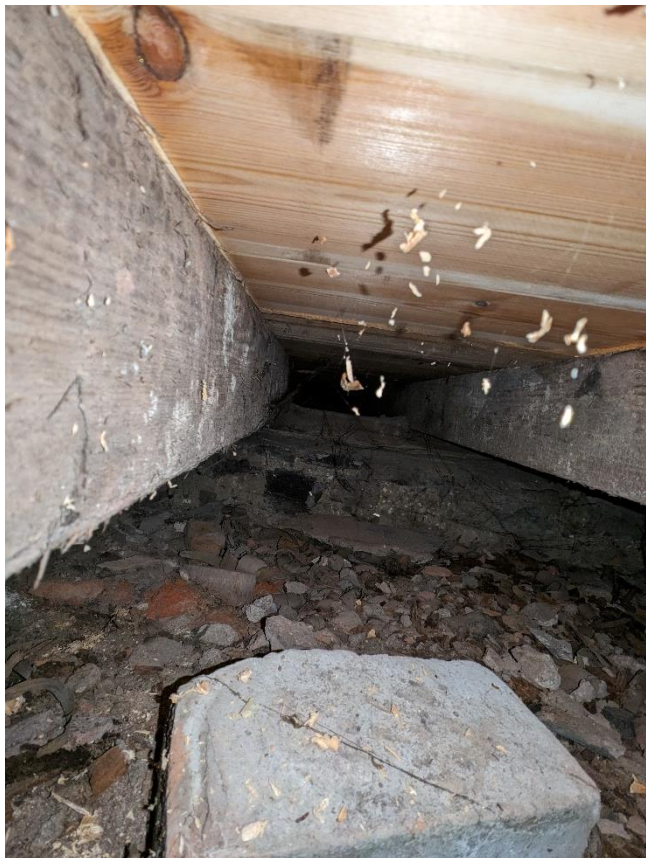
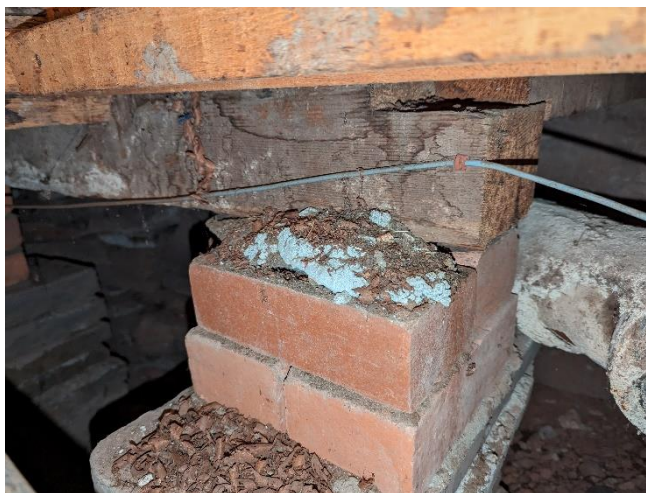
- 2.1.4 Below the floor of room No.26, a historic pipe runs from the centre of the west wall, towards the middle of the room then bends 90° to continue to the south of the building. The pipe sits within a 900mm deep trench, formed with rubble stone retaining walls on all sides, with stub masonry columns to support the floor joists / timber bearing members. Floor joists have been locally cut to permit passage of services.
- 2.1.5 Beyond the hatch the floor construction is the same as the general construction described above.

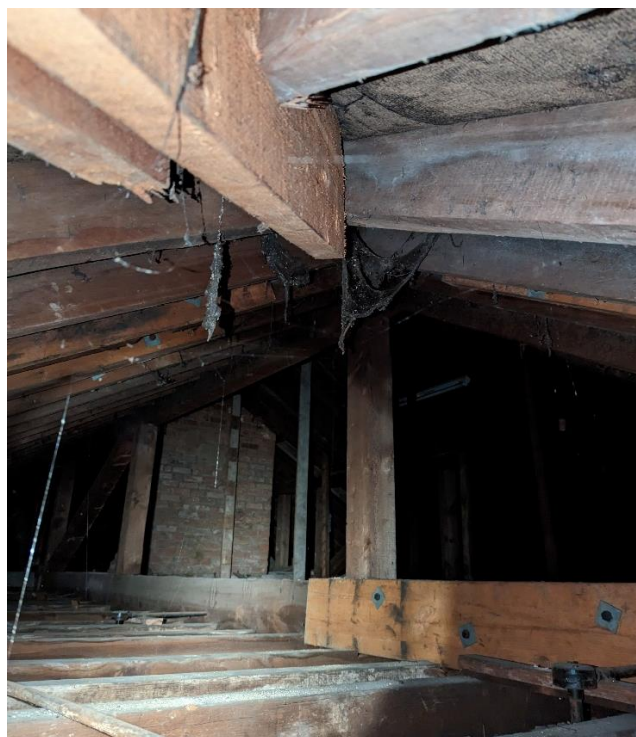
- 2.3.1 The roof is of timber construction, with a series of timber trusses generally spanning N-S onto masonry walls and 100x50mm timber common rafters forming the pitches or flat sections of roof. The ceiling comprises 100x50 timber joists underlaid with lath and plaster.
- 2.3.2 There is evidence that elements of the roof have been replaced in more recent years as suggested by spliced sections of rafters and localised repairs to one of the trusses (shown in the photograph).

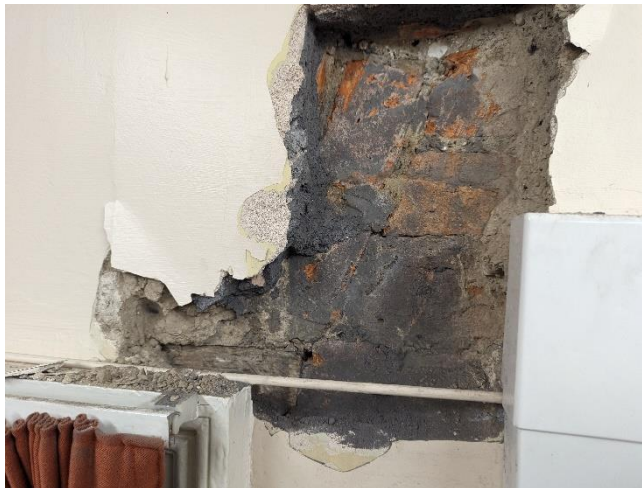
2.4.1 The load bearing walls of the building are of masonry construction typically 400-500mm thick and comprising 2 skins of brickwork with dressed stone detailing. It is unclear whether walls are solid / cavity walls. In 1No. location (shown in photograph) the coursing appeared to be poor.
