# Brynglas House

## Visual Exterior Structural Inspection - Elevations

Client: Newport Norse  
Project Ref: C2723  
Report Revision: P01

| Document reference | C2723-CAM-ZZ-XX-RP-S-0001 |

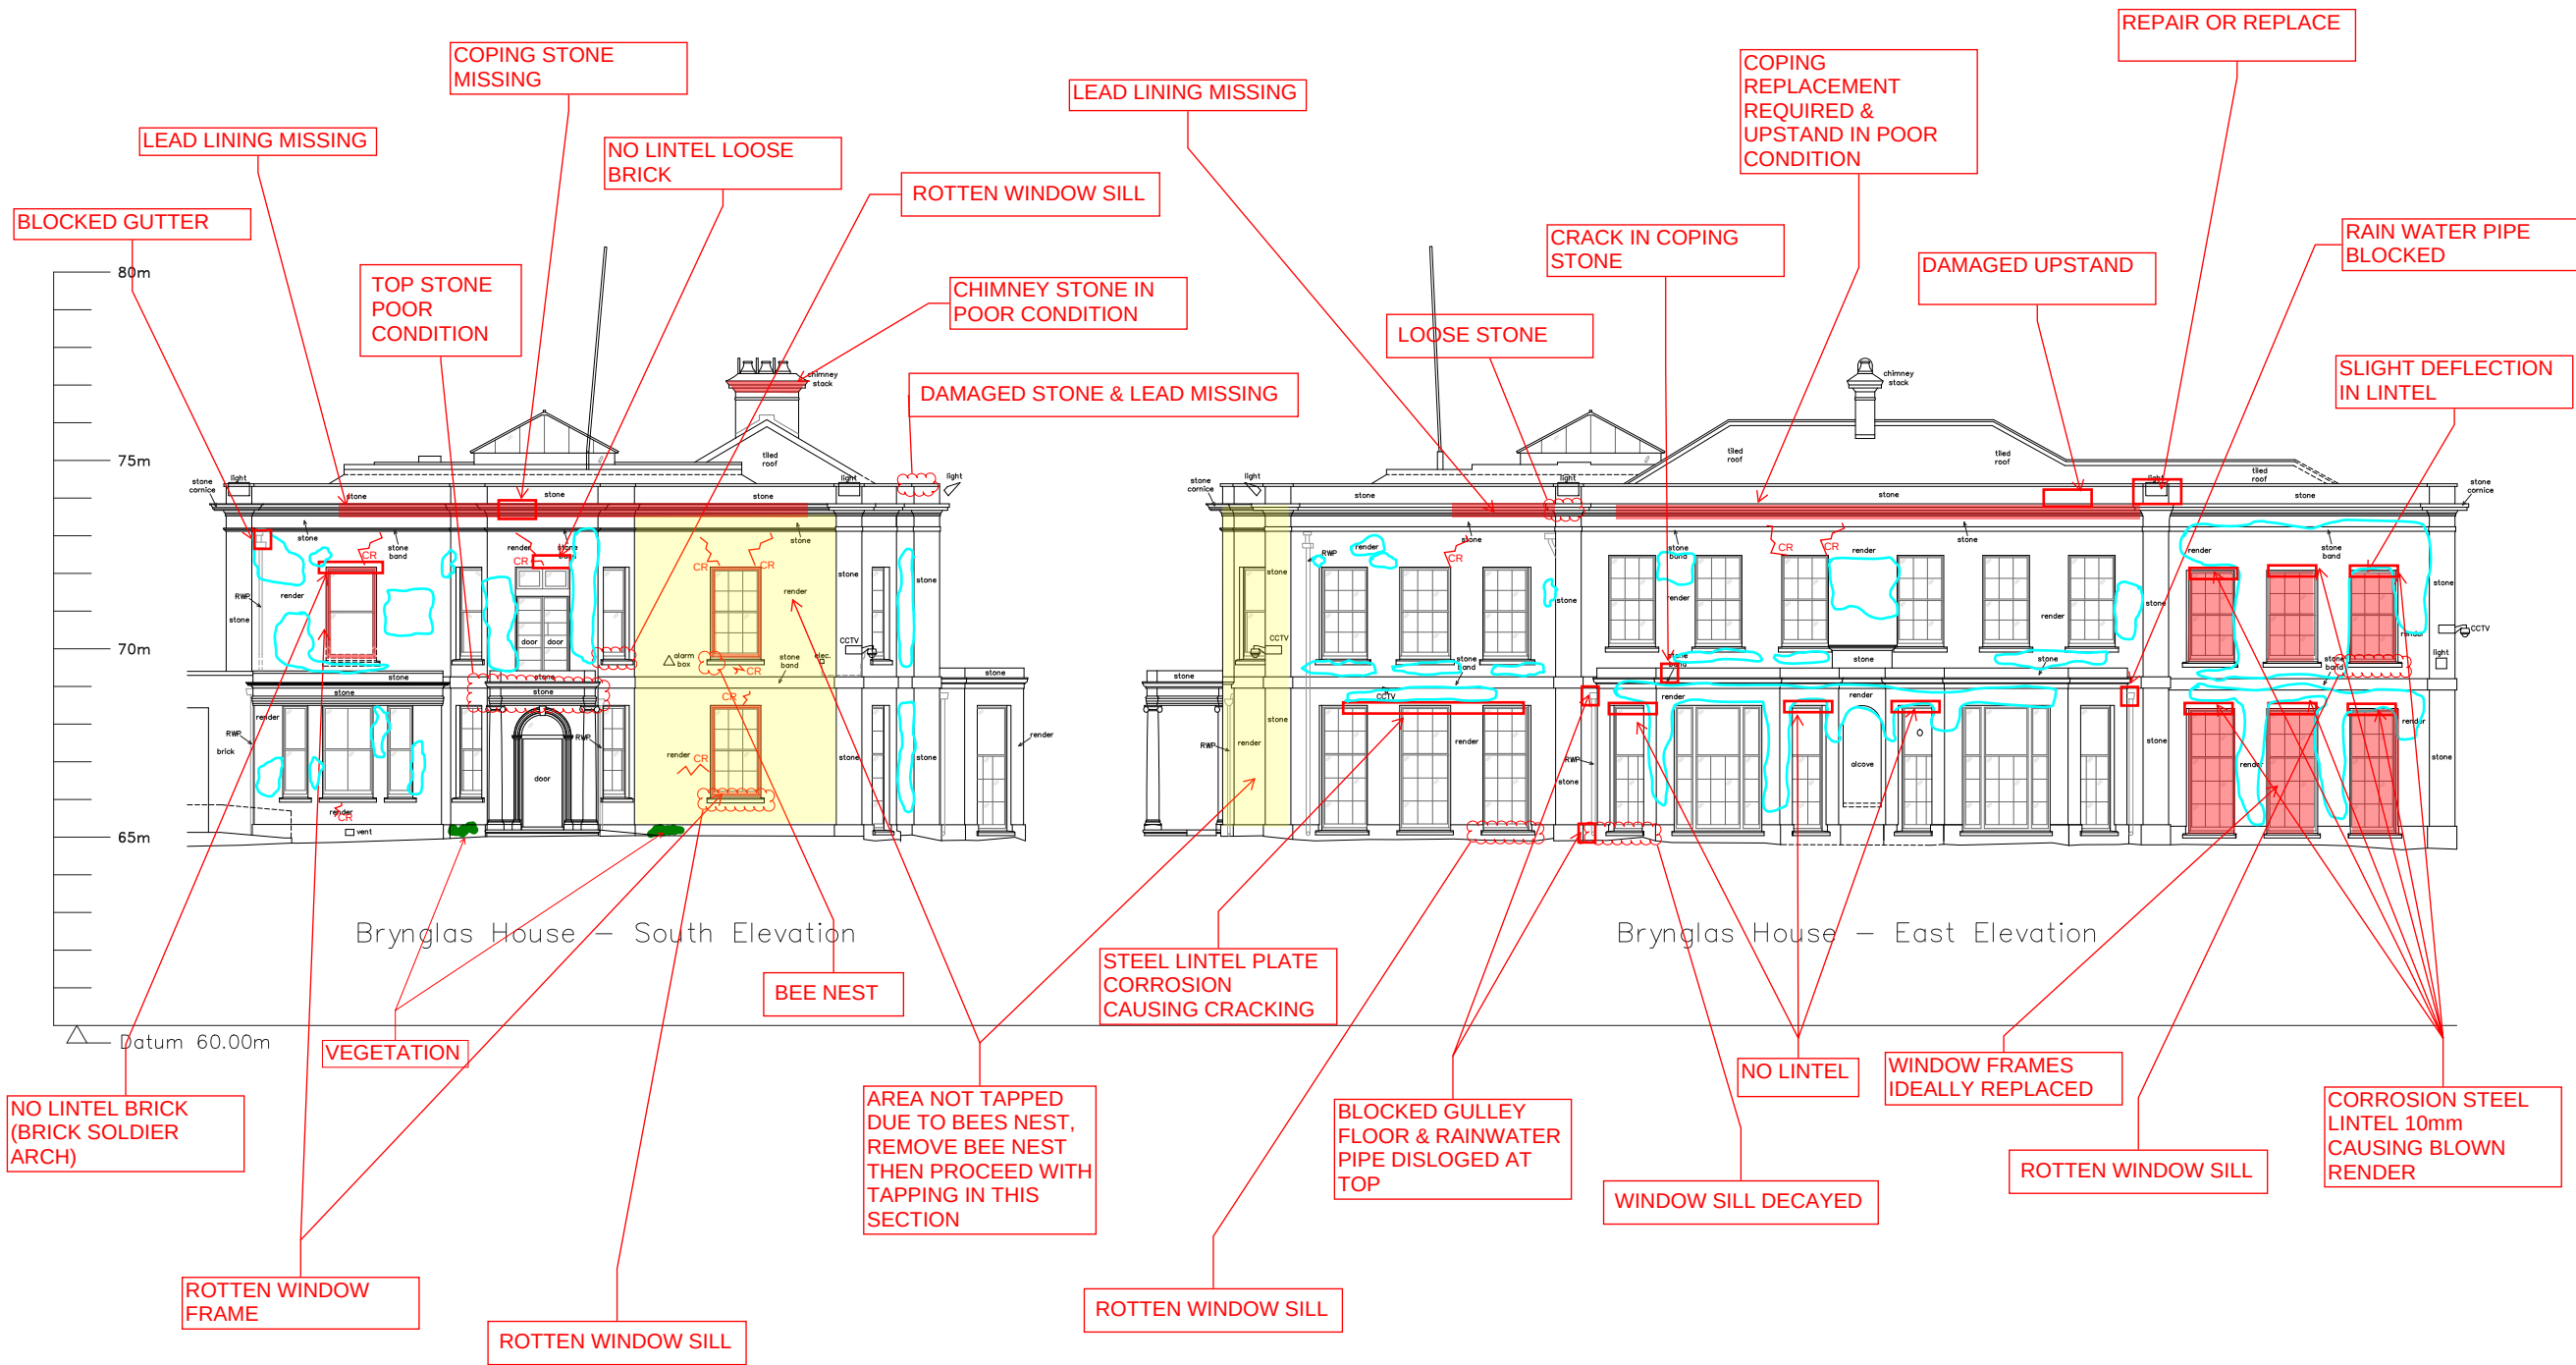
- 4.1.1 There are a few vertically propagating cracks located on all elevations see Appendix A. These are primarily propagating from the corner lines of windows and sills but can also be found around door frames. **See Photo 4.1.**

- TAPPED REMOVED RENDER

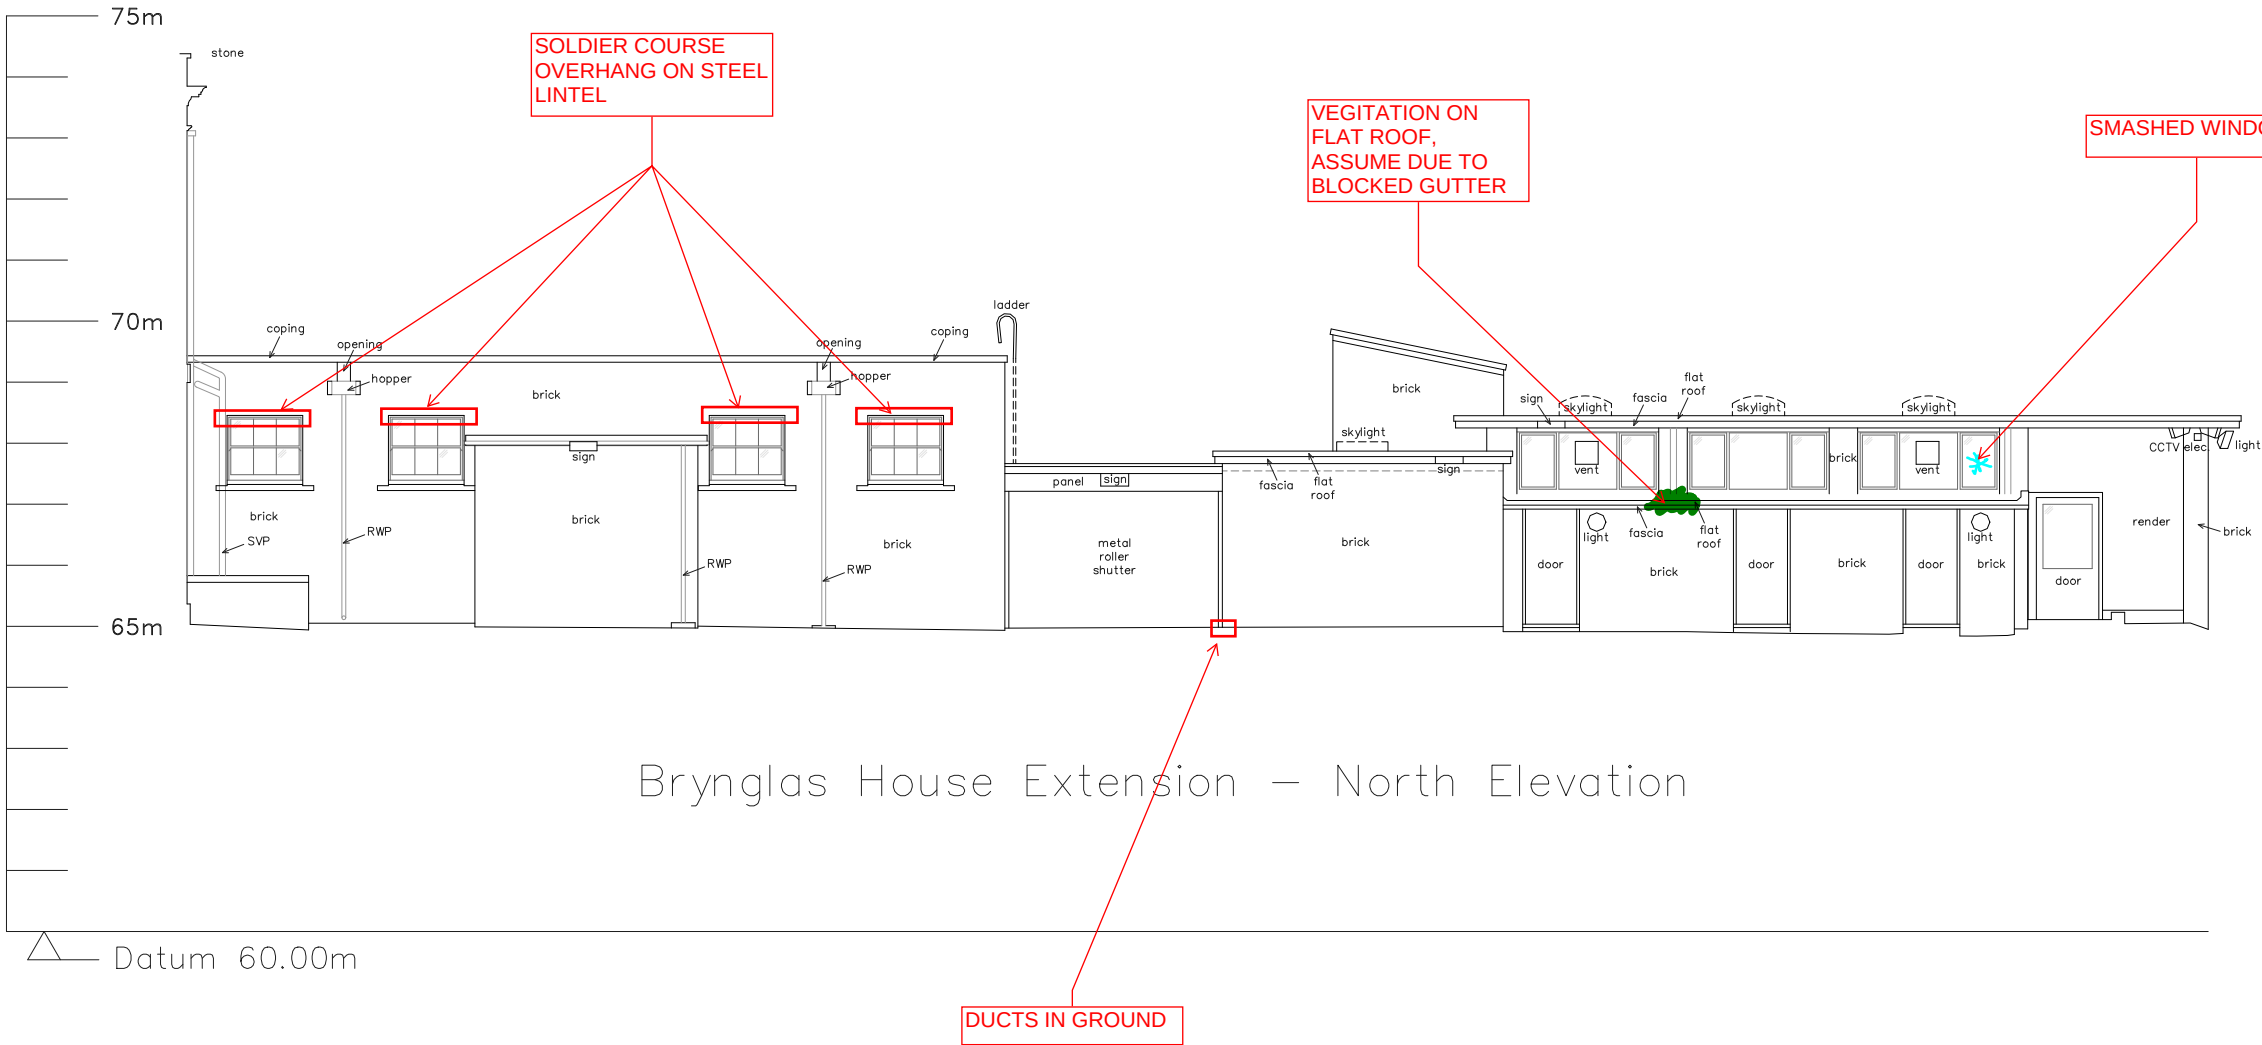
Brynglas House Extension – North Elevation

- 4.1.16 A smashed window has been noted on the north elevation of the rear extension. **See Photo 4.15.**
- 4.1.17 Vegetation is growing at the base of the downpipe on the north elevation of the extension due to inadequate drainage and an un-sloped flat roof allowing ponding at the base. **See Photo 4.16.**

- 6.1.9 The flat roof with ponding on the extension should be cleaned of all growth, a maintenance plan written and therefore cleaned periodically to stop future deterioration to the flat roof.

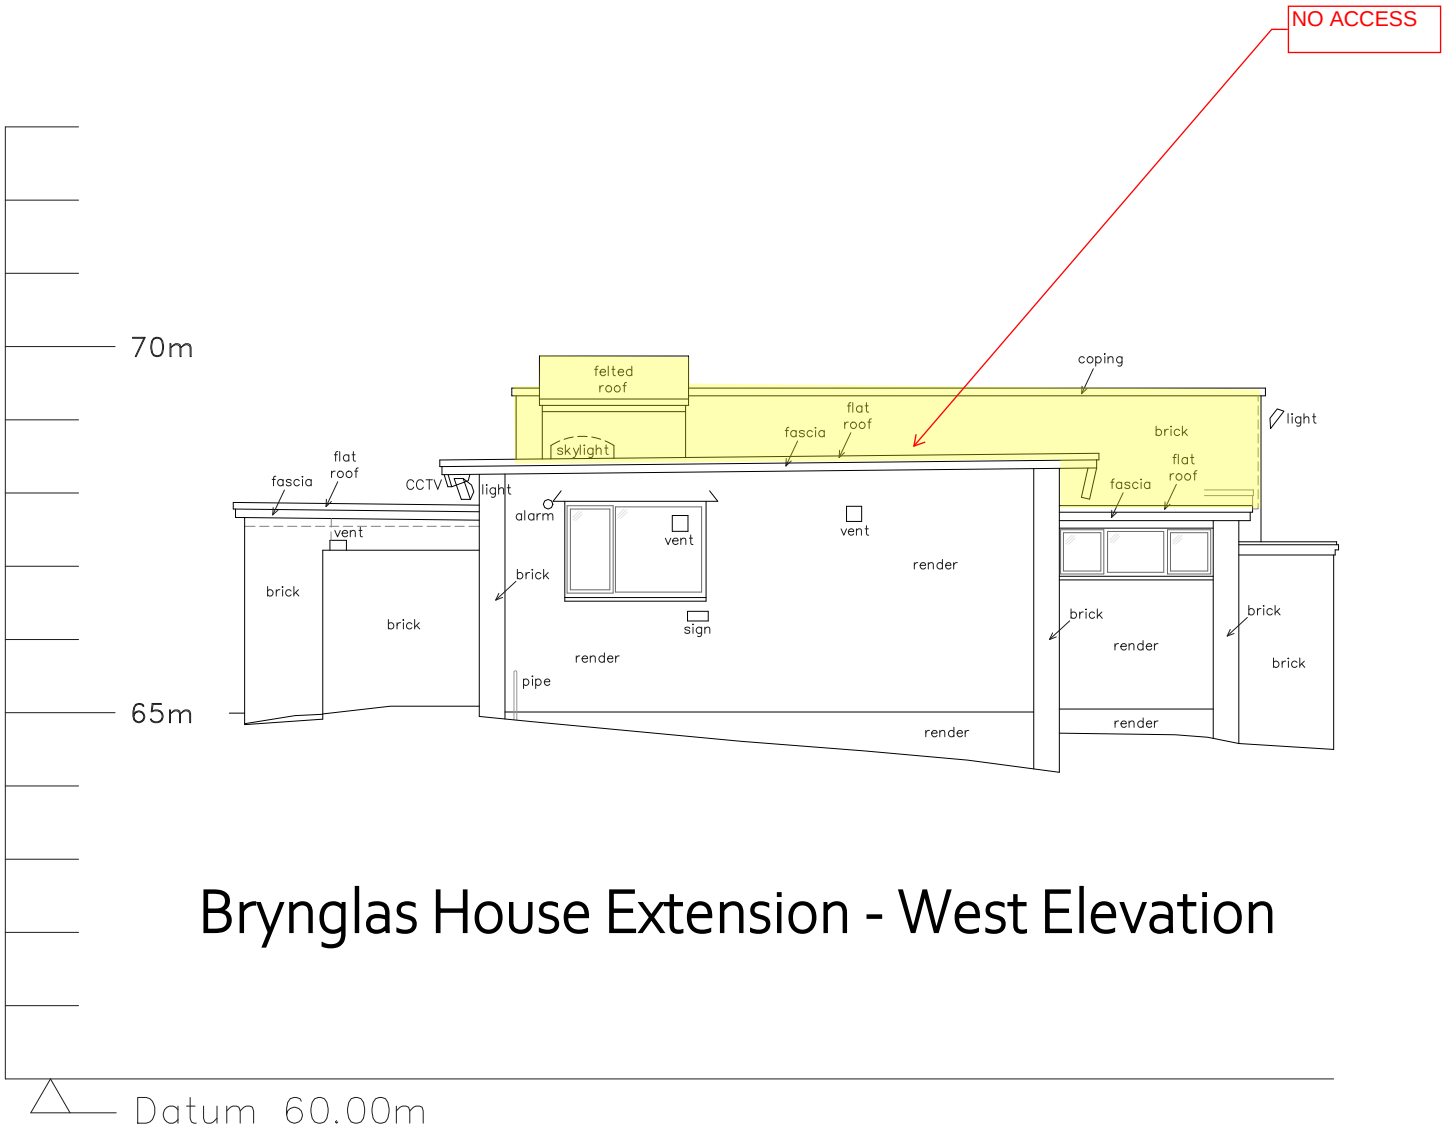
Brynglas House Extension - West Elevation

- 4.1.14 Paint slurry has been noted on the stonework of the west elevation.
- 4.1.15 The top coping stone on the west elevation has been historically cut back, which is cantilevering but appears ok presently, however would be advised to be monitored due to the risk of detachment in the future. **See Photo 4.14.**
