# **BRYNGLAS HOUSE: REPLACEMENT OF STOLEN ROOF LEAD**

## HERITAGE IMPACT STATEMENT

Newport City Council

Issue 02

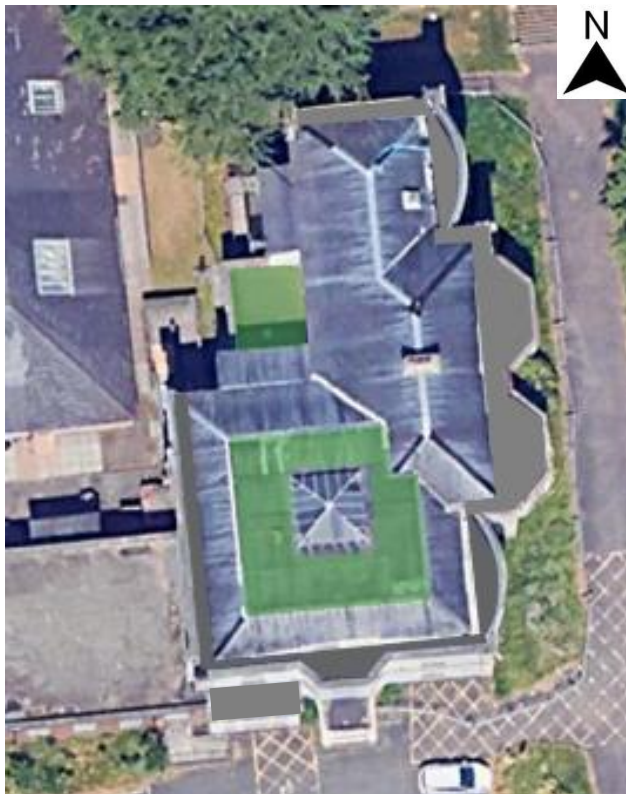
**Left:** annotated roof plan showing proposed flat roof works

This work is necessary since these felt roof coverings are at the end of their serviceable lives. There are numerous blisters and widespread liquid repairs, indicating that there has been a longstanding issue with water-ingress in these locations. The toilet area beneath the north-west roof is frequently flooded and significant mould growth has become established on the ceilings.

#### 3.1. Flat roof areas highlighted in green:

Whilst there will be a minimal visual impact – the replacement covering has an opaque olive-green appearance in contrast to the black of the existing – this is offset by the new covering's impressive environmental credentials. Derbigum Olivine's naturally-sourced upper mineral layer neutralises carbon dioxide during rainfall and is fully recyclable at the end of its life (circa 50 years). Additionally, these areas of roof are hidden behind parapets and so are not visible to the public.

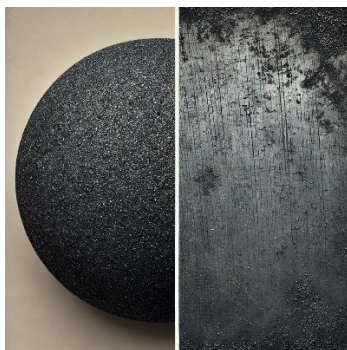
**Left:** comparison between Eurorof felt (l-h) and weathered lead (r-h)

- **Deterrence** – Replacing lead with mineral felt removes the incentive for theft, reducing security risks and costs associated with repairs.
- **Cost-effectiveness** – Eurorof is more cost-effective than lead due to lower upfront costs and easier installation.
- **Environmental considerations** – providing a safer and less toxic alternative, Eurorof also negates the ecological harm caused by lead mining and processing.
