# ALUMASC ROOFING

## Roof Condition Report

Project:  
Brynglas House

Project ID: SP143935  
Date of issue: 14/01/2025

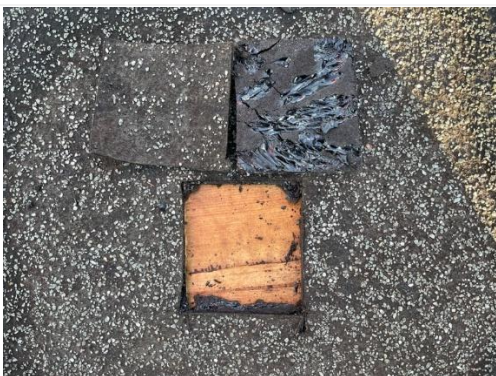
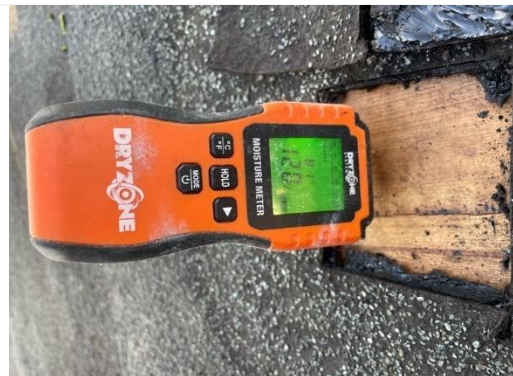
| Core 1 - Location: | Roof Area Highlighted in Red | | |

| Core 1 - Condition: | Dry | Core 1 - Probe reading: | 12% |
