# Management Survey Report Assessment and Register of Asbestos Containing Materials

9 Clyffard Crescent, Newport,  
Gwent, NP20 4GE

Centre Peace Homes

Job No J050628

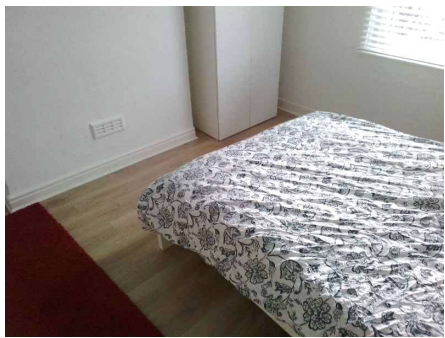
| Inspection Number | Location | Photograph |
|---|---|---|
| Inspection 4 | 1st Floor,<br>Bedroom 1<br>Lath and plaster ceiling, masonry walls, laminate to timber floor. | |

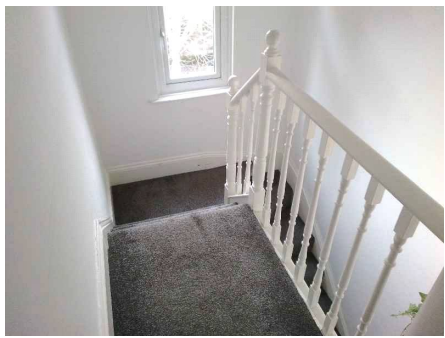
| Inspection Number | Location | Photograph |
|---|---|---|
| Inspection 5 | 1st Floor,<br>Landing<br>Lath and plaster ceiling, masonry and plasterboard walls, laminate to timber floor. | |

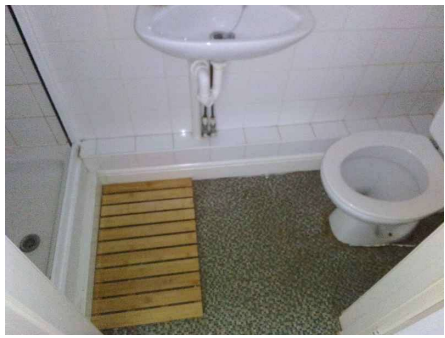
| Inspection Number | Location | Photograph |
|---|---|---|
| Inspection 6 | 1st Floor,<br>Shower Room<br>Lath and plaster ceiling, masonry and plasterboard walls, ceramic cistern, plastic soil pipe, fixed ceramic tiled boxing, non suspect vinyl and timber fibreboard to timber floor. | |

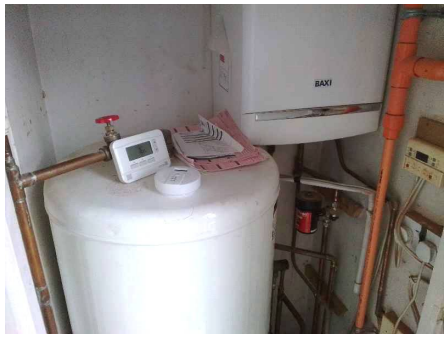
| Inspection Number | Location | Photograph |
|---|---|---|
| Inspection 10 | Ground Floor,<br>Tank/Boiler Store<br>Lath and plaster ceiling, masonry and timber walls, modern boiler and flue, modern tank, consumer units to timber panels, timber floor. | |

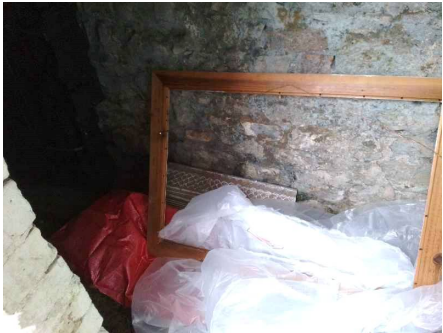
| Inspection Number | Location | Photograph |
|---|---|---|
| Inspection 17 | Lower Ground Floor,<br>Bin Store 1<br>Brick ceiling, brick walls, concrete floor. | |

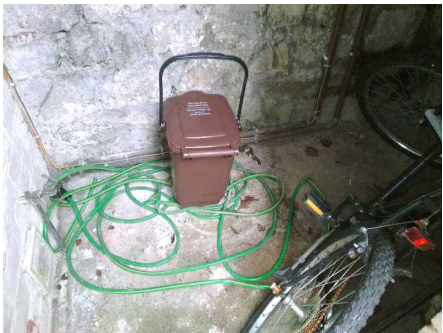
| Inspection Number | Location | Photograph |
|---|---|---|
| Inspection 18 | Lower Ground Floor,<br>Bin Store 2<br>Brick ceiling, brick walls, concrete floor. | |
