## Archaeological Watching Brief Report

Old St Peter's Church, Peterstone, Wentlooge, Cardiff, CF3 2TR

Prepared for  
Newport City Council

October 2024

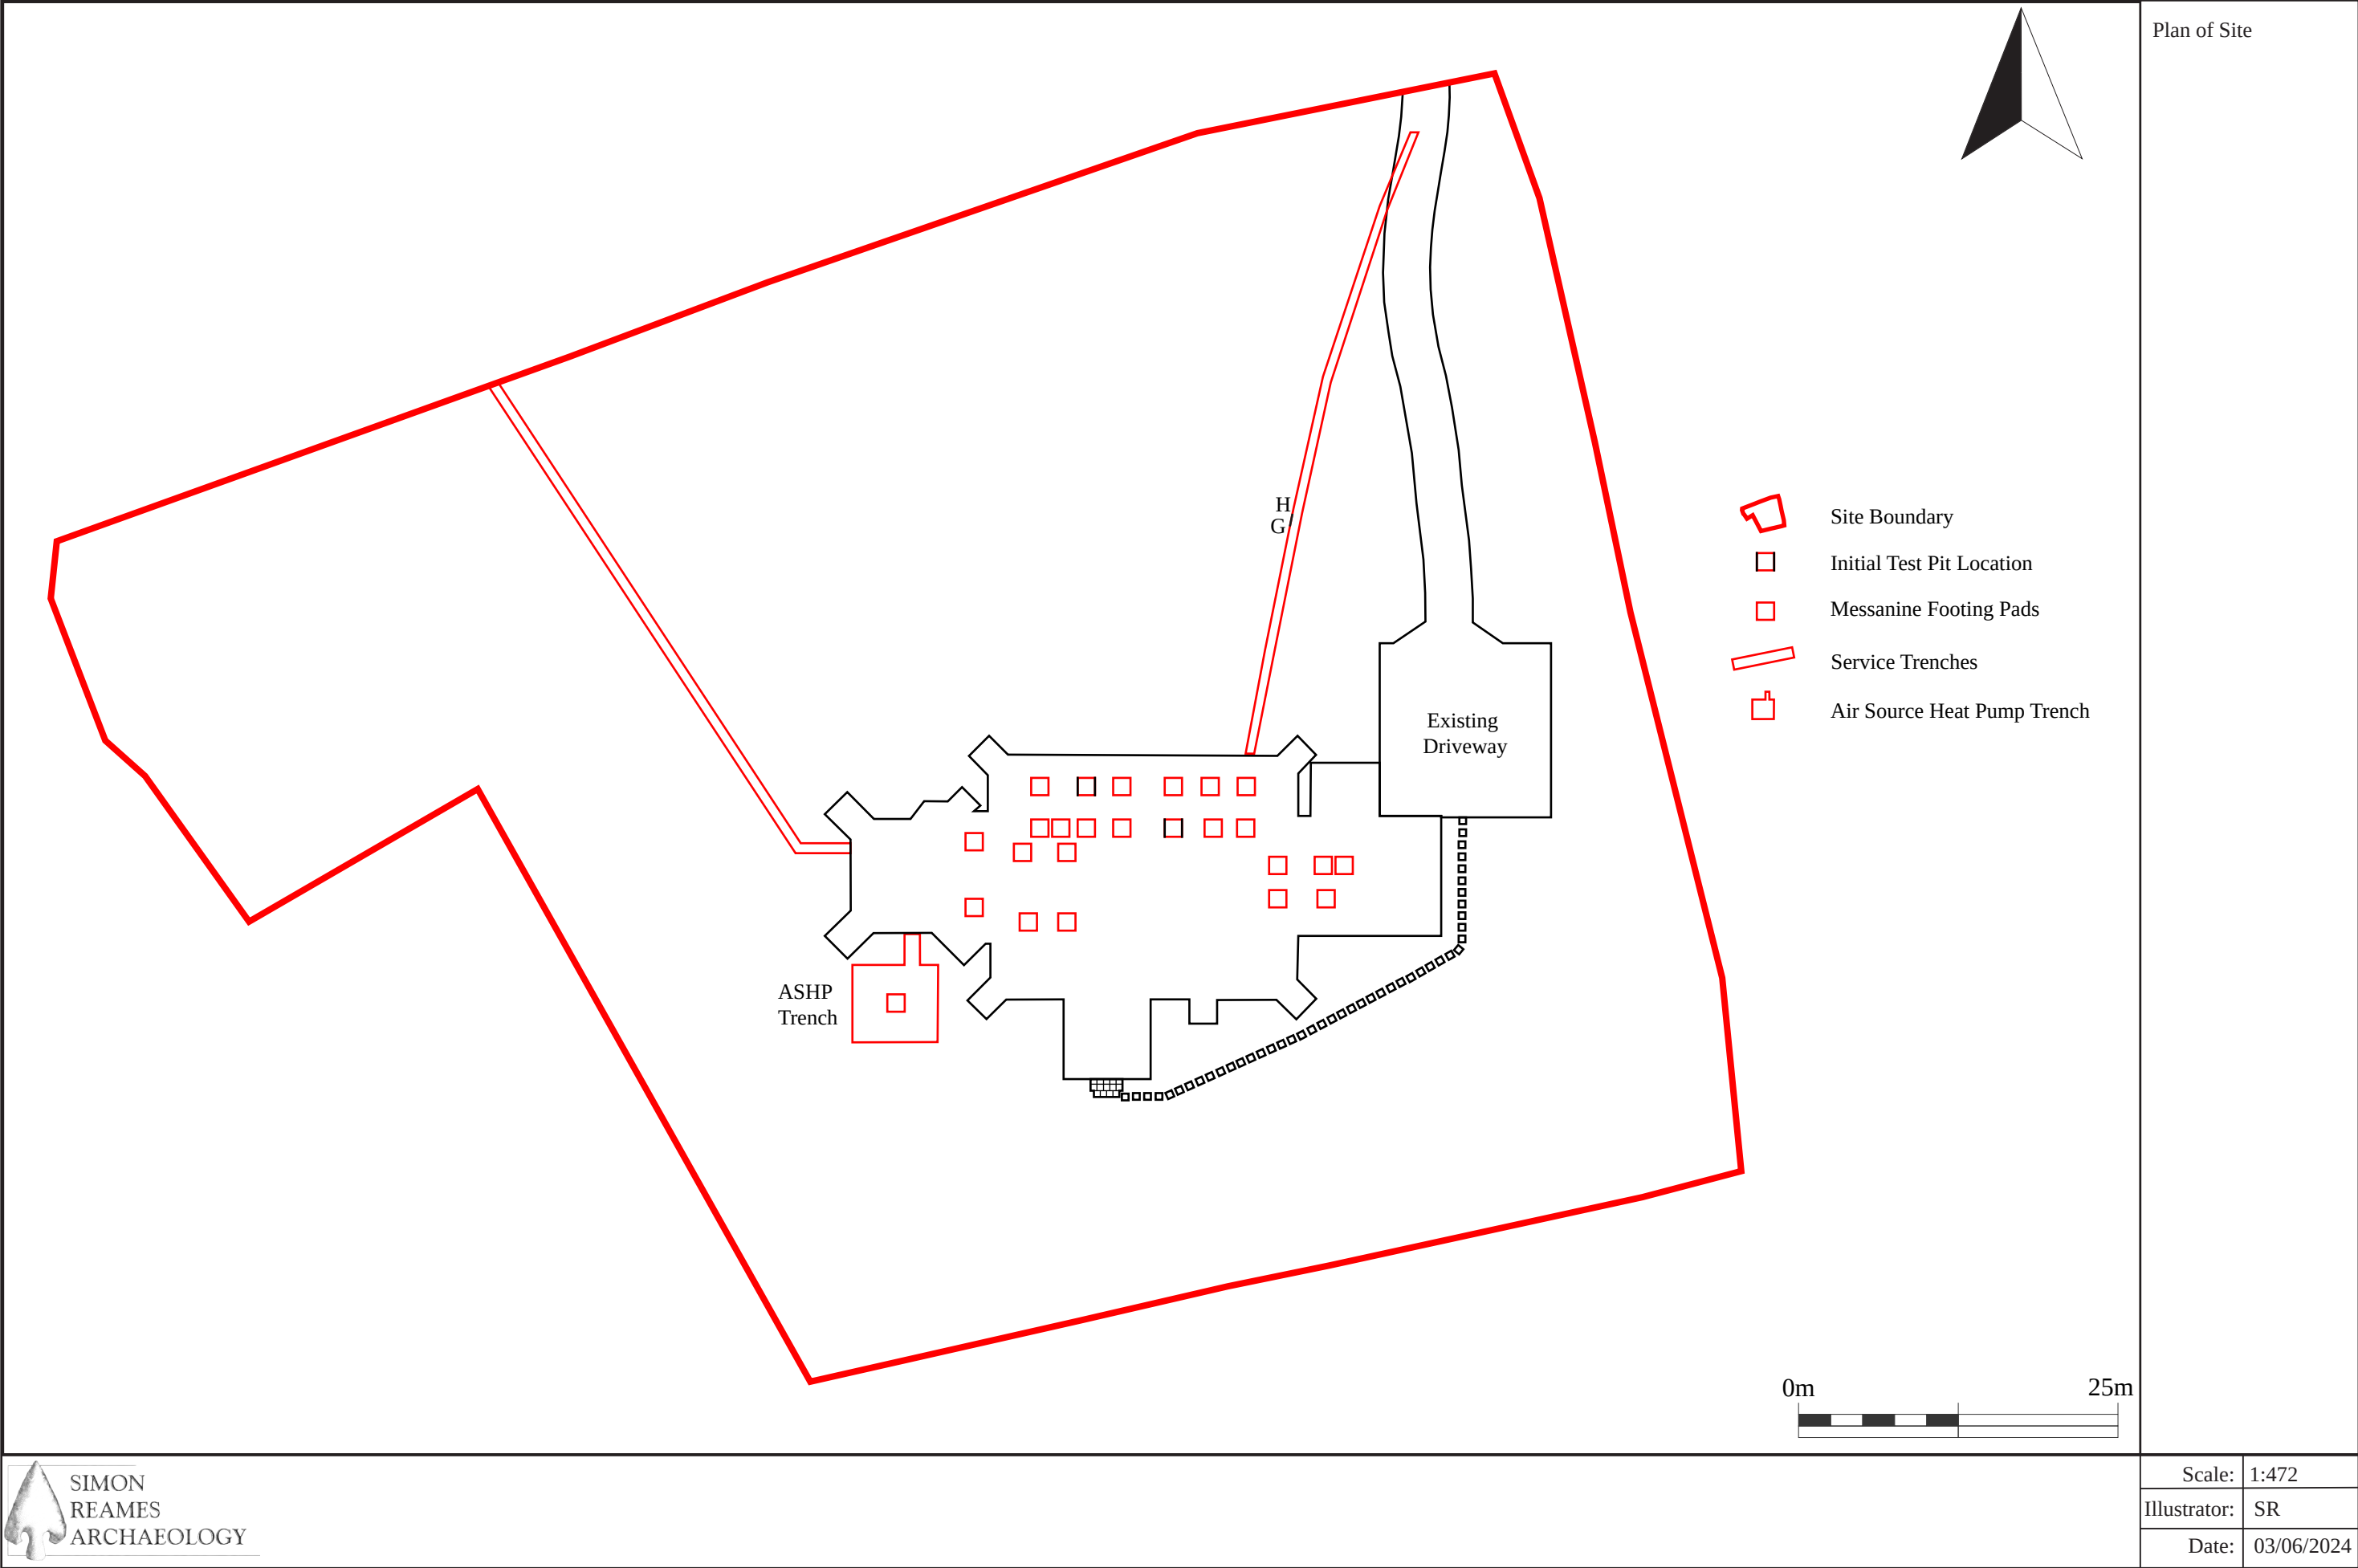
Figure 2

- 3.2.5. The bulk reduction consisted of the removal of 106.59m<sup>3</sup> of soil within the footprint of the structure. Once the limit of the reduction was achieved, 24 0.6m by 0.6m square footing pads were excavated a further 0.25m (4.69m aOD) in the location of the mezzanine uprights (**Figure 2**).

Site Plan of Subsurface Works

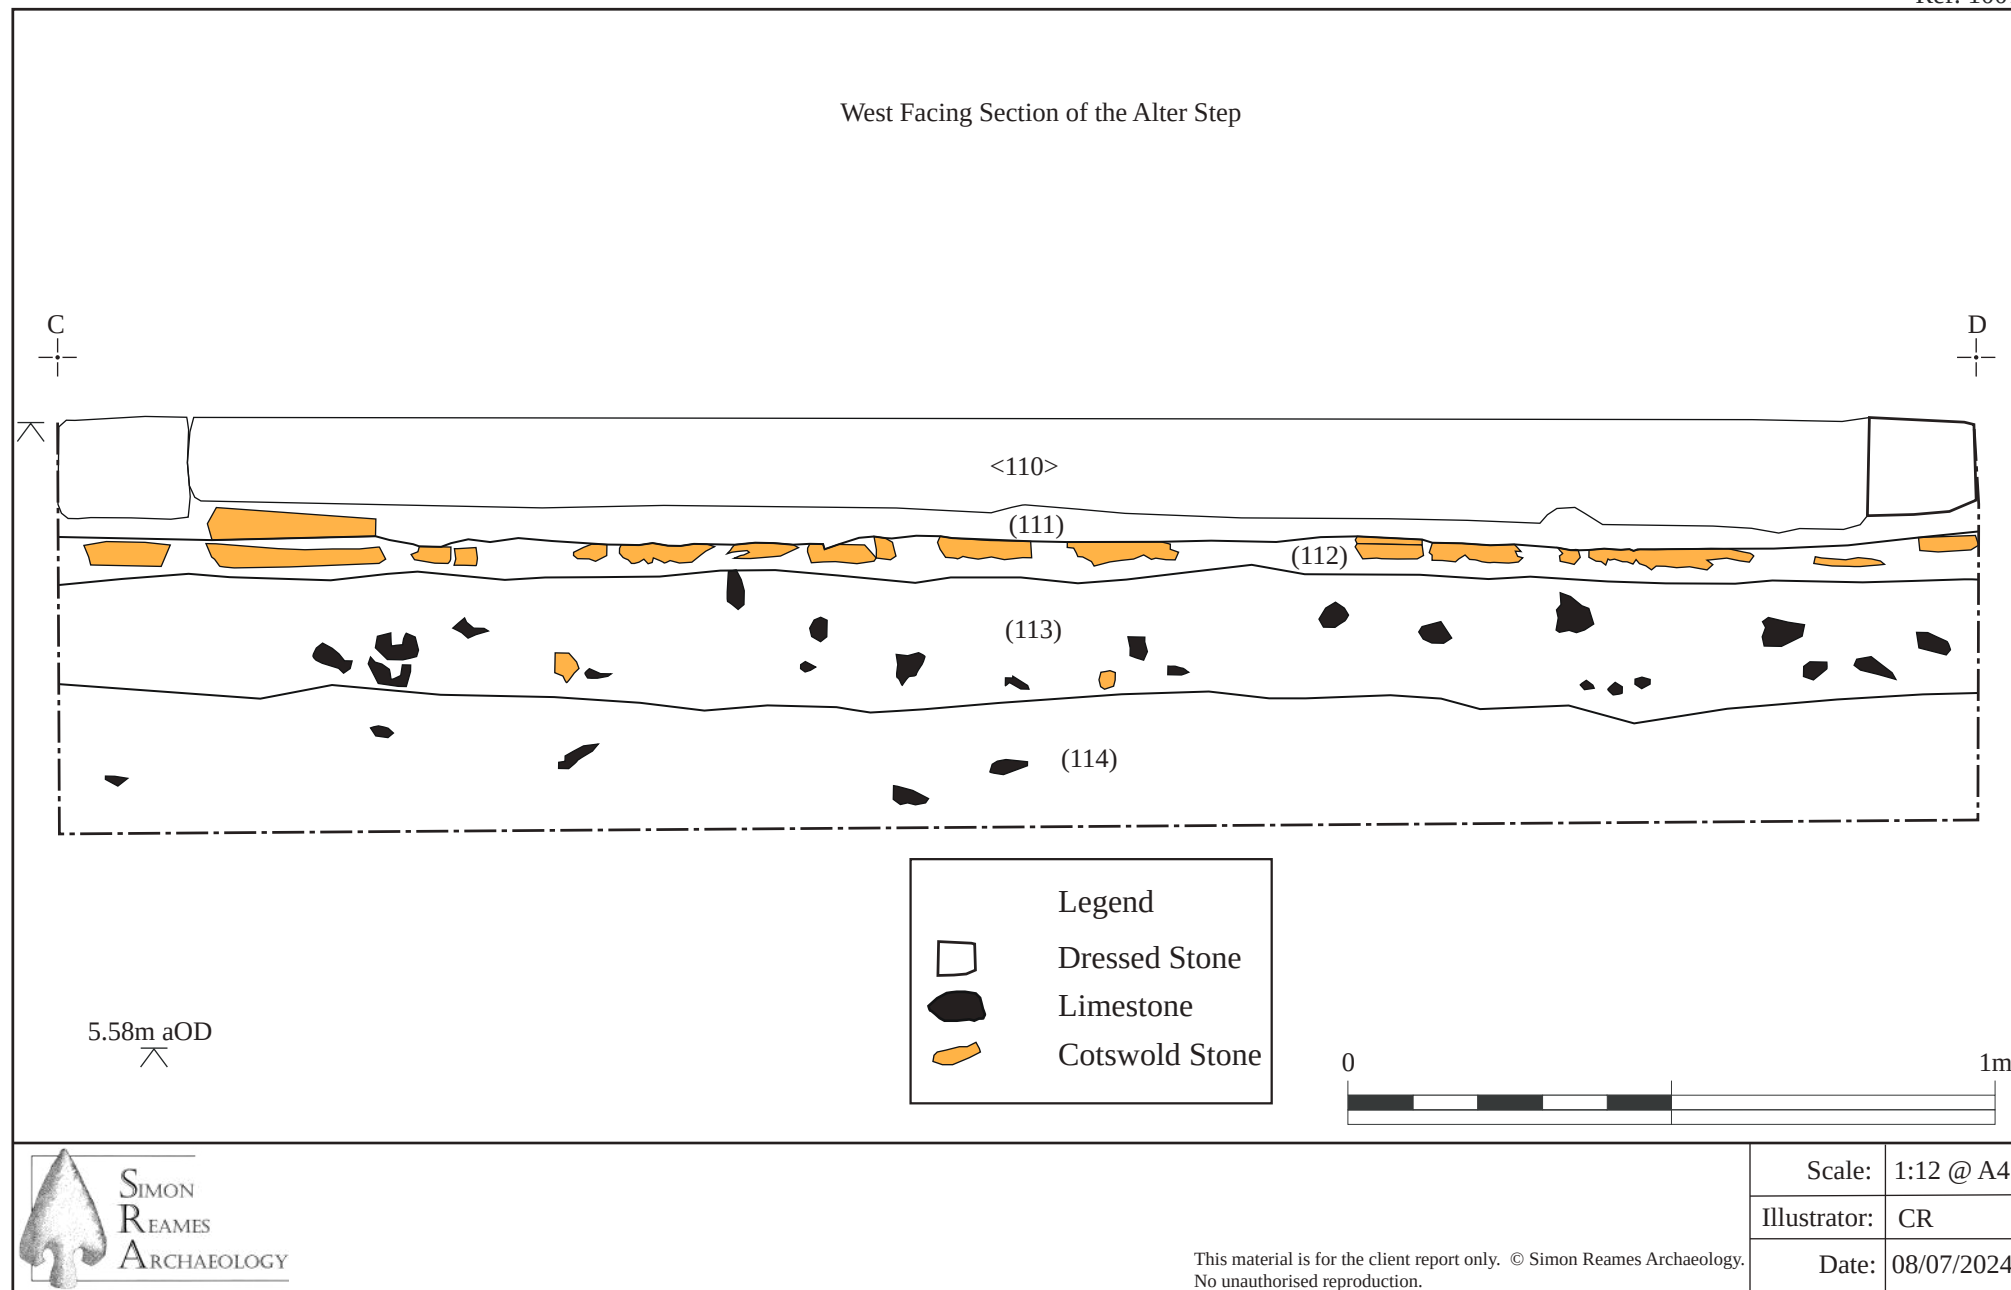
Figure 5

# West Facing Section of the Chancel Step

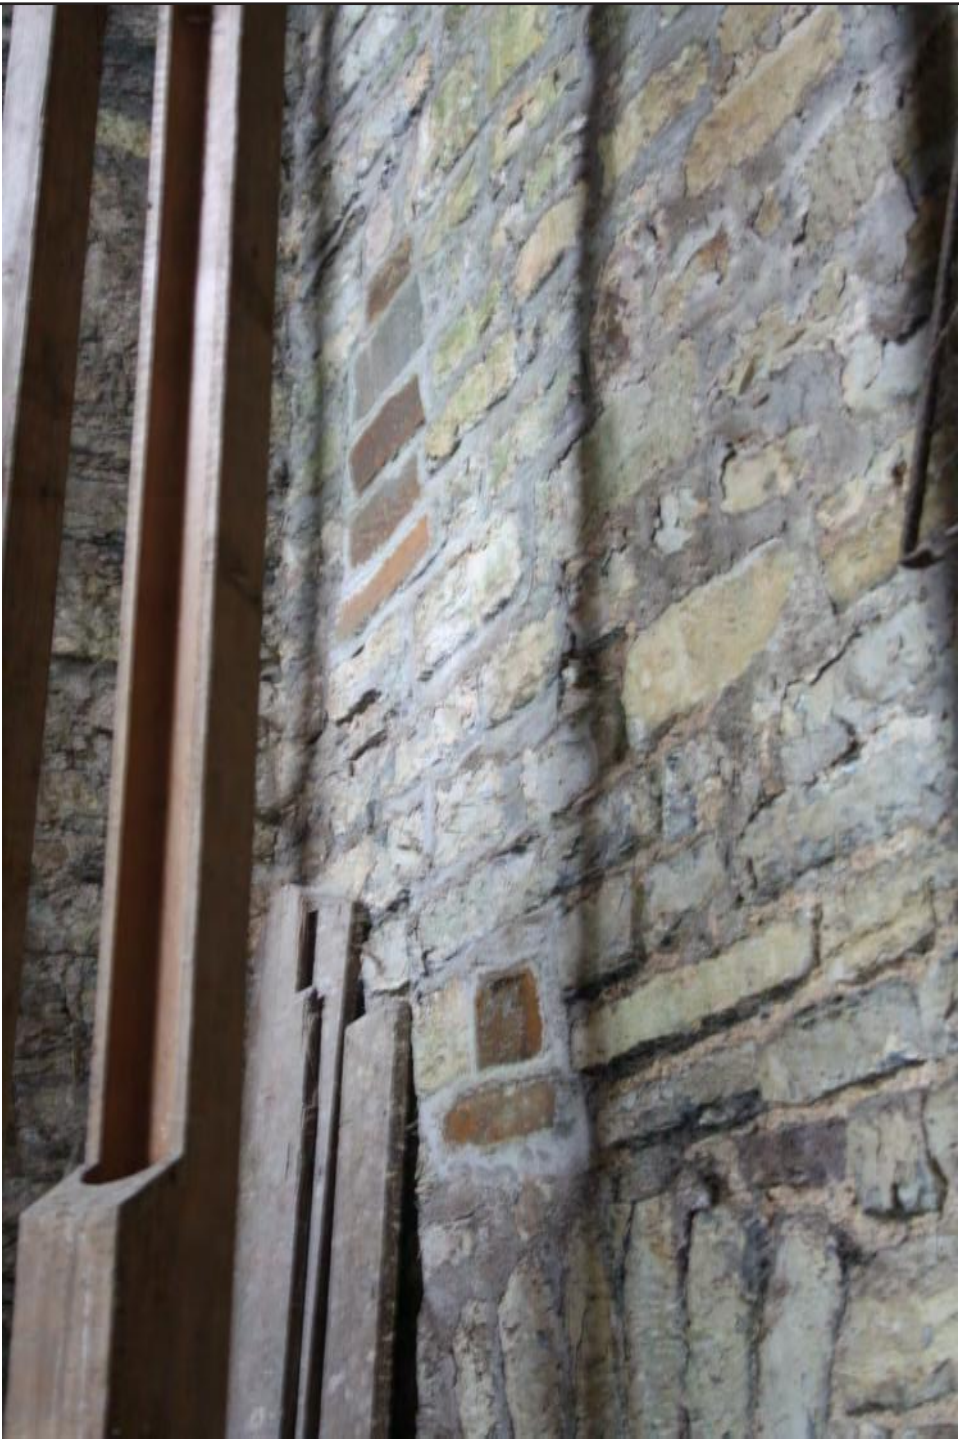
Plate 4

Internal Shot of Structure {122} below Structure {123} at the South Porch Threshold

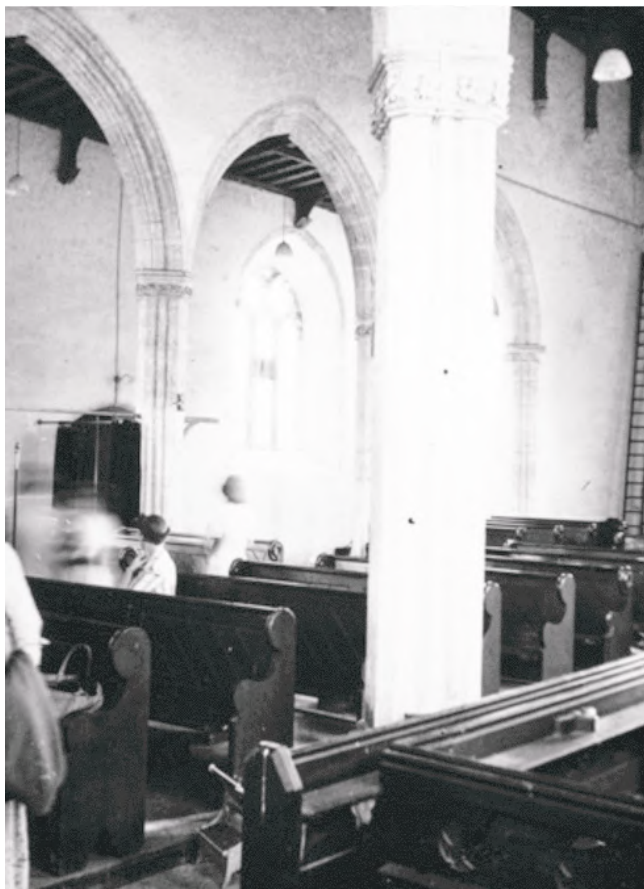
Plate 15

- 8.1.1. **Plate 15** depicts the internal area of the church looking from the north aisle, through the nave to the south aisle and south porch entrance. The photography clearly depicts the interior of the church with pews seated on raised plinths and a curtain mounted next to the south porch entrance. The walls appear rendered and whitewashed as it is in the present-day with the columns apparently bare.

1949 Internal Shot of St Peter's Church Looking South  
from the North Aisle to the South Porch Entrance ©  
Copyright Frith Content Inc, Photo Ref.:P429304

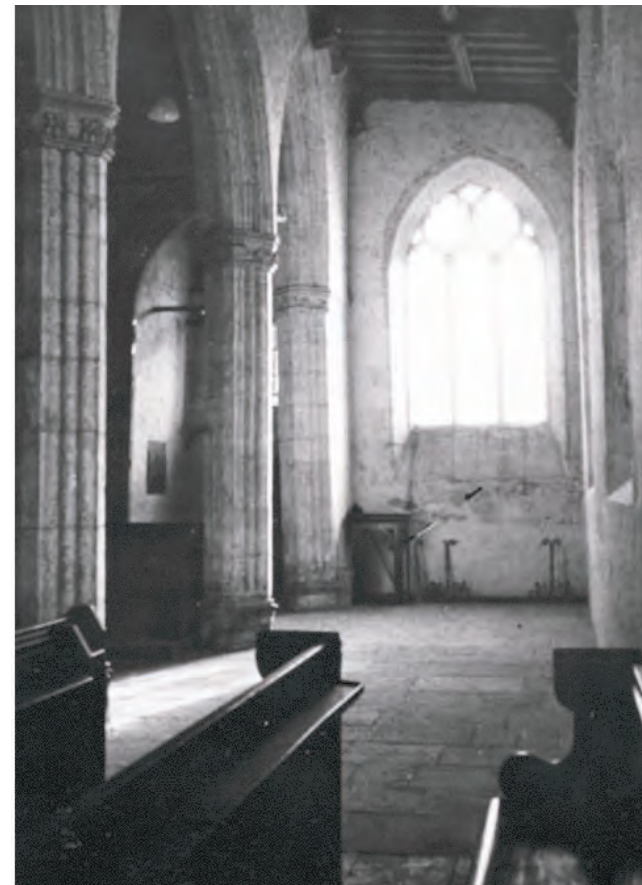
Plate 16

- 8.1.2. **Plate 16** reveals the interior of the north aisle looking west. The interior of the western end of the north aisle appears slightly more faded however this could well be due to inadequate lighting. The western end of the north aisle is bare with the exception of some furnishing at the extreme western extent. The present-day flagstone floor is clearly visible as is the slightly different alignment of the northwesternmost column.

1949 Internal Shot of St Peter's Church Looking West  
Along the North Aisle  
© Copyright Frith Content Inc, Photo Ref.:P429303
