## **Felthorpe House, College Road, Caerleon**

Cofnodi Adeiladau Hanesyddol / Historic Building Recording

Planning App.No: 26/0342

**Rhif Adroddiad / Report Number 2026/1069**

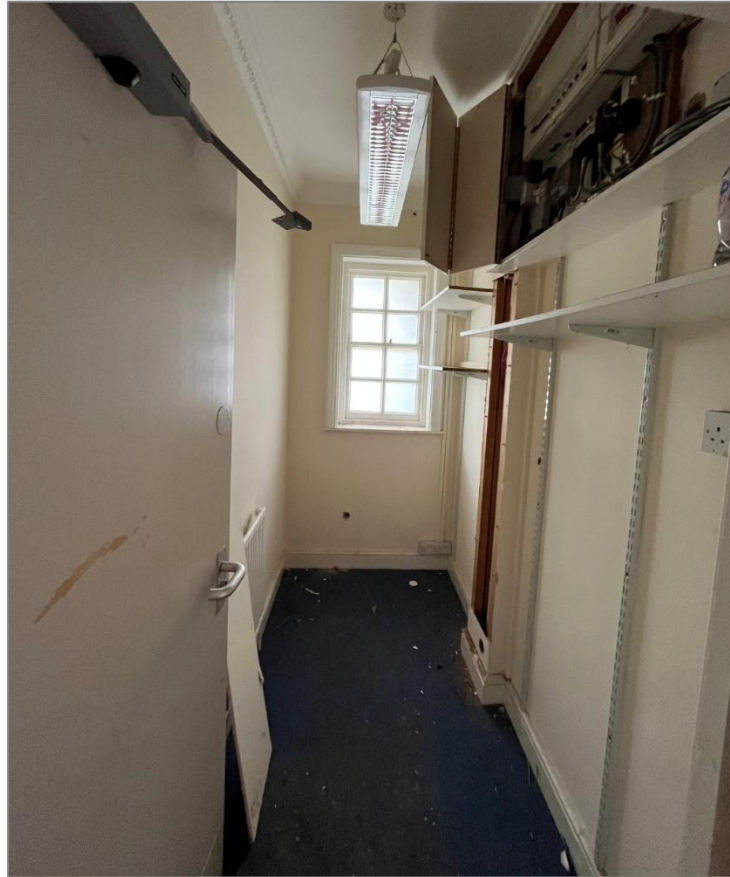
- 4.32. On the opposite, southeast side of the hallway a small passageway before the stairs accesses two rooms. The first is a small narrow room behind a modern timber fire door, with a carpeted floor, torus skirting, plain plastered walls, a continuation of the decorative coving, plain plastered ceiling with modern strip lighting (Photo 30). The room is lit by a small sash window in the front wall with opaque glass panels. A modern fuse box is attached to one side wall.

*Photo 30: View southwest of small front room.*

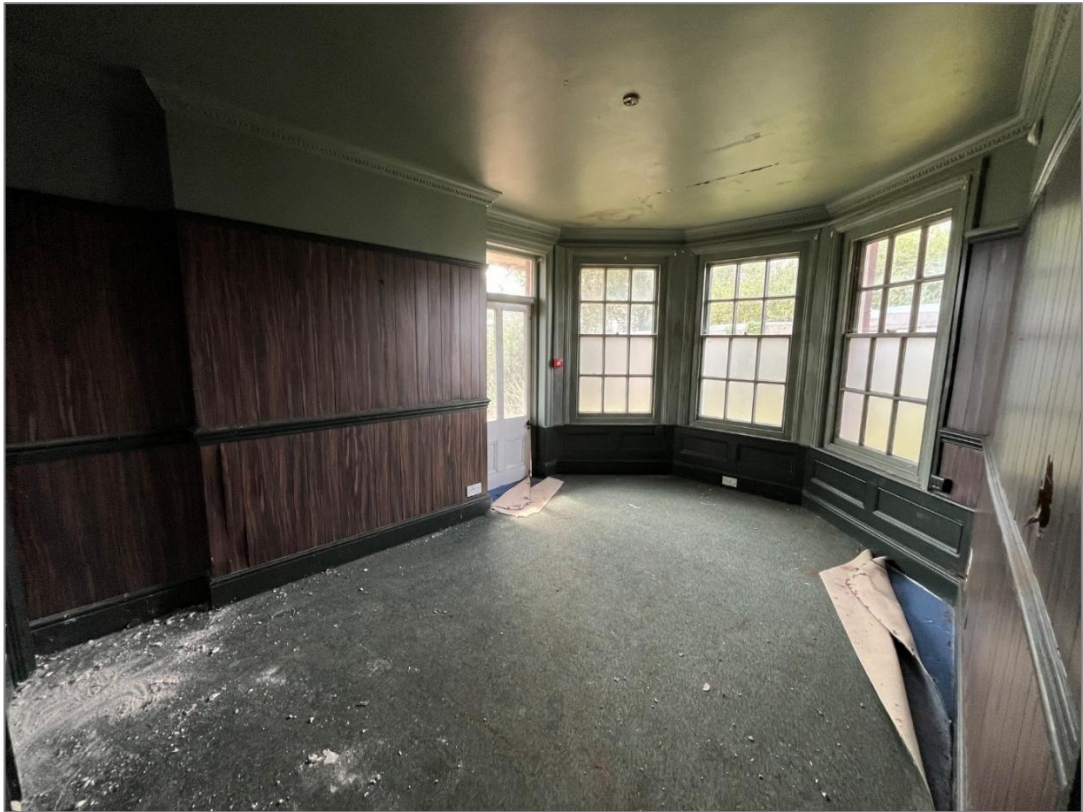
- 4.33. Beyond, a traditional timber panel door with rounded brass handle accesses a room occupying the front bay window area (Photo 31). The floor is carpeted, with high torus skirting, modern wood-panel effect walling and continuation of dado rail, picture rail and coving. The room is lit by three sash windows in the bay (Photo 32), all with opaque glass panels in the lower half, with an adjacent glazed doorway accessing the garden beyond. In the rear northeast wall lies a wood-panelled door, shorter than the typical doorways and since blocked with plasterboard (Photo 33).

*Photo 31: View southwest into the front bay window room.*

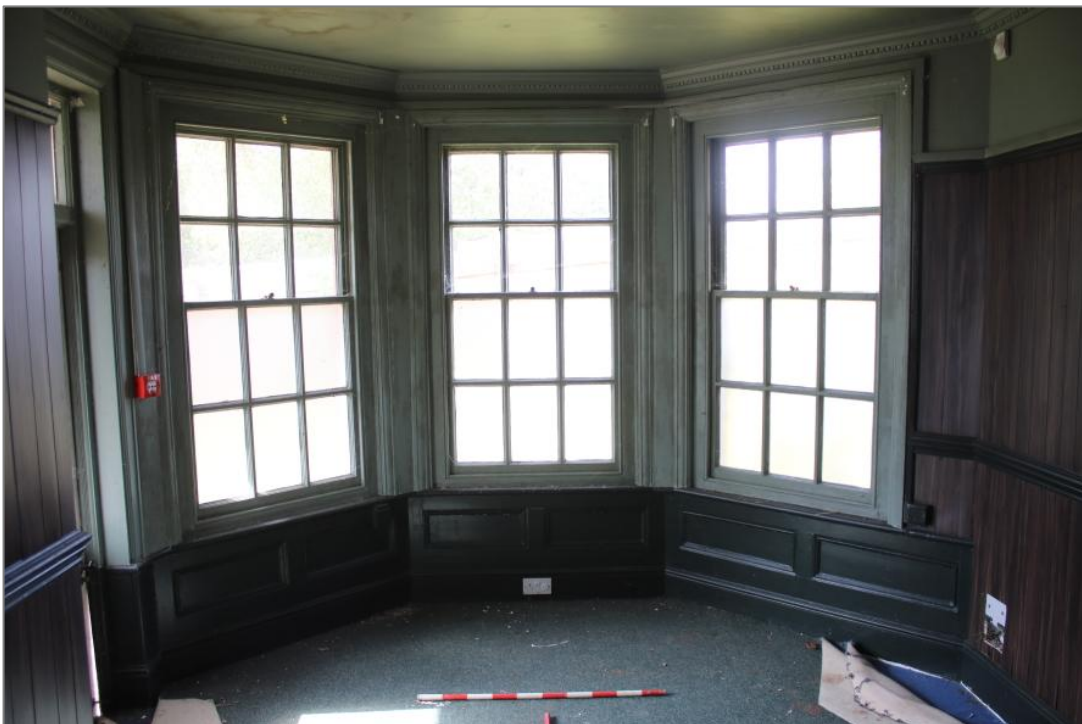
*Photo 32: View southwest of the internal side of the bay window. 1m scale.*

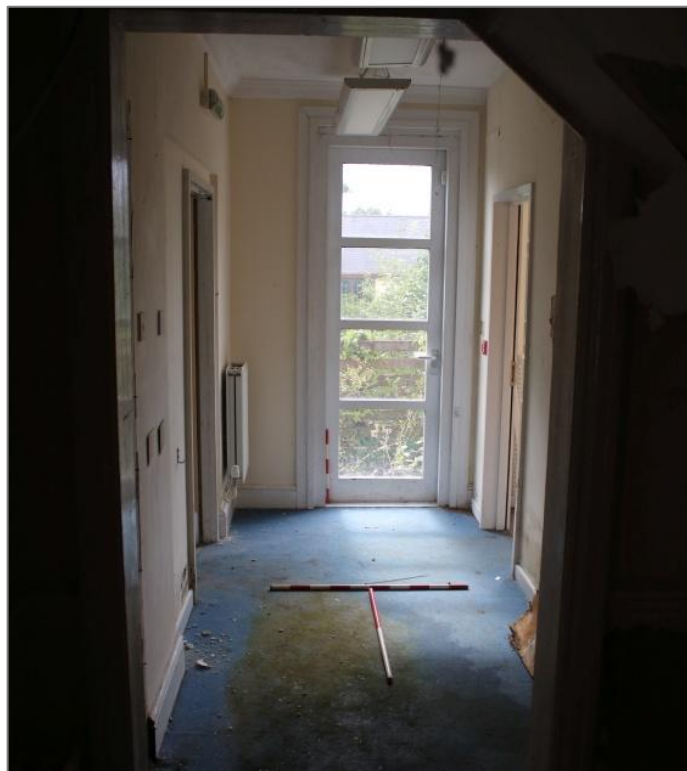
- 4.34. From the hallway to the rear of the stairs a right-angled side corridor leads to a garden door (Photo 34). The corridor floor is carpeted with torus skirting to the northeast, low plain skirting to the southeast, plain plastered walls, a continuation of the decorative coving and plain plastered ceiling with modern strip lighting. At the end of the corridor lies a modern glass panelled door in a heightened timber frame (possibly suggesting an inserted entrance) that opens out into the garden.

*Photo 34: View southeast of rear corridor. 1m & 0.5m scale.*

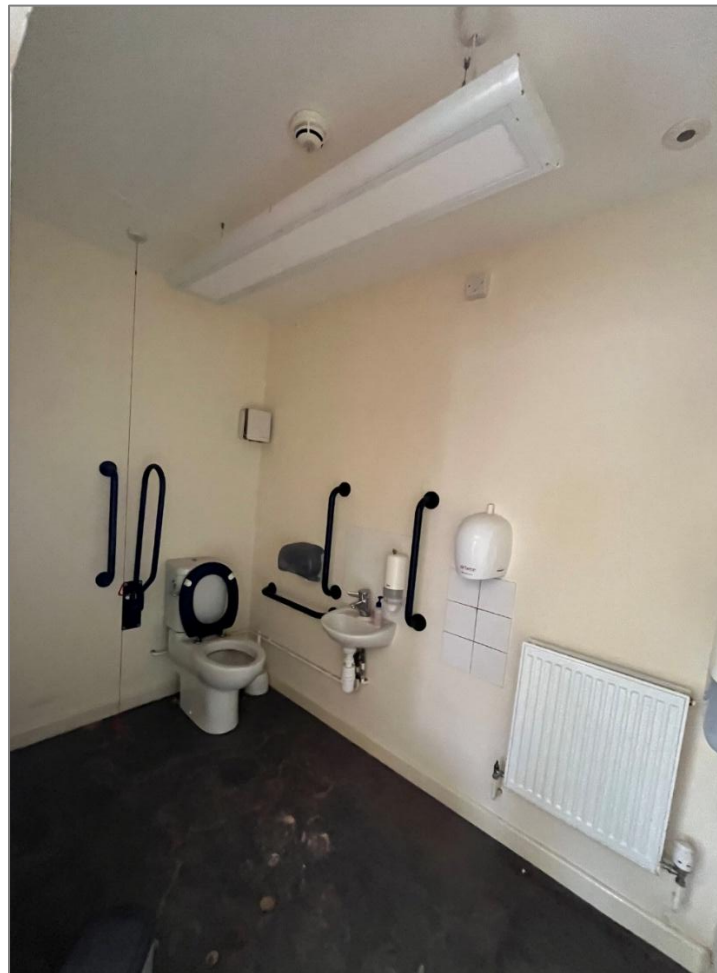
*Photo 35: view south into the toilet.*

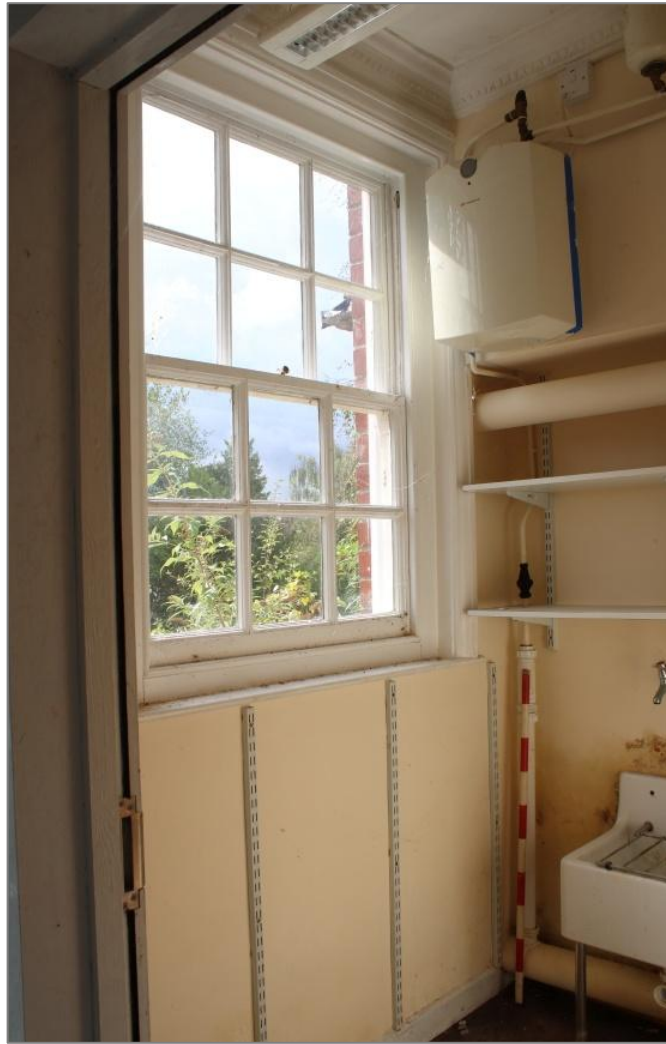
- 4.35. On the southeast side of the corridor are two rooms. The first, accessed via a modern fire door, contains a toilet, with vinyl flooring, plain skirting, plain plastered walls and ceiling and a modern porcelain toilet and sink (Photo 35). The second room, also accessed via a modern timber fire door is a small services room, with vinyl floor, plain plastered walls and ceiling with a continuation of the decorative coving (Photo 36). The room is lit by a sash window, a low Belfast sink stands on southeast wall with water heater above. Pipework runs across this rear wall, which appears to block the former doorway through to the bay window room to the southwest.

*Photo 36: View south into the small rear room. 1m scale.*

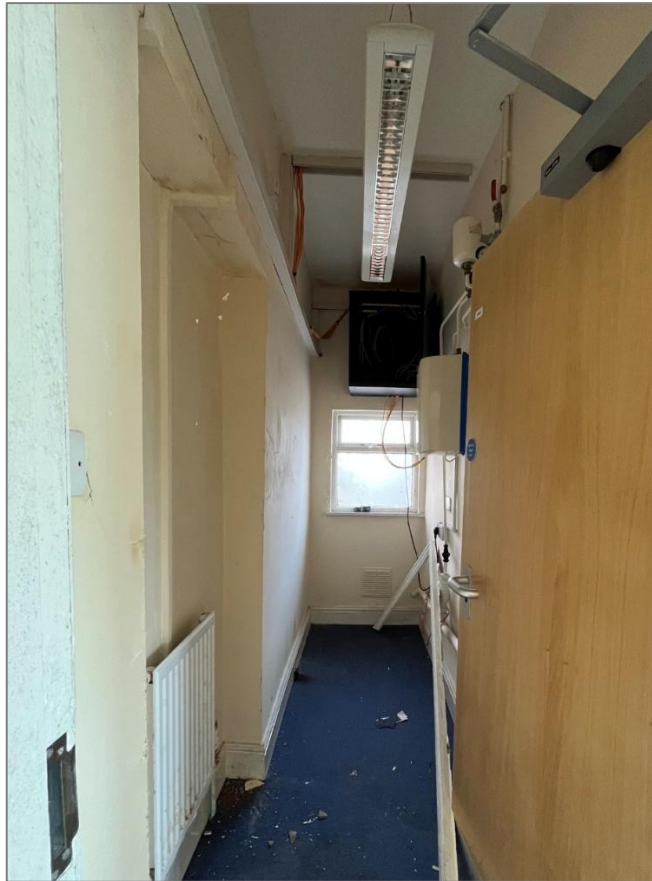
- 4.36. On the northeast side of this corridor a small room is accessed via a modern fire door (Photo 37). The floor is carpeted, with torus skirting, plain plastered walls, decorative coving and plain plastered ceiling with modern strip lighting. The room is lit by modern timber-framed awning window in the northeast wall. An alcove lies on the northwest wall, possibly blocking a former access through to the adjacent single storey extension.

*Photo 37: View northeast into narrow room on northeast side of corridor.*

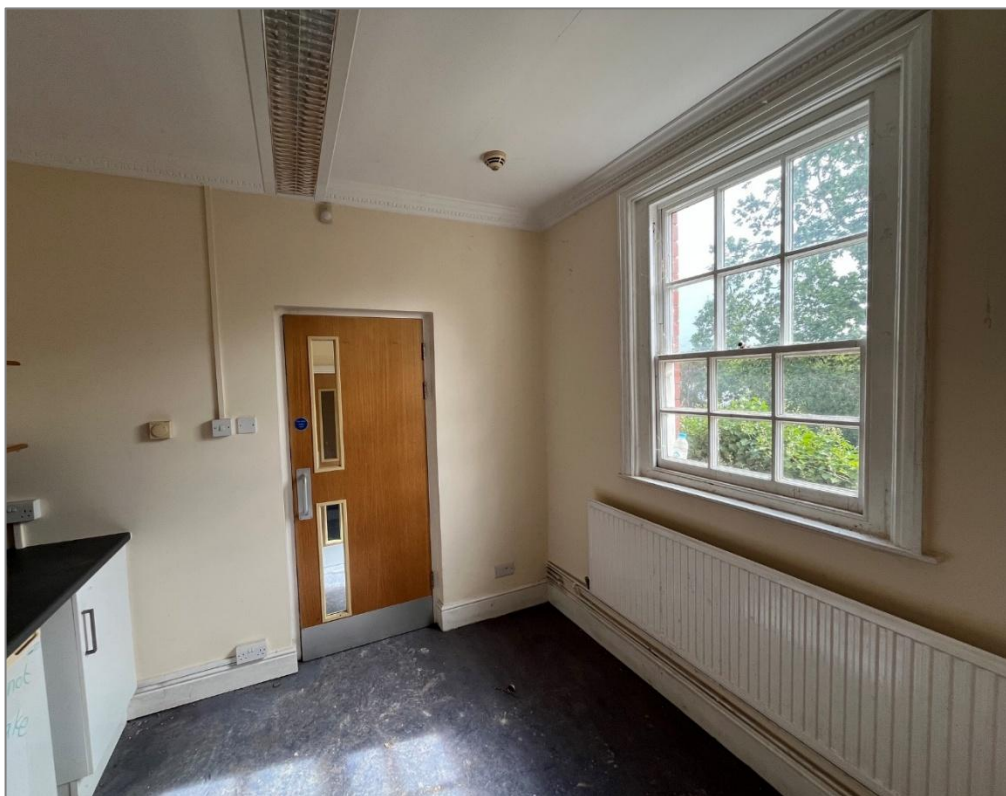
- 4.37. Adjacent lies a small kitchen, accessed via a doorway set in a larger recessed section of the corridor wall suggesting a part infilled opening (Photo 38). The kitchen has vinyl flooring, torus skirting, plain plastered walls, decorative coving and a plain plastered ceiling with modern strip lighting. The room is lit by a sash window in the southeast wall with a shortened lower section of the sash. Opposite lies a modern kitchen range comprising low cupboards and a double stainless-steel sink with a glazed-tile splashback panel above. A second doorway opposing the entrance accesses the former service wing beyond.

*Photo 38: View northeast into the kitchen.*

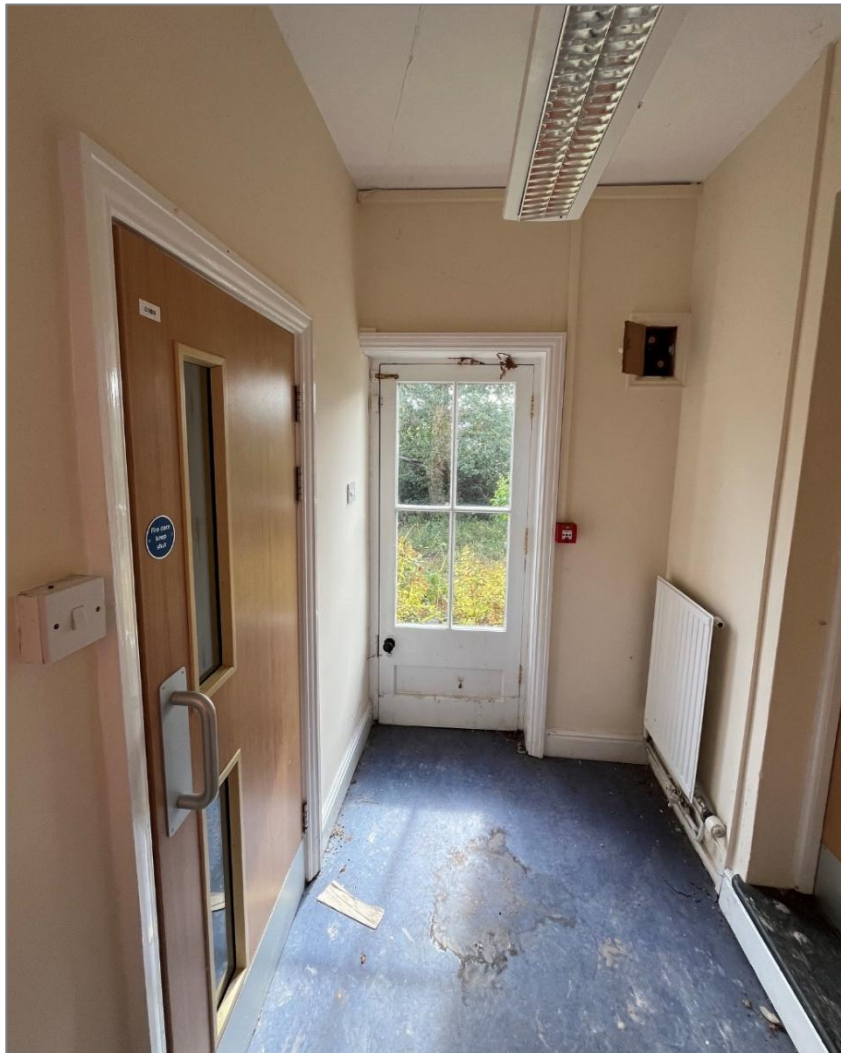
- 4.38. Beyond the kitchen lies a small cross-corridor, at a lower level than the kitchen (Photo 39). The corridor has a vinyl floor, torus skirting, plain plastered walls and ceiling and modern strip lighting. To the southeast lies a largely glass panel timber door with very low octagonal door handle, opening into the garden. Only one side of the timber door surround is visible, suggesting the internal wall may be a later insert. Opposite lies a half glazed, half timber panel door that opens into a small external access between the rear extensions (Photo 40). In between a modern fire door access a small room with carpeted floor, torus skirting, plain plastered walls and sloping ceiling with modern strip lighting (Photo 41). The room is lit by a pair of awning windows to the northwest.

*Photo 39: View southeast along rear service wing corridor.*

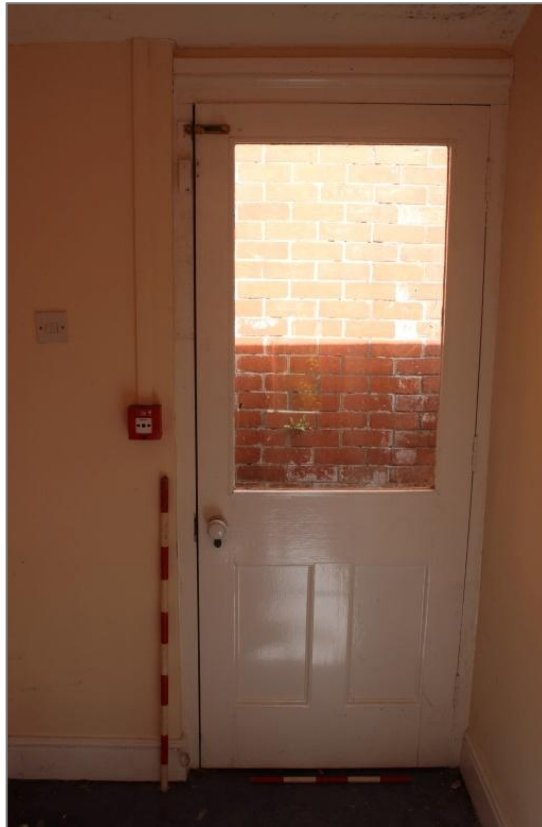
*Photo 40: View northwest of opposing door in rear service wing corridor. 1m & 0.5m scale.*

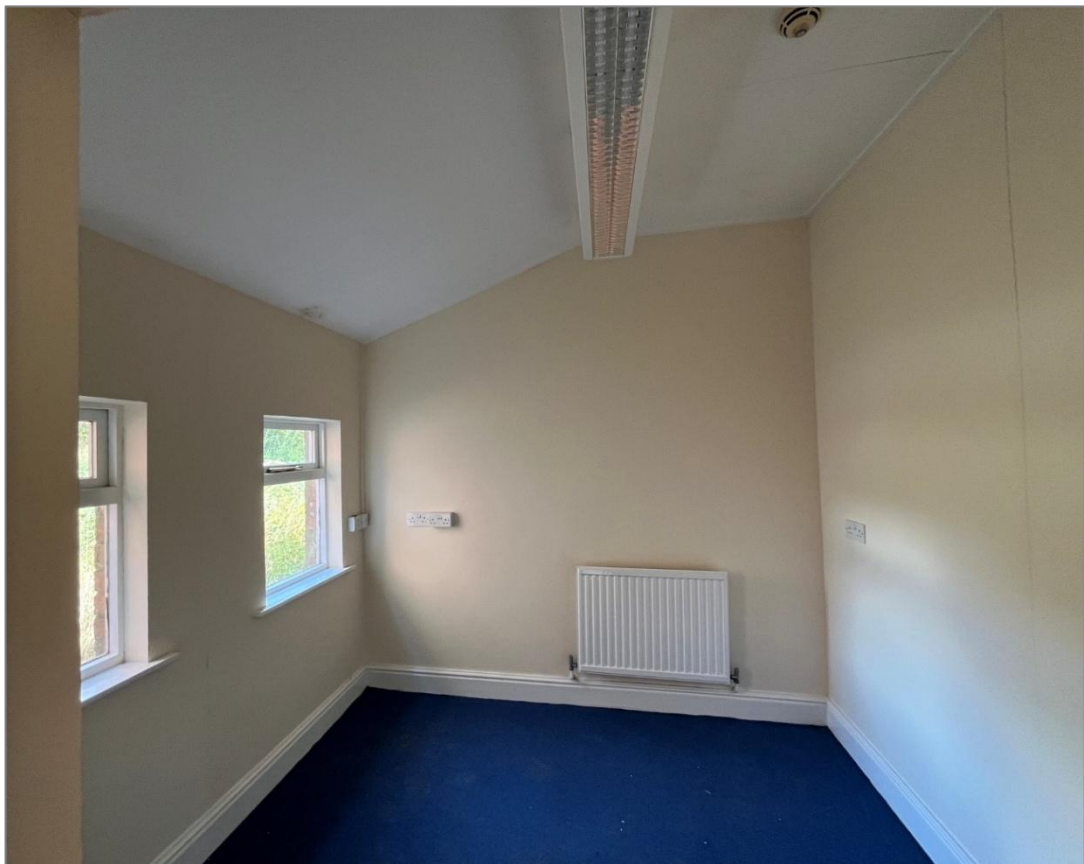
*Photo 41: View northeast into rear service wing room.*

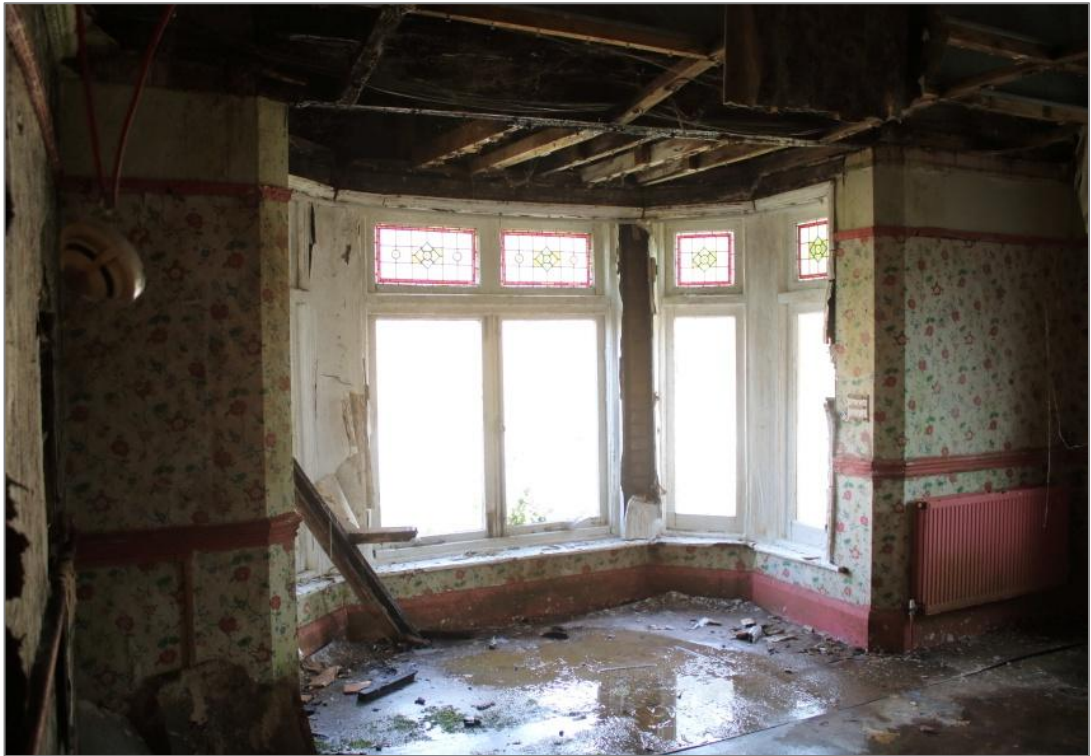
- 4.39. The room occupying the single storey extension was not closely examined due to water ingress through the flat roof. The room is accessed from the end of the entrance hallway beyond the stairs, through a modern timber fire door. The floor appears to be vinyl-covered, high chamfered skirting, with a continuation of the dado and picture rails (Photo 42). The walls are covered in floral-design wallpaper up to the picture rail. The ceiling has come down through water damage. The room is lit by casement windows in the bay to the northwest, with painted leaded glass panels in an Edwardian style above (Photo 43). A pair of doors lie in the northeast wall (as described externally), but these have been part boarded internally to turn them into windows with additional internal glazing. The large window into the adjoining room to the southwest is similarly boarded. A boarded fireplace lies on the southeast wall (Photo 44).

*Photo 43: View northwest of the bay window in the single-storey extension.*

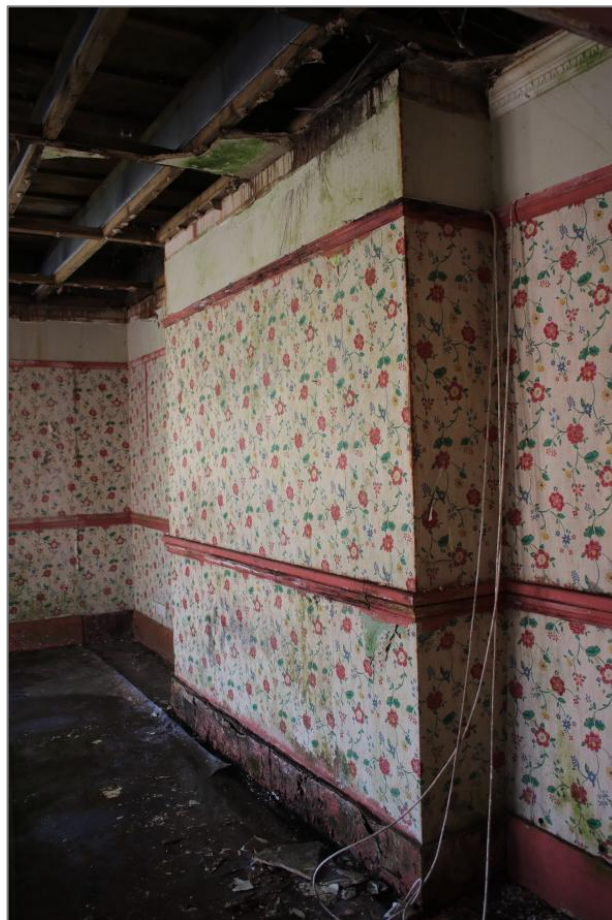
*Photo 44: View east of the former fireplace in the single storey extension.*

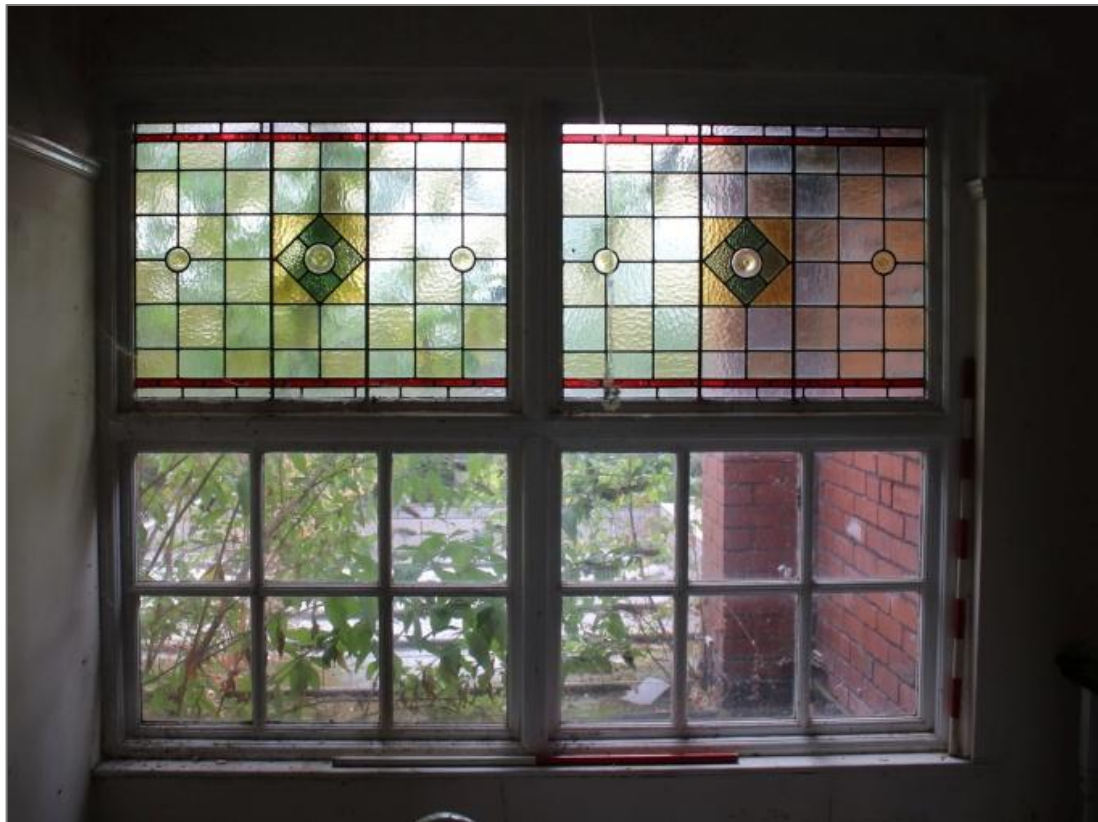
*Photo 45: View northeast of the stairwell window. 1m scales.*

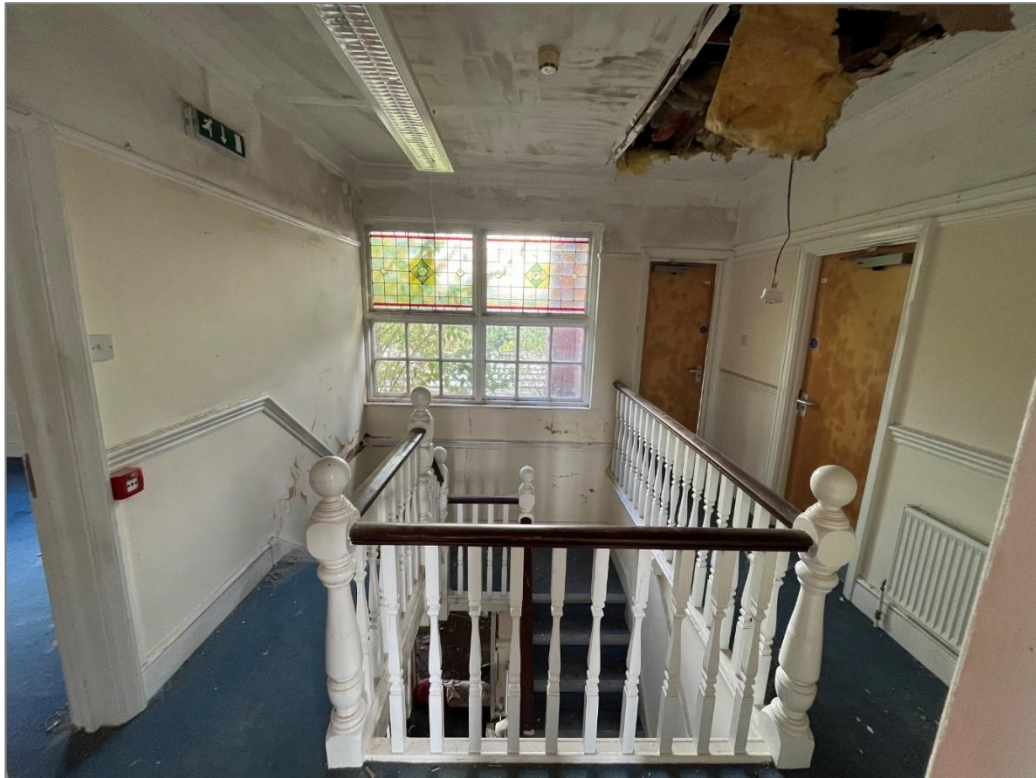
- 4.41. The stairwell itself is surrounded by a continuation of Victorian-style turned newels and balusters (Photo 46). The landing is lit by a large Edwardian-style window in the northeast wall, comprising two lower panels of 6-panes, each with a leaded light above containing small painted stippled glass in yellow and green with central diamond design and thin bands of red to the top and bottom (Photo 45). The landing is carpeted, with high torus skirting, plain plastered walls with a continuation of the dado rail, picture rail and decorative coving, with a plain plastered ceiling with modern strip lighting above. The surrounding doors are all plain modern fire doors in timber surrounds.

*Photo 46: View northeast of the 1st floor landing.*

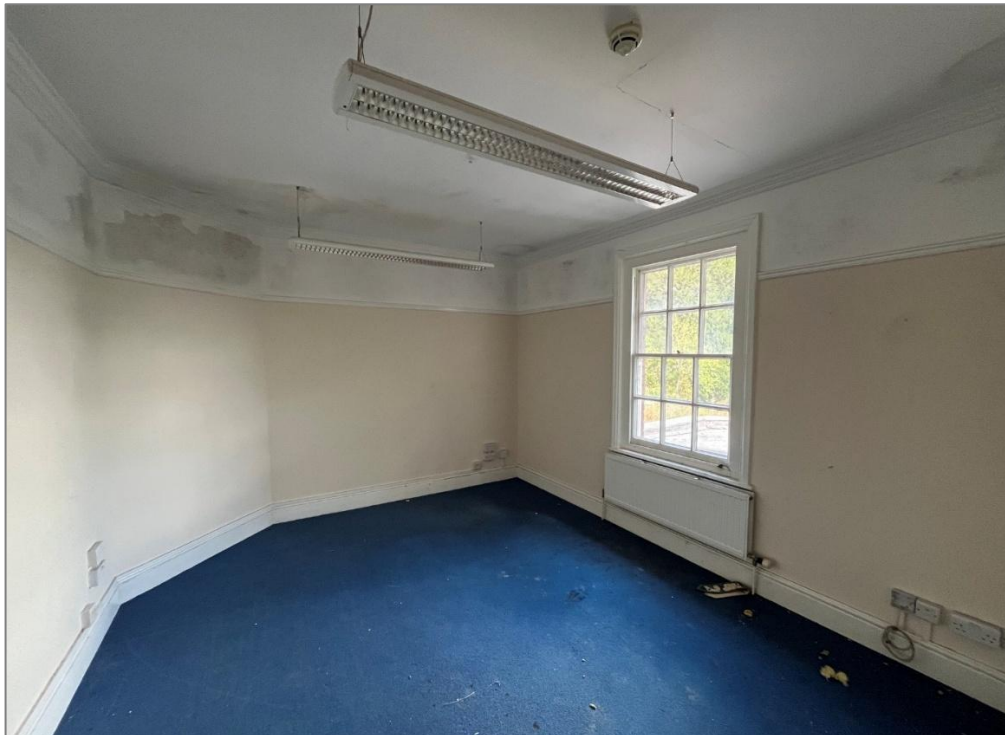
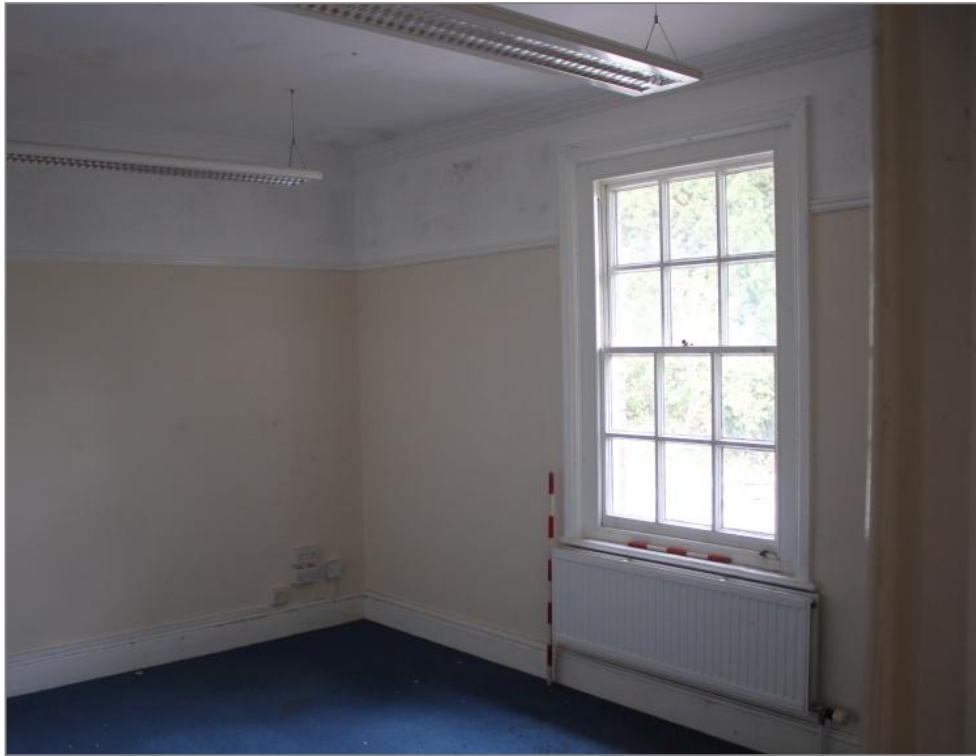
- 4.42. Bedroom 1 is carpeted with torus skirting, plain plastered walls, picture rail, decorative coving and plain plastered ceiling and modern strip lighting (Photos 47 and 48). The room is lit by a standard sash window in the northeast wall. An angled western corner suggests a blocked fireplace.

*Photo 47: View north into Bedroom 1.*

*Photo 48: View north of detail within Bedroom 1. 1m & 0.5m scale.*

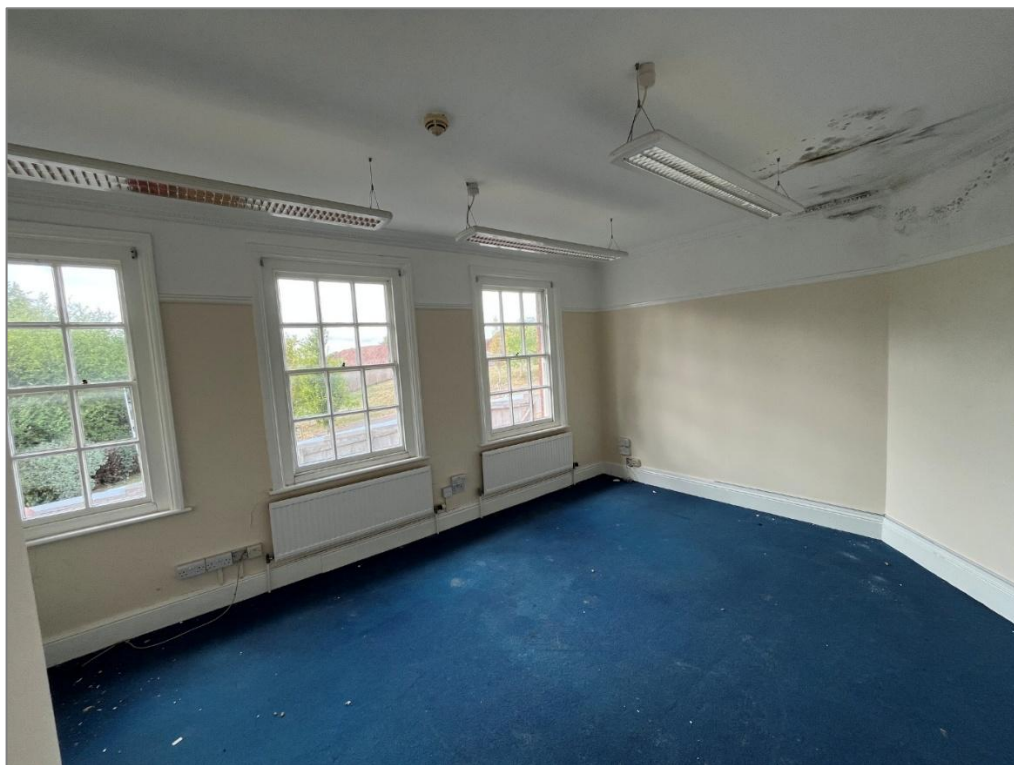
- 4.43. Bedroom 2 is carpeted with torus skirting, plain plastered walls, picture rail, decorative coving and plain plastered ceiling with modern strip lighting (Photo 49). The room is lit by three sash windows in the southwest wall, two standard size and one narrower window. An angled east corner suggests a blocked fireplace (Photo 50).

*Photo 49: View west into Bedroom 2.*

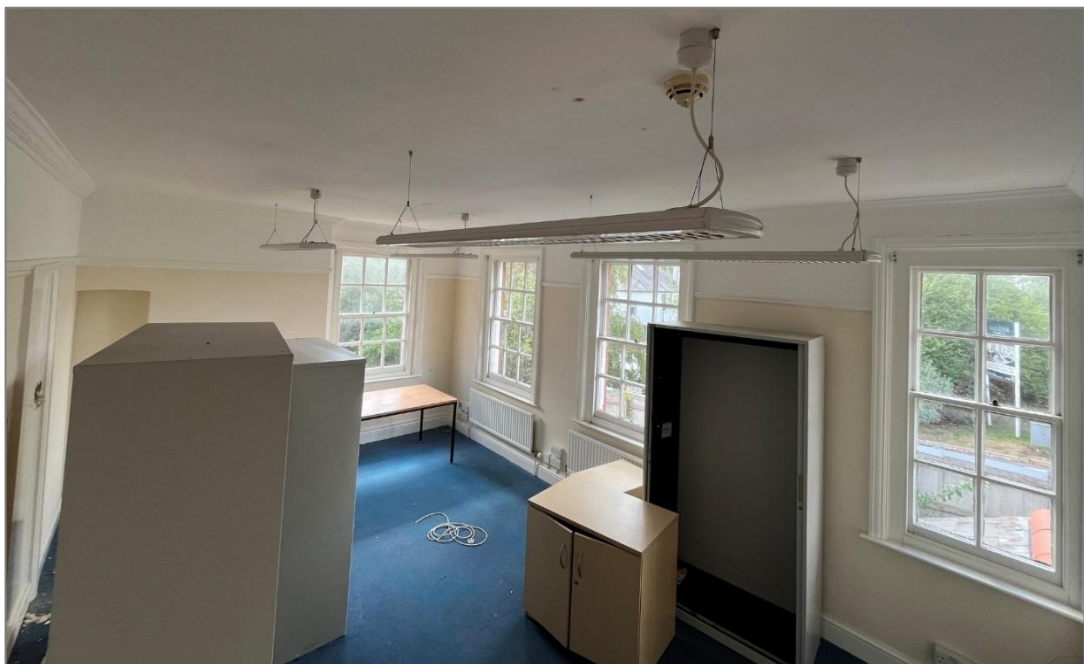
- 4.44. Bedroom 3 is carpeted with torus skirting, plain plastered walls, picture rail, decorative coving, plain plastered ceiling and modern strip lighting (Photo 51). It is lit by two standard sash windows and a narrower sash in the southwest wall and a third standard sash window in the southeast wall. The southeast walls steps in, with a small rounded-head alcove against the northeast wall, suggesting a blocked fireplace on the southeast wall (Photo 52). A blocked doorway lies adjacent on the northeast wall.

*Photo 51: View south into Bedroom 3.*

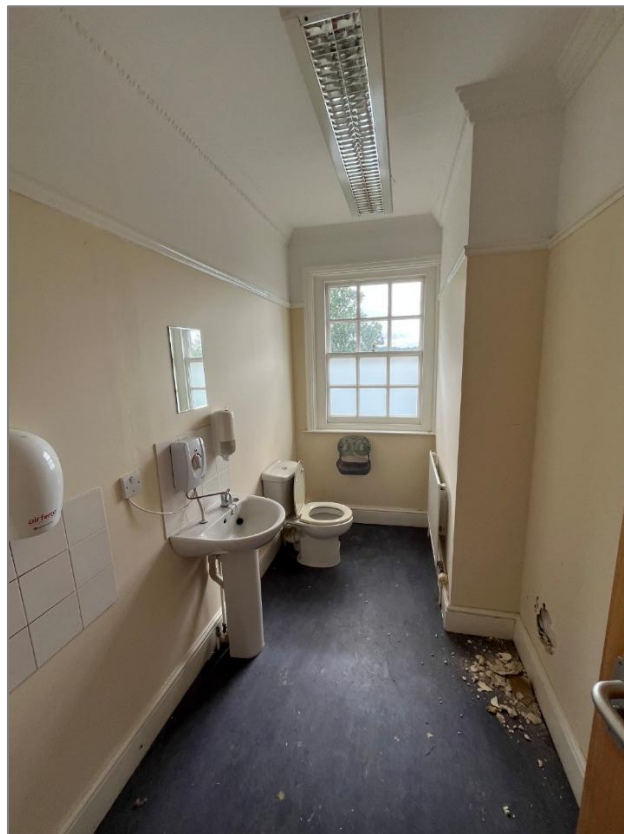
- 4.45. The toilet occupies a narrow room with carpeted floor, torus skirting, plain plastered walls, picture rail, decorative coving and plain plastered ceiling with modern strip lighting (Photo 53). The room is lit by a sash window in the southeast wall, the lower section contains opaque glass. A modern porcelain sink and toilet lie on the side wall, with no indication of the blocked doorway into Bedroom 3 opposite.

*Photo 53: View southeast of the 1st floor toilet.*

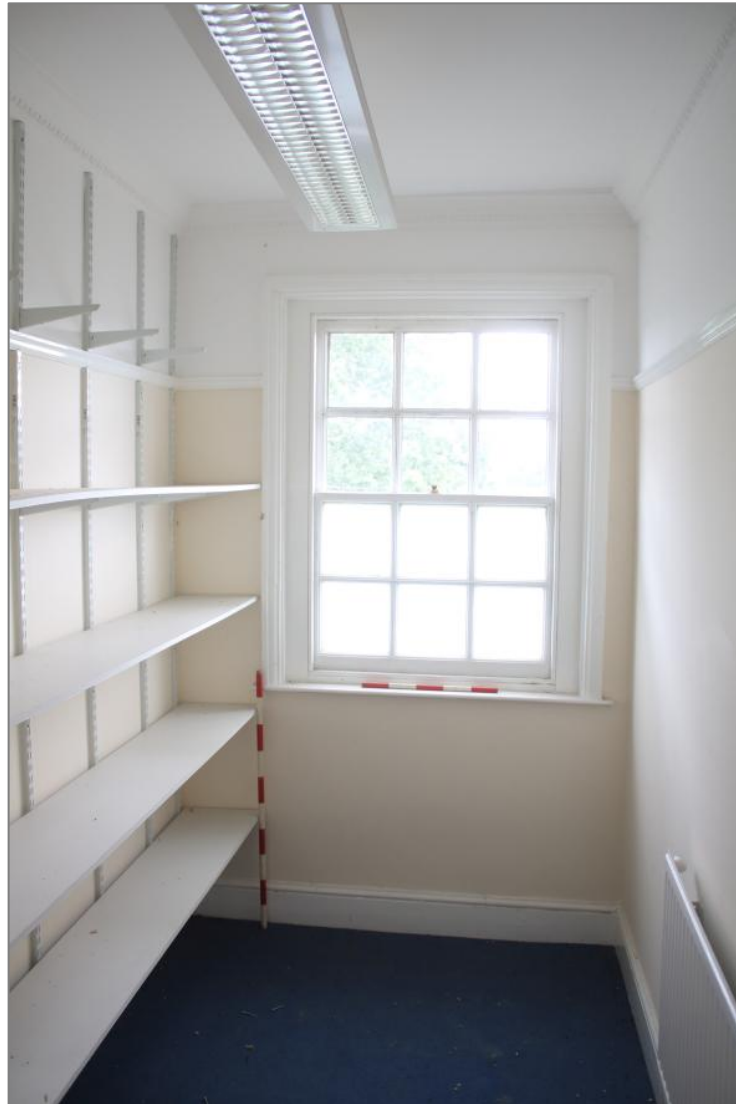
- 4.46. Bedroom 4 is a narrow room with carpeted floor, torus skirting, plain plastered walls, picture rail, decorative coving, plain plastered ceiling with modern strip lighting (Photo 54). It is lit by a sash window in the southeast wall, the lower section of which contains opaque glass. Modern shelving lines one wall, the wall to the adjacent bathroom is an inserted stud wall.

*Photo 54: View southeast into Bedroom 4. 1m and 0.5m scale.*

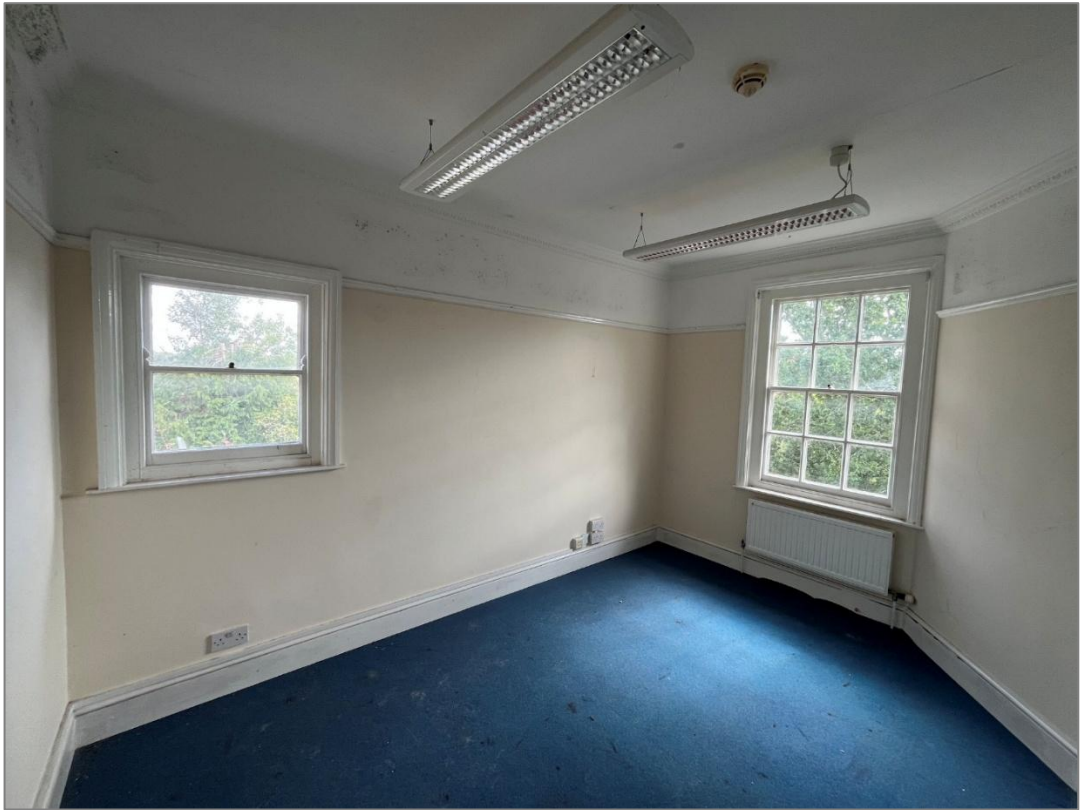
- 4.47. Bedroom 5 is a small rear bedroom, accessed through a narrower door frame. The room has a standard carpeted floor, torus skirting, plain plastered walls, picture rail, decorative coving, plain plastered ceiling with modern strip lighting (Photo 55). The room is lit by a standard sash window in the southeast wall, and a small, two-pane, sash window in the northeast wall (Photo 56). An angled east corner suggests a blocked fireplace, not apparent in the adjoining room.

*Photo 55: View east into Bedroom 5.*

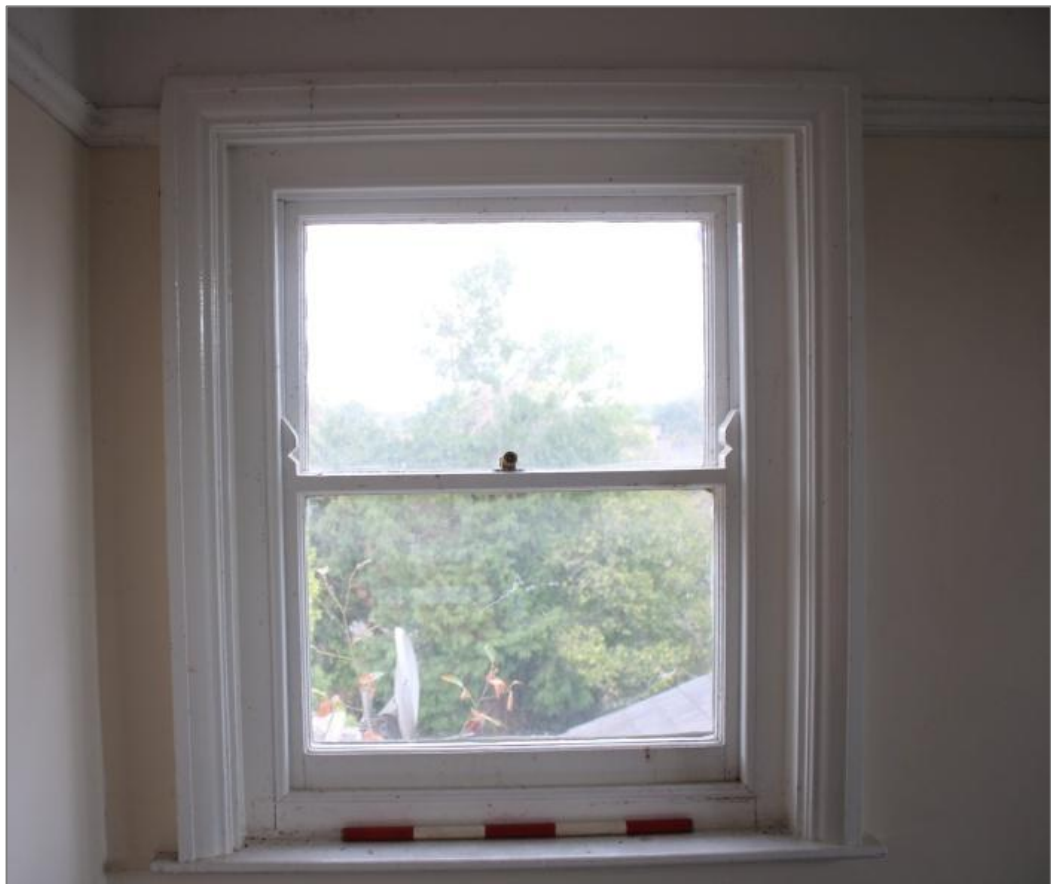
*Photo 56: View northeast, showing window detail in Bedroom 5. 0.5m scale.*

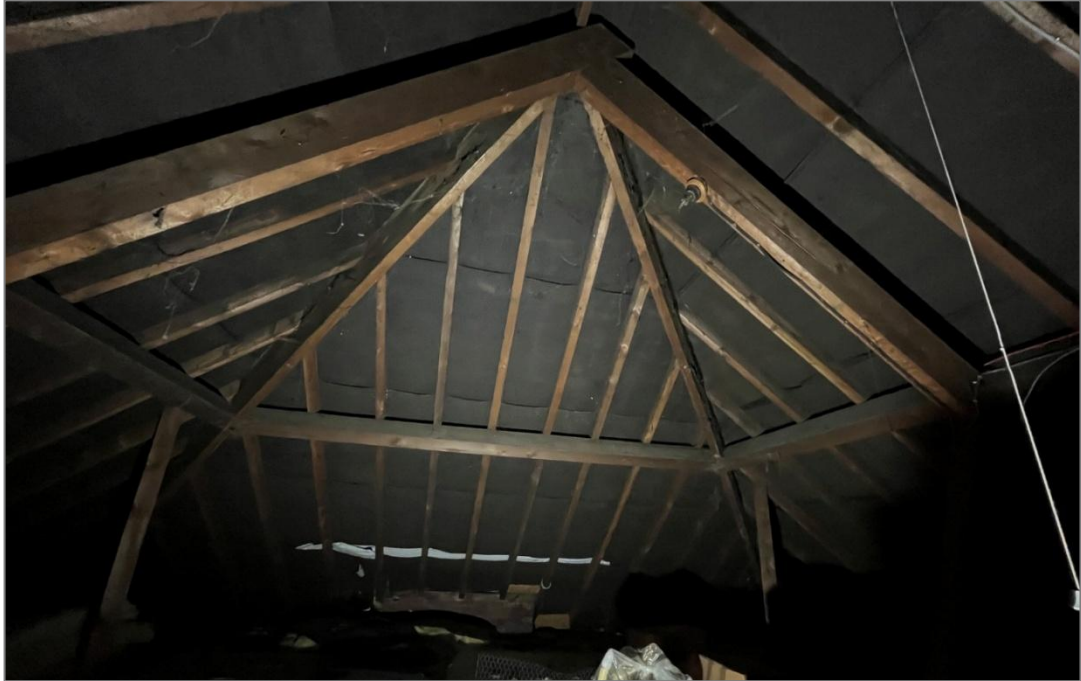
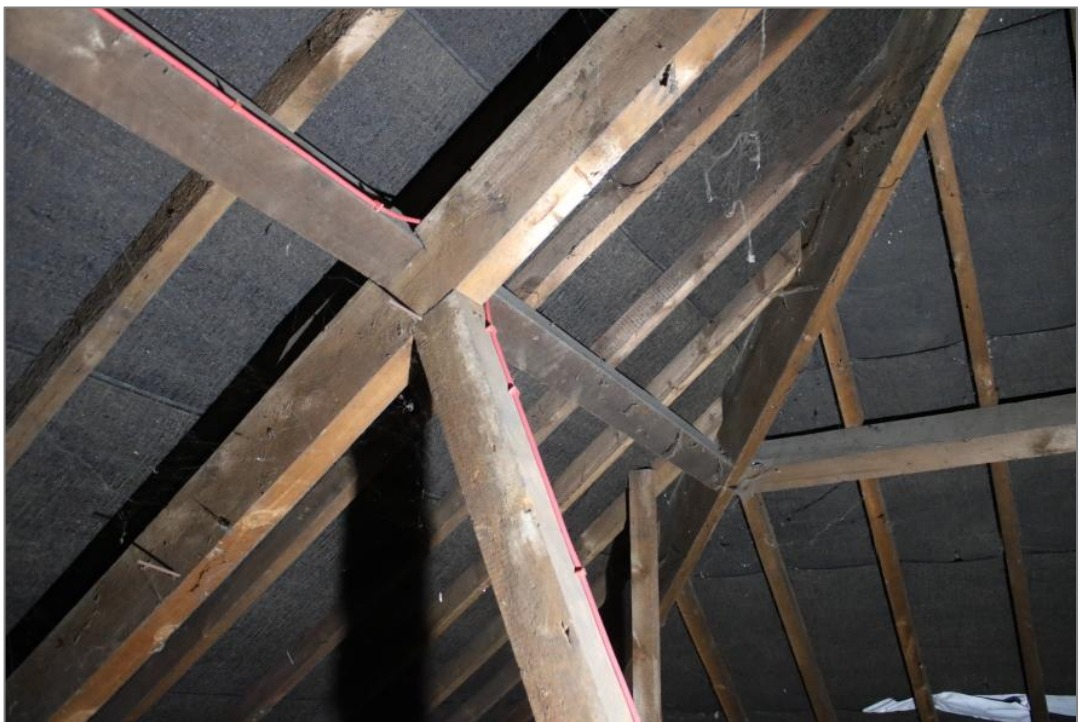
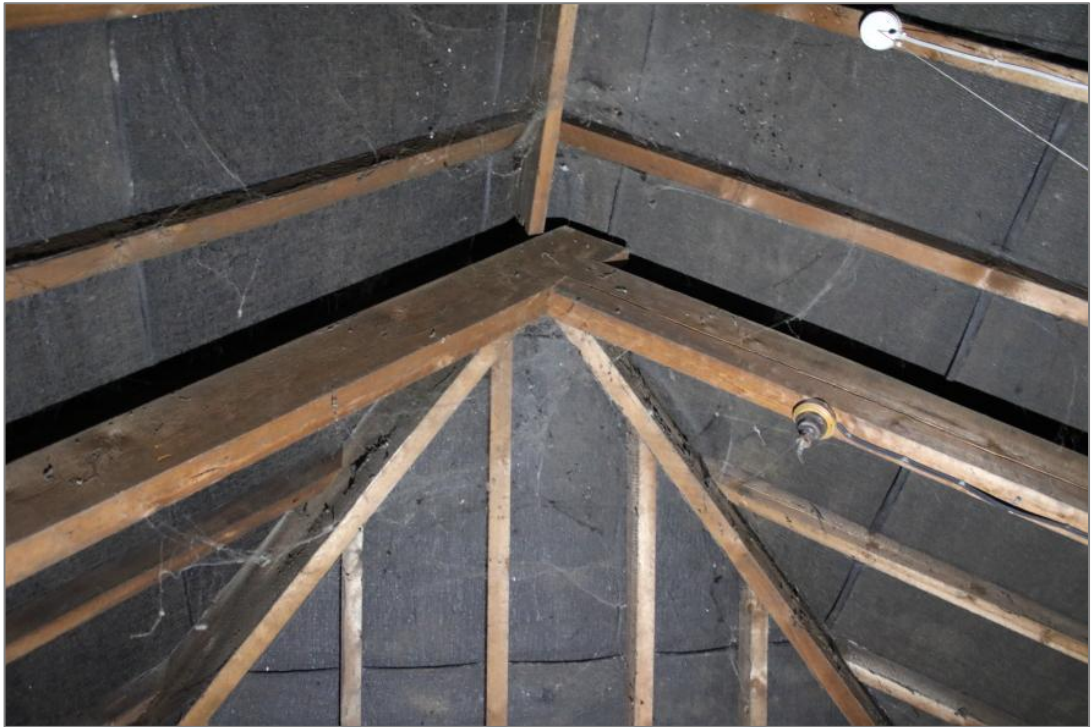
- 4.48. In the small lobby access to Bedroom 2 is a loft hatch, with modern steel retractable loft ladder. The loft area above is a single space, boarded out across the floor with exposed roof timbers of machine-cut pine (Photos 57 to 59). The timbers appear to be nailed in place, with an intermediate brace partly notched into the main rafter, in turn supported by internal members. The roof itself is felted.

*Photo 57: View northwest of the roof structure.*

*Photo 58: Detail of roof structure joints.*

*Photo 59: Detail of roof structure joints.*
