**Ground Gas Protection System
Validation Report:**
Residential Development
Phases 2B, 2C & 2D
Herbert Road
Newport

REPORT TITLE : **Ground Gas Protection System Validation Report: Residential Development, Phases 2B, 2C & 2D, Herbert Road, Newport**

REPORT REFERENCE : **TFW_0920_12032_GGVR_V01**

DATE : **September 2020**

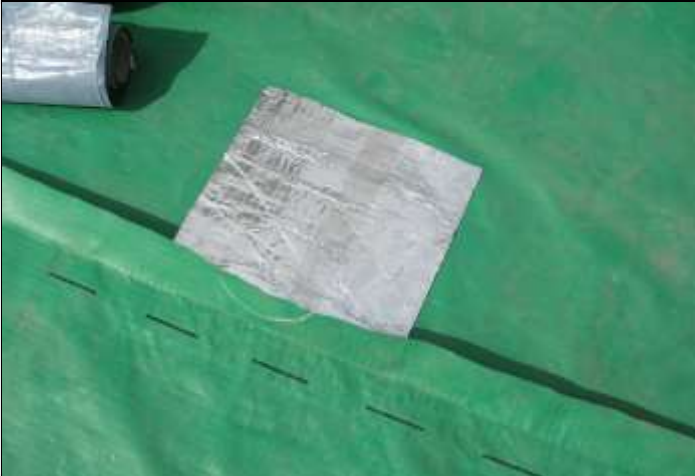
Photographs	
No.	Description
1	Corner detail
2	Service entries
3	Repaired puncture
4	Repaired puncture
5	Damage post screeding
6	Liquid seal repair
7	Liquid seal repair
8

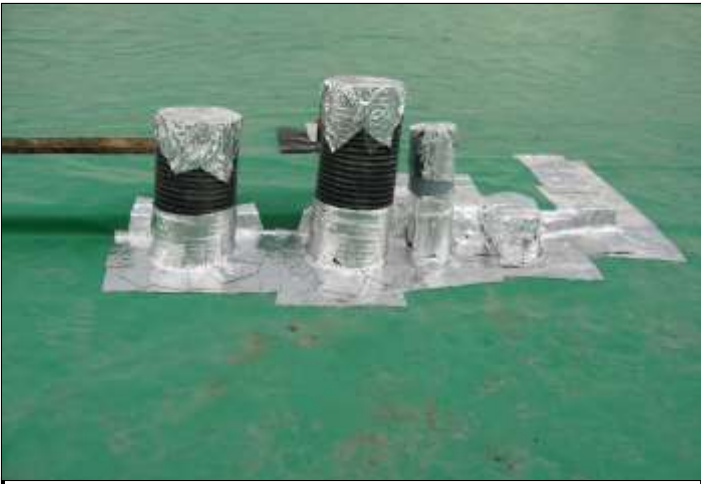
Photographs	
No.	Description
1	Service entries
2	Recess for stair well
3	Corner details
4	Lap tape install
5	Damage post screed
6	Damage post screed
7	Liquid seal repair
8	Liquid seal repair

Conclusions
<p>The gas protection measures inspected: A - are acceptable and comply with the specification; B - Are Acceptable but attention is drawn to issues related to item no. XX; C - Are not acceptable due to the issues related to item no. XX. B - Sealing of service entry ducts to be completed.</p>

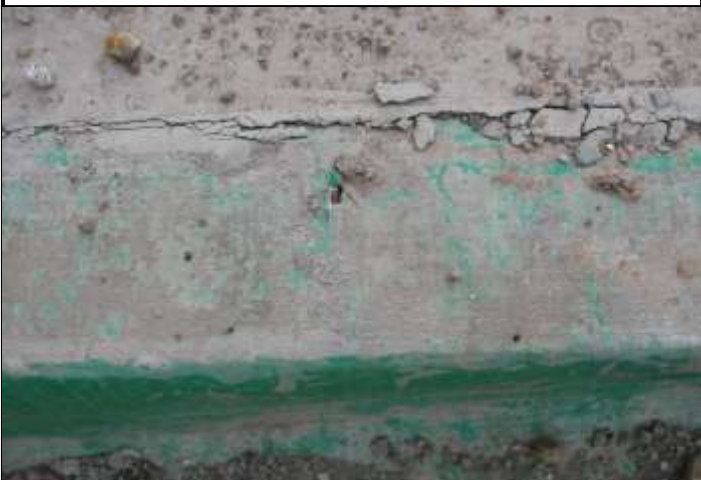
5

2.2	External wall airbricks	14 periscopes installed
2.3	Internal sleeper walls/Beams	Seen previously - Clear 150mm void minimum
2.4	External vents trenches/ducts	NA
<p>Additional Notes: 10/5/19 - damaged occurred to membrane perimeter from screeding process. Asked for membrane to be cleaned off to inspect damage fully. 29/5/19 - inspected repair to damaged perimeter membrane. However damage still noted. 18/06/19 - Inspected repair to damaged perimeter membrane. Membrane either replaced or damage repaired with Solseal liquid gas barrier to manufacture recommendations.</p>

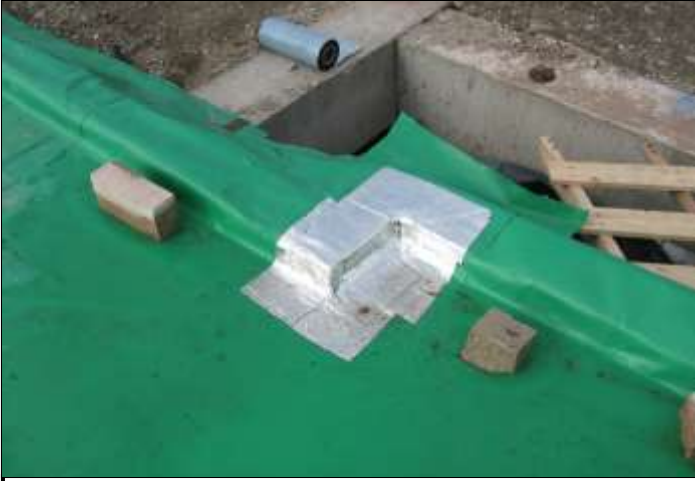
No.	Description
1	Corner detail
2	Corner detail
3	Service entries
4	Puncture repairs
5	Damage post screed
6	Liquid seal repair
7	Liquid seal repair
8

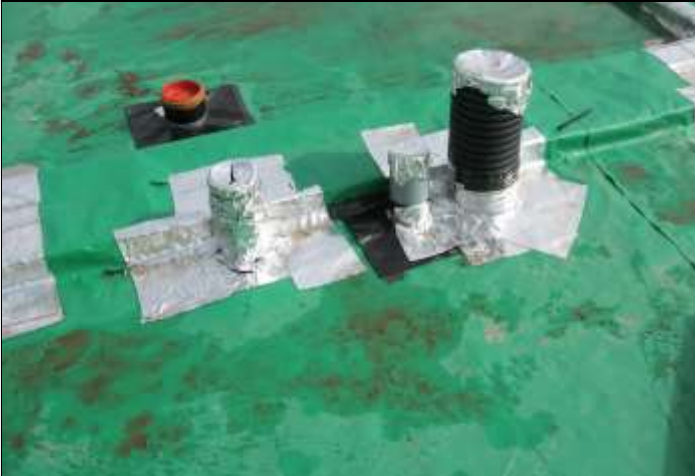
3

The gas protection measures inspected: A - are acceptable and comply with the specification; B - Are Acceptable but attention is drawn to issues related to item no. XX; C - Are not acceptable due to the issues related to item no. XX. **B - Sealing of service entry ducts to be completed.**

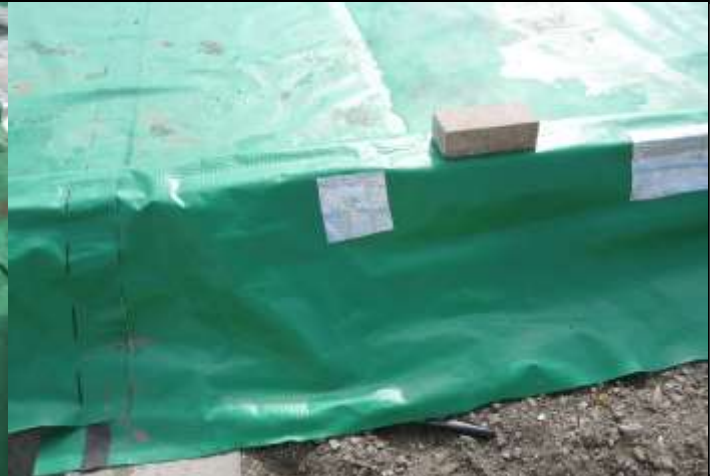
4

No.	Item	Comments
1. Membrane		
1.1	Condition of sub-grade and underside of gas membrane	Insulation boards - Very good condition
1.2	Gas membrane type	Solco Ultra Gas Barrier - green
1.3	Gas membrane condition	Good - some punctures noted and repaired
1.4	Joining tape product	50mm double sided butyl tape
1.5	Lapping design	150mm lap. Lap tape to be installed post verification
1.6	Laps, welds, and joints seals	Taped. All air lanced to ASTM D4437. Passed
1.7	Service entries seals	XL Jointing tape & top-hat covers used. 2No. Fish mouths noted and repaired
2. Ventilation		
2.1	Sub-floor void	Seen previously - Clear 150mm void minimum

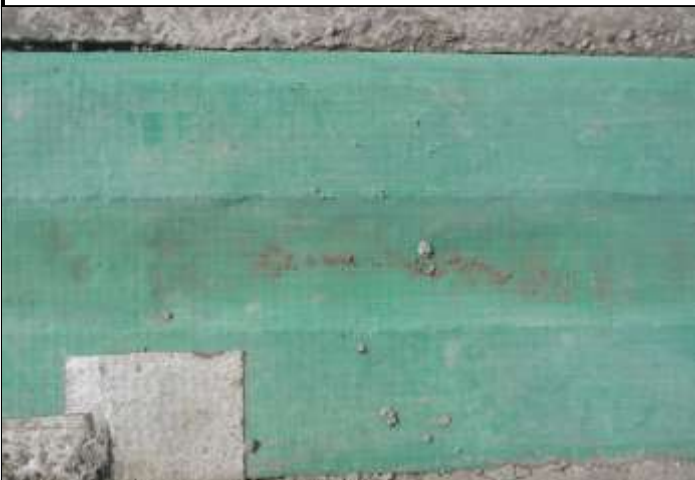
5

2.2	External wall airbricks	14 periscopes installed
2.3	Internal sleeper walls/Beams	Seen previously - Clear 150mm void minimum
2.4	External vents trenches/ducts	NA
<p>Additional Notes: 10/5/19 - minor damaged occurred to membrane perimeter from screeding process. Asked for membrane to be cleaned off to inspect damage fully. 29/5/19 - marked out all damage with crayon for repair. 25/6/19 - inspected repair to damaged perimeter membrane. However damage still noted along party wall. 26/06/19 - Inspected repair to damaged membrane. Membrane either replaced or damage repaired with Solseal liquid gas barrier to manufacture recommendations or XL jointing tape.</p>

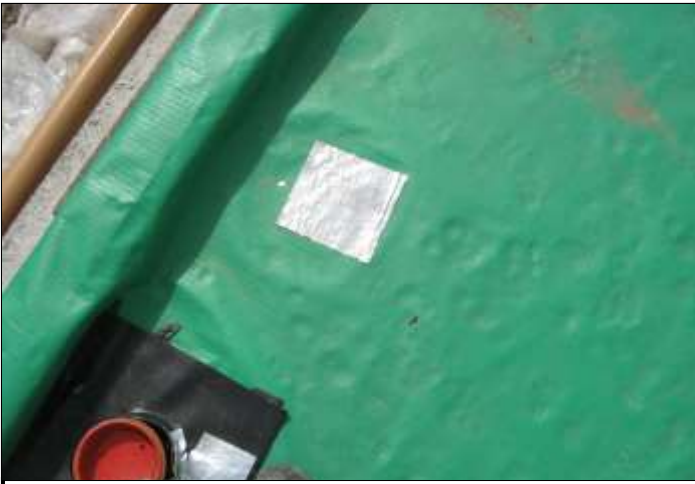
No.	Description
1	Installer repair
2	Gap in joint, later sealed
3	Service entries
4	Corner details
5	Perimeter repair
6	Party wall repair
7	Perimeter repair
8	Perimeter repair

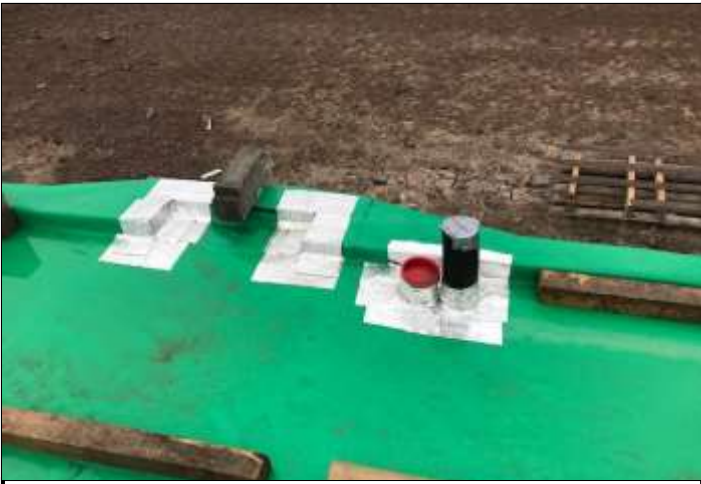
Photographs	
No.	Description
1	Service entries and corner details
2	Corner details
3	Reinforcement placement
4	Reinforcement steel damage
5	Reinforcement steel damage repair
6	Perimeter damage
7	Perimeter repair
8	Perimeter repair

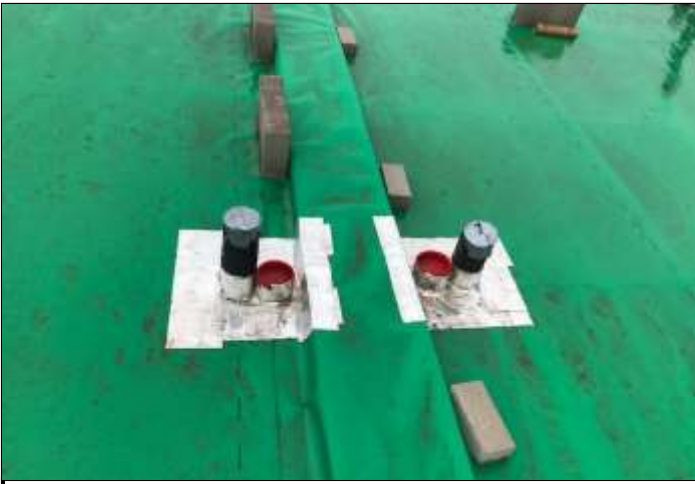
No.	Description
1	Service entries
2	Corner details
3	Perimeter damage
4	Perimeter damage
5	Perimeter repair
6	Perimeter repair
7	Perimeter repair
8

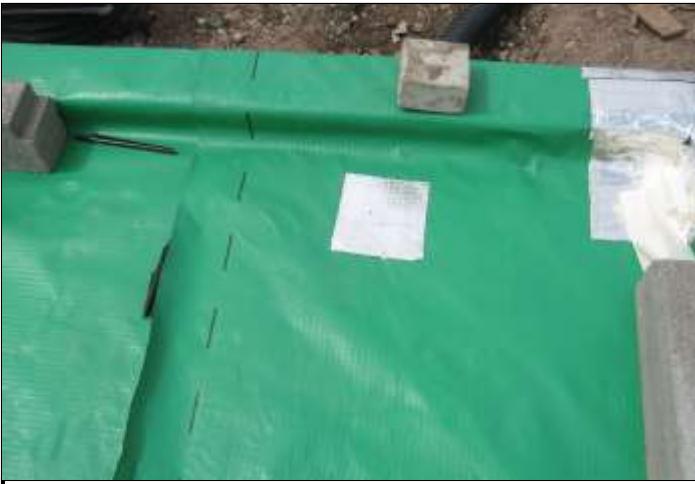
Photographs	
No.	Description
1	Installer repair
2	Service entries
3	Corner details
4	Reinforcement placement
5	Reinforcement placement
6	Perimeter repair
7	Perimeter repair
8	Perimeter repair

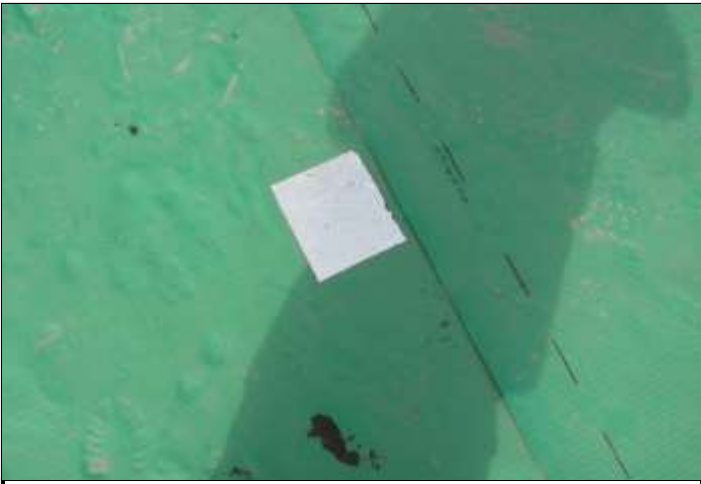
No.	Description
1	Installer repair
2	Overlap repair
3	Service entries
4	Corner details
5	Perimeter repair
6	Perimeter repair
7	Perimeter repair
8

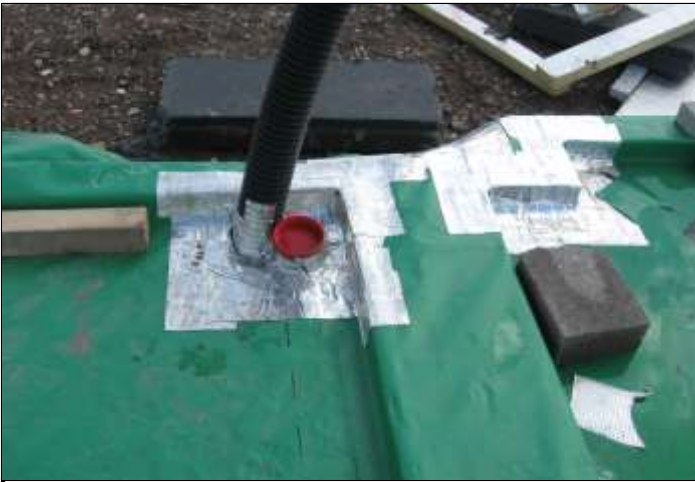
No.	Description
1	Service entries and corner details
2	Service entries and corner details
3	Corner details repaired pocket
4	Corner details repaired pocket
5	Reinforcement placement
6	Perimeter repair
7	Perimeter repair
8	Perimeter repair

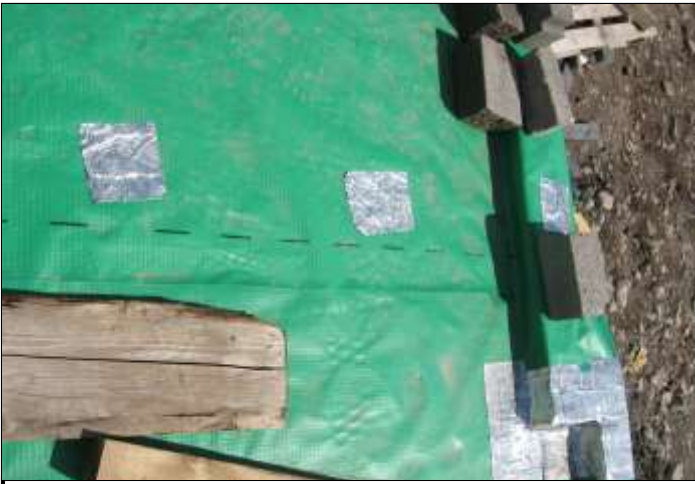
Photographs	
No.	Description
1	Installer repairs
2	Service entries
3	Corner details
4	Reinforcement damage
5	Reinforcement damage repair
6	Reinforcement damage repair
7	Perimeter repair
8	Perimeter repair

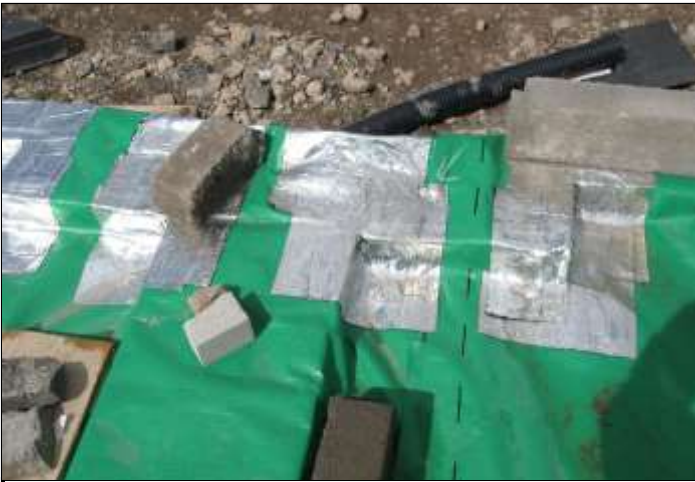
No.	Description
1	Corner details
2	Service entries
3	Corner details
4	Repaired joint on service entry
5	Perimeter repair
6	Perimeter repair
7	Perimeter repair
8

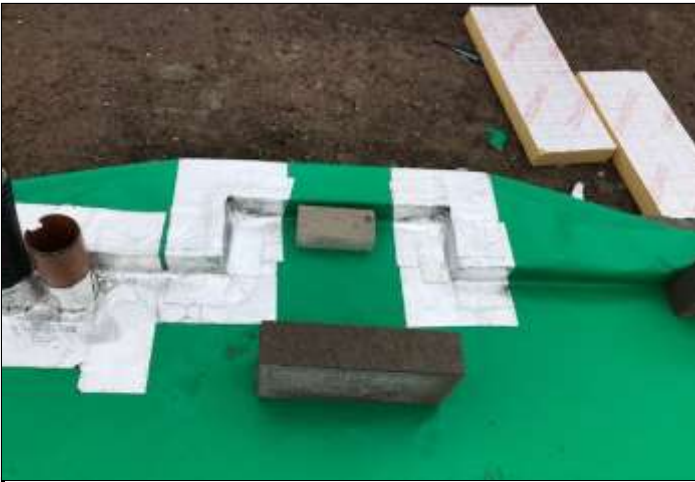
Photographs	
No.	Description
1	Service entries and corner details
2	Corner details
3	Service entries
4	Reinforcement steel damage repair
5	Reinforcement steel damage repair
6	Perimeter repair
7	Perimeter repair
8	Perimeter repair

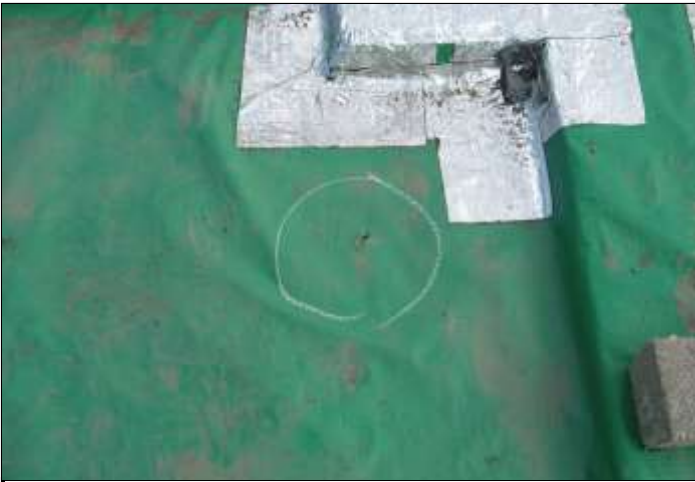
No.	Description
1	Corner details, hole in membrane
2	Service entries, missing clip
3	Joint not sealed
4	Service entries
5	Repairs using patched
6	Perimeter repair
7	Perimeter repair
8	Perimeter repair

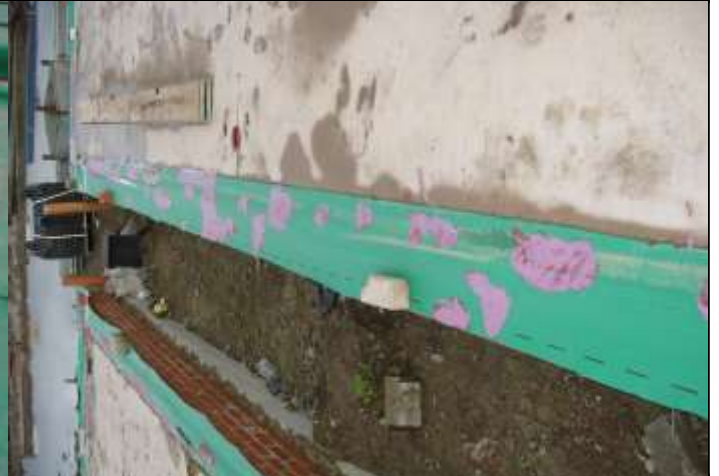
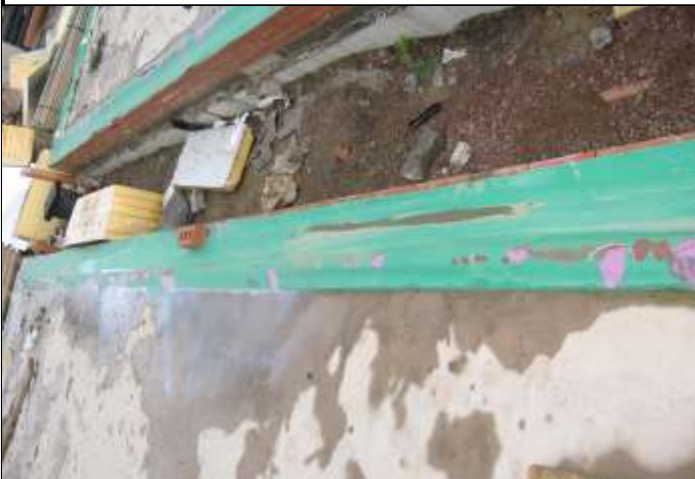
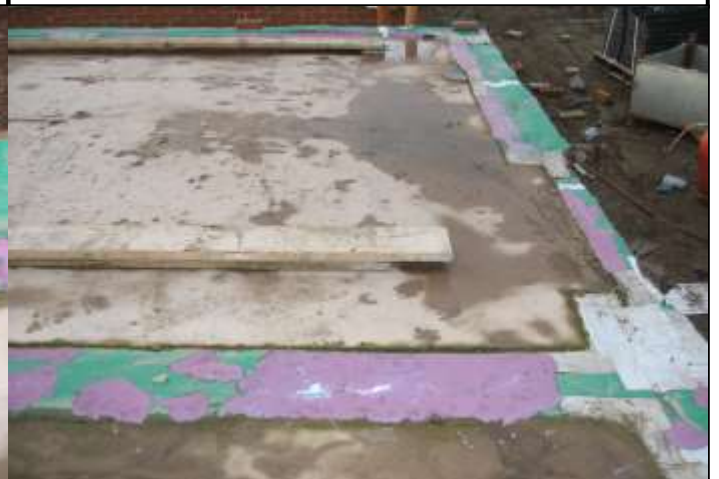
2.2	External wall airbricks	14No. periscopes installed
2.3	Internal sleeper walls/Beams	Seen previously - Clear 150mm void minimum
2.4	External vents trenches/ducts	NA
Additional Notes: 20/11/19 - Inspection of perimeter damage repairs, all repaired using Liquid membrane or XL jointing tape.

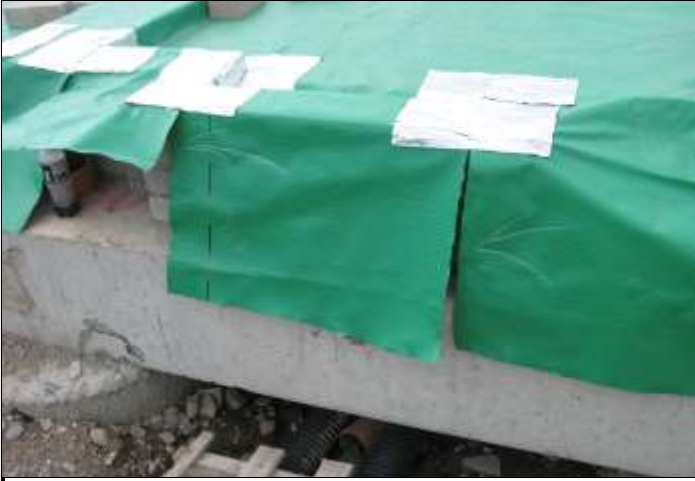
No.	Description
1	Perimeter joints not sealed
2	Holes in membrane
3	Holes on perimeter edge
4	Holes repaired
5	Joints repaired
6	Service entries and corner detail
7	Perimeter repair
8	Perimeter repair

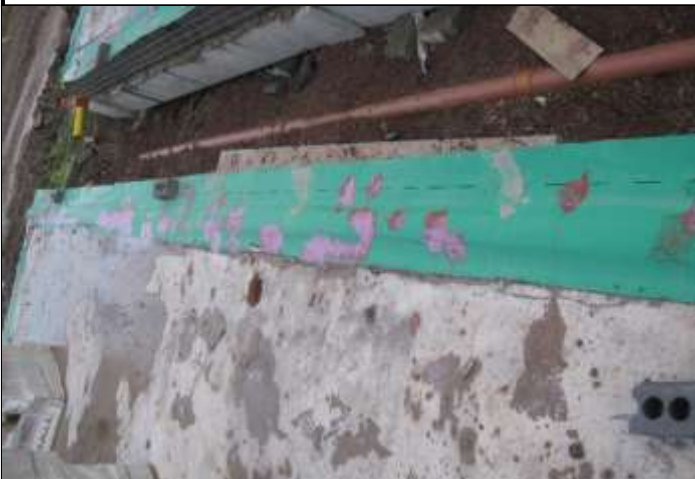
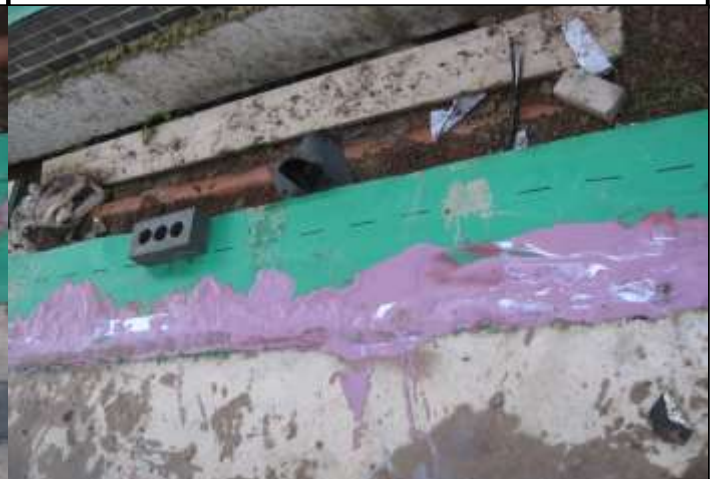
Additional Notes: 25/7/19 - minor damage noted around perimeter post screed. 20/11/19 - Inspection of perimeter damage repairs, all repaired using Liquid membrane or XL jointing tape.
