# HERITAGE STATEMENT

## **Samson Court Farm** **Goldcliff, Newport NP18 2PH**

**HFWJ/5997**

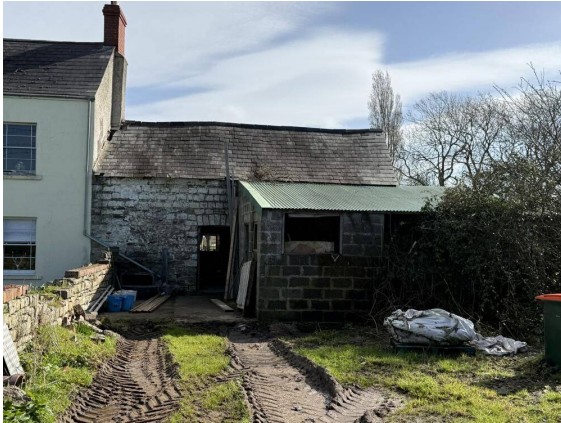
**Plate 1.** Stone outbuilding (Element 3) viewed from the north, showing the slate front (west) slope. The C20 concrete-block shed (Element 4, corrugated metal roof, to be demolished) abuts on the right with the principal farmhouse beyond.

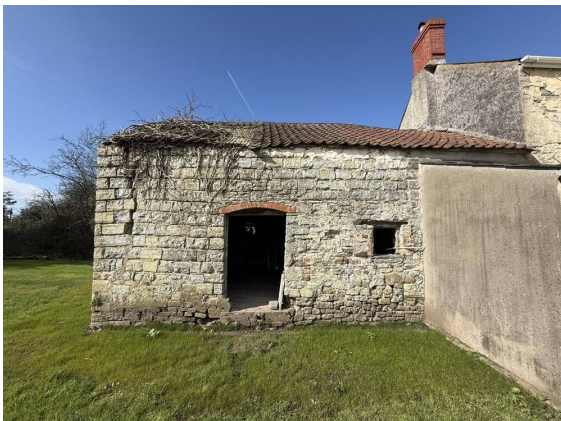
**Plate 3.** Rear (east) elevation of the stone outbuilding (Element 3), showing the original low arched stock doorway with brick voussoir arch. This position is to form the new bi-fold door opening serving the ancillary accommodation (see paragraph 7.4). The corresponding arched doorway on the west (principal) frontage is to be retained in situ with a recessed infill behind the voussoirs.

**7.4.1** The east (rear) elevation faces inwards into the rear yard and is screened from public view by the existing rear modern extension (Element 5). The rear elevation has its own original low arched stock doorway with brick voussoir arch — see Plate 3 in the appendix. The position of this rear arched doorway is to form the new bi-fold door opening (per drawing 5997/007) in powder-coated aluminium joinery, providing primary access from the rear and a strong relationship between the new accommodation and the rear yard. The existing brick voussoir arch is to be carefully dismantled and recorded prior to works (see paragraph 10.3), with salvaged brickwork and stone reincorporated in the new opening detail where practicable. This intervention is not visible from any public viewpoint.

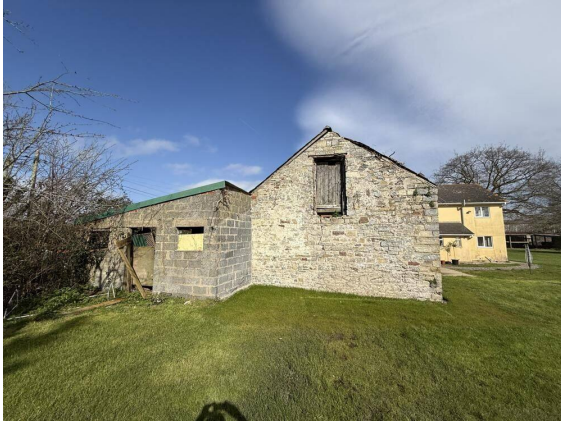
**Plate 5.** North gable of the stone outbuilding, showing the timber loading opening with the remains of a timber lintel — diagnostic evidence of the original byre or stable function with hayloft.
