**Former Zanzibar nightclub****Proposed Methodology of works****Original – 11.09.2024****Revision 1 – 25.03.2025****Revision 2 – 16.09.2025****Revision 3 – 23.09.2025****Cleaning**

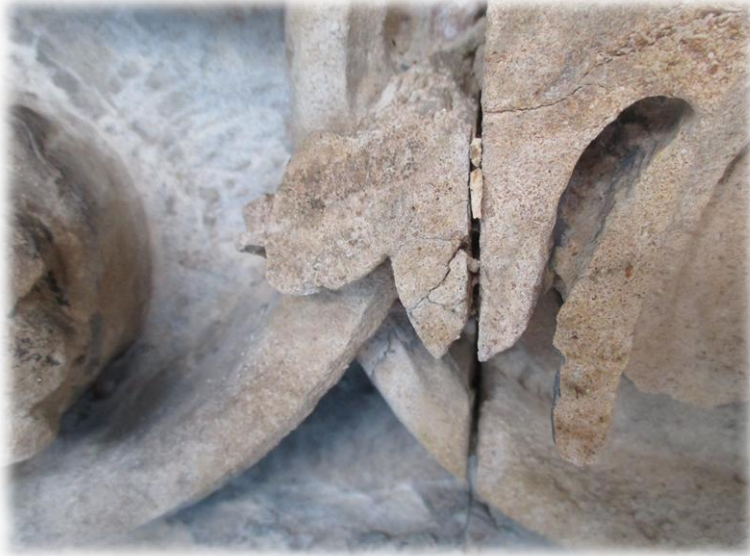
Dawson Stone Masonry (DSM) will **only** remove loose and defective sand/cement joints to the whole façade in question. Joints are to be carefully raked out to a depth of twice the width of the joint, but in no case less than 15mm, without damaging the arises of the adjoining masonry. Use suitable jointing, plugging and toothed masonry chisels. Hacksaw, blades and bent spikes may also be used. Hacking hammers, cold chisels are not to be used. Remove dust and any remaining loose debris with a stiff bristle brush and thoroughly flush out with clean water. Avoid unnecessary saturation.

Dampen down the surface of the joints and adjoining stones to adjust suction immediately before mortar is placed. Mortar is to be pressed home hard into prepared joint ensuring cavity is completely filled and to prevent rapid drying out we would use sacking that has been dampened or tarpaulins in extreme conditions hot or cold.

Replacement mortar is to be built up in a ratio 3:1:1 sand lime (N.H.L 3.5) and stone dust from a matching stone material. By
