**Zanzibar, Newport**

**Retained Façade Condition Survey**

**March 2025**

| <b>Document Title</b> | 2479-PHG-RP-S-0001_ Retained Façade Condition Survey |

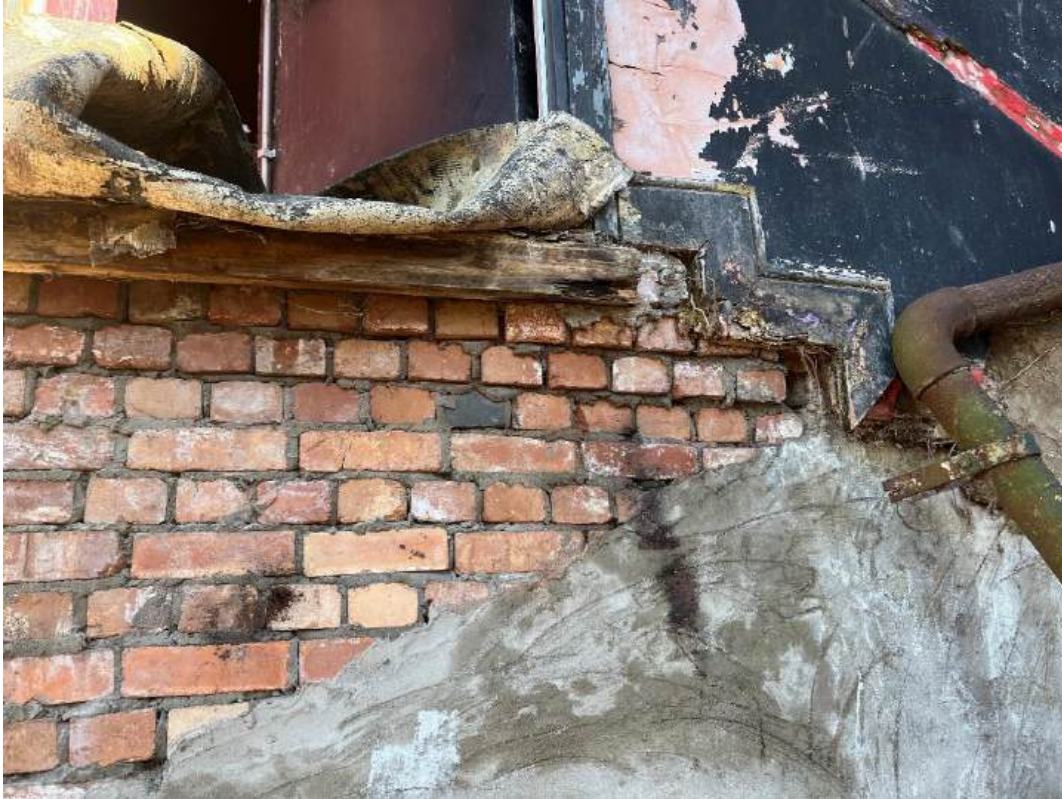
**Photo 11 – Showing timber door threshold and stair profile.**

***Remove all render and electrical conduit. Inspect lintel over door, check condition and replace like for like if necessary. Remove timber cill and remaining stair stringer, then infill door opening and any other voids with fully lime mortared brickwork.***
