Disused Agricultural Building at Penyworld  
Farm, Penhow, Caldicot NP26 3AJ

Structural Inspection Report

QPM-R-S-500

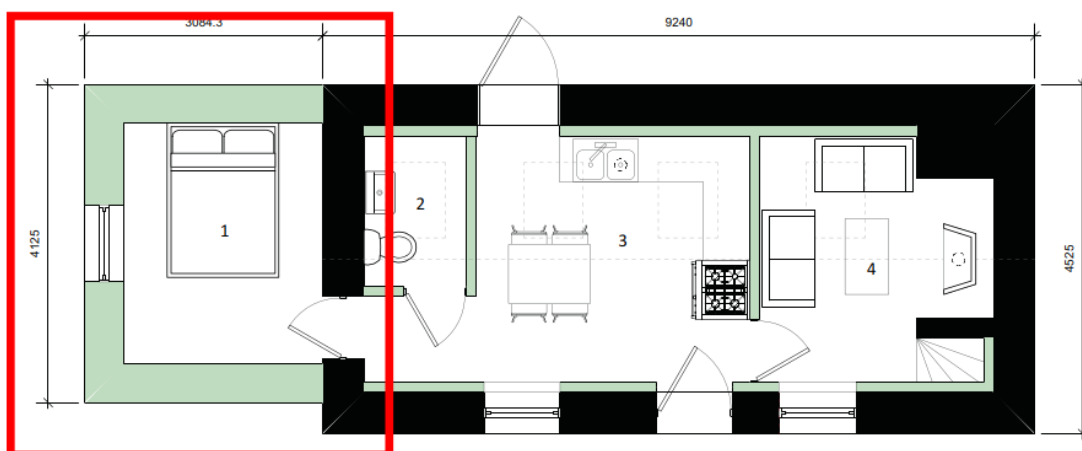
We understand it is the applicants' intention to re-submit a planning application to construct a small side extension to the barn, as highlighted in red on the below plan. There will be no increases in height to the existing building. A small opening will be formed in the rear of the building, as will an opening which gives access to the proposed extension, to facilitate a conversion to residential usage.

Fig1 – Architect drawing – small side extension
