APPLICATION NUMBER: 25/0220

PROPOSAL: 26 AFFORDABLE DWELLINGS, NEW ACCESS WORKS, LANDSCAPE PLANTING, A NEW PUMPING STATION AND ASSOCIATED WORKS

SITE: Land at Traston Lane Newport

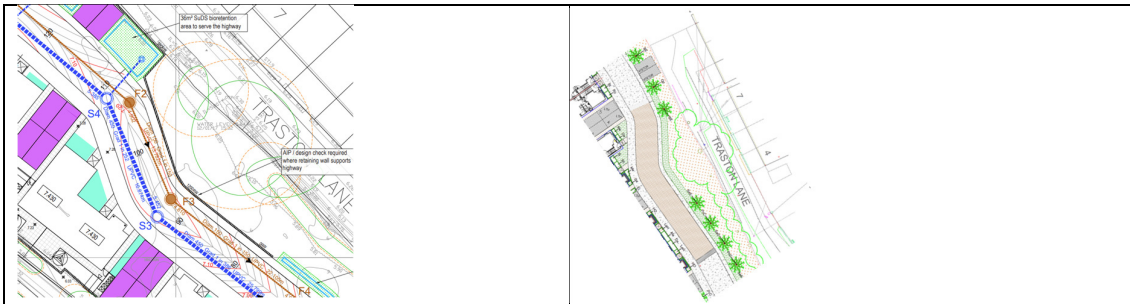
A 1.2m wall is proposed along the access road – section below - but with no planting to soften.

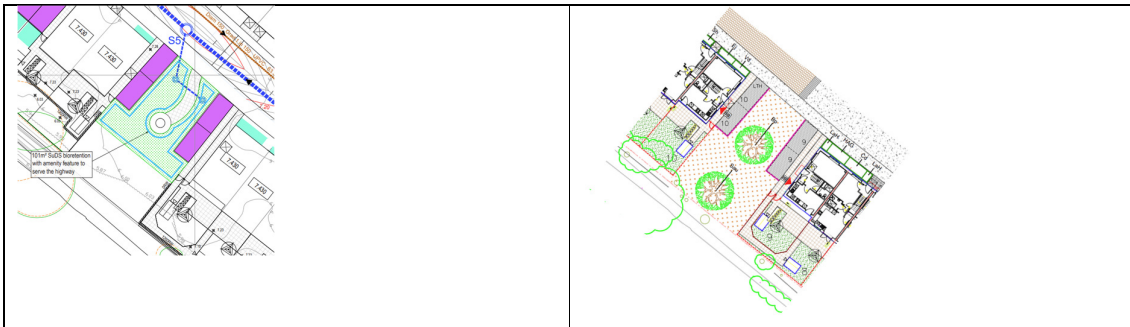
Several plans show public open space with a circular seat – this is not shown on soft landscape plan.

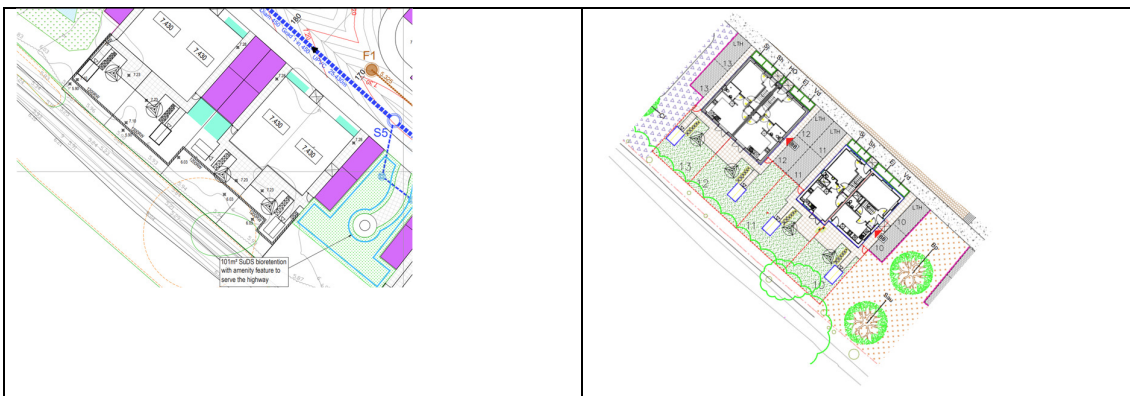
It is not clear how is access is possible to the rear of the rear gardens onto the south-east boundary? Engineering plan shows retaining walls – see below. Retaining walls will result in very small areas of grass to be managed.
