# Felthorpe College Road Caerleon

## Heritage Impact Statement

November 2025

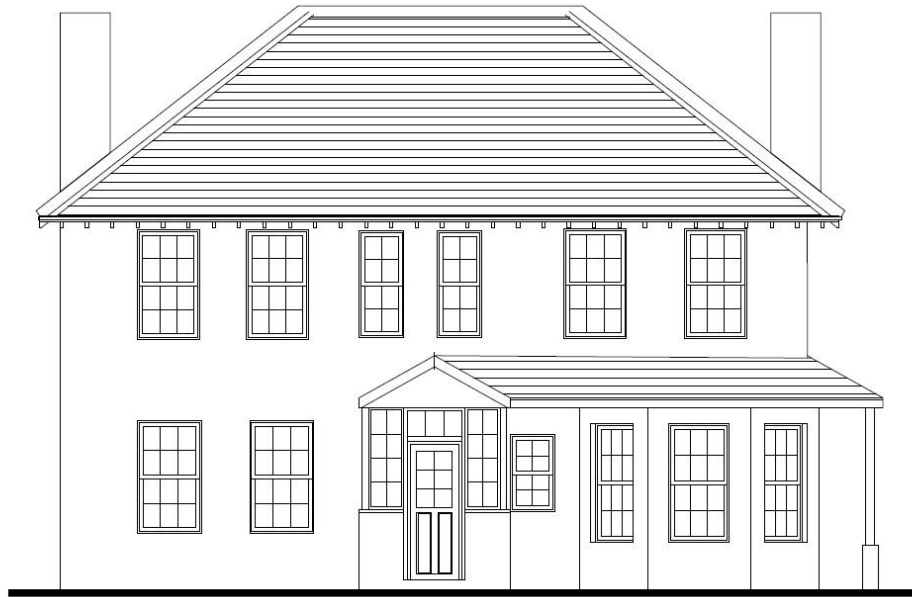
*Figure 7. Entrance front, as existing.*

The front is asymmetrical (fig 7, 8). The central entrance is within an added gabled porch, which is half-glazed in its front wall and has a half-glazed door. The porch is an addition, coarser construction and wider joints than the main house, suggesting a post-war date. On the right hand side is a canted bay window in the lower storey, beneath a lean-to veranda on a wooden post. The veranda originally extended over the entrance to the house and was

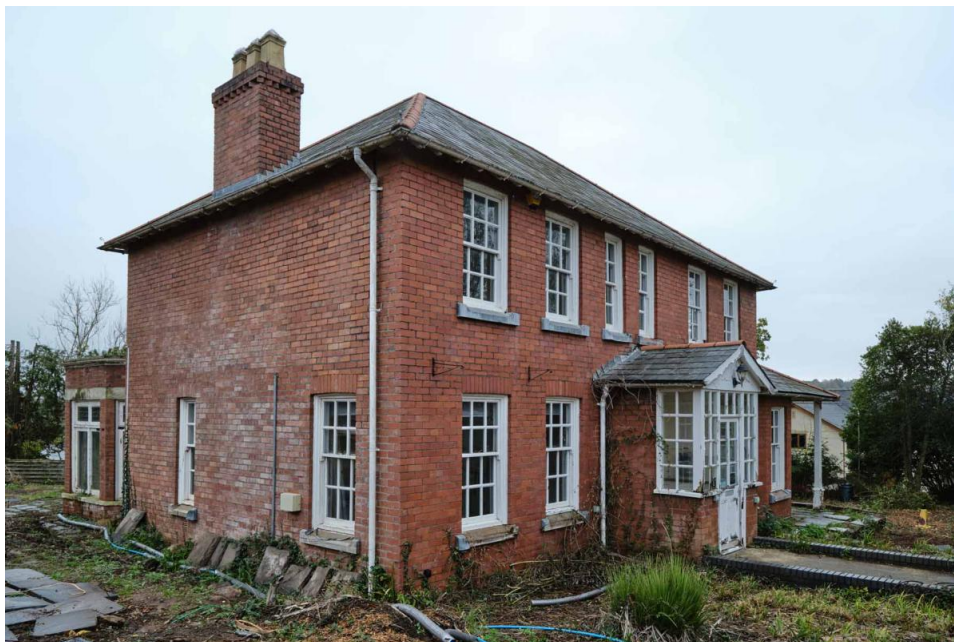
*Figure 8. The entrance front and left-hand side wall.*

In the left hand (NW) side wall are two small-pane sash windows in the lower storey (fig 8).

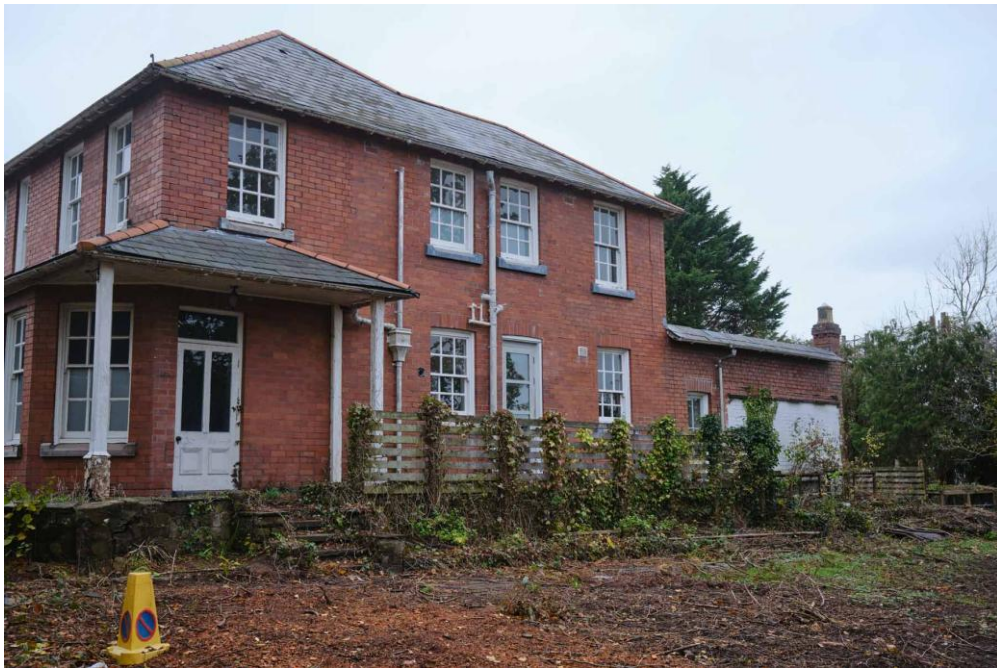
*Figure 9. Right-hand (SE) side wall.*

The veranda is wrapped around the angle of the building and continues on the right-hand (SE) side wall, where it shelters a half-glazed panel door under an overlight (fig 9). This four-window side wall also includes the kitchen on the right-hand side (the rear wing), with another half-glazed door. The Ordnance Survey maps mark a lean-to, canopy, or pentice, continuing on this side of the building, but no trace of it is now visible. There is a single original cast-iron rainwater head, to the right of the veranda.

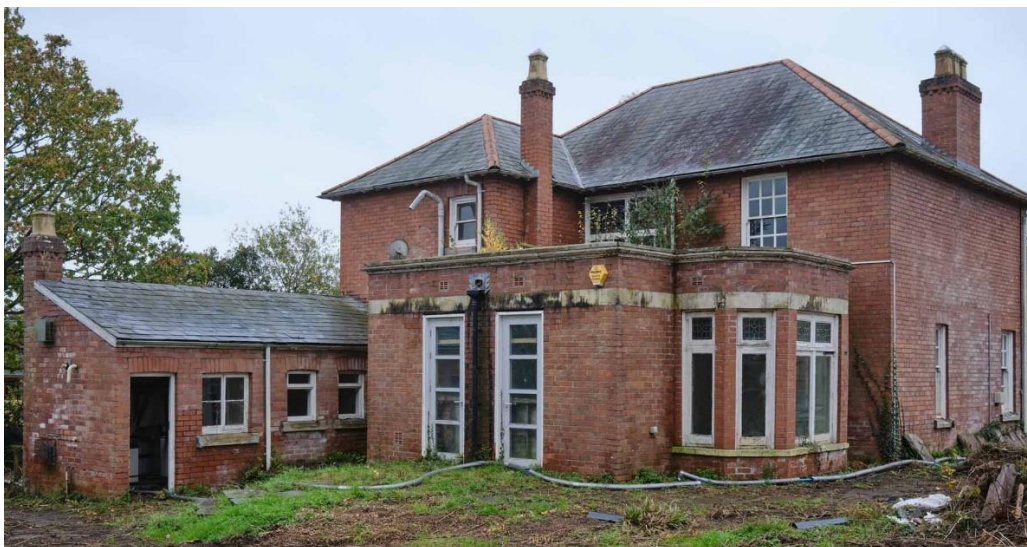
*Figure 10. The rear of the building.*

At the back of the house are two single-storey additions (fig 10). A single-storey flat-roofed garden room is on the right-hand side (NE), first shown on the 1920 Ordnance Survey map (fig 11). It is brick with stone banding, and its roof is concealed behind a coped parapet. It has two doorways facing the rear, both unsympathetic replacements, and canted bay window in the side wall. This window has tracery lights with coloured glass. A single-storey service range on the left-hand side, under a monopitch roof, is marked first on the 1939 Ordnance Survey map. It has a slate roof, and openings with cambered heads. There is a stack on the SE angle of the building, but no surviving fireplace inside. Part of the rear wall is painted white and there is evidence of a former lean-to greenhouse here.

approach on College Road (fig 32). At present there are three first-floor windows at the back of the main range (fig 10). One of these is a small-pane sash window which could be salvaged for re-use in the extension, perhaps in one of the side walls. The rear extension will be most visible from the north-west side of the house, on College Road. However, from this viewpoint the new houses are the dominant visual feature, and the extension would be hidden if there was any further development on the south-east side of the new houses, where there is a customer car park. From the opposite direction the boundary vegetation inhibits views of the back of the house.

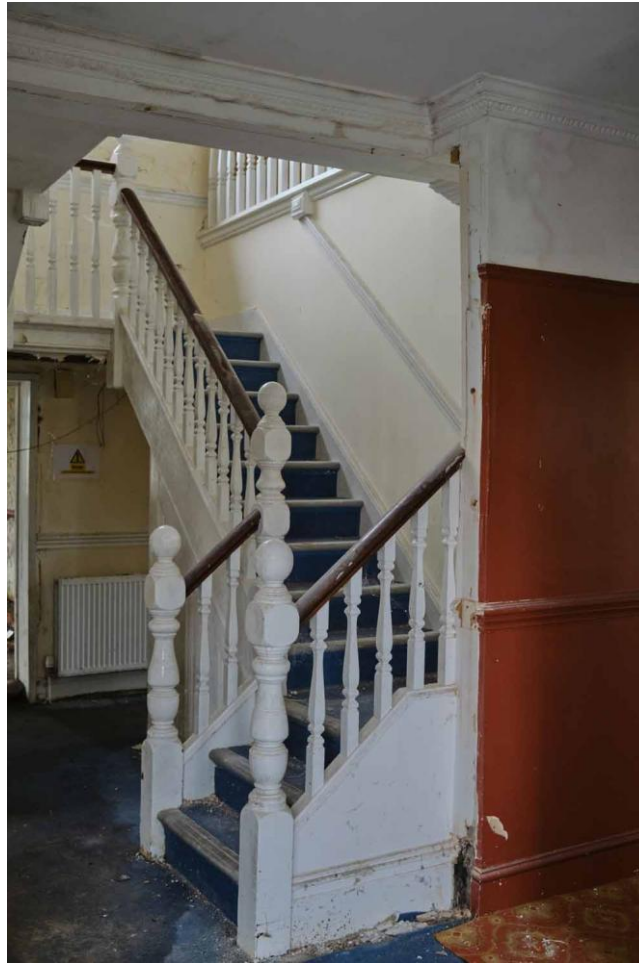
*Figure 13. Stairway.*

Inside the building, the ground floor has a central entrance/stair hall, with the rooms leading off it (fig 12). The open-well staircase has shaped balusters and newels, which are also used as the banister on the landing (fig 13). Original doors have been replaced by fire doors,

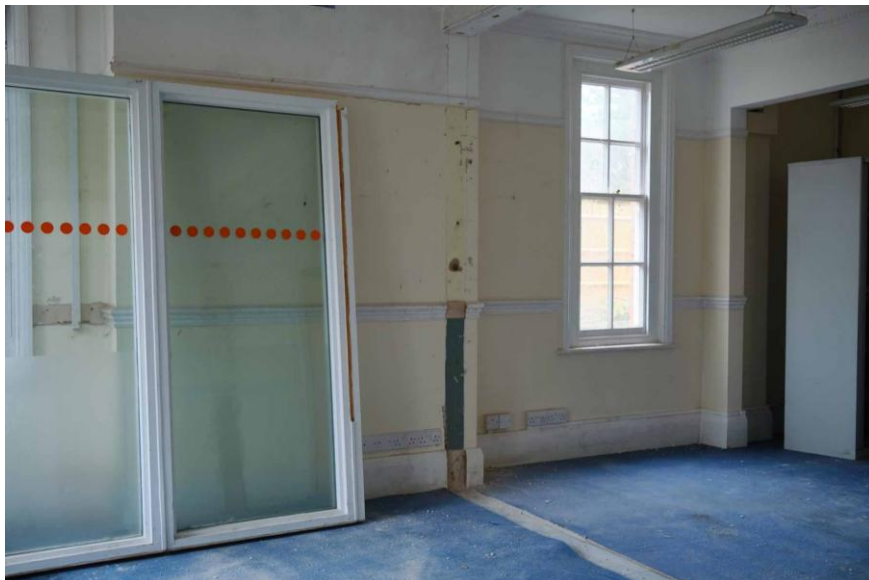
*Figure 14. Interior showing position of a former fireplace.*

presumably c2010 when the building was used as offices. There are no original fireplace surrounds, and original fireplaces have been blocked and plastered over (fig 14). In the main ground floor rooms and the stair hall the ceilings have egg-and-dart cornices, although sections have been cut away in places (fig 15). As mentioned above, there is coloured and frosted glass in the stair window at the back of the house, and in the upper lights of the bay window in the garden room (fig 16). In the garden room the ceiling has collapsed, leaving exposed steel beams supporting the flat roof (fig 17).

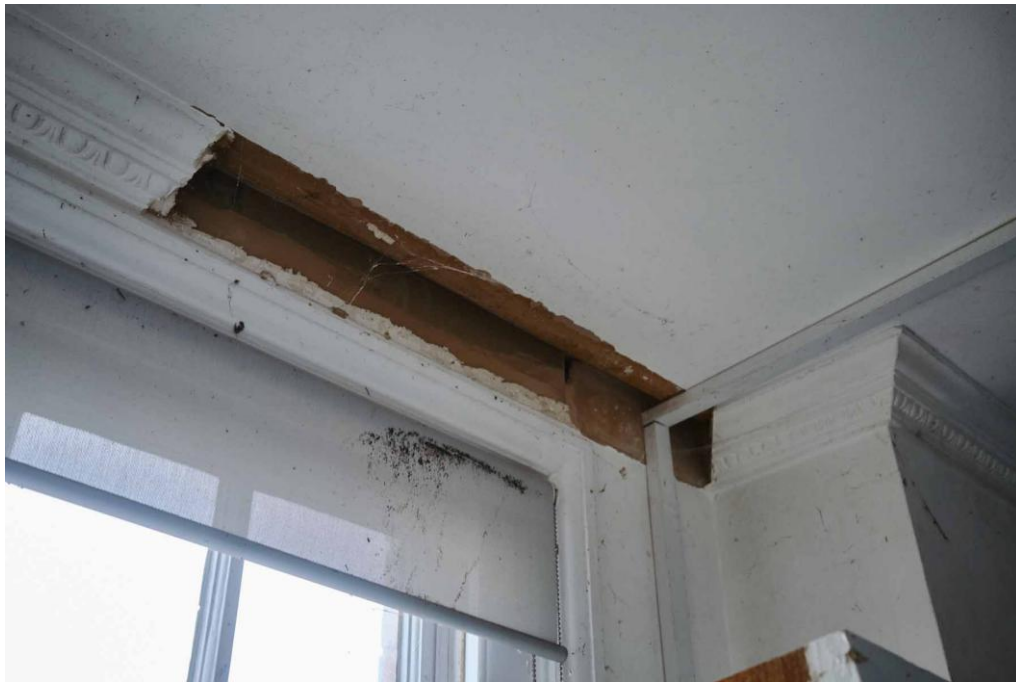
*Figure 15. Example of damaged egg-and-dart cornice.*

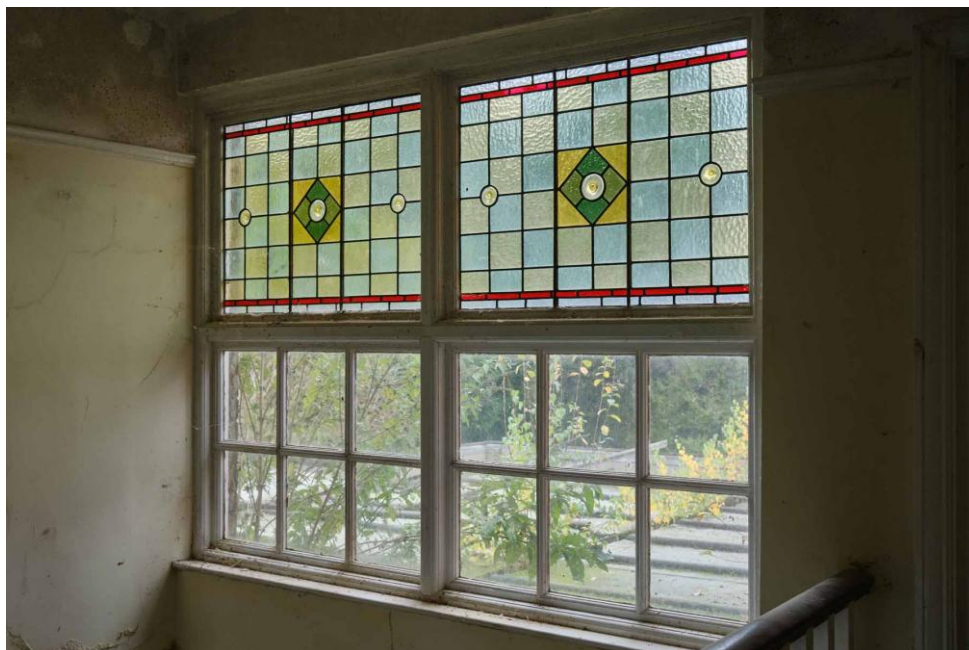
*Figure 16. Stair window.*

Above these rear extensions are the first-floor windows in the rear of the main house, including a large stair window which incorporates coloured glass in its upper lights.

The interior of the house has little of historic or architectural interest, and interior changes will not have an impact on the nearby listed buildings. Alterations to the staircase would require removal of some of the existing stair window. With its coloured glass it is one of the few features of interest inside the building so its partial loss would be disappointing. Consideration could be given to salvaging the window in its entirety to make a glazed screen elsewhere in the house.

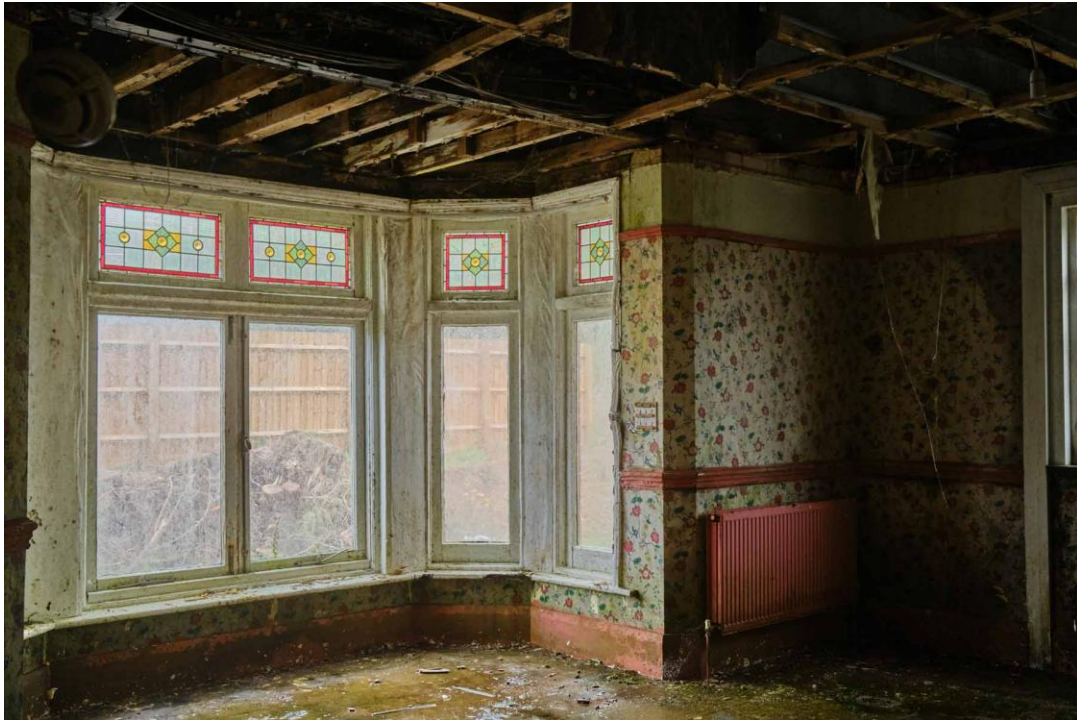
*Figure 17. Garden room.*

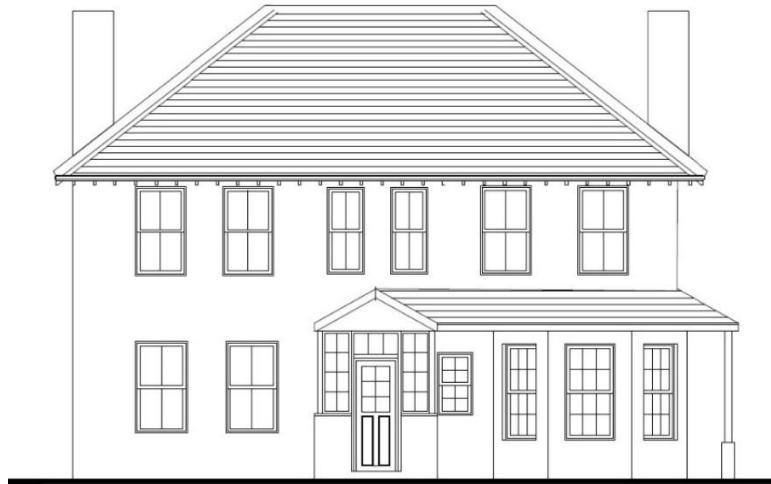
*Figure 18. Proposed entrance (SW) front.*

Early design ideas for the front considered removing the veranda and the gable over the porch, but this was considered detrimental to the setting of the listed gate piers. In the current design no significant changes are proposed to the front of the house, although some of the window frames are in need of repair (fig 18). The other fronts are impacted, to varying degrees, by the proposed addition of a two-storey rear wing under a hipped roof, giving the house a double-pile roof (figs 19, 20). The hipped roof is the preferred form because it will match the roof over the main range. It should also be noted that hipped roofs are used in the listed college buildings, and in the new houses built on the former sports ground.

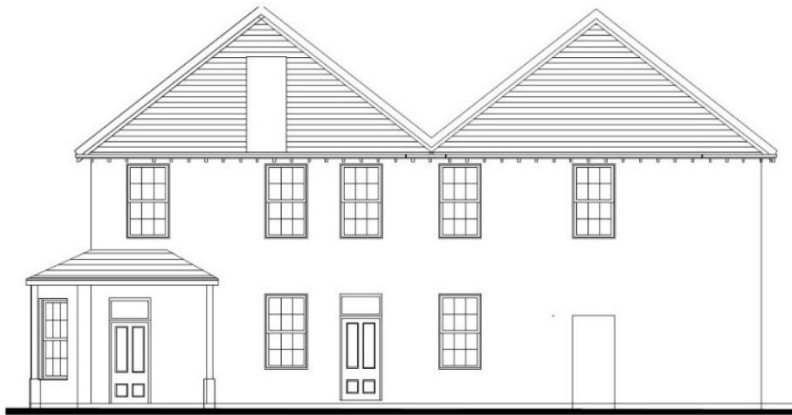
*Figure 19. Proposed SE front.*

The new build, to be as wide as the main range, would be of red brick and would involve replacing the lower hipped roof of the rear wing. In the south-east front an additional window would be added at first-floor level, but otherwise the openings would remain the same (fig 19). In the left-hand side wall the rear extension would have two windows on the ground floor, similar to the main range (fig 20).

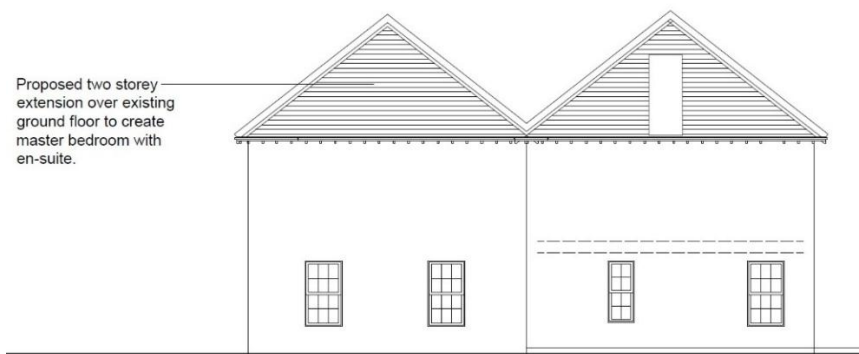
*Figure 20. Proposed NW front.*

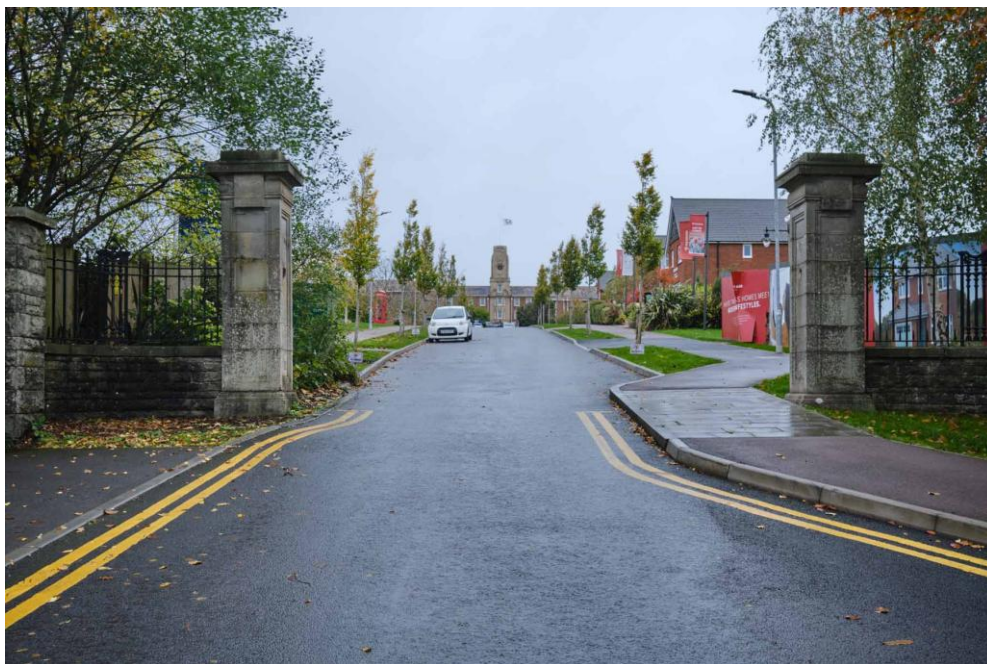
*Figure 27. Gate piers at the entrance to College Road.*

The gate piers stand at the entrance to the grounds on College Road (fig 27). The original gates were replaced in 2011-12, but can be seen on Google Streetview taken in 2008 and 2011 (figs 28, 29). Listed building consent was later granted for removal of the replacement gates (17/0782), leaving only the gate piers and flanking walls. They are listed for group value as 'an integral part of the development of the college'.

Panelled ashlar gate piers with bases and capitals, curved rubble stone wing walls to either side with iron railings and rubble stone end piers. Gates replaced.

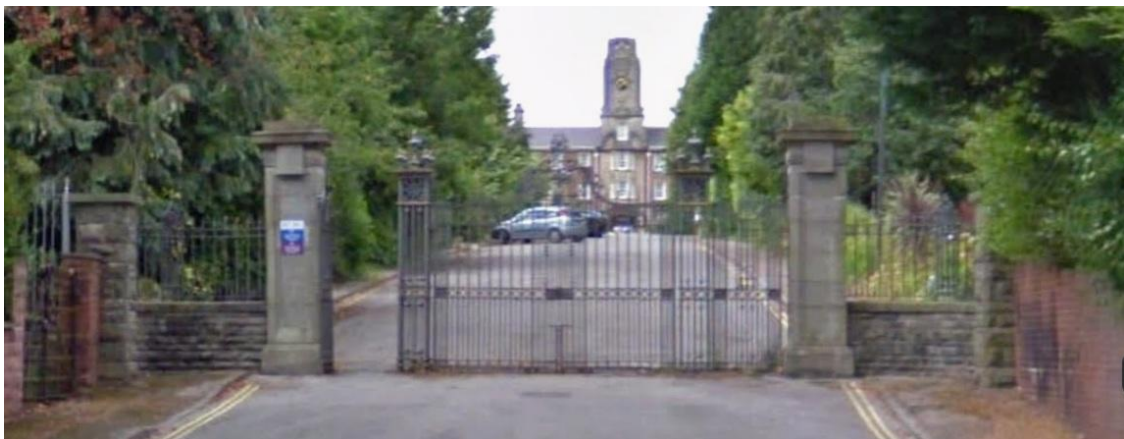
*Figure 28. Original gates photographed in 2008. (Google Streetview).*

From the perspective of 1914, the position of the gates is odd, so far from the college buildings and long before the college grounds were recognisably a campus. The original gates comprised central vehicle gates, flanked by cast iron piers and then pedestrian gates, but the pedestrian gates were not aligned with the pavement, an unconvincing arrangement. In fact the flanking walls block the pavement on the Felthorpe side of the road. Furthermore, the gates are not shown on any of the large-scale Ordnance Survey maps up to 1969, which clearly mark the pavement that is blocked off by the flanking walls (fig 30). It is probable, therefore, that the gates originally stood closer to the main college buildings and were moved next to Felthorpe at a later date, after 1969. The 1920 Ordnance Survey map shows a gate at the entrance to the college forecourt, between the two pavilions, which was still in place on the 1969 map, but it was later removed (figs 5, 31). The appearance of the original gates, providing vehicle and separate pedestrian access, is more suited to a forecourt than a distant position on College Road. In their present location the gate piers provide an entrance point on College Road and frame the approach to the main college buildings on the top of a gently rising hill, but their contribution to the setting of the college buildings appears to be a modern one, and has been diminished by the modern housing on College Road.

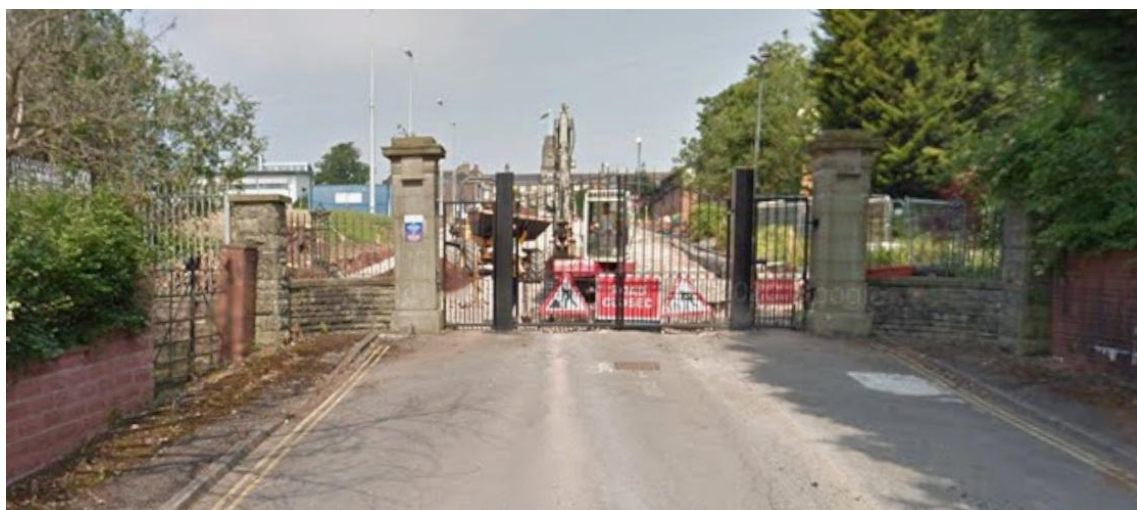
*Figure 29. Replacement gates in 2012. (Google Streetview).*
