| <b>Project:</b> | P17-480 Indurent Park, Newport, Units 15 - 18 |
| <b>Subject:</b> | Units 15-18 - Piling Risk Assessment |
| <b>Report Ref:</b> | 17480-RLL-25-XX-DR-O-1332-P01 |

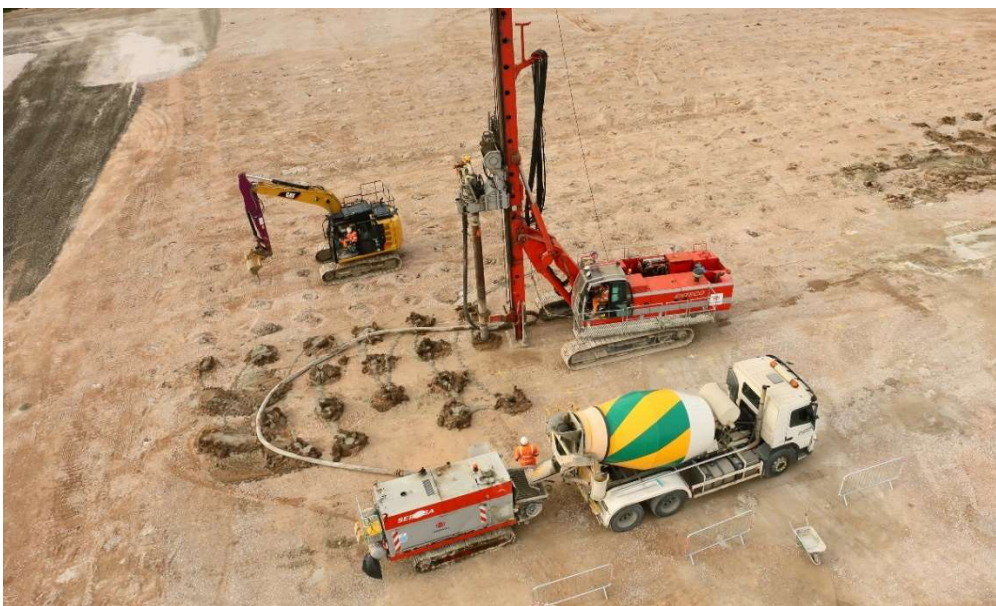
**Figure 4 - CMC setup on site**
