## ST WOOLLOS CATHEDRAL, NEWPORT: PROTECTION TO NORTH GULLY

### HERITAGE IMPACT ASSESSMENT:

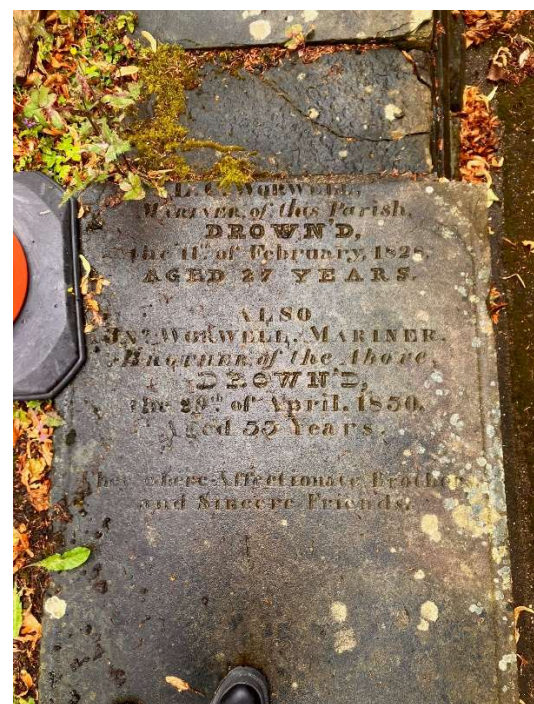
Left: Ledger stone to Elizabeth Bittle, described in relation to her husband, Charles Bittle.

Right: Ledger stone to the Worwell brothers.

Both ledgers can be found on the north side of the North Aisle and would be retained in their existing positions.

- One ledger commemorating two Worwell brothers who were mariners and 'sincere friends'. They were both 'drown'd' at sea in 1828 and 1830. The ledger stone retains its text clearly and tells an interesting local and family story.

- A ledger to Elizebeth Bittle, dated 1724, which has some decorative markings around the outside. The same markings can be seen on plain ledger slabs around other areas of the gully, which may make them of the same date.

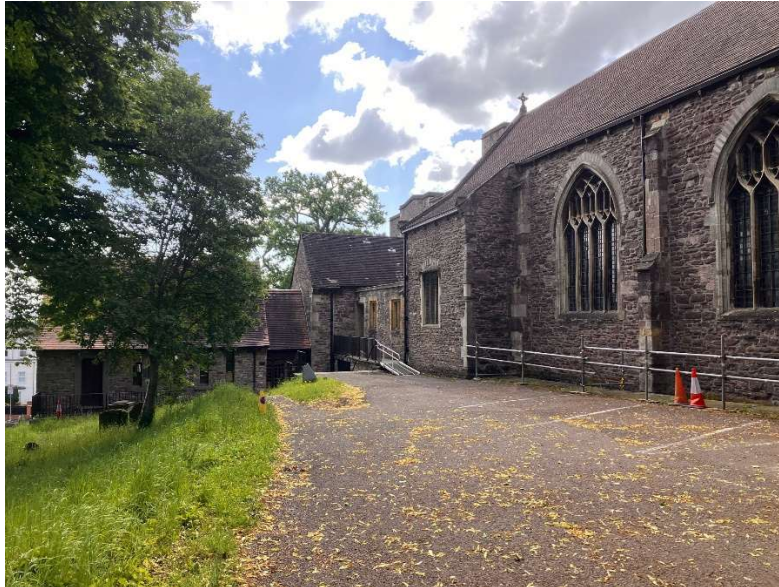
*(right): Tarmac parking area on north side of North Aisle.*

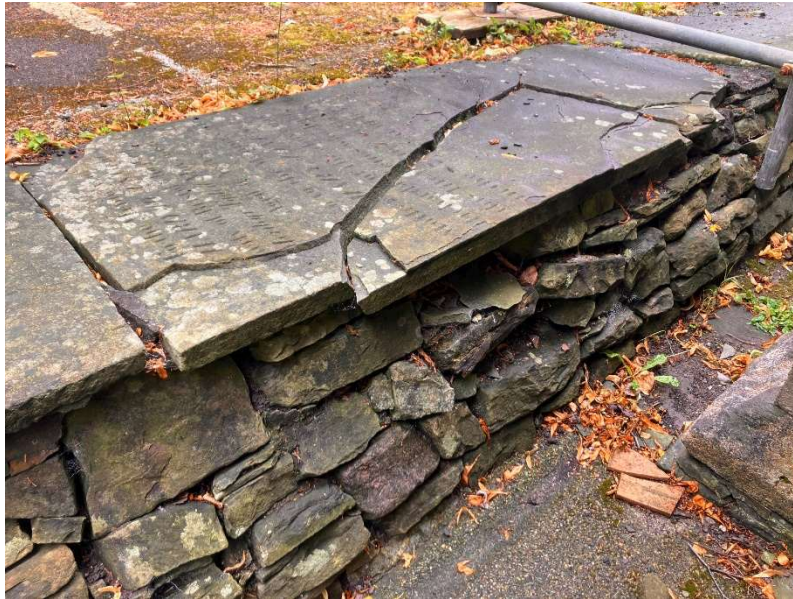
*Condition of ledger stone on north side of North Aisle.*

- 3.6 A detailed survey of the ledgers; their condition and setting out has been conducted and the information is submitted as part of this application. It is therefore proposed to reinstate all ledgers in their current position. Where existing ledgers have split into pieces, they are to be repaired by re-bedding them on a sound slab, as shown in the details. This will avoid loss of historic material.

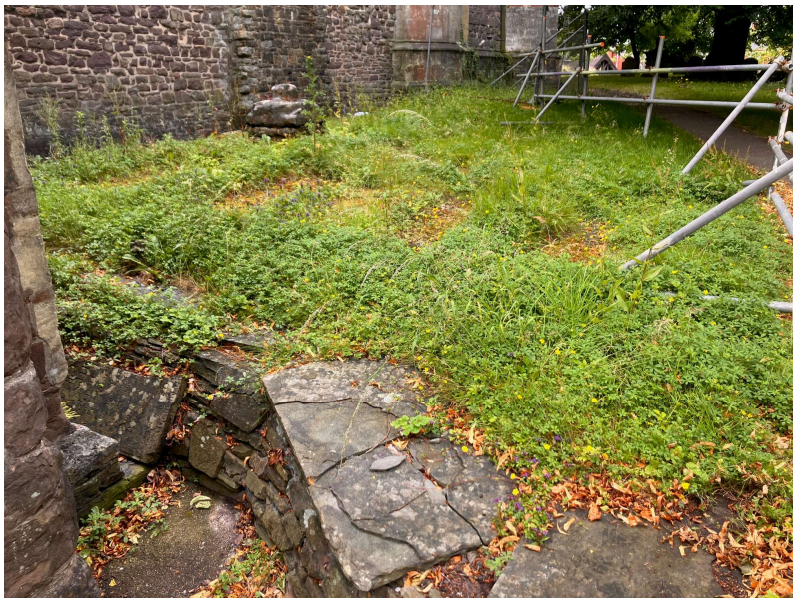
*Grass area in front of the Galilee Chapel, which is to be retained as existing, i.e., with no guarding to the drainage channel and ledgers retained in-situ.*

- 3.7 In front of the Galilee Chapel, the sunken drainage channel is set back from the pedestrian areas by an area of grass that contains burial markers and the remains of a memorial. It is not considered necessary to install guarding around the edge of this channel, as the impact of fall protection in front of the Galilee Chapel and potential below ground archaeology, cannot be justified. As the ledgers and retaining walls are in poor condition, in-situ conservation and repair is proposed in this area, with all works above ground, such as re-pointing in hydraulic lime mortars, as specified.

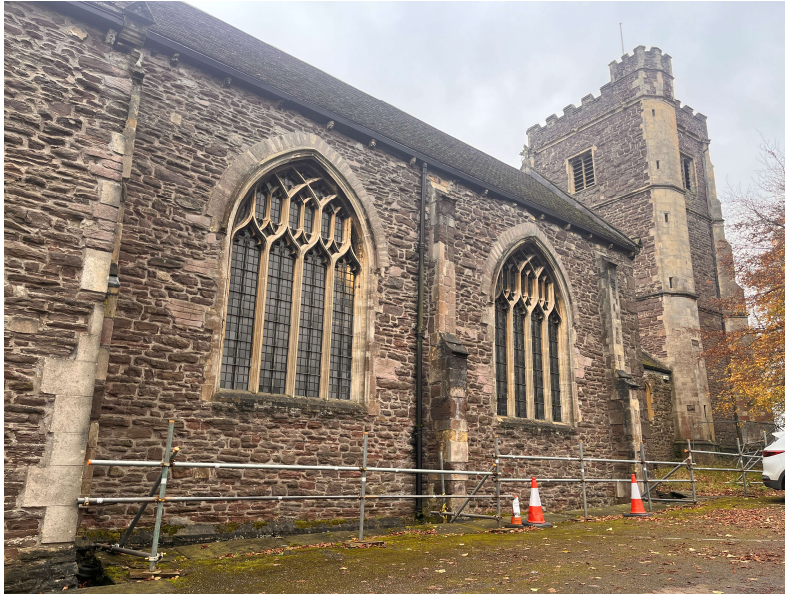
*North side of the North Aisle, looking westward toward the Tower.*

- 3.8 No works are proposed within the drainage channels themselves; the existing concrete lining will be retained.
- 3.9 The new railings and vehicular kerb on the north side of the North Aisle will constitute a visual change to the appearance of the building from the north side.
