# **BRYNGLAS HOUSE: DEMOLITION OF ANNEXE BUILDING**

## HERITAGE IMPACT STATEMENT

Incorporating Design & Access Statement

Newport City Council

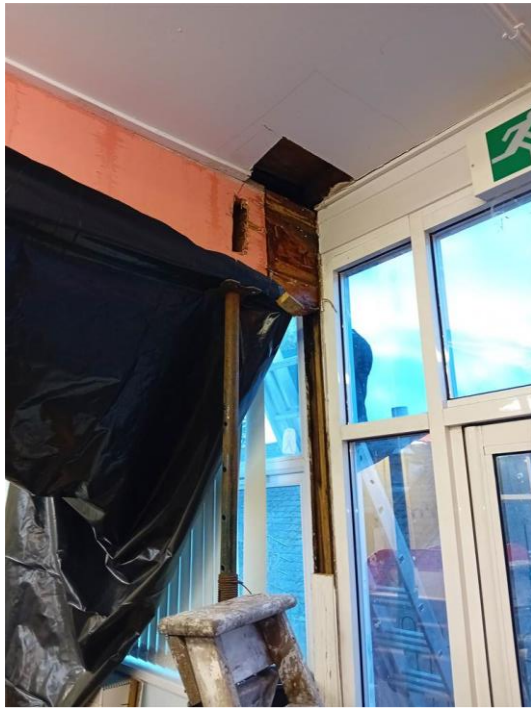
**Above:** 'dropped' beam with tarpaulin to contain water-ingress

Cambria (structural engineers) were engaged in 2024 to carry out a comprehensive assessment of the annexe building following the discovery of a dropped/decayed beam and post connection in one of the classrooms. Subsequent investigations of the rest of the building revealed an inherent design defect with the structure of the building. This had been compounded by later ill-conceived window replacements and prolonged ponding of water on the roof, which have collectively undermined its structural strength.

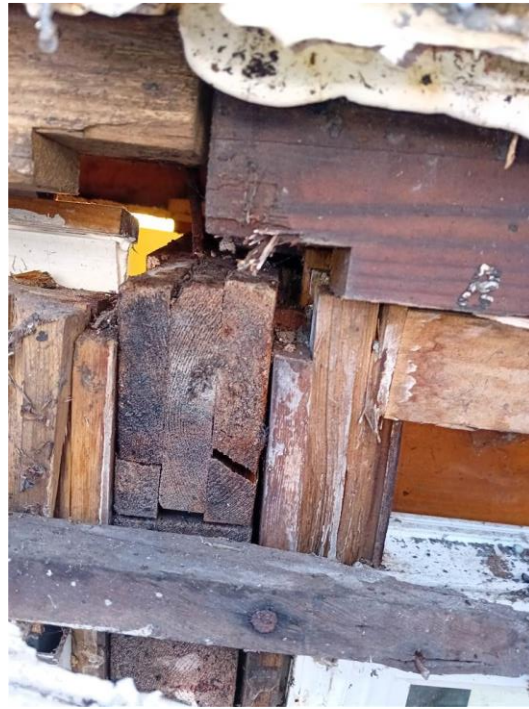
**Above:** external opening-up works of typical beam-post connection, revealing extent of movement

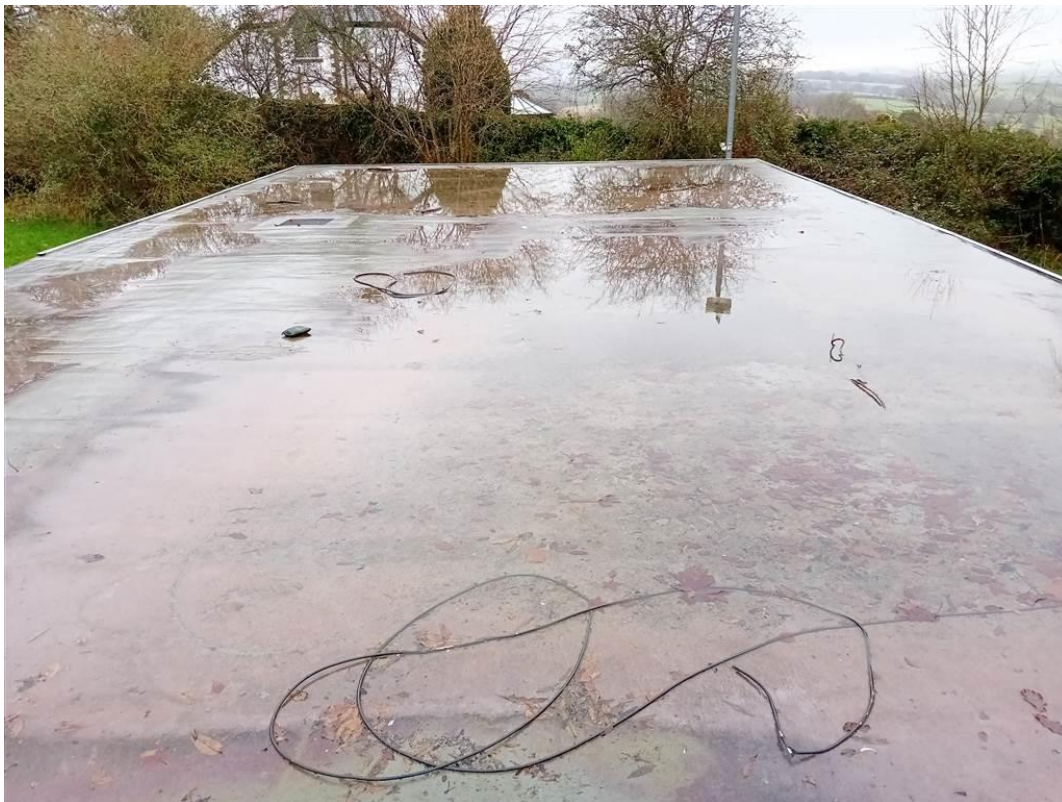
**Left:** Significant ponding on annexe roof (2024)

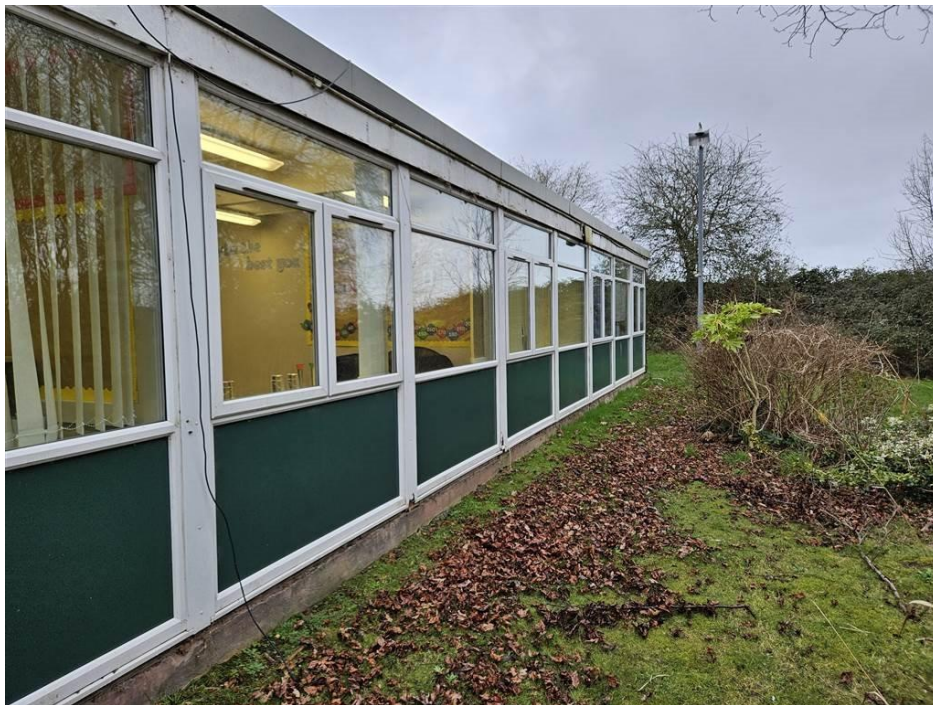
**Left:** typical elevation finish (2024)

The annexe building is of lightweight demountable construction and sits on the site of the original walled kitchen garden. The building's main core was built in the late 1960s as an additional classroom block when the site housed Brynglas Central School. At some stage, a sizeable extension of similar construction – painted joinery and low-level infill panels – has been added to the north elevation. Prior to Millbrook Primary School's relocation to the site, this building was used for day services. The school then utilised it as a teaching space until they vacated in early 2024 because of concerns over its poor structural condition. Like the other curtilage structures, this building does little to enhance or compliment the site.
