# **BRYNGLAS HOUSE: DEMOLITION OF ANNEXE BUILDING**

## HERITAGE IMPACT STATEMENT

Incorporating Design & Access Statement

Issue 01

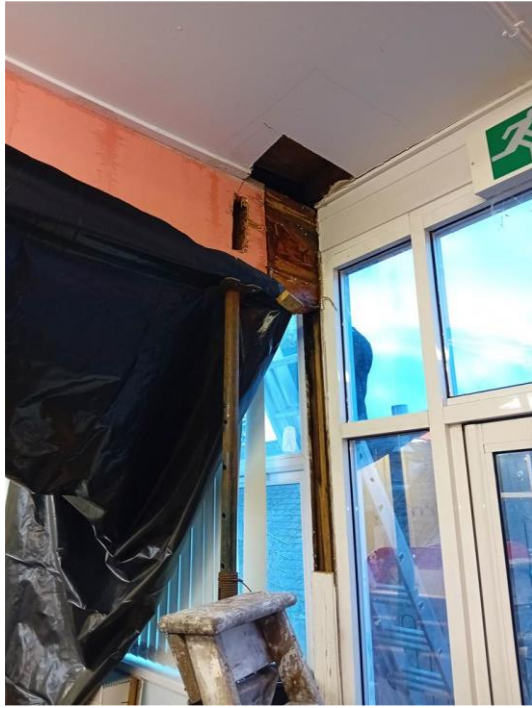
**Above:** 'dropped' beam with tarpaulin to contain water-ingress

Cambria (structural engineers) were engaged in 2024 to carry out a comprehensive assessment of the annexe building following the discovery of a dropped/decayed beam and post connection in one of the classrooms. Subsequent investigations of the rest of the building revealed an inherent design defect with the structure of the building. This had been compounded by later ill-conceived window replacements and prolonged ponding of water on the roof, which have collectively undermined its structural strength.

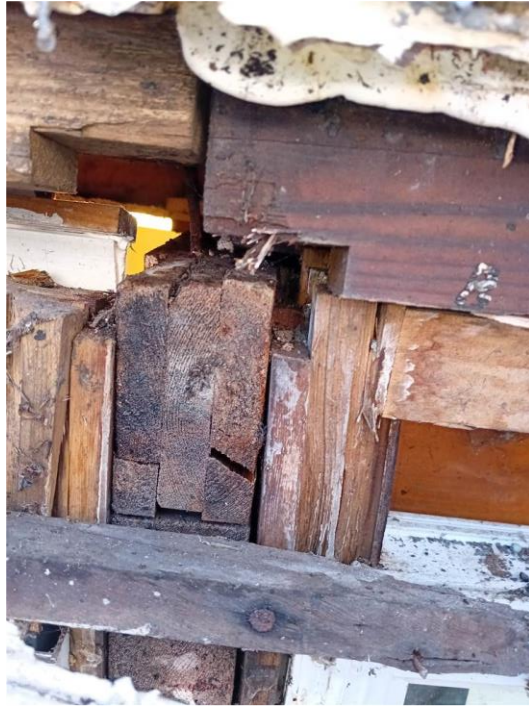
**Above:** external opening-up works of typical beam-post connection, revealing extent of movement

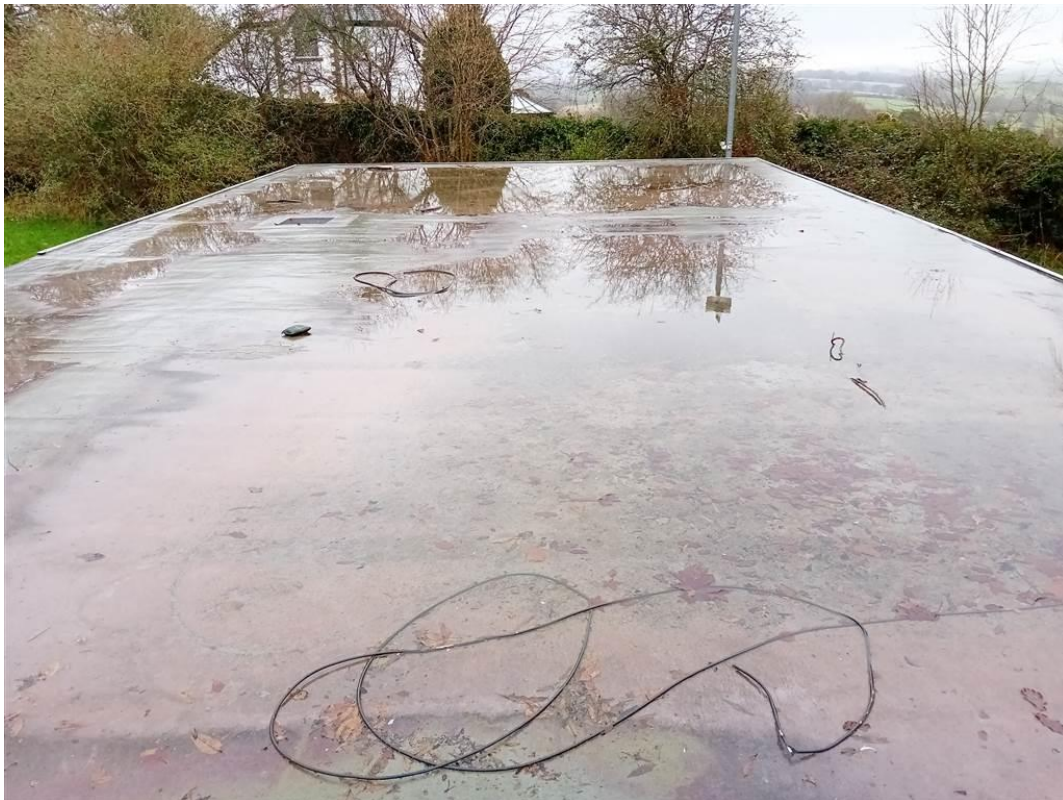
**Left:** Significant ponding on annexe roof (2024)

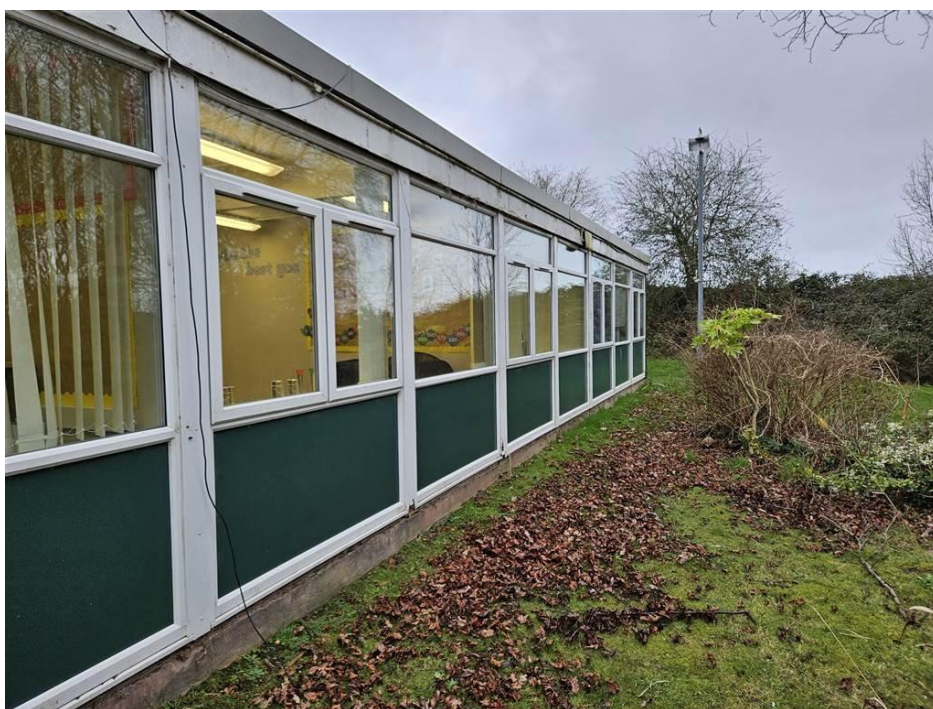
**Left:** typical elevation finish (2024)

The annexe building is of lightweight demountable construction and sits on the site of the original walled kitchen garden. The building's main core was built in the late 1960s as an additional classroom block when the site housed Brynglas Central School. At some stage, a sizeable extension of similar construction – painted joinery and low-level infill panels – has been added to the north elevation. Prior to Millbrook Primary School's relocation to the site, this building was used for day services. The school then utilised it as a teaching space until they vacated in early 2024 because of concerns over its poor structural condition. Like the other curtilage structures, this building does little to enhance or compliment the site.

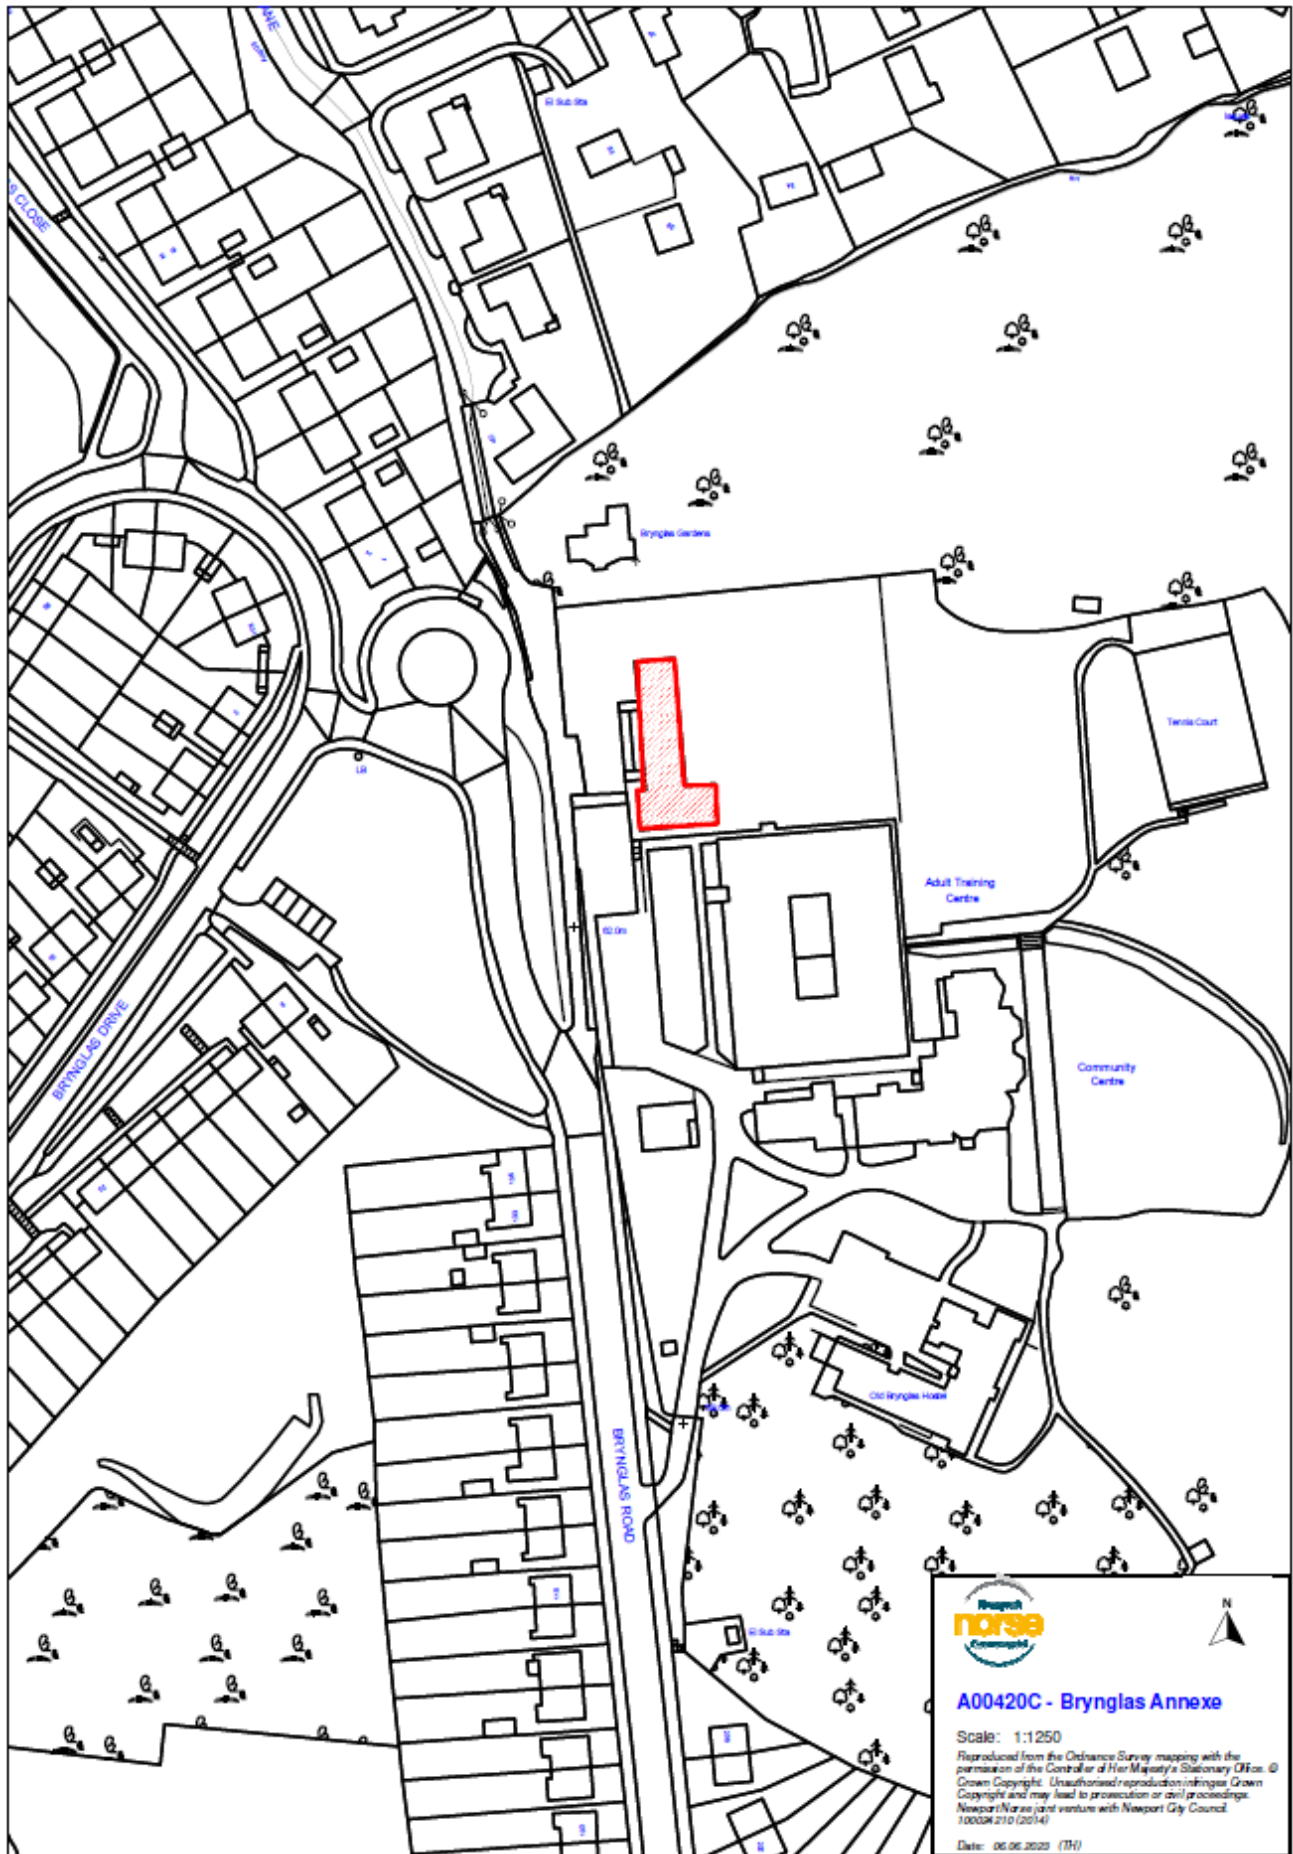
# Appendix C – Site Plan

Please refer to the attached site plan [Appendix 'C'], which shows the location of the annexe building and its context with the surrounding buildings, and their relationship with the main house (Brynglas House).
