You have asked me to conduct a review of a new fence installation at your home address, 7 BARDSEY CLOSE, ST JULIANS, NEWPORT and comment on it from a roads policing perspective as to whether it has any impact or safety implications on the highway.

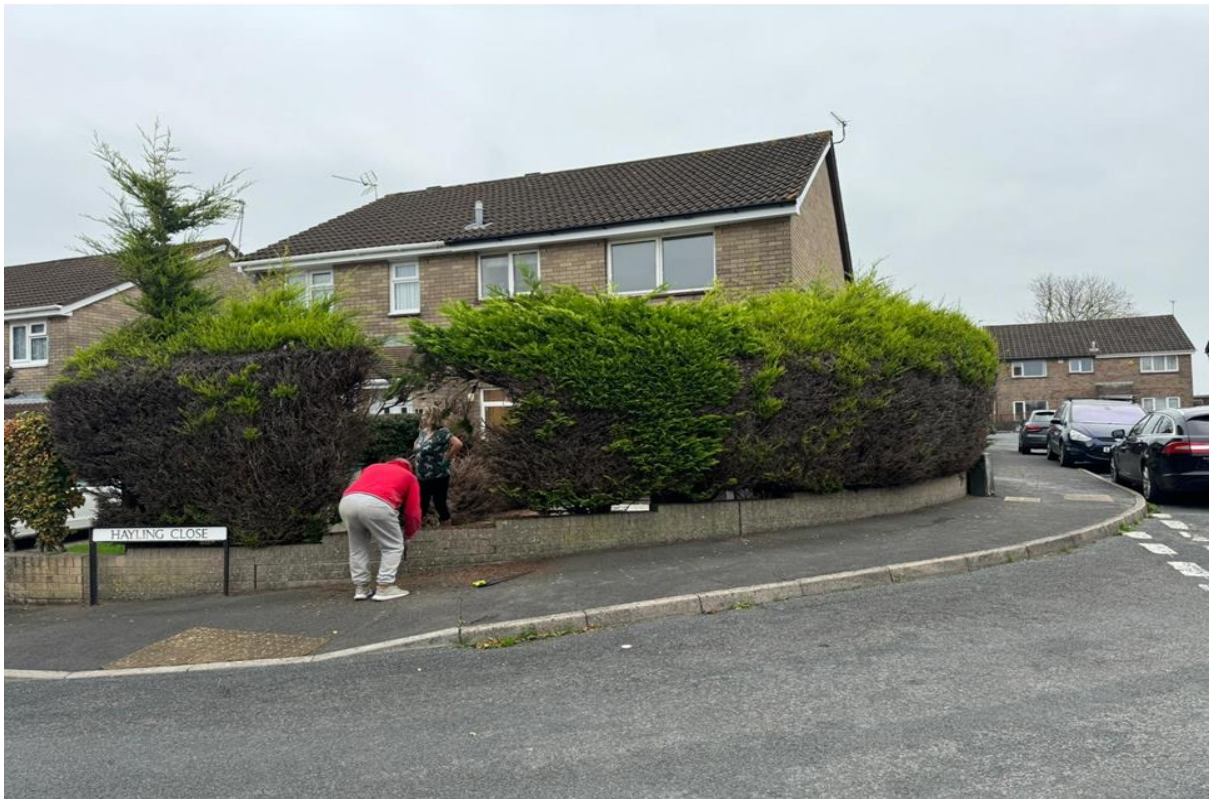
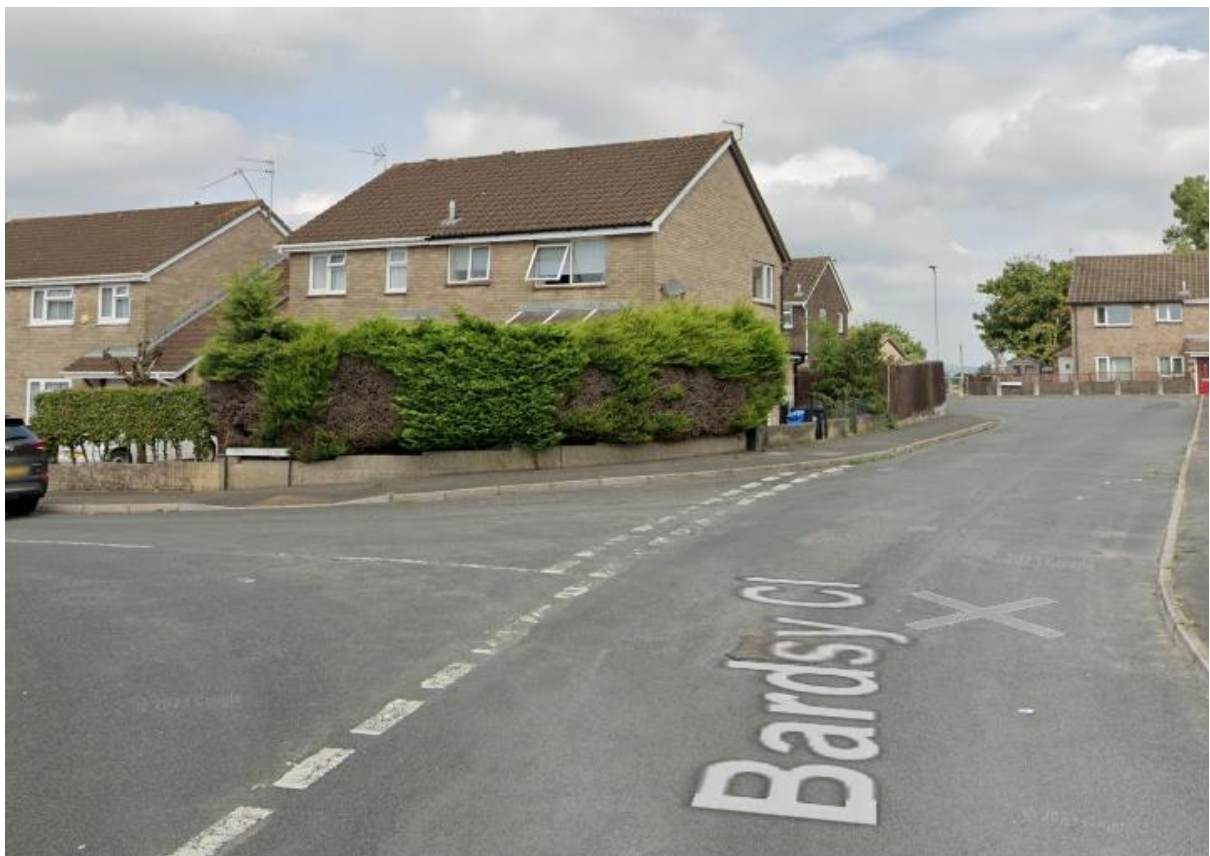
*Pre fence installation, showing hedgerow along the wall, adjacent to the pavement. Top image supplied by Laura Jones / Bottom image Google maps (September 2023)*

Prior to you erecting a fence, I can see there were bushes in place around the wall edge area, which were dense and appeared to have grown out towards the pavement area. You have replaced this with a wooden fencing, which follows the boundary wall in its entirety and does not protrude on to the pavement.

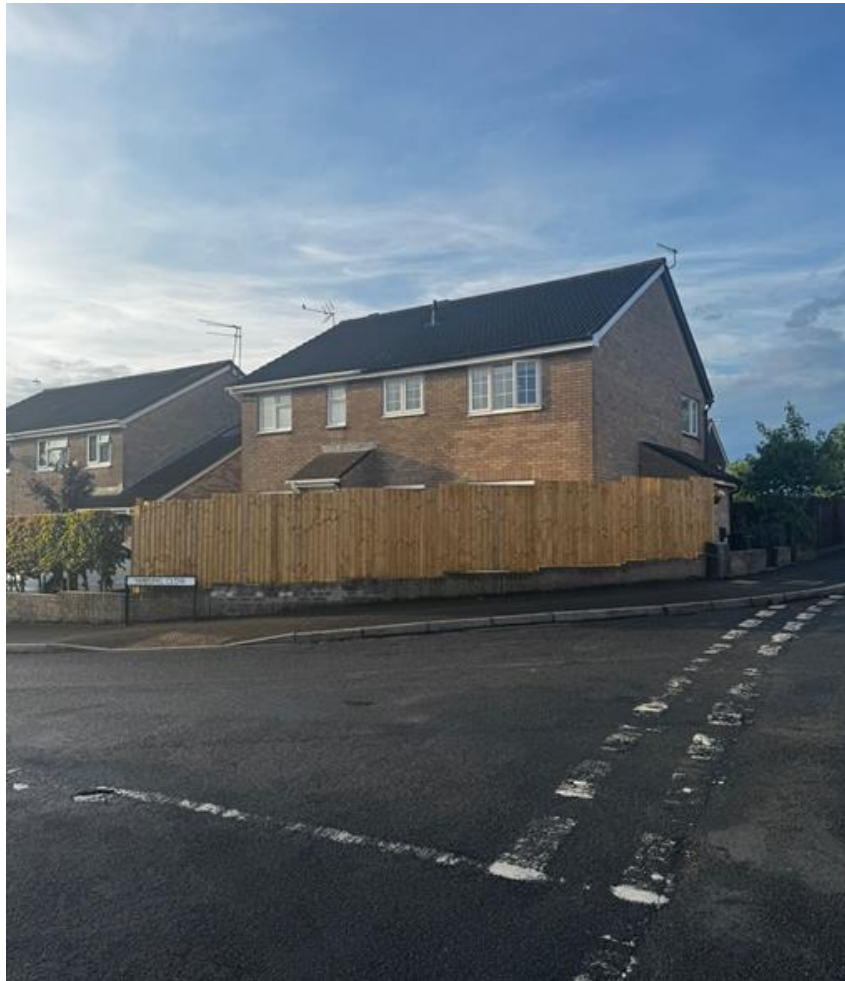
*Post fence installation, showing wooden fence erected along the wall, adjacent to the pavement.*

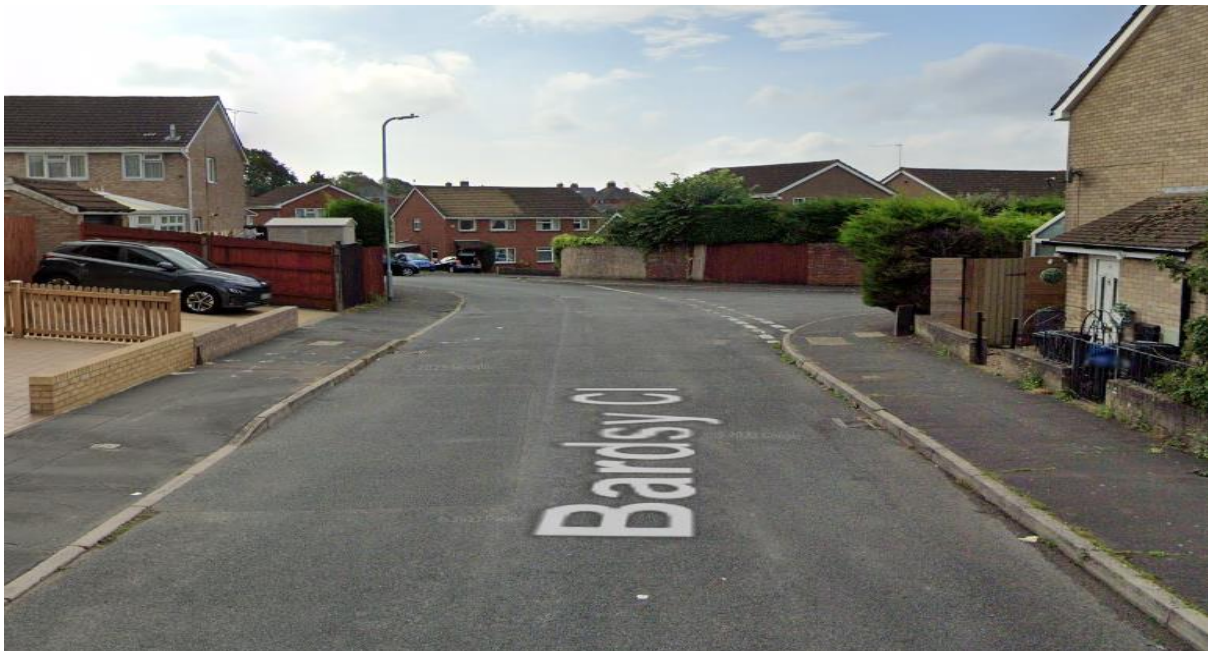
Travelling along BARDSEY CLOSE, with your property to the offside, I can confirm that your fencing had no impact on the road itself and no impact on visibility ahead. In fact, when travelling in this direction, the fencing has allowed for a clearer view of the T-Junction with HAYLING CLOSE. To evidence this, I have used GOOGLE MAPS STREET VIEW. The image captured is from September 2023, prior to your purchase of the property.

*View of T-JUNCTION, HAYLING CLOSE, September 2023, with the view of the junction partially obscured by the bushes.*

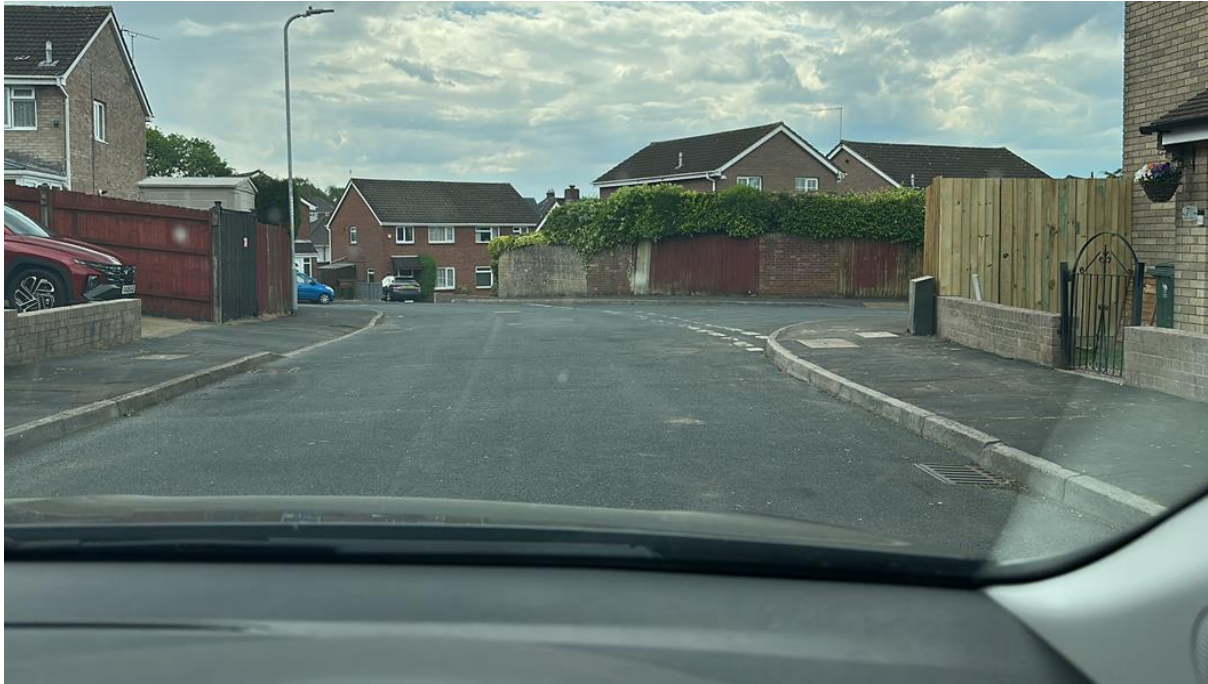
*View of T-JUNCTION, HAYLING CLOSE, May 2025, with the view of the junction improved.*

The work has made the T-Junction more open to vehicle traffic, allowing for a better view into the junction and out of the junction.
