## Arboricultural Report

To the British Standard 5837:2012  
*(Trees in relation to design, demolition  
and construction. Recommendations)*

Site – Newport Glan Llyn

Project Reference – ArbTS\_1923.1\_Newport Glan Llyn

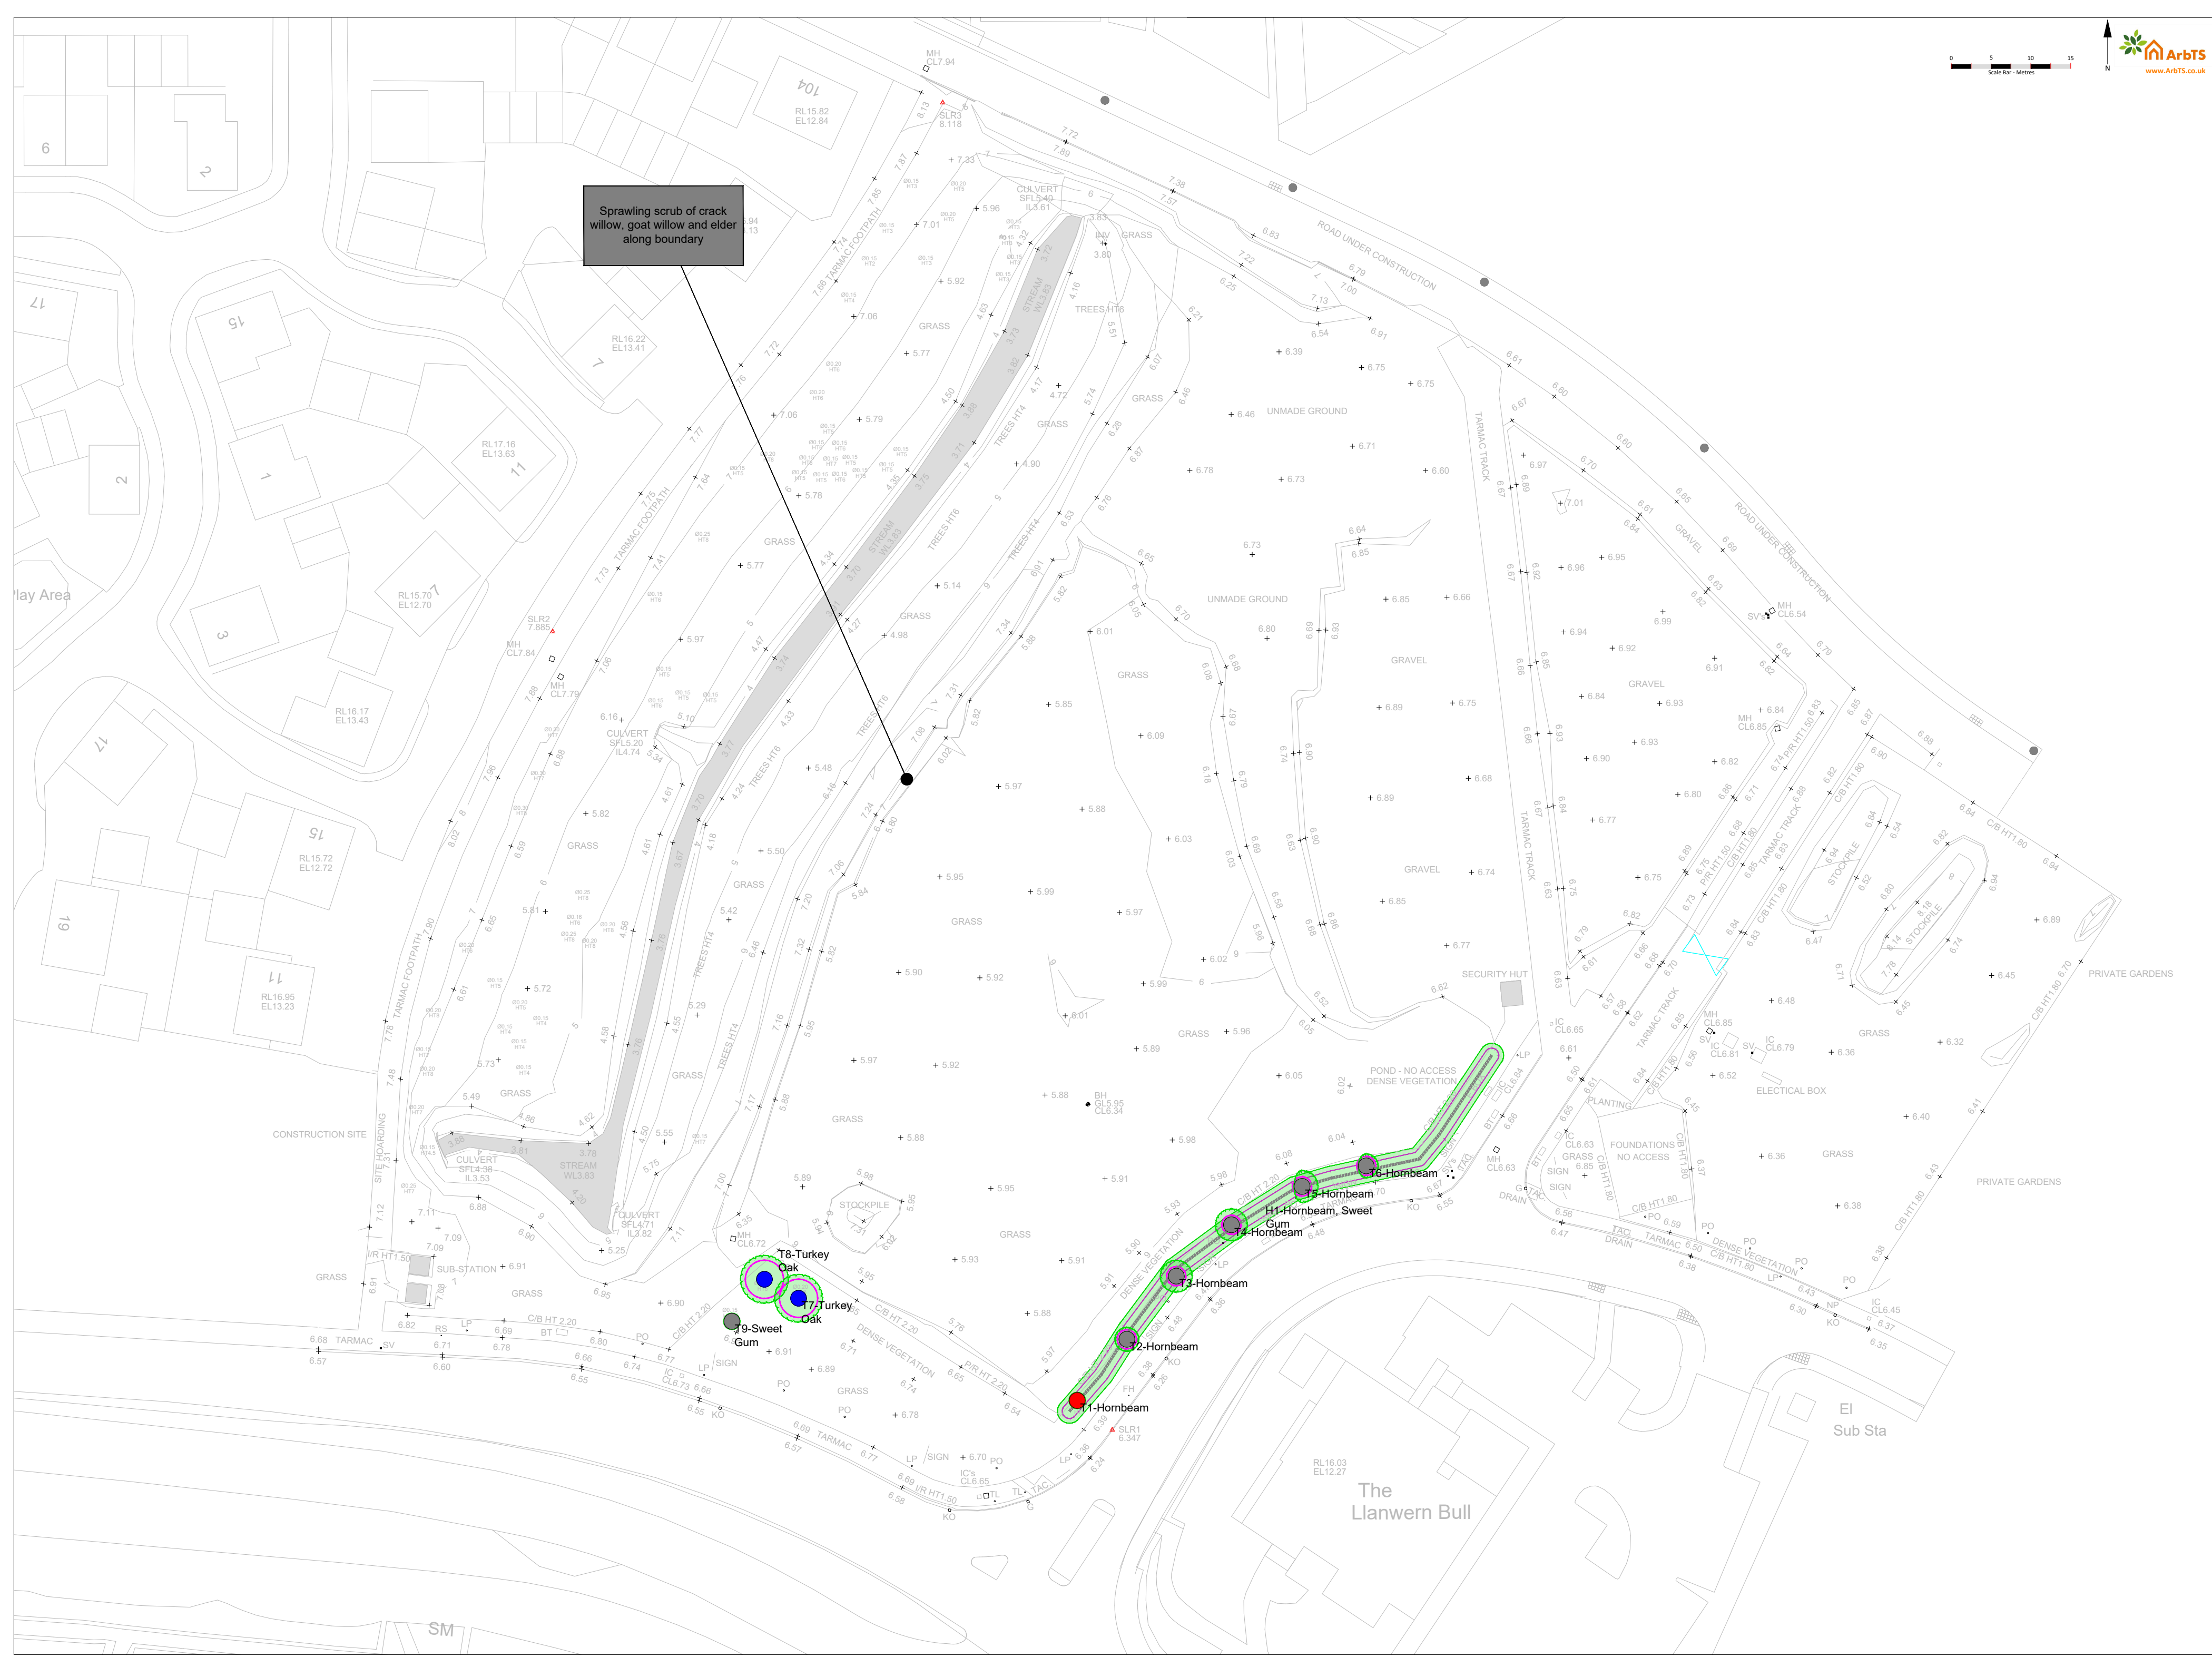
### Tree Constraints Plan

- **Tree Quality** - The TCP highlights the above and below-ground constraints each tree poses to design future development schemes. Further, the BS5837 tree quality category (A - High, B - Moderate, C - Low and U- Unsuitable for retention) are coloured coded as solid circles at the centre of the tree's position.

- **Root Protection Area** – The magenta circle on the TCP sets out the root protection area (RPA). No construction work in this area, ground-level alteration or site traffic (machinery or persons) should occur. This prevents damage to tree roots and soil compaction. (Where possible, an Arboriculturist can design suitable tree protection methods to facilitate construction work/site traffic within these areas).

- **Tree Canopy** - The green circle/oval on the TCP sets out the above-ground constraints of tree canopy spread. Within this area, no construction work or site traffic (machinery or persons) should occur if the tree is to be retained. This prevents damage to the tree branches and trunk. (Where possible, an Arboriculturist can design suitable tree protection methods to facilitate construction work/site traffic within these areas).

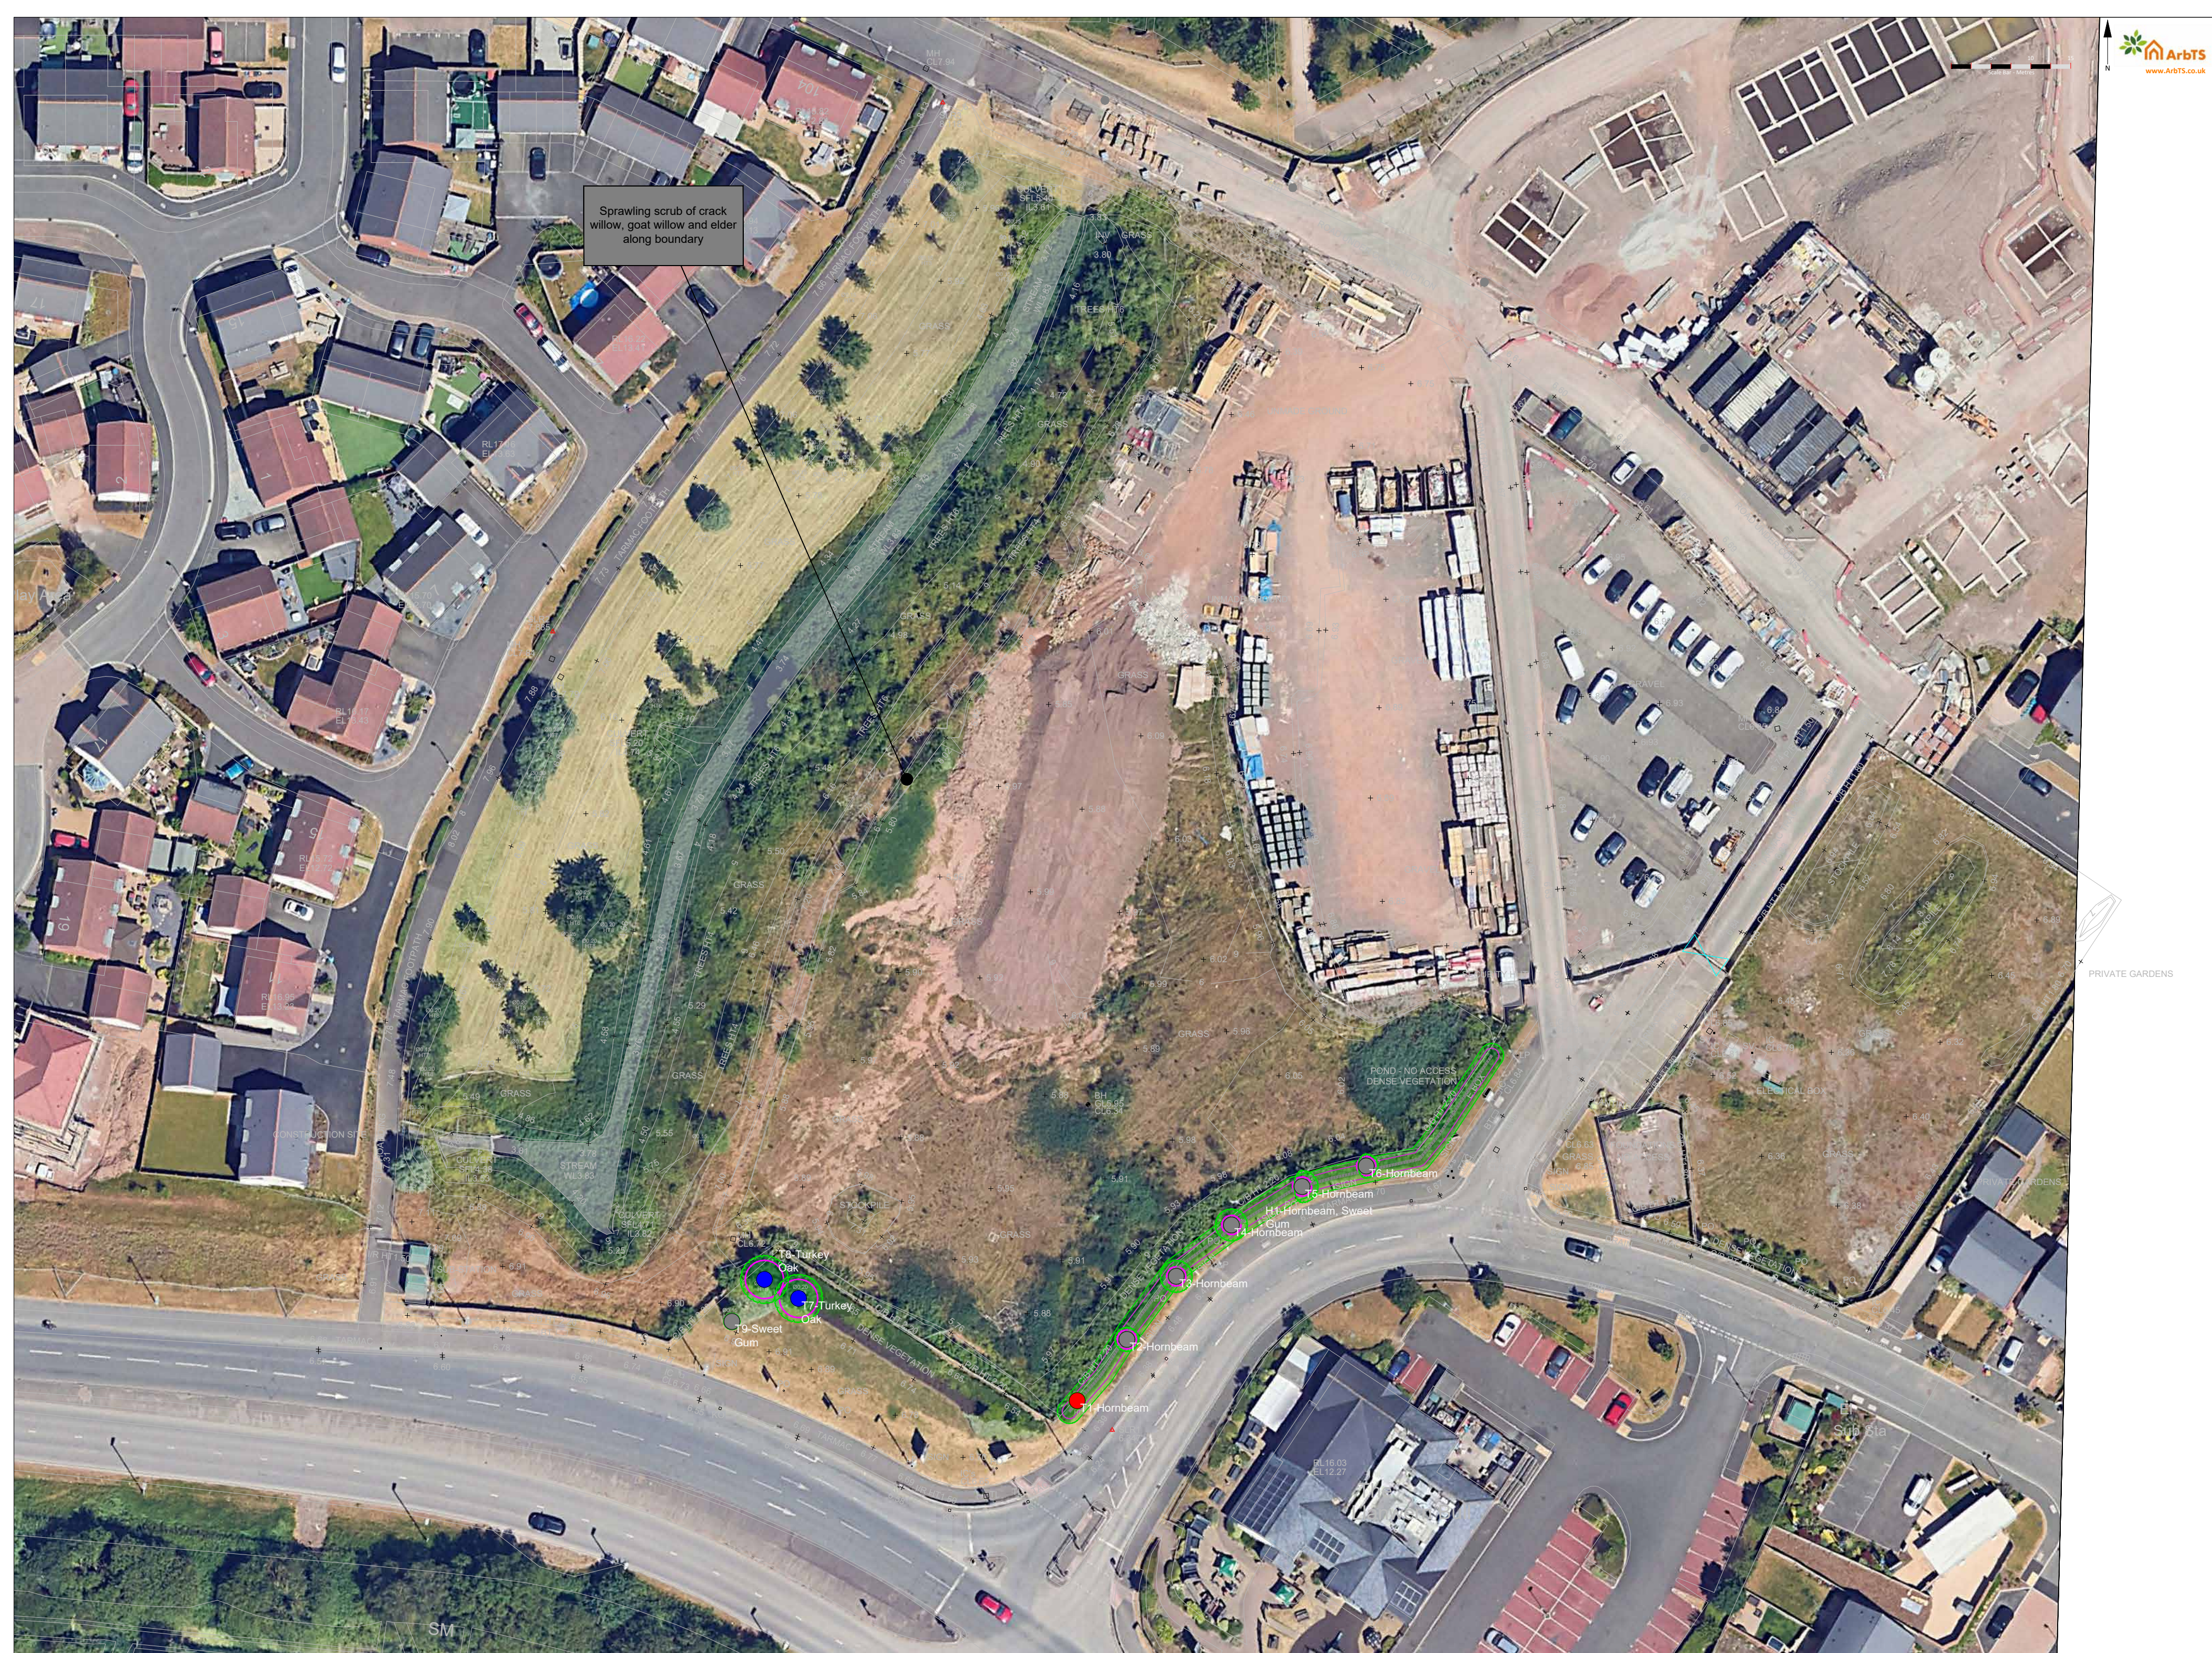
Sprawling scrub of crack willow, goat willow and elder along boundary

Barriers and Ground Protection must be designed by an arboriculturist, installed before materials or machinery is brought onto site and before any demolition, development or stripping of soil commences. Once erected, barriers and ground protection should be regarded as sacrosanct, and should not be removed or altered without prior recommendation by an Arboriculturist and approval of the Local Planning Authority (LPA).

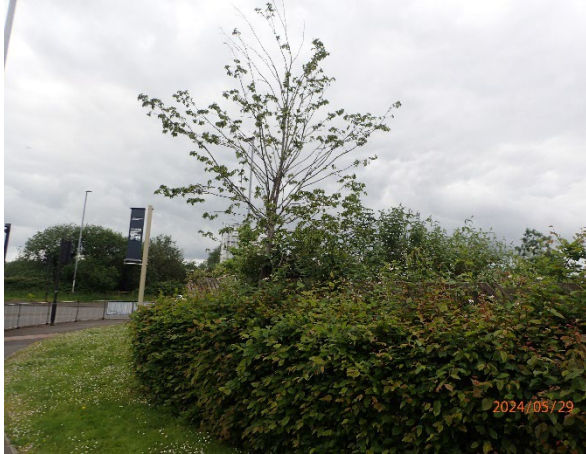
Tree ID#T1

| Tree ID # | Tree Species | Age | Stems | Stem Diam (mm) | Cat | Height + (Lower Branch Height) | Nrth | Est | Sth | Wst | Phys Cond | Struc Cond | Est. Remain Contrib | Comments | Preliminary Management Recommendations | Work Priority | RPR (m) | RPA (m2) |
|---|---|---|---|---|---|---|---|---|---|---|---|---|---|---|---|---|---|---|
| T1 | Carpinus betulus (Hornbeam) | SM | 1 | 100 | U | 4(2) | 1 | 1 | 1 | 1 | F/P | N/A | <10 | Sparse foliage cover. Surrounding vegetation prevented close inspection of the tree therefore all observations and measurements are estimated. | | | 1.2 | 4.52 |

- Tree T1 - Hornbeam – Poor quality (**U** category)
- Tree T3 - Hornbeam – Low quality (**C** category)
- Tree T4 - Hornbeam – Low quality (**C** category)
- Tree T6 - Hornbeam – Low quality (**C** category)
- Tree T7 – Turkey Oak – Moderate quality (**B** category)
- Tree T8 – Turkey Oak – Moderate quality (**B** category)

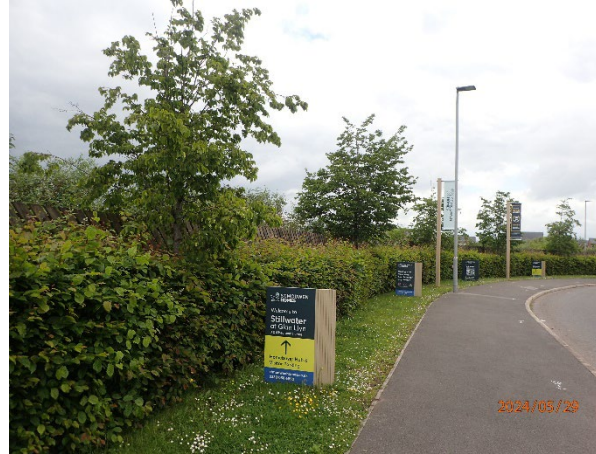
Tree ID#T2 – T6

| Tree ID # | Tree Species | Age | Stems | Stem Diam (mm) | Cat | Height + (Lower Branch Height) | Nrth | Est | Sth | Wst | Phys Cond | Struc Cond | Est. Remain Contrib | Comments | Preliminary Management Recommendations | Work Priority | RPR (m) | RPA (m2) |
|---|---|---|---|---|---|---|---|---|---|---|---|---|---|---|---|---|---|---|
| T2 | Carpinus betulus (Hornbeam) | SM | 1 | 100 | C2 | 4(2) | 1.5 | 1.5 | 1.5 | 1.5 | F | N/A | <10 | Slightly sparse foliage cover. Surrounding vegetation prevented close inspection of the tree therefore all observations and measurements are estimated. | | | 1.2 | 4.52 |
| T3 | Carpinus betulus (Hornbeam) | SM | 1 | 100 | C2 | 4.5(2) | 2 | 2 | 2 | 2 | G/F | N/A | <10 | Slightly sparse foliage cover. Surrounding vegetation prevented close inspection of the tree therefore all observations and measurements are estimated. | | | 1.2 | 4.52 |
| T4 | Carpinus betulus (Hornbeam) | SM | 1 | 100 | C2 | 4(2) | 2 | 2 | 2 | 2 | F | N/A | <10 | Sparse foliage cover. Surrounding vegetation prevented close inspection of the tree therefore all observations and measurements are estimated. | | | 1.2 | 4.52 |
| T5 | Carpinus betulus (Hornbeam) | SM | 1 | 100 | C2 | 4.5(2) | 2 | 2 | 2 | 1 | F | N/A | <10 | Slightly sparse foliage cover. Surrounding vegetation prevented close inspection of the tree therefore all observations and measurements are estimated. | | | 1.2 | 4.52 |
| T6 | Carpinus betulus (Hornbeam) | SM | 1 | 100 | C2 | 4.5(2) | 1.5 | 1.5 | 1.5 | 1 | F | N/A | <10 | Slightly sparse foliage cover. Surrounding vegetation prevented close inspection of the tree therefore all observations and measurements are estimated. | | | 1.2 | 4.52 |

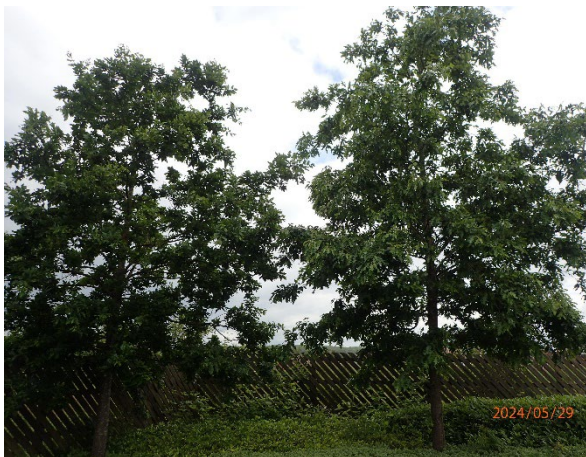
Tree ID#T8 + T9

| Tree ID # | Tree Species | Age | Stems | Stem Diam (mm) | Cat | Height + (Lower Branch Height) | Nrth | Est | Sth | Wst | Phys Cond | Struc Cond | Est. Remain Contrib | Comments | Preliminary Management Recommendations | Work Priority | RPR (m) | RPA (m2) |
|---|---|---|---|---|---|---|---|---|---|---|---|---|---|---|---|---|---|---|
| T8 | Quercus cerris (Turkey Oak) | SM | 1 | 200 | B2 | 7(2) | 3 | 3 | 3 | 3 | G/F | G/F | 20+ | | | | 2.4 | 18.1 |
| T9 | Liquidambar styraciflua (Sweet Gum) | Y | 1 | 80 | C2 | 3(1) | 1 | 1 | 1 | 1 | G/F | G/F | 10+ | | | | 0.96 | 2.9 |
