#### Front elevation Cross Street view

**Rear elevation Backhall Street view**

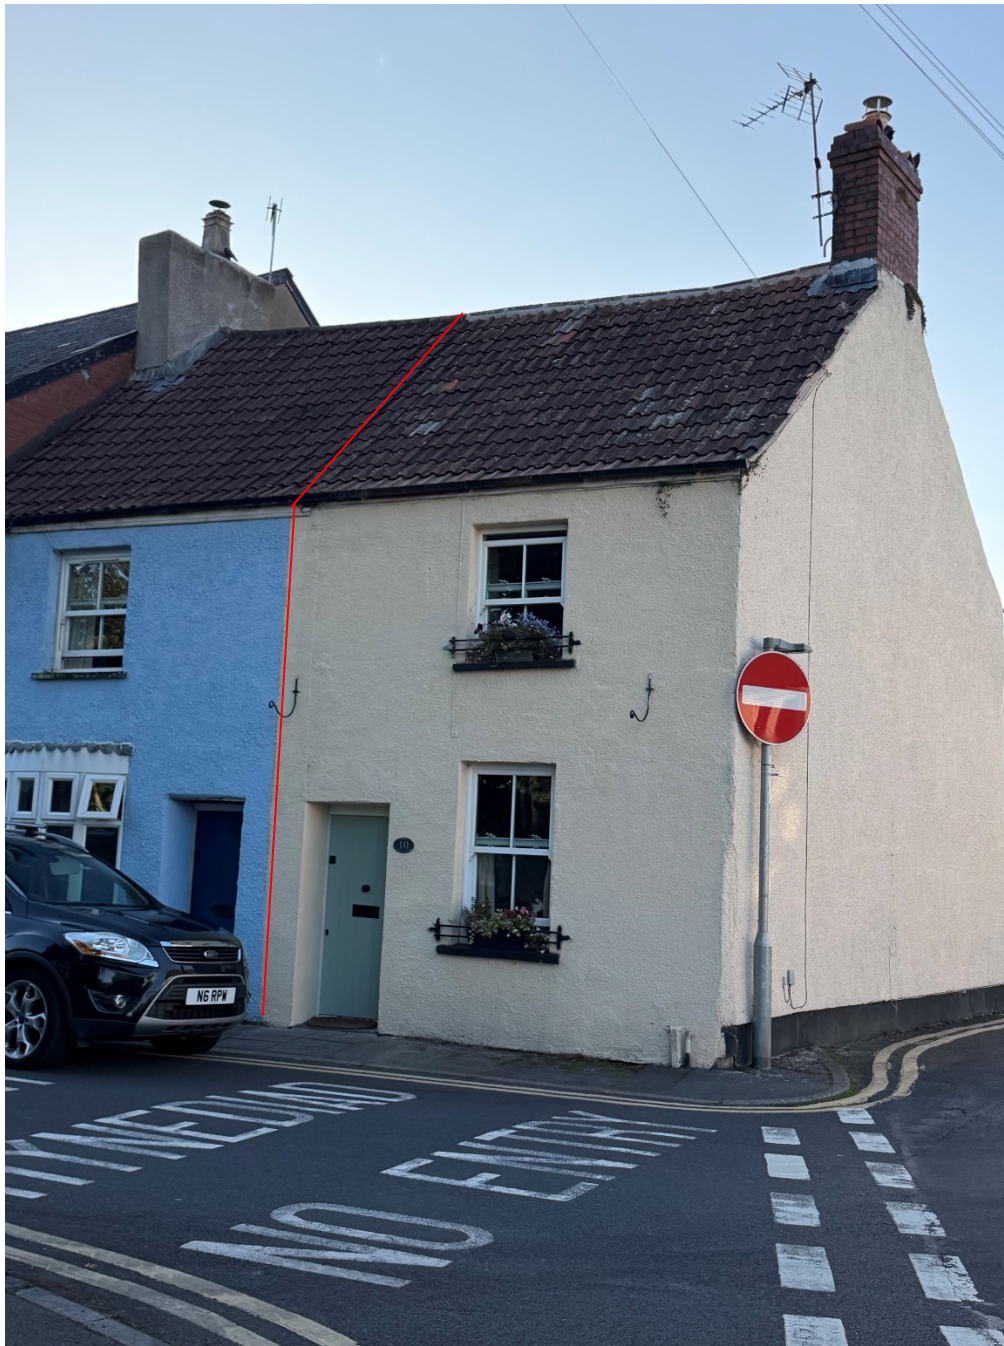
- Roman Clay pantiles to match existing and maintain a unified pair adjacent property
- Timber fascia boards painted to match existing
- Black metal gutters to be replaced with uPVC to bring in line with adjacent property
- Chimney stack flashing in lead
- Wet verge details to gable end to match existing

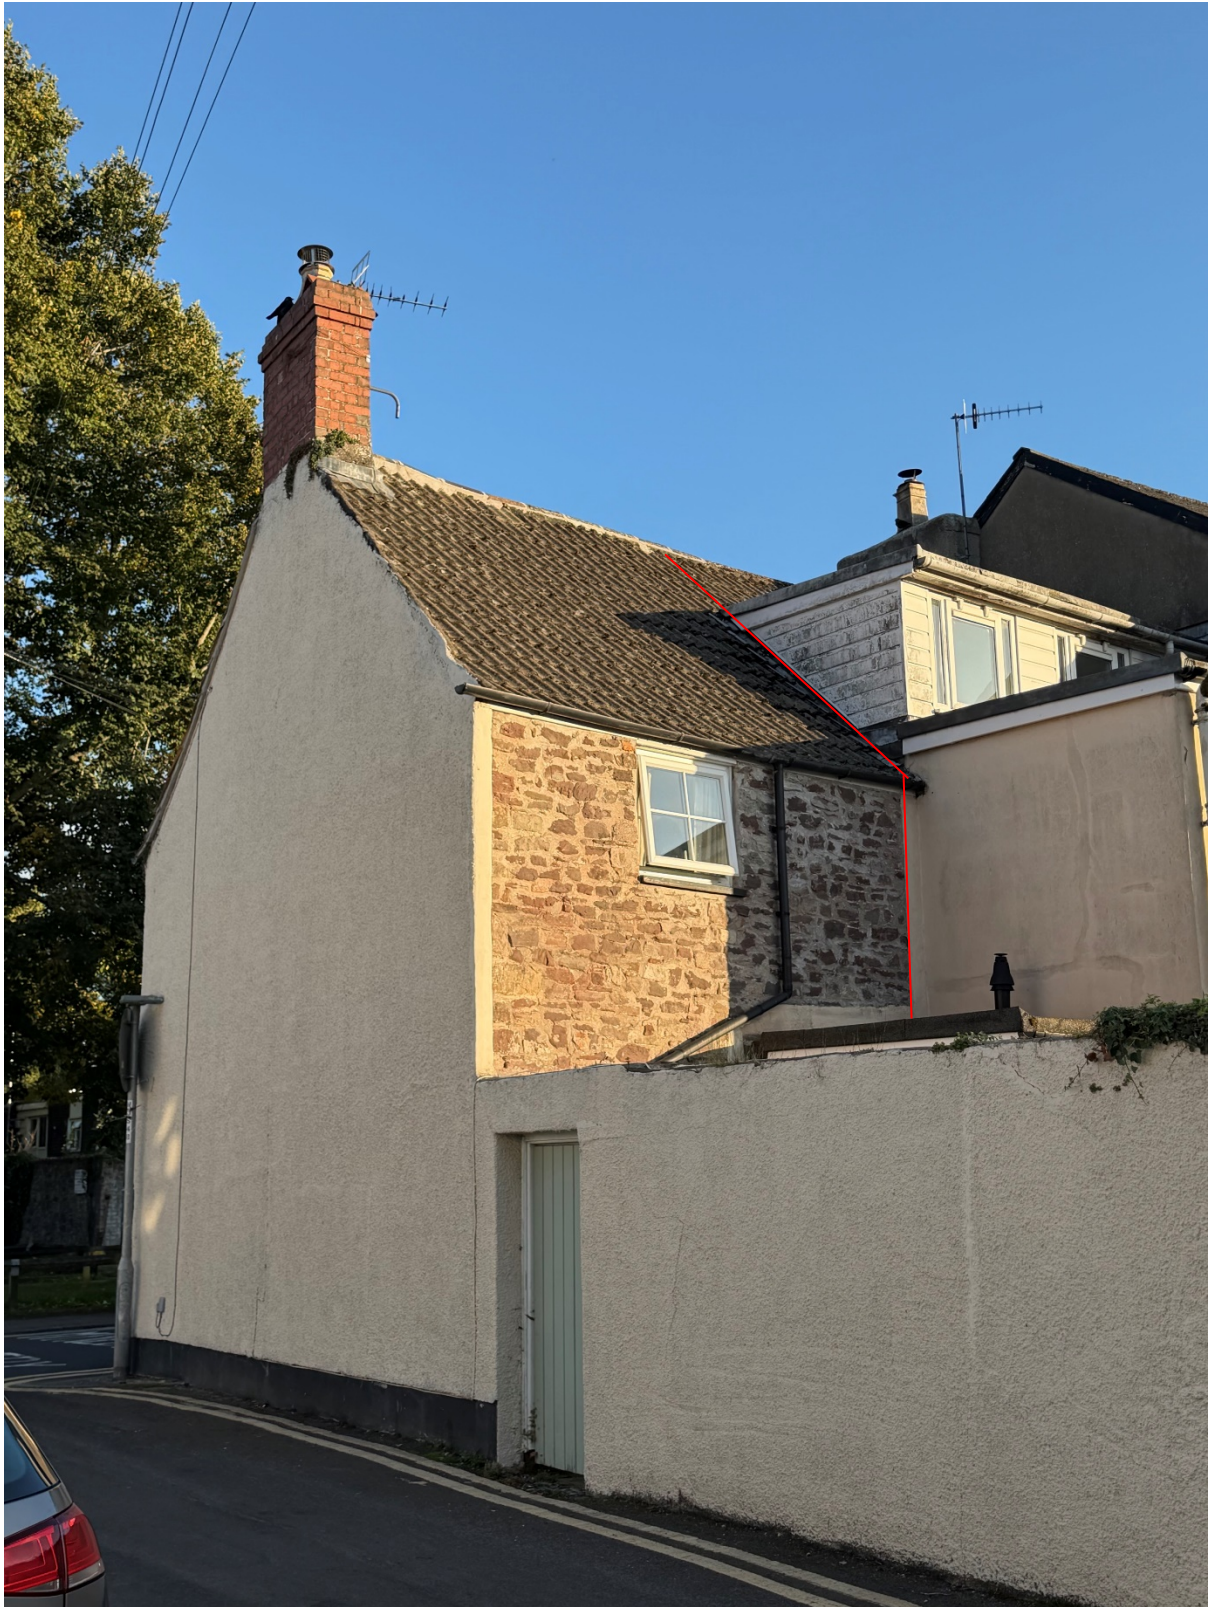
- Pantiles (concrete) to match existing and maintain unified pair with adjacent property
- Timber fascia boards painted to match existing
- Black uPVC gutters to be replaced like for like
- Chimney stack flashing in lead

- Wet verge details to gable end to match existing
