# Proposed Agricultural Building and Machinery Store Pencoed Castle Farm Llanmartin

Heritage Statement

February 2026

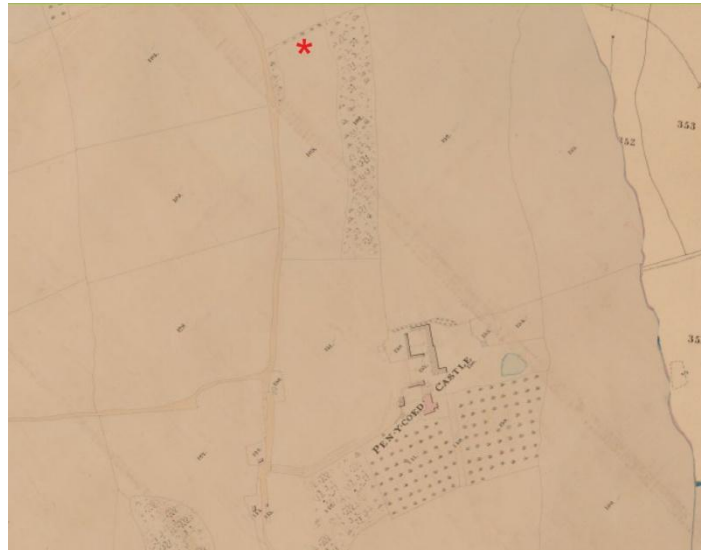
The site of the development is a field which, on the Llanmartin Tithe map of 1839, was part of a large field let to Morgan Williams by the owner Thomas Perry, at a time when the castle was used as a farmhouse (fig 2). By the time of the 1886 Ordnance Survey it was rough pasture with a stream flowing through it, which now acts as a boundary of the subdivided plot by means of trees planted along its edge (fig 3).

Figure 2. Llanmartin Tithe map, 1839.

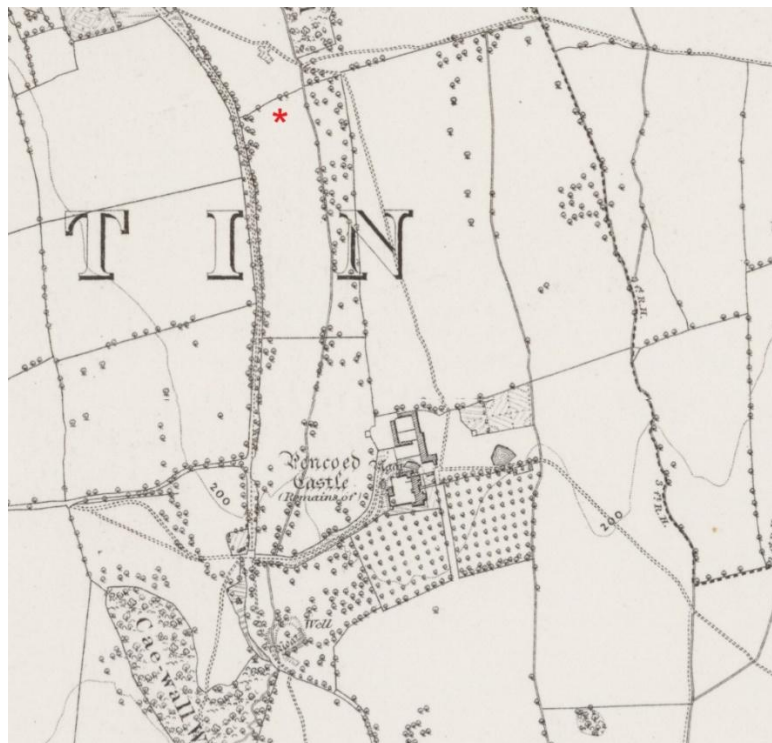
Figure 3. Ordnance Survey map, 1886.

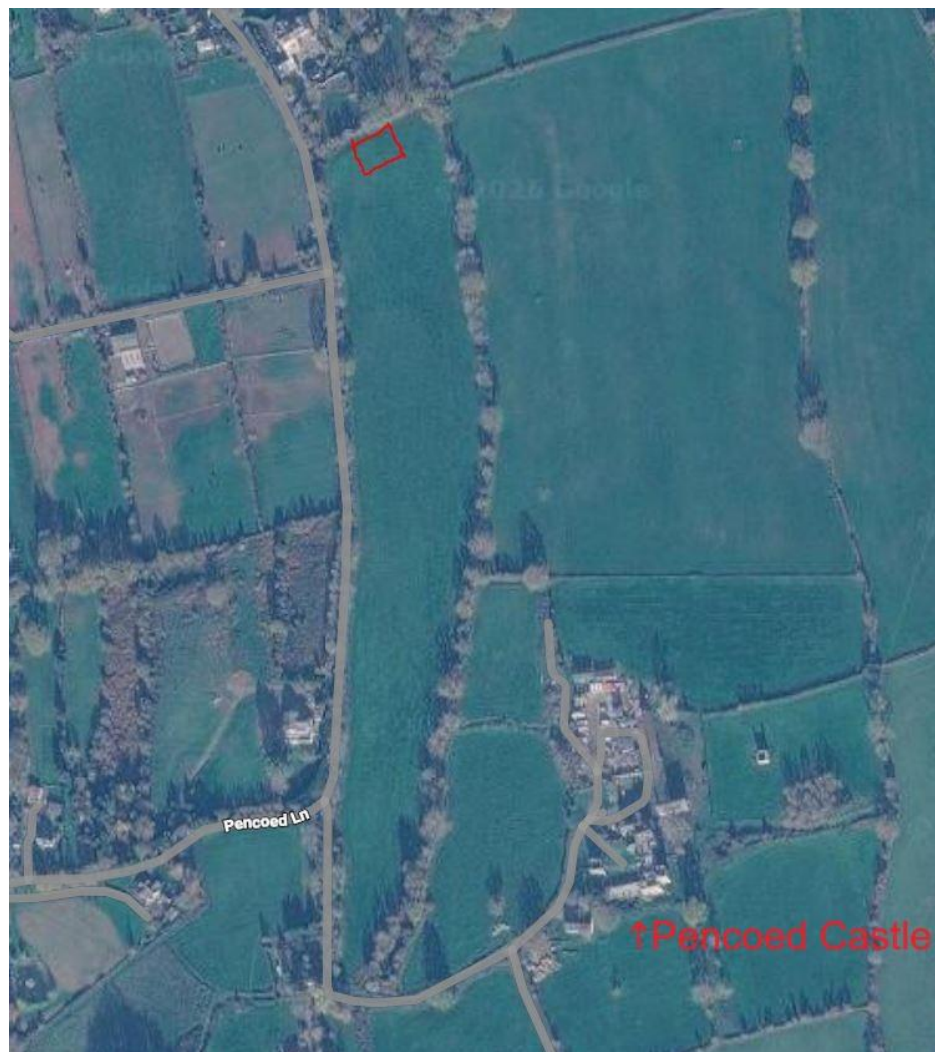
*Figure 4. Site of proposed building in relation to Pencoed Castle.*

The site of the proposed shed is approximately 530 metres north-north-west of Pencoed Castle and its gatehouse, and approximately 450 metres north-west of the long barn and

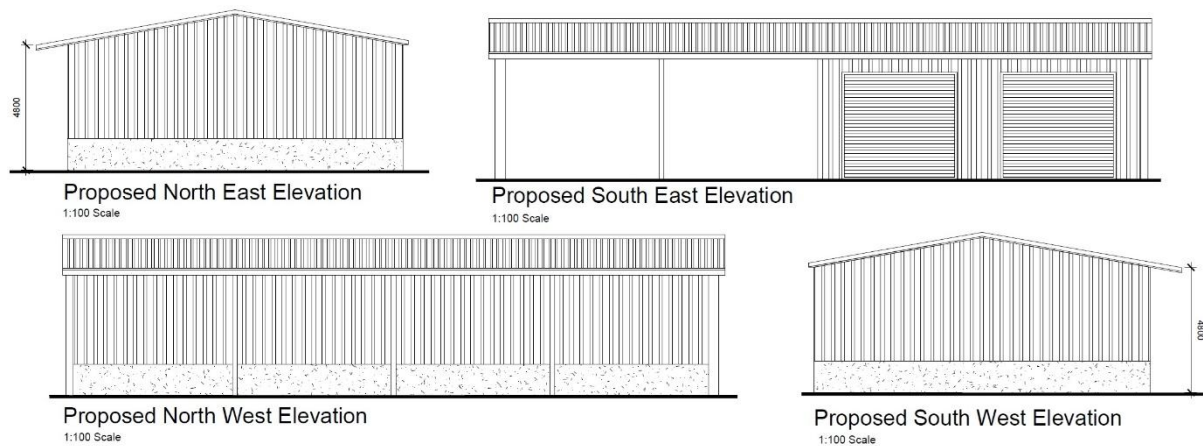
The building is to be close to the northern boundary of a field, approximately 450 metres north-north-west of the Pencoed Castle farmyard. It is to be a steel-framed structure clad in single-skin profiled metal sheeting, under a shallow pitched roof of similar material (fig 5). Plan dimensions are approximately 24 metres N-S by 12 metres, and 4.8 metres high to the eaves. At present there is a line of trees on the east side of the site. The building will be sited a minimum of 10 metres away from the hedge (fig 6). Access to the building will be from Pencoed Lane, using an existing gateway to prevent any unnecessary loss of the existing hedge.

*Figure 5. Proposed elevations.*

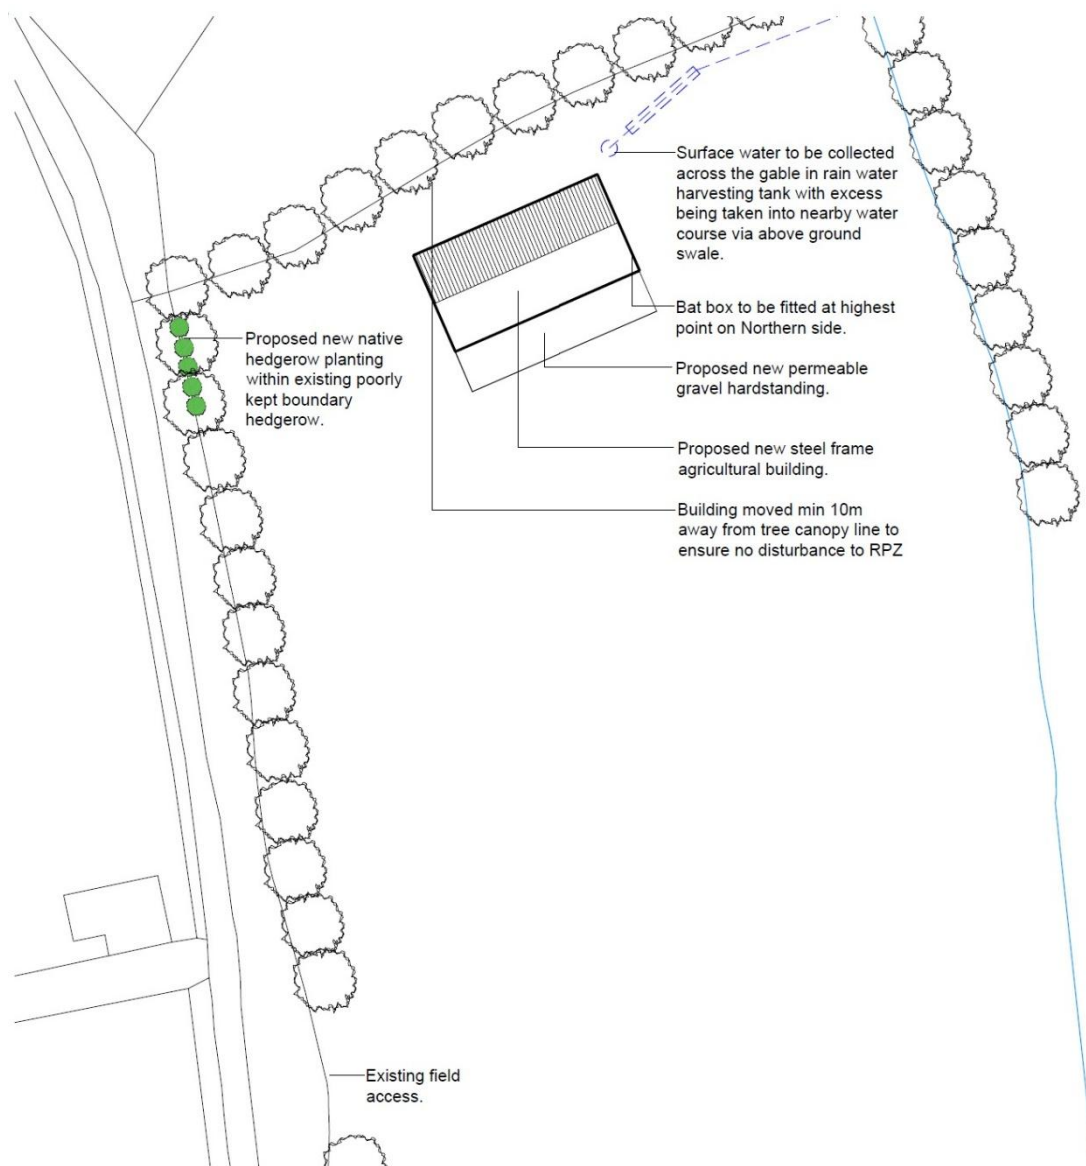
The site of the proposal is at the north end of the field, currently used as pasture. It is bordered on the north and east sides with mature trees, but with some gaps (fig 4). On the west side is a wall and mature hedges and trees to Pencoed Lane.

*Figure 6. Site of proposed new building.*

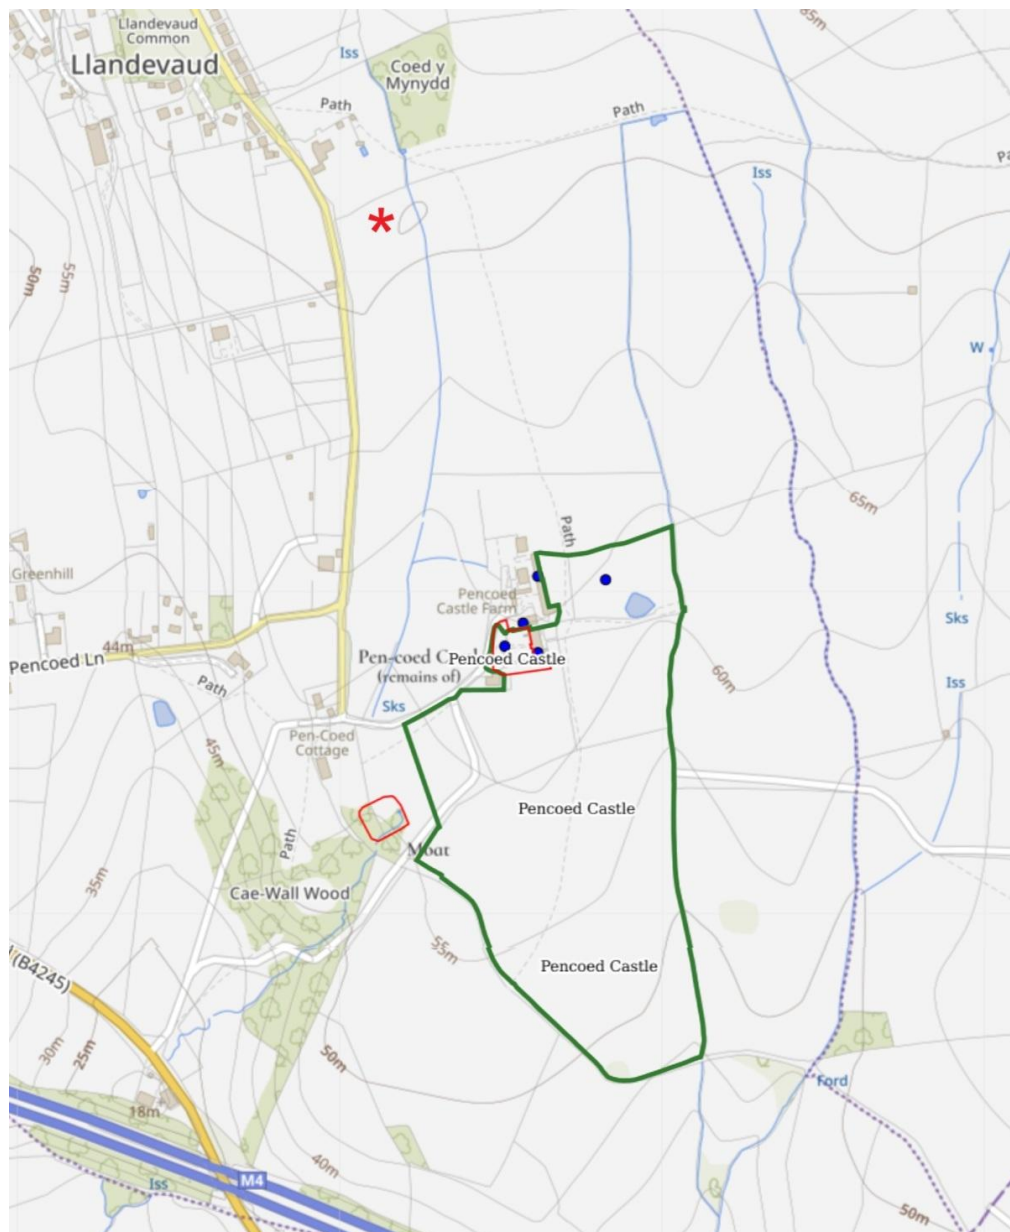
There are eight designations at Pencoed Castle (fig 7).

Figure 7. Designations affected by the proposal.

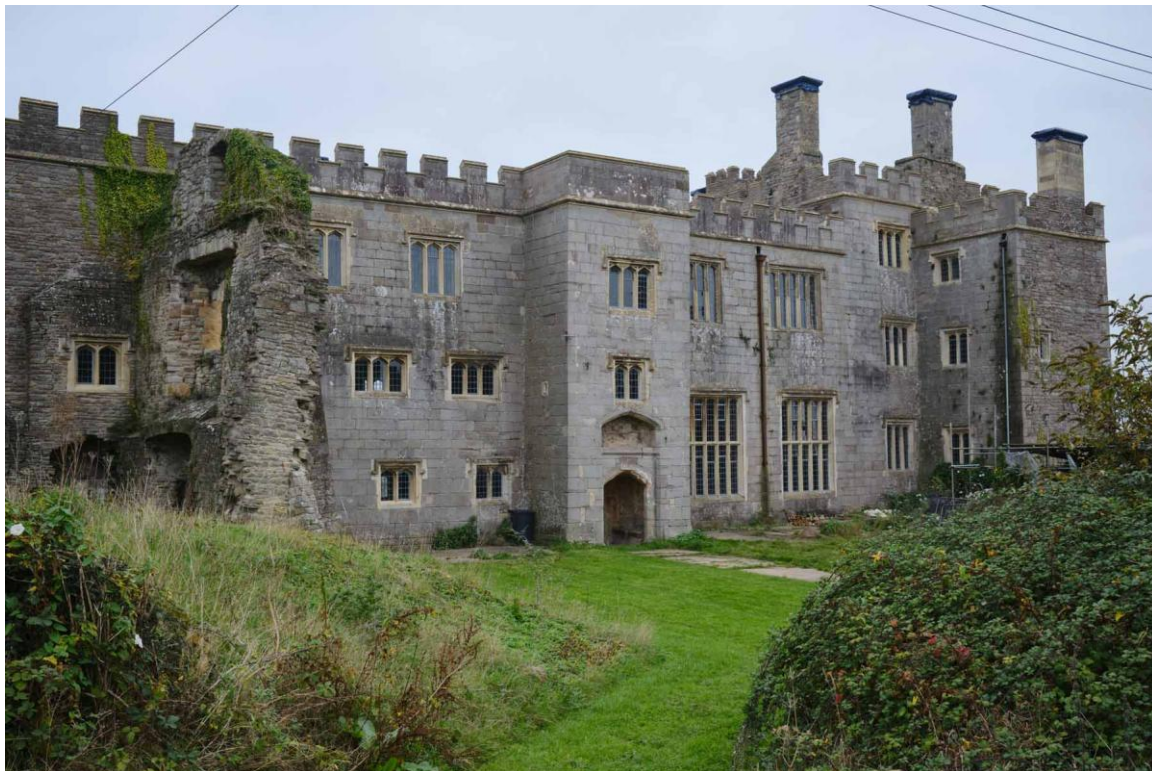
*Figure 8. Pencoed Castle.*

Pencoed Castle is an exceptional example of one of the great Tudor manor houses of South Wales, retaining evidence of its earlier form as a medieval moated castle (fig 8). The remains of the moat, replaced by the courtyard wall, are important symbols of social status, as is the gatehouse, one of the few surviving examples in Monmouthshire. The house itself retains fabric from several periods, including medieval and the restorations made in the early-twentieth century by Lord Rhondda. The significance of Pencoed Castle is enhanced by its rural setting, and by the park, including the dovecote and the raised terrace, to the south and east of the house.

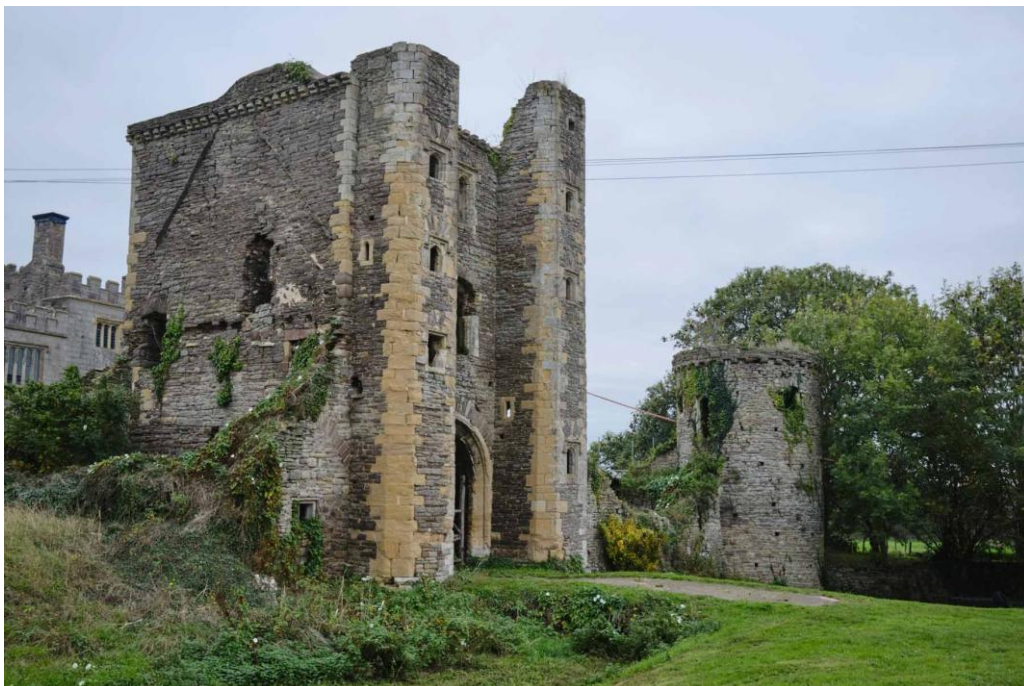
The gatehouse is a substantial three-stage square tower on the west side of the Tudor manor house and was built to complement it and express the high status of the house. It is attached to the courtyard walls in front of the house and makes an important contribution to the setting of Pencoed Castle (fig 9).

*Figure 9. Pencoed Castle Gatehouse.*

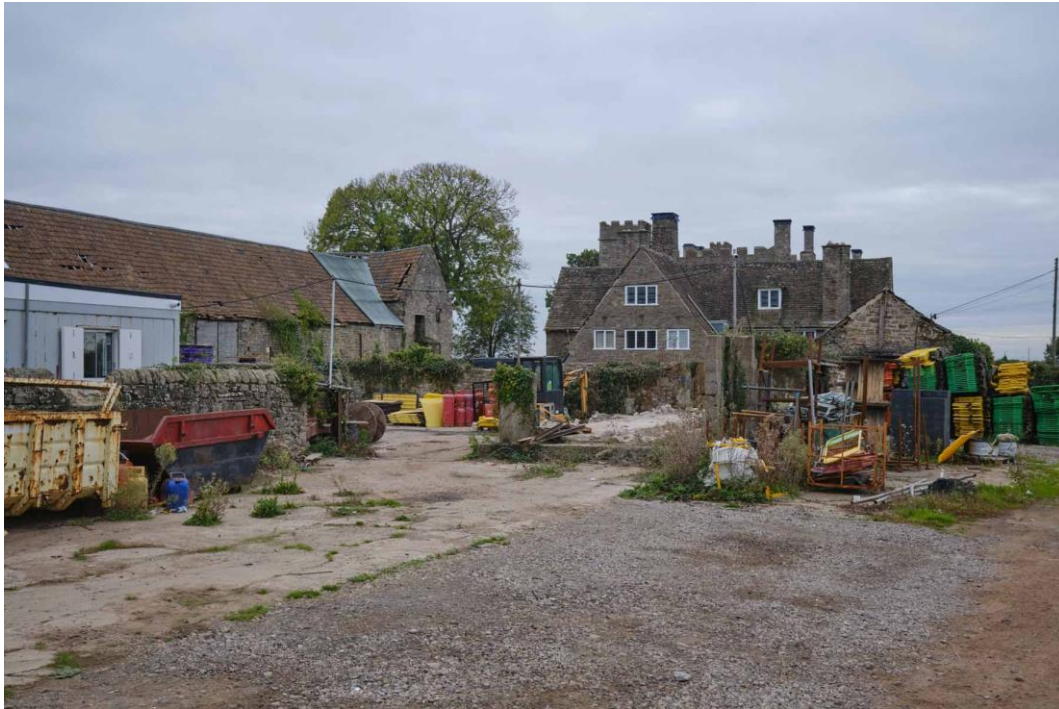
*Figure 10. Farmyard, with long barn and farmhouse.*

The farmhouse belongs to the period of ownership by Viscount Rhondda in the early twentieth century. Its style is derived from Arts and Crafts design, with swept eaves and dominant tall gables to the front, which faces away from the castle to the farmstead, an indication of an optimistic future for Pencoed as a farm which did not materialise. The setting of the house is primarily important in its visual relationship with the farm buildings, although this is marred when viewed from the north west by the area of hardstanding described above (fig 10).

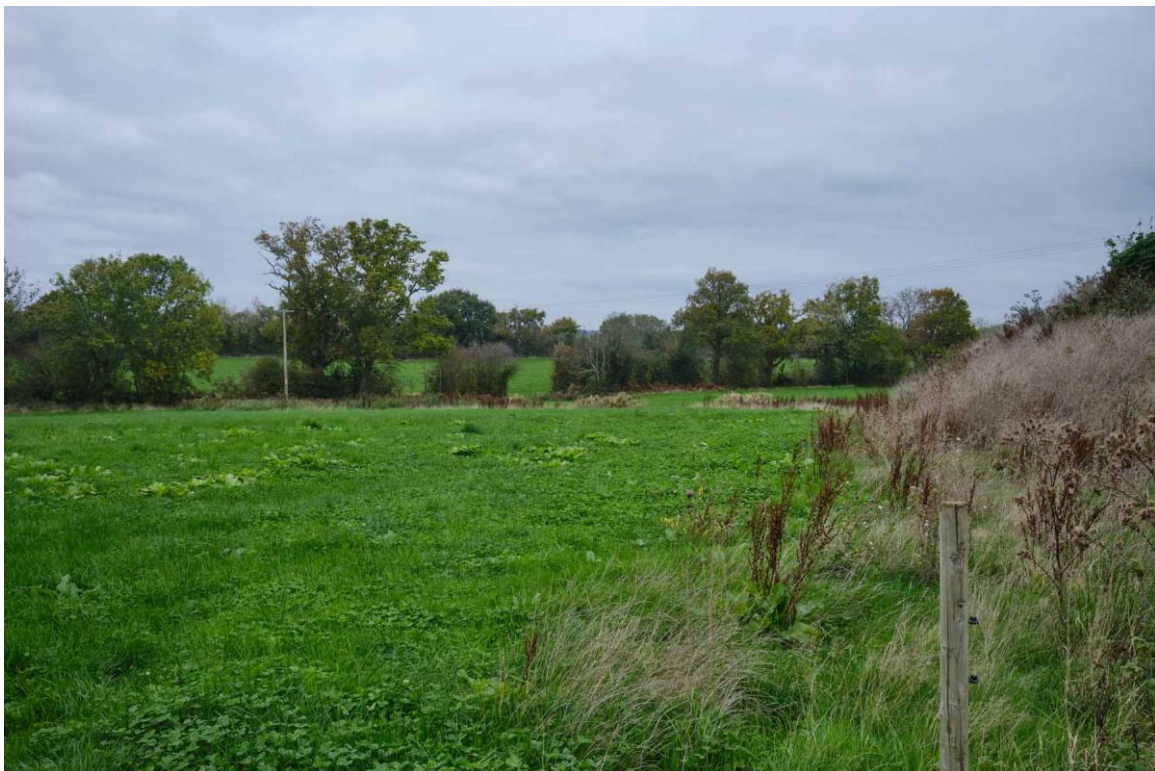
The rural setting of Pencoed Castle contributes to the setting of all the designations associated with the property. Although the tree line on the boundary of the field is not continuous, the new building will be far enough from the designated heritage assets in the farmyard, park and castle for it not to be visible. From Pencoed Lane, it is very difficult to see across the field to the castle. Although there is a gate into the field where the store building is to be built, the castle is not visible from this distance (fig 11). Looking north-north-west from the castle gatehouse it will likewise not be possible to see the new building (fig 12).

*Figure 11. View from the development site looking SSE towards Pencoed Castle.*

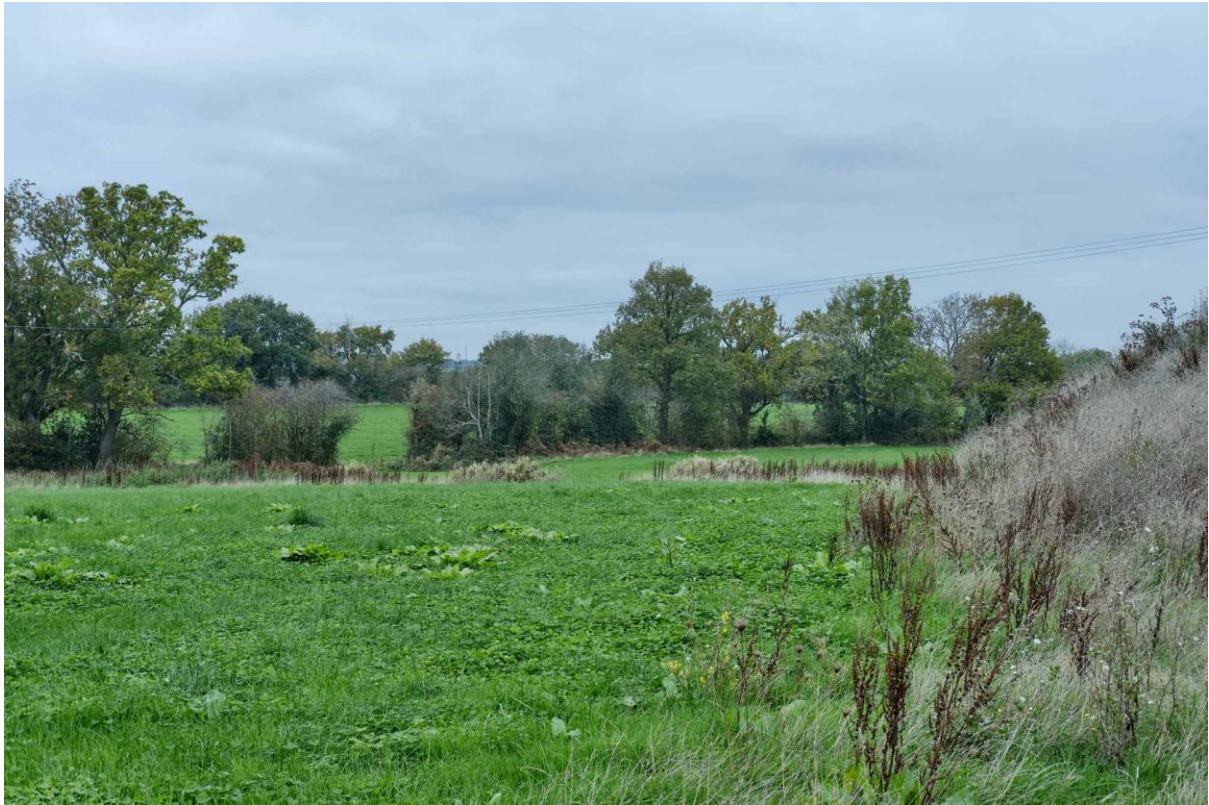
*Figure 12. View looking NW to the development site from in front of the Gatehouse.*
