**Former Whiteheads Steelworks, Mendalgief Road, Newport, NP20 2HY**  
**NHBC Outstanding Land Quality Conditions, Ref: 216335 LQ conditions LQ5 & LQ6.**  
**Planning Permission Number RM1-18/1039, RM2-18/1142 and RM3-21/0464**  
**Validation of Imported Clean Cover Block M Plots 324 to 347.**

Appendix A      Photographic Records.

**14092: Remedial Capping Works to Gardens and Landscape Areas**

**Former Whiteheads Steelworks, Mendalgief Road, Newport.**

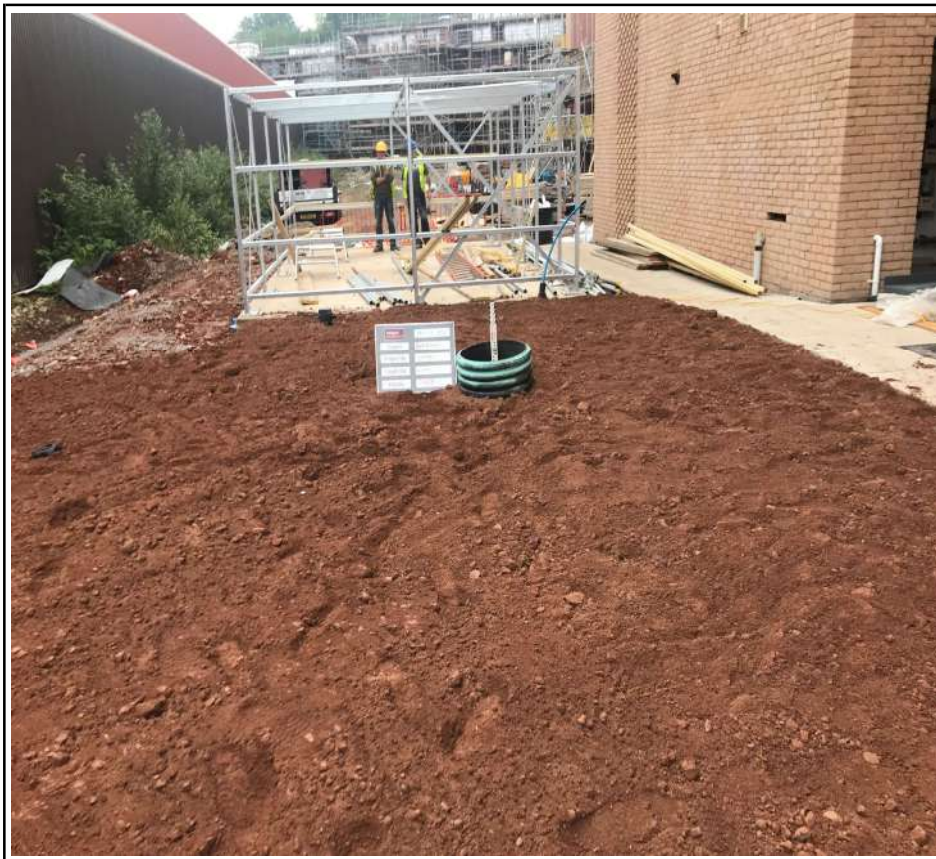
This trial pit was found to exhibit the required total of a minimum 600mm of clean cover soil material placed in the landscaped area along with observation of the Hi-Visibility Geotextile Membrane placed at the base of the capping soils.

Block M Plots 324 to 347 Capping Depth Check

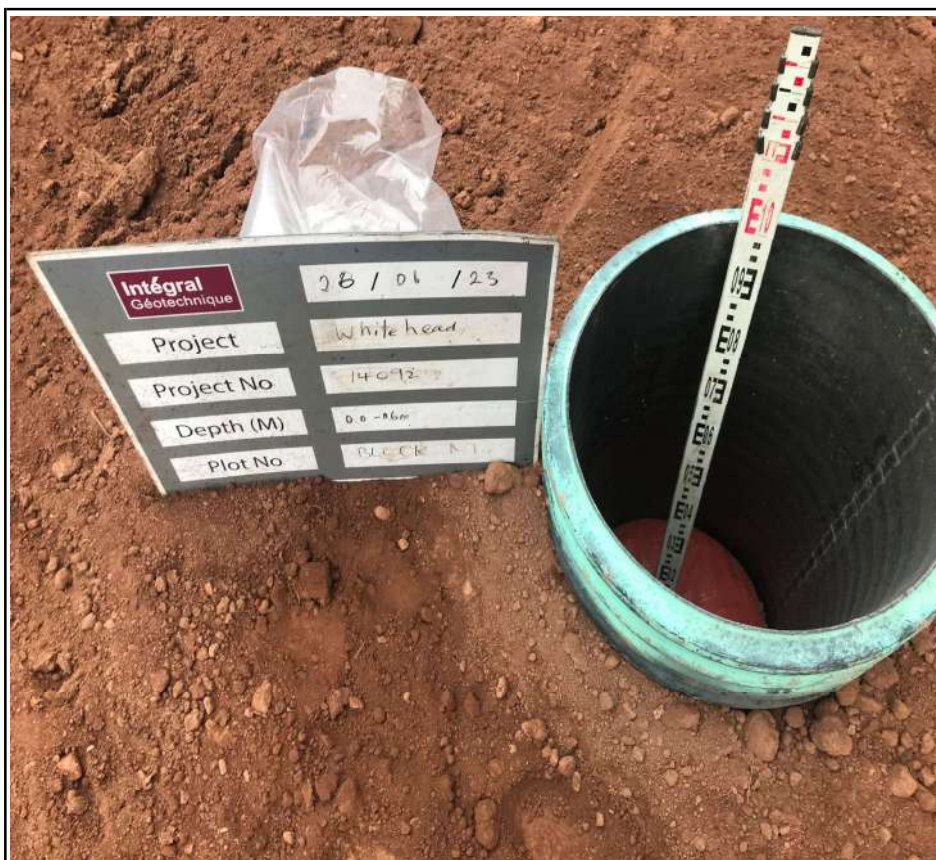
An engineer from Intégral Géotechnique attended site on 28<sup>th</sup> June 2023, Block M plots 324 to 347, is an apartment block of 24 internal apartments, encircling the apartment block are limited landscape areas, entrance pathways and public pavement access. Within the larger landscaped areas to the main entrance of the apartment block a hand/machine dug trial pit for validation purposes was advanced within the west flank of Block M Plots 324 to 347. The topsoil resembled a cohesive silty clay strata and was underlain by a subsoil material found to be a granular material comprising a medium dense becoming dense orangish brown and brown very sandy clayey gravel with medium cobble content.

Block M Plots 324 to 347 Trial Pit Excavation
