# **BRYNGLAS HOUSE: DEMOLITION OF ANNEXE BUILDING**

## HERITAGE IMPACT STATEMENT

Incorporating Design & Access Statement

Newport City Council

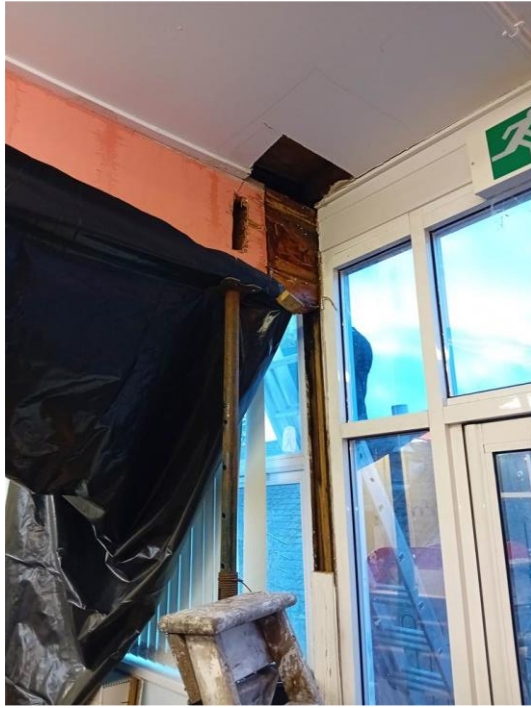
**Above:** 'dropped' beam with tarpaulin to contain water-ingress

Cambria (structural engineers) were engaged in 2024 to carry out a comprehensive assessment of the annexe building following the discovery of a dropped/decayed beam and post connection in one of the classrooms. Subsequent investigations of the rest of the building revealed an inherent design defect with the structure of the building. This had been compounded by later ill-conceived window replacements and prolonged ponding of water on the roof, which have collectively undermined its structural strength.

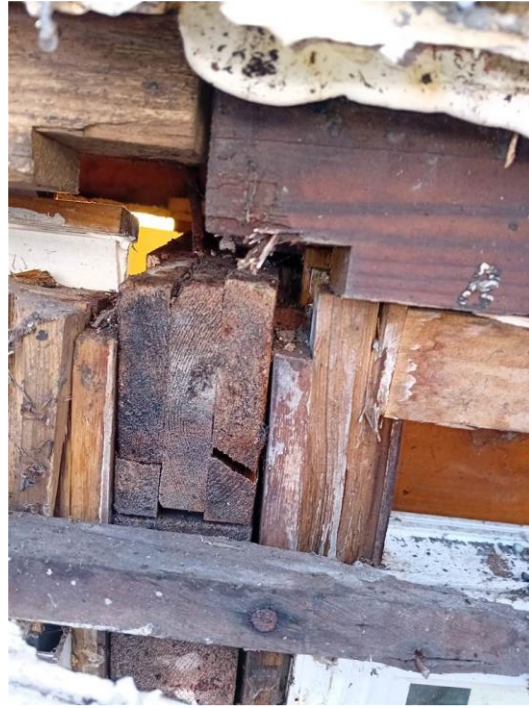
**Above:** external opening-up works of typical beam-post connection, revealing extent of movement

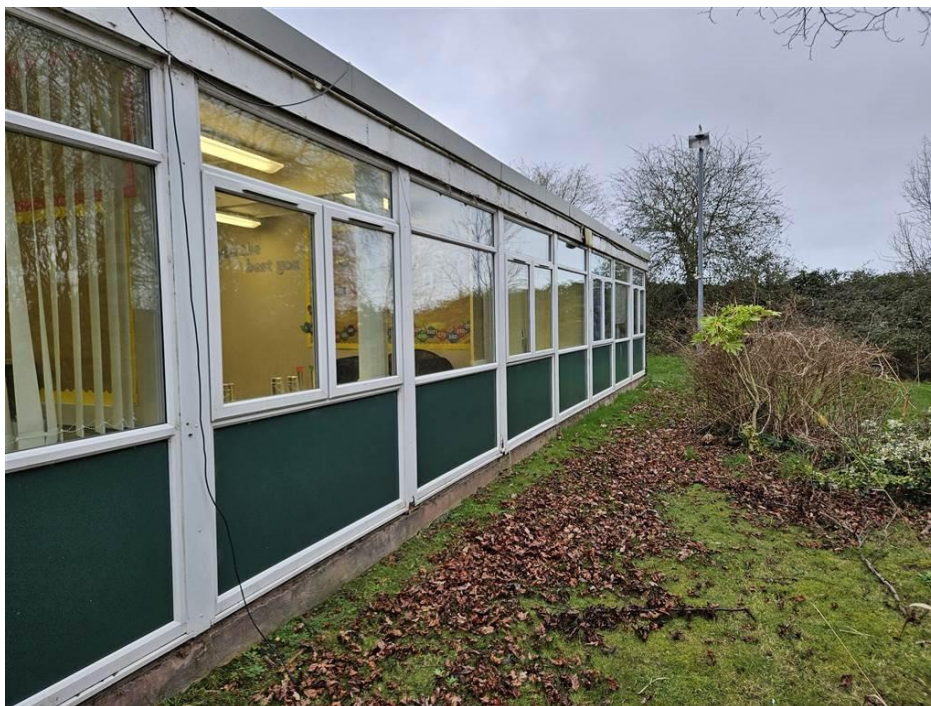
**Left:** typical elevation finish (2024)

The annexe building is of lightweight demountable construction and sits on the site of the original walled kitchen garden. The building's main core was built in the late 1960s as an additional classroom block when the site housed Brynglas Central School. At some stage, a sizeable extension of similar construction – painted joinery and low-level infill panels – has been added to the north elevation. Prior to Millbrook Primary School's relocation to the site, this building was used for day services. The school then utilised it as a teaching space until they vacated in early 2024 because of concerns over its poor structural condition. Like the other curtilage structures, this building does little to enhance or compliment the site.

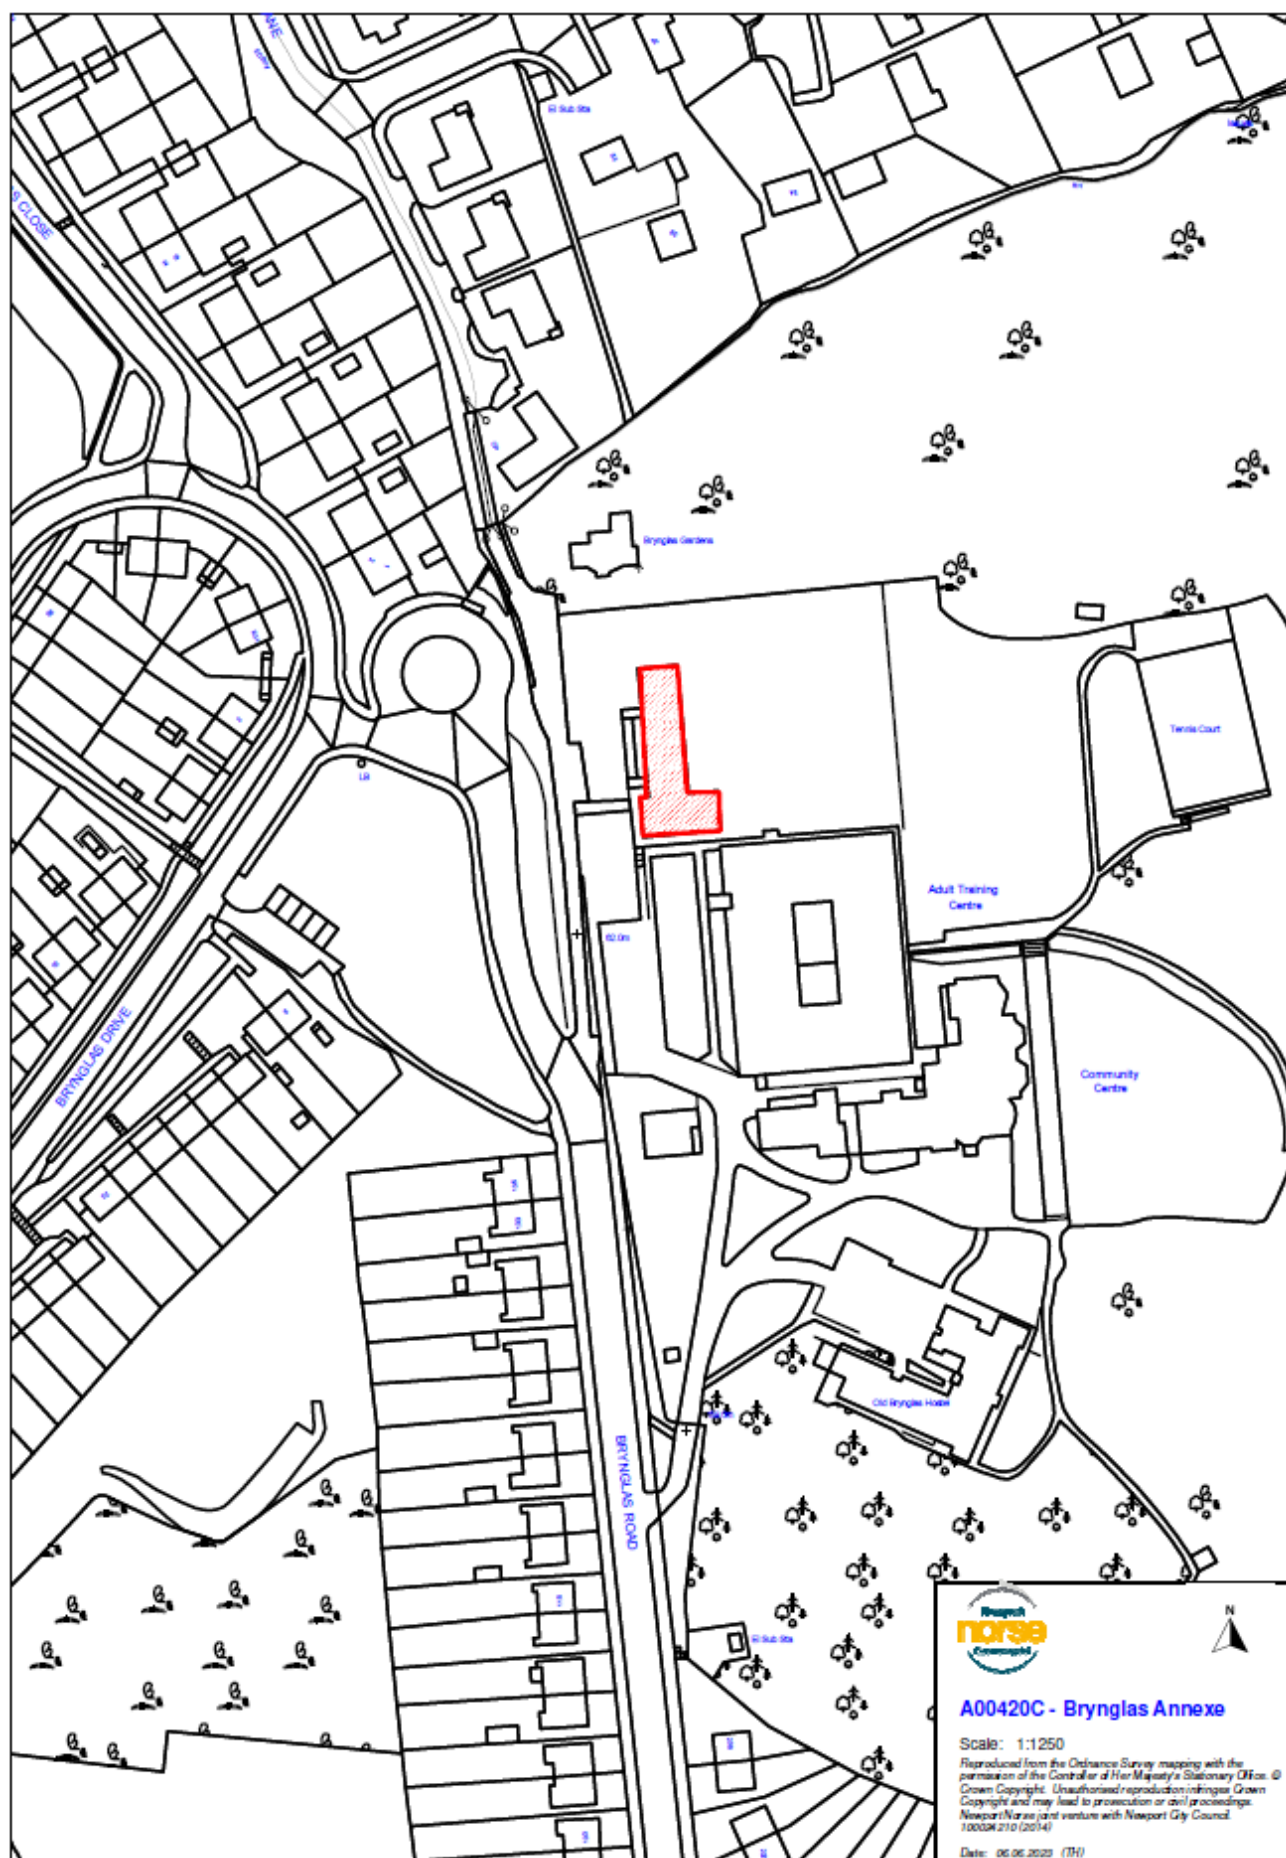
## Appendix C – Site Plan

Please refer to the attached site plan [Appendix 'C'], which shows the location of the annexe building and its context with the surrounding buildings, and their relationship with the main house (Brynglas House).
