| Job Name | <b>Drake House, Langstone, Newport</b> | Job Number | <b>1228</b> | Date | <b>14.02.25</b> |

## Site Report – Final snagging

The above site was inspected on the 14<sup>th</sup> February 2025 at 12.00pm by Dan Patterson of dp landscape architecture [DPLA]. This report assesses the completed work against DPLA drawing number 1228.01.

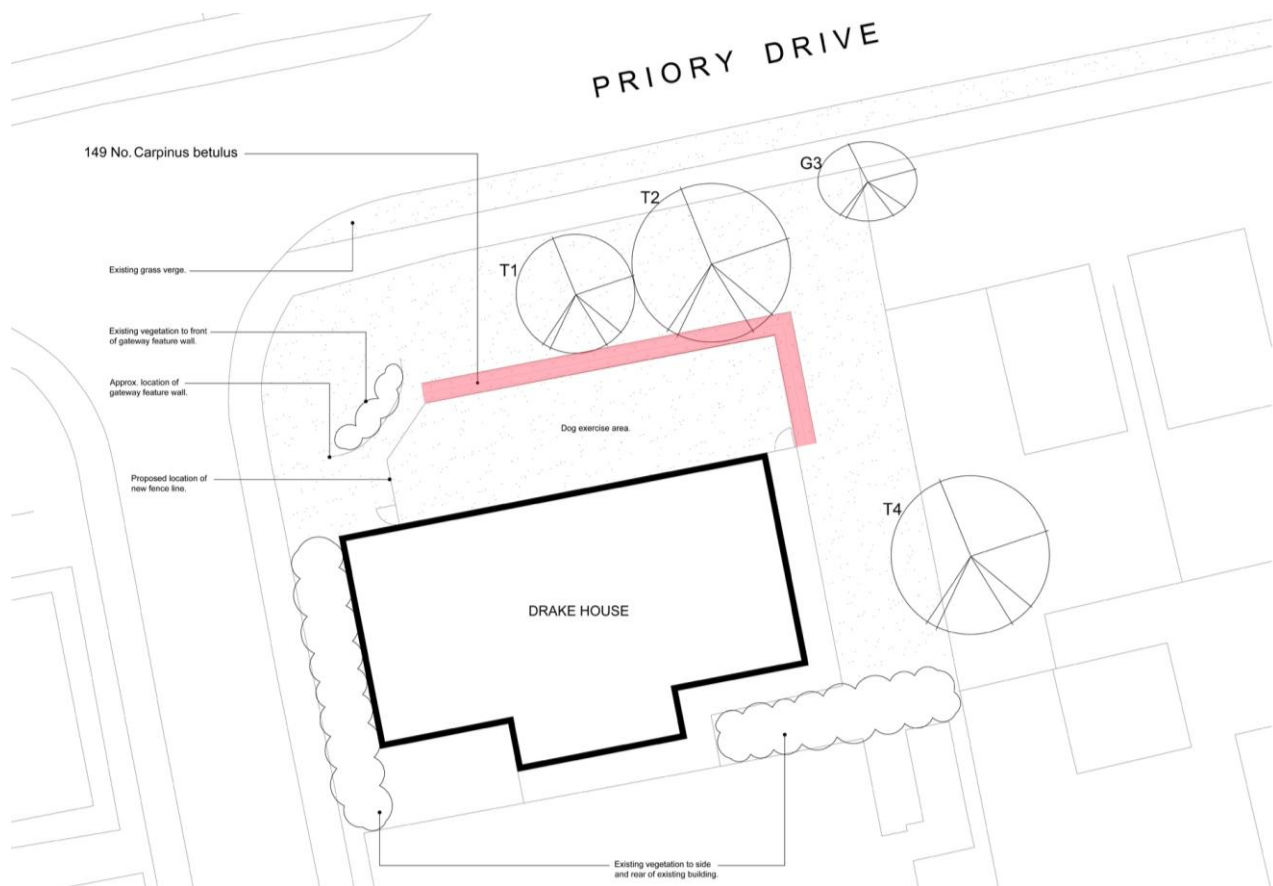
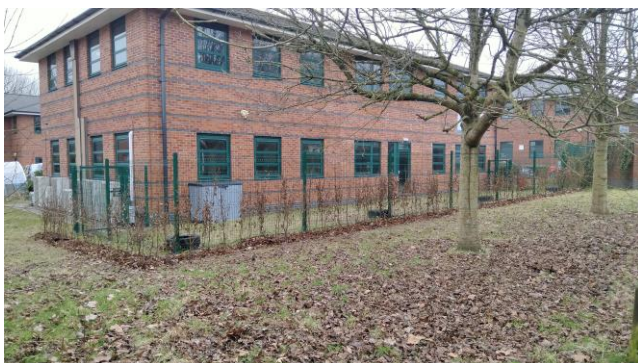
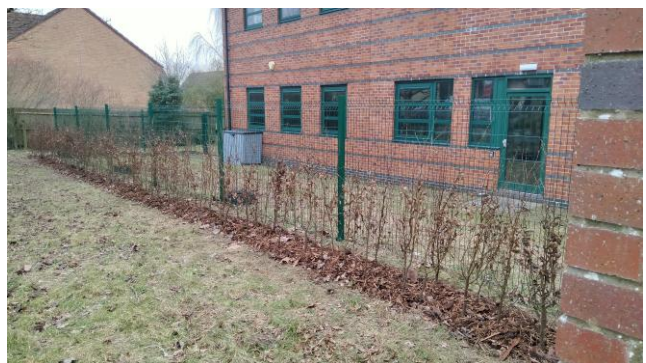
The new hedge has been completed in accordance with the above drawing. The species used [hornbeam] appears to be correct.

The height of the new planting is acceptable and the spacing / planting density is correct. Plant numbers are also in line with the drawing and bark mulch is in place to the correct depth.

The plants themselves appear to be good quality and have been planted correctly.

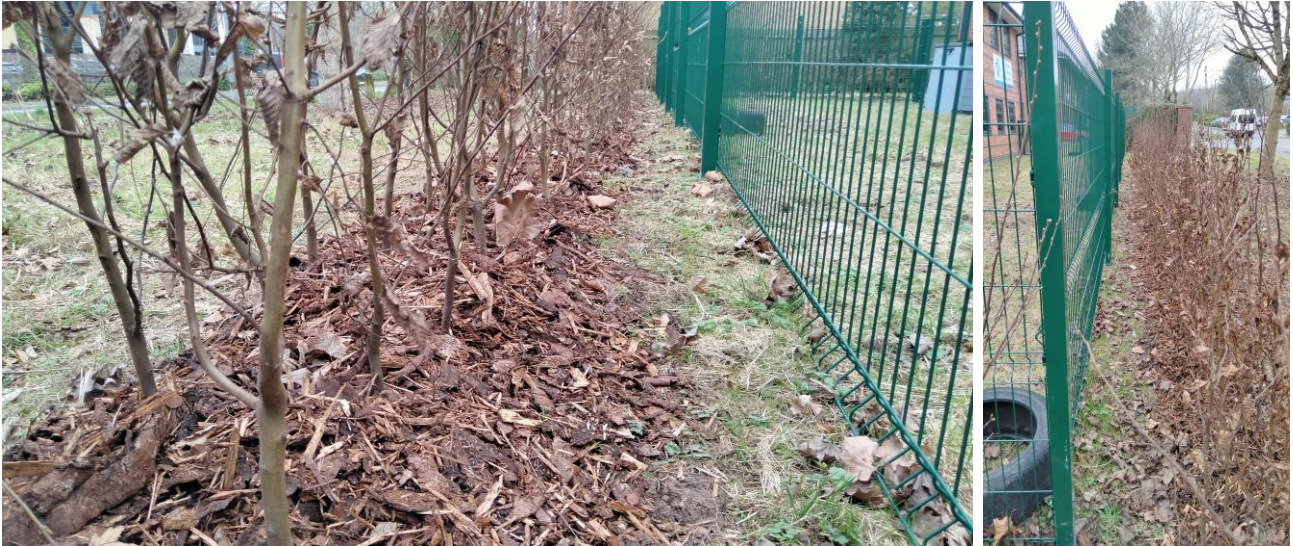
There is a very narrow strip of grass between the hedge and the fence line. See photographs below. It would be beneficial to remove / kill off this grass to avoid any future maintenance issues. The gap should be filled with bark, up to the fence line.
