# Tree Check Arboriculture LTD

## Site Supervision Report

| <b>Project Name</b> | | Bryn Glas Annex Demolition | |

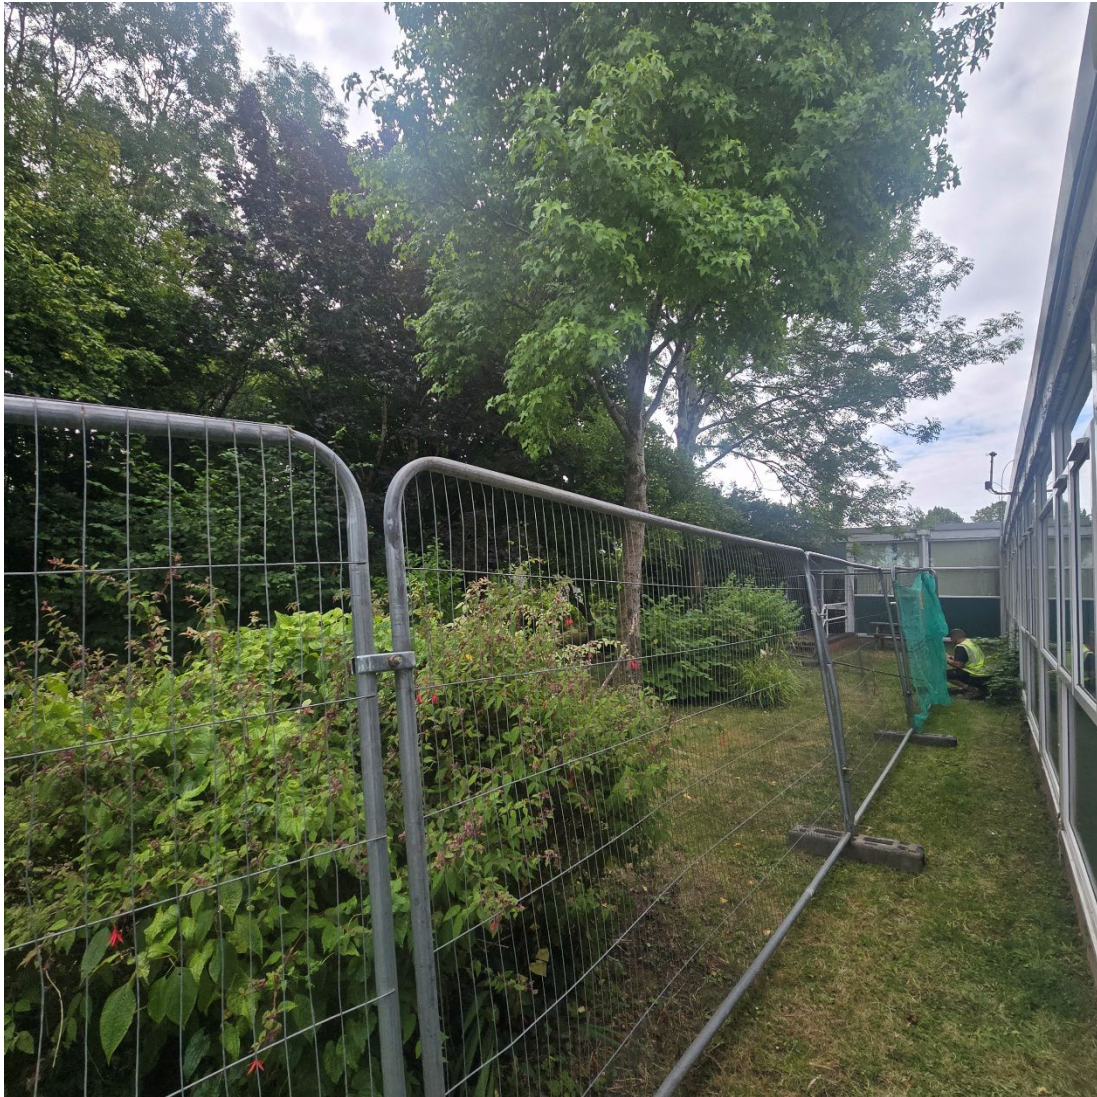
**Pphoto 1:** Boundary fencing segregates retained trees from the structure. Demolition is to be supervised by the project arboriculturalist in this location.
