| <b>JOB</b><br><b>TITLE</b> | 27 Backhall Street<br>Caerleon | <b>DRAWING</b><br><b>TITLE</b> | Details | <b>DRAWING No.</b> | SD1081-03 |

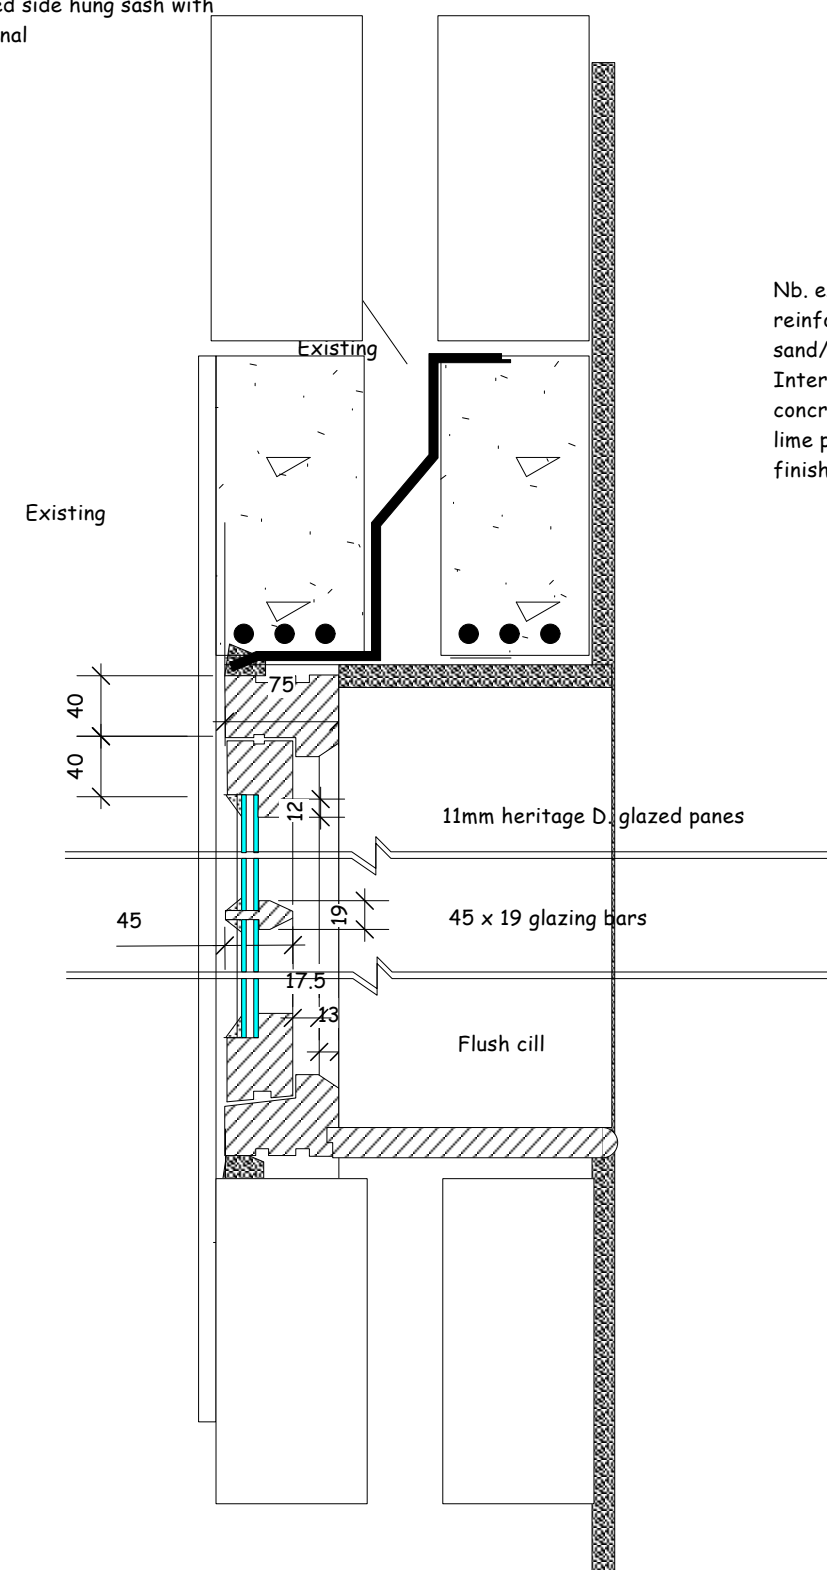
Vertical section through Window  
Showing Flush mounted side hung sash with  
details to match original  
19th Century window

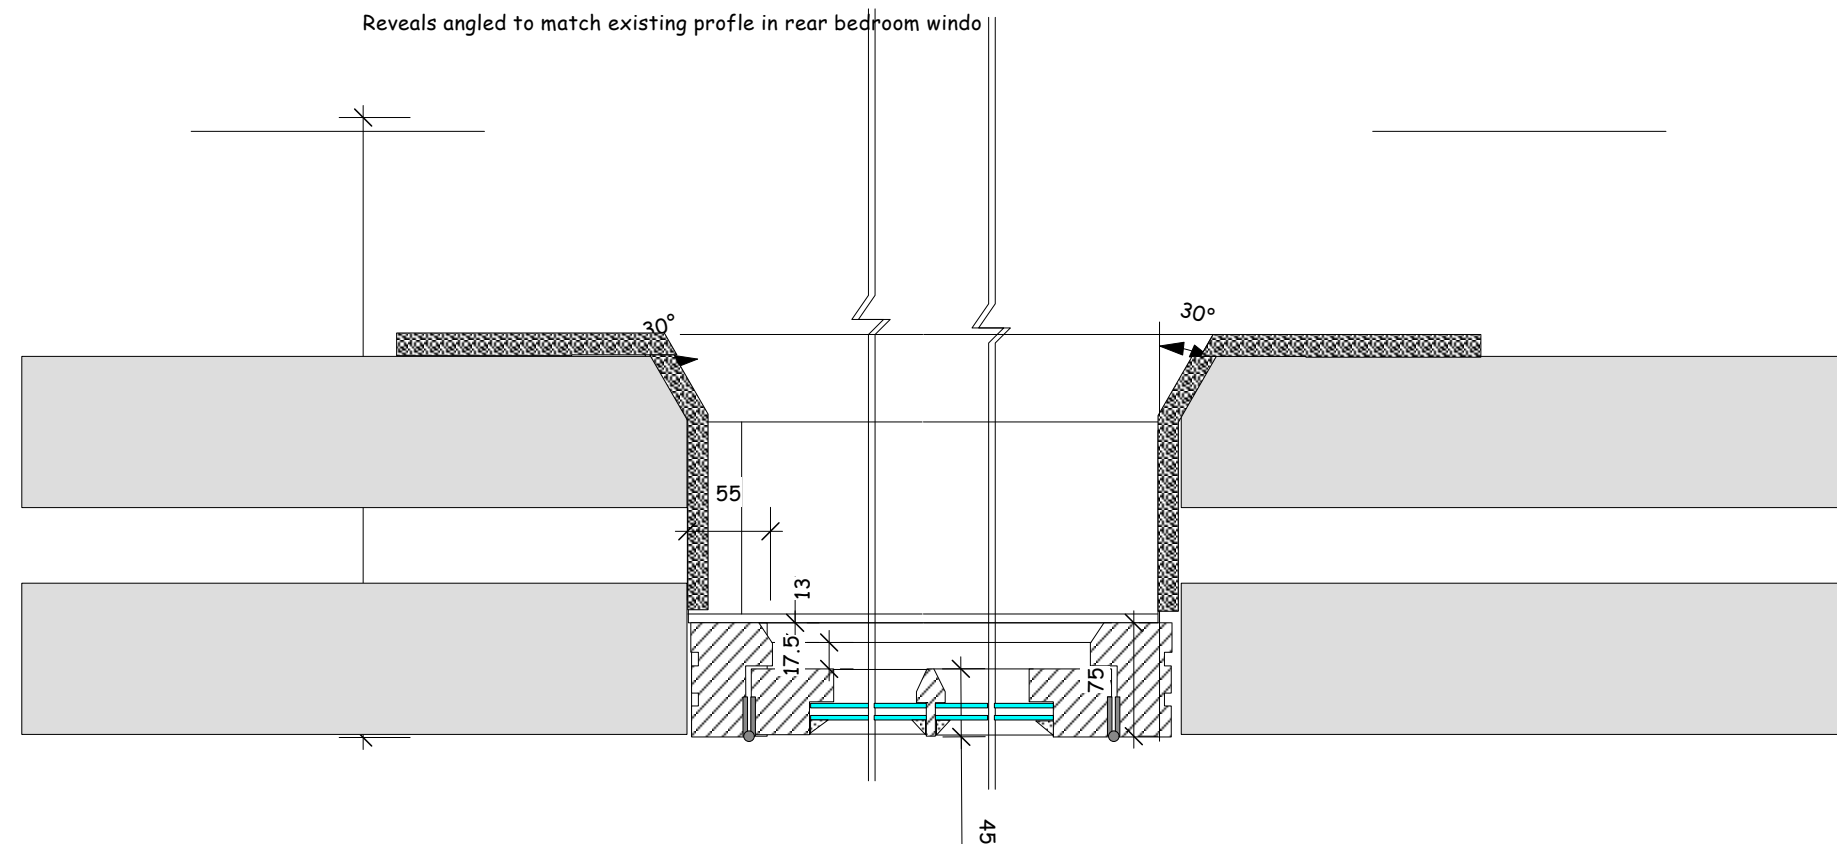
Nb. existing openings formed with reinforced concrete lintels with sand/cement slurry coat.  
Internal skin supported on reinforced concrete lintels with lime render and lime plaster skim  
finish to match existing internal finish.

Sw cill board in 150 x 19 tand  
g boards with bull nose

Reveals angled to match existing profile in rear bedroom window
