**Glan Llyn**  
**Phase 5A & 5B**  
Remediation Strategy

Brighton STM Developments Limited

DATE: June 2026

18669-RLL-25-XX-RP-O-0816

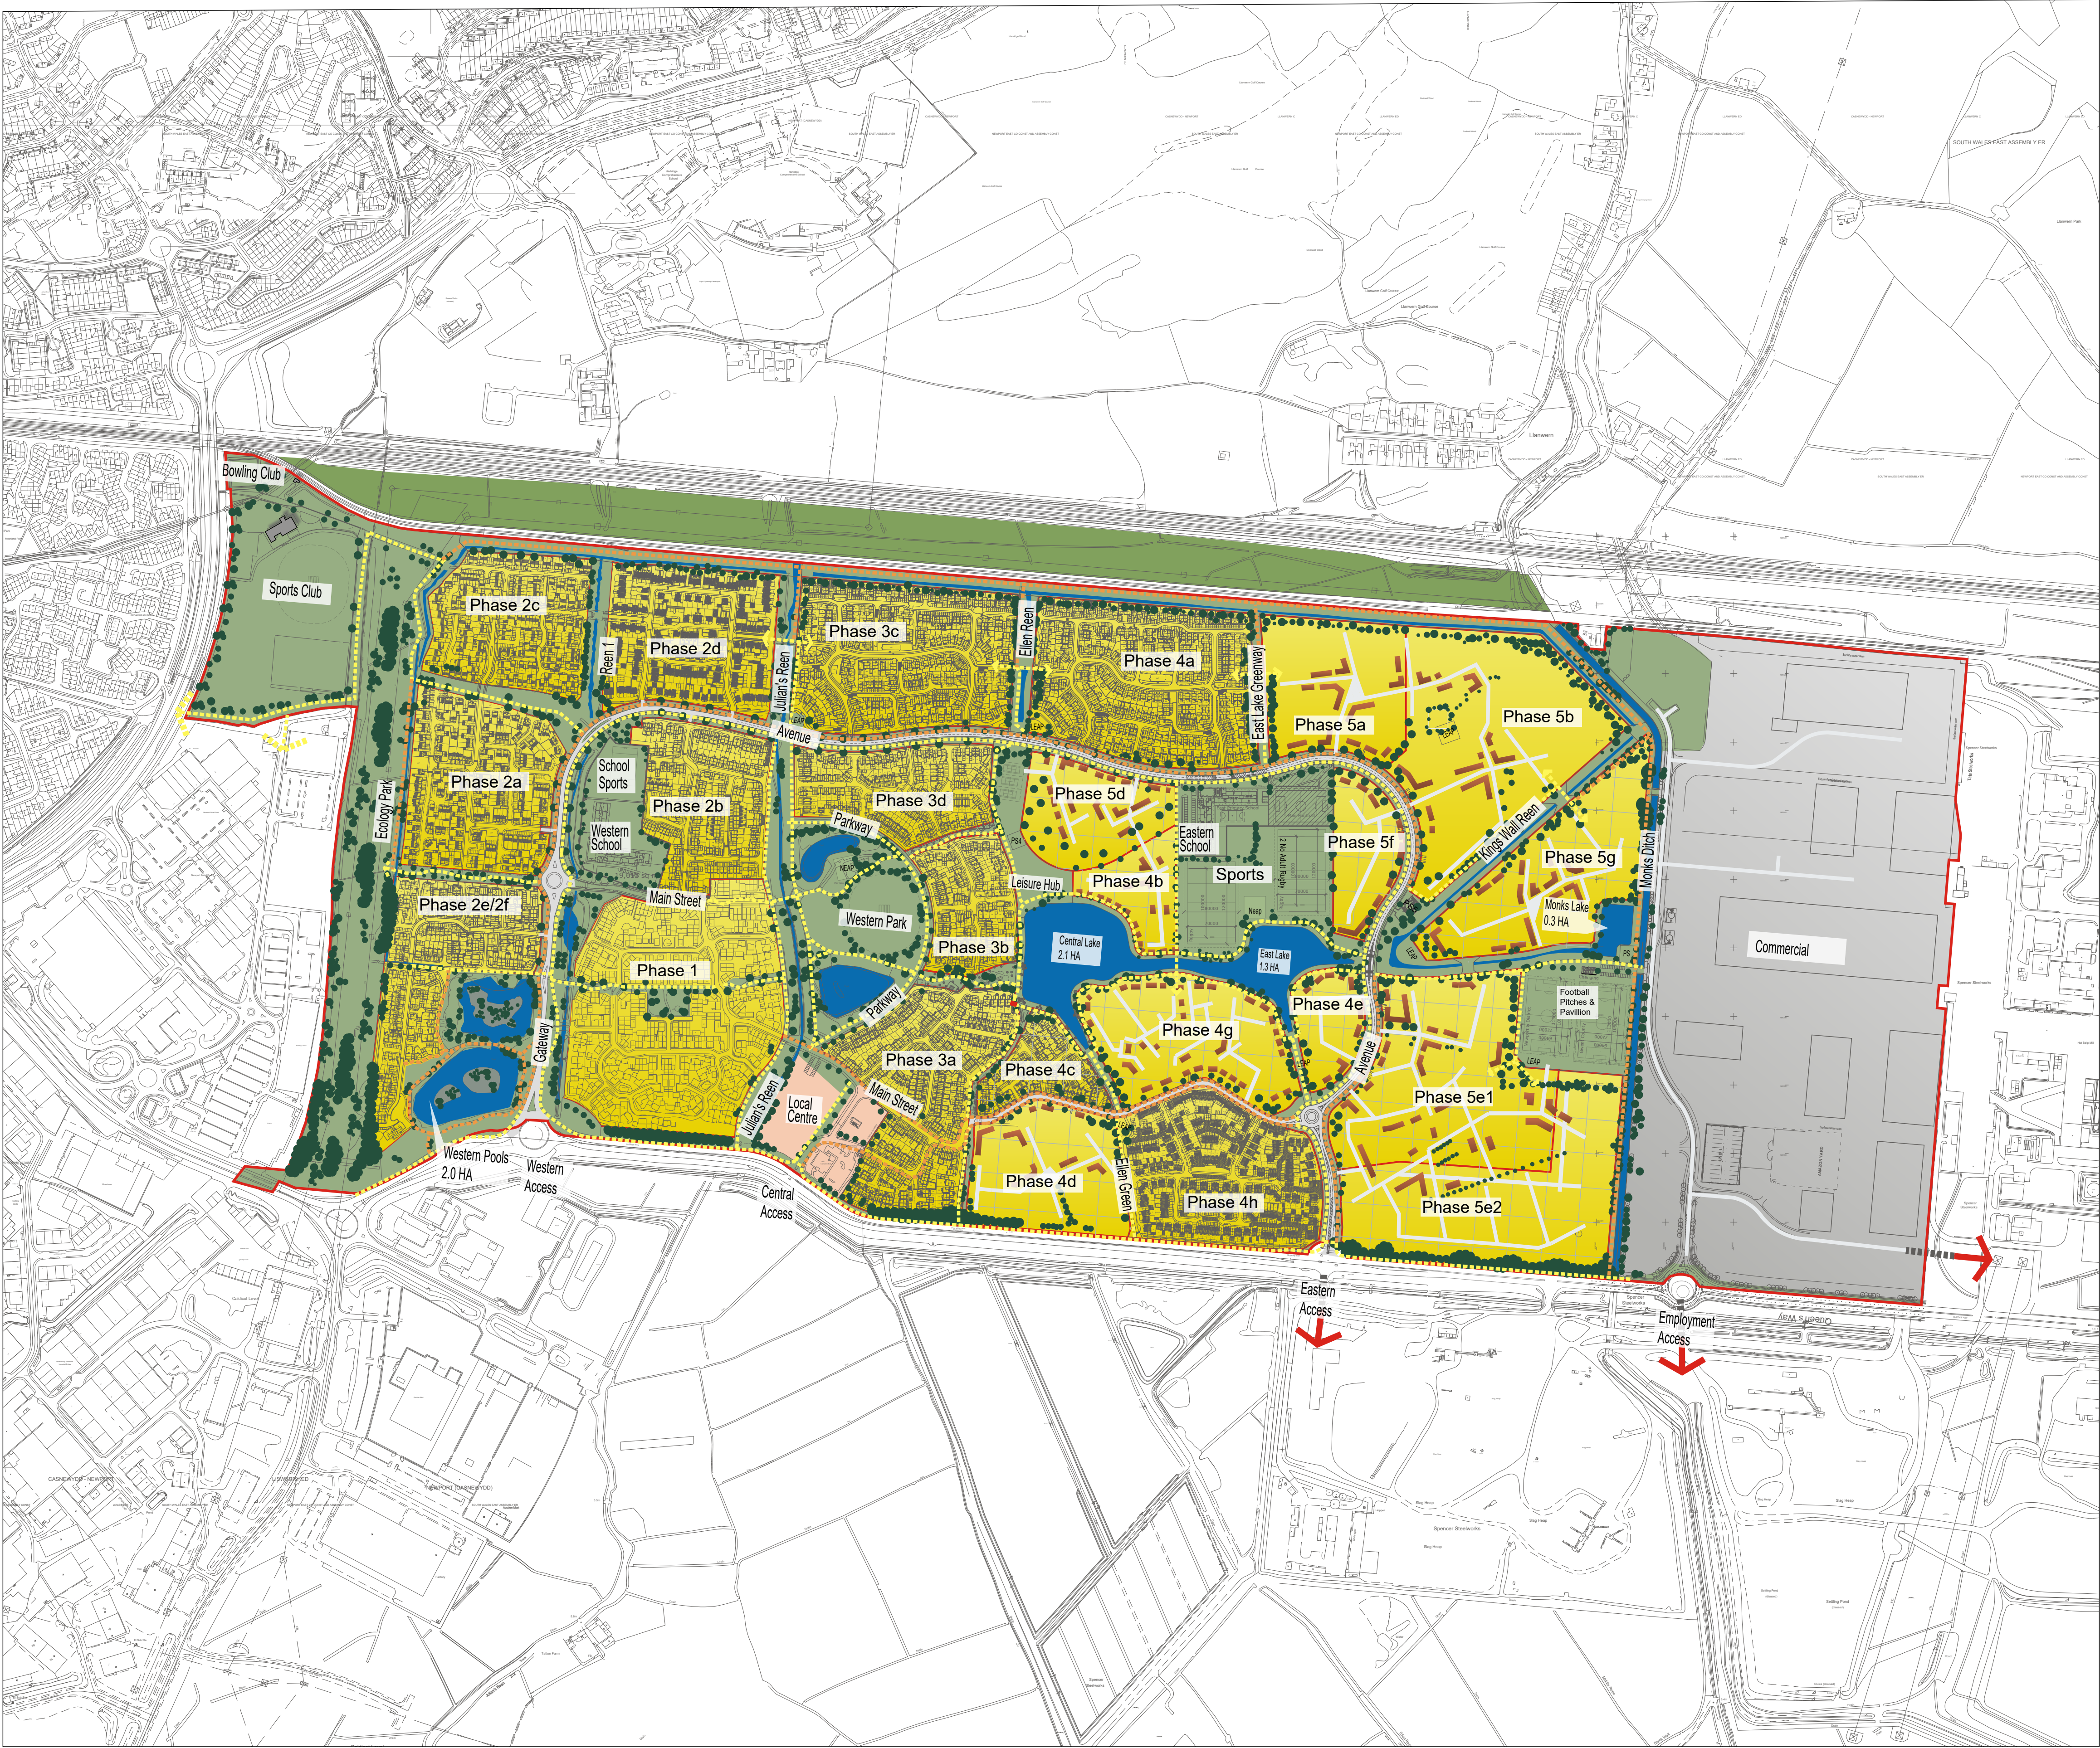
Glan Llyn -ESAMP Indicative Masterplan

It is understood that the Site is proposed to be redeveloped for a residential end-use. An illustrative masterplan (ref. 8111-08-A011, dated April 2019) is available in **Appendix A**.
