**Site Name: Land at Docks Way, Newport**

**Report Reference: WWE26082 Land at Docks Way - Fencing Plan REV B.**

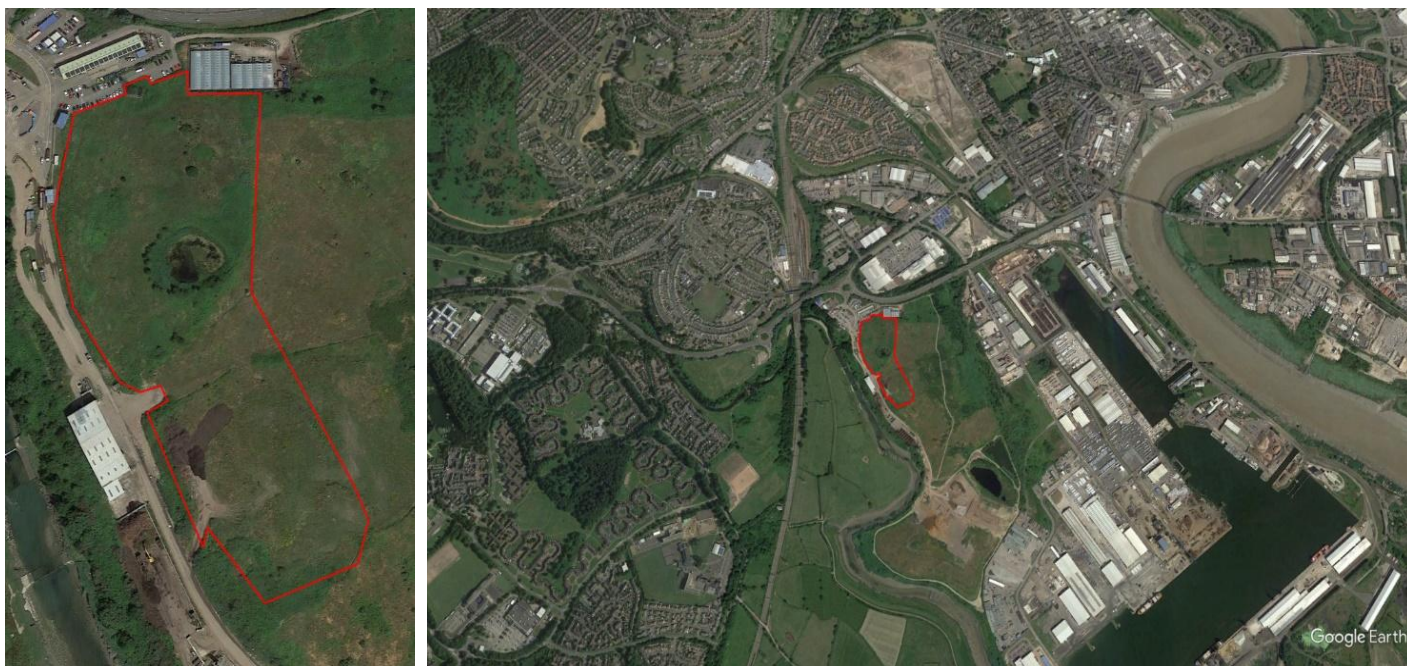
**Figure 1: Aerial image of the site (red line shows the site boundary) in relation to the rivers Usk (To the east) and the Ebbw (to the immediate west).**

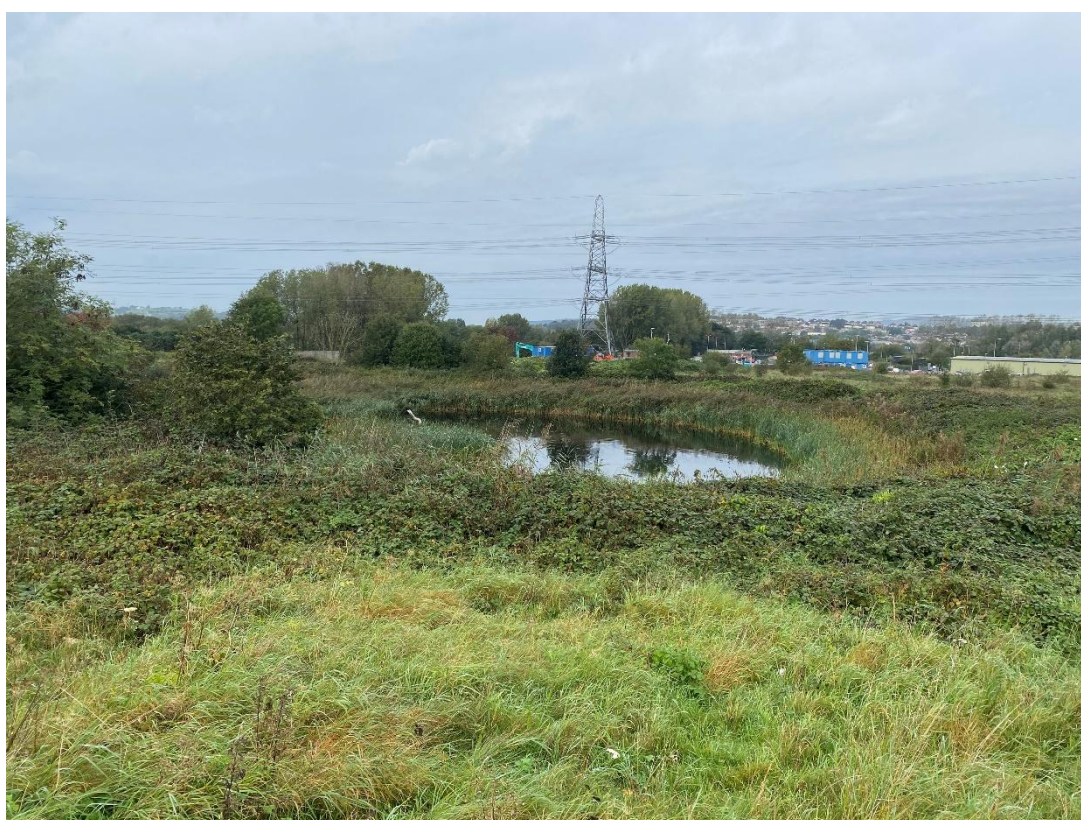
**Figure 2: Dense scrub and pond recorded on site October 2023; suitable terrestrial and foraging habitats for otter**

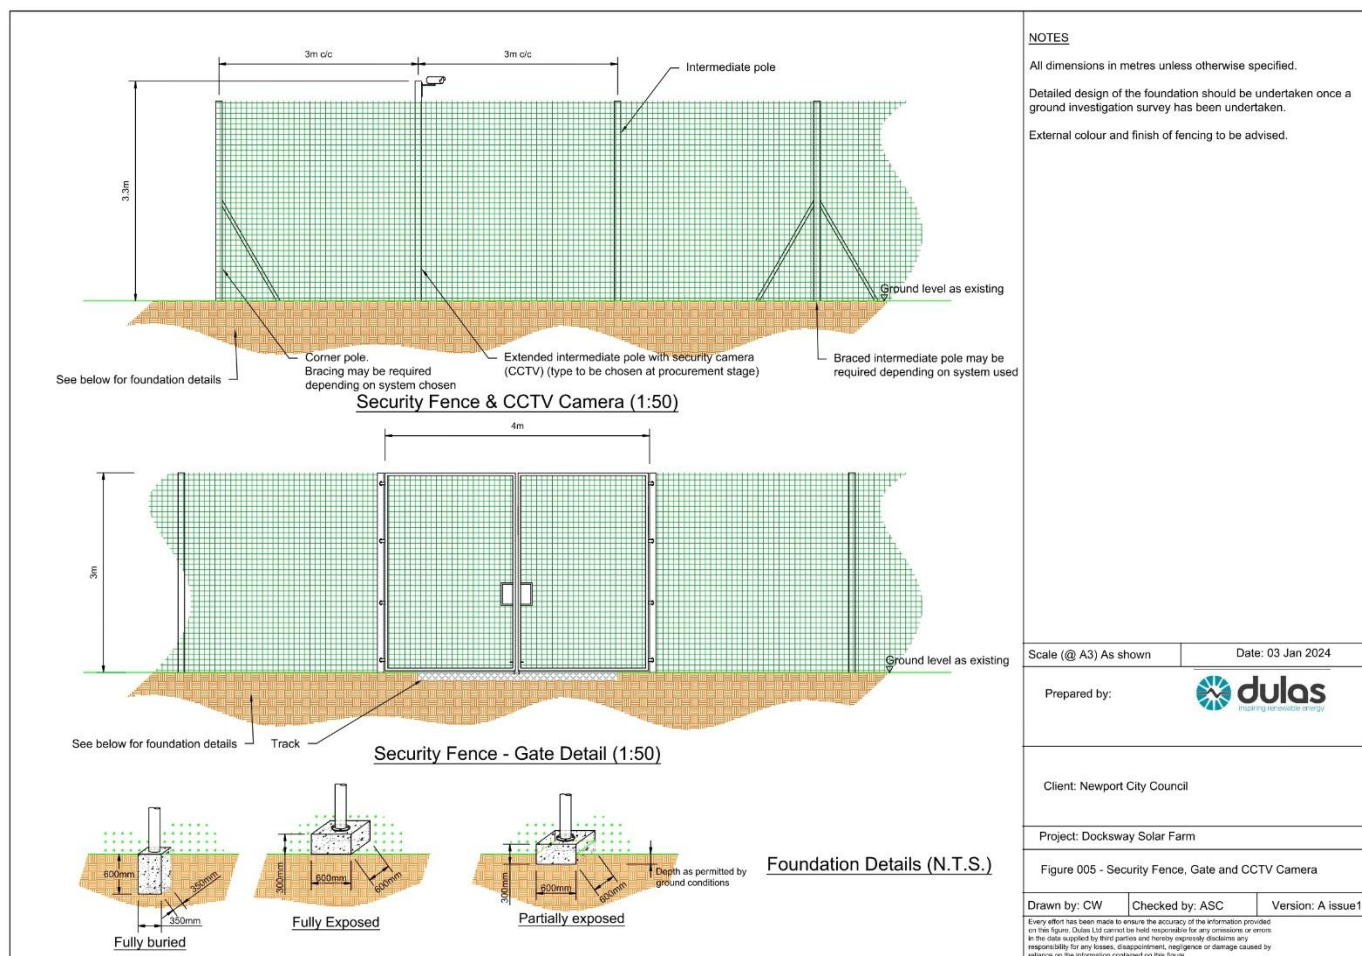
**Figure 2:**

***Security Fence, Gate and CCTV Camera (Version A – Issue 1)* Dulas Fencing plan submitted 04/01/2024**

Fencing plans have previously been submitted alongside proposals for this site (*Figure 005 – Security Fence, Gate and CCTV Camera (Version A – Issue 1)*) Dulas. See Figure 3 below. This current fencing is proposed to bound the entirety of the site. See figure 4 below. Under these current fencing proposals access for commuting mammals would be obstructed to site, thereby potentially obstructing access to otter.

It is therefore advised that alterations be made to either the fencing, or gaps be created below the proposed fencing in order to keep the site accessible to commuting mammals, while still providing security for the site.

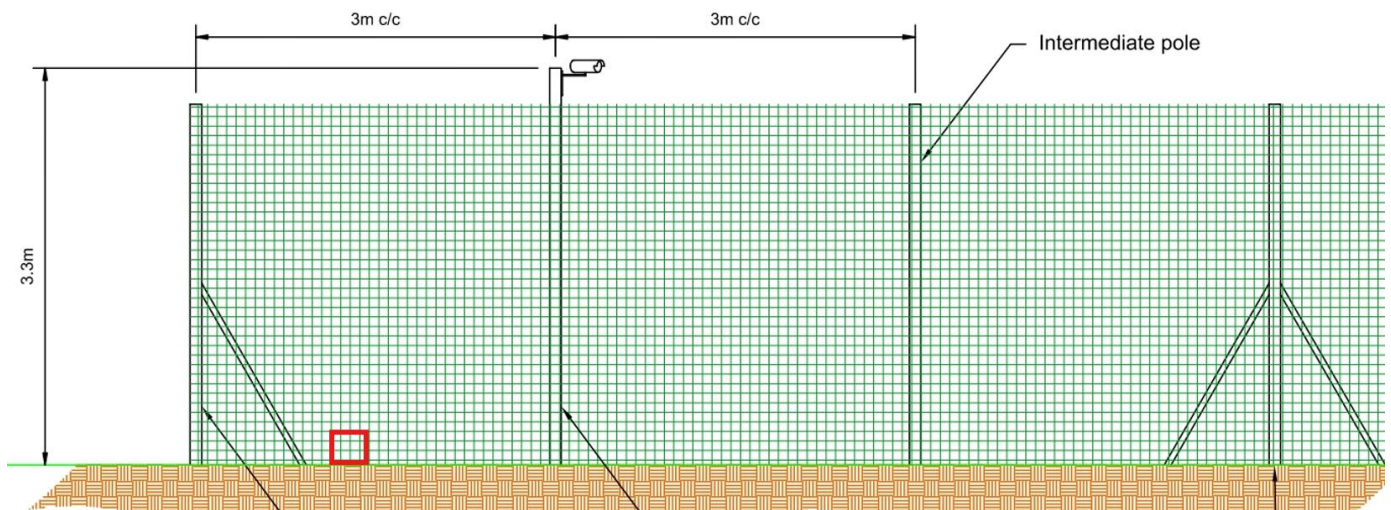
**Figure 3: Approximate size of created gap within fencing plan**

The current proposed fence could have intermittent gaps created after their installation, or during their fabrication. These gaps should be approximately 20 x 20cm to allow adult otters, as well as other commuting mammals (i.e. hedgehogs, badgers), to access the site. The gaps should be created at the base of the fence, so it is easily accessible for commuting mammals. If these gaps are cut into the fence after installation, care must be taken to ensure that no sharp or jagged edges are left that may injure wildlife passing through.

See Figure 3 below for the approximate size of a 20 x 20cm gap in relation to the current fencing proposals.

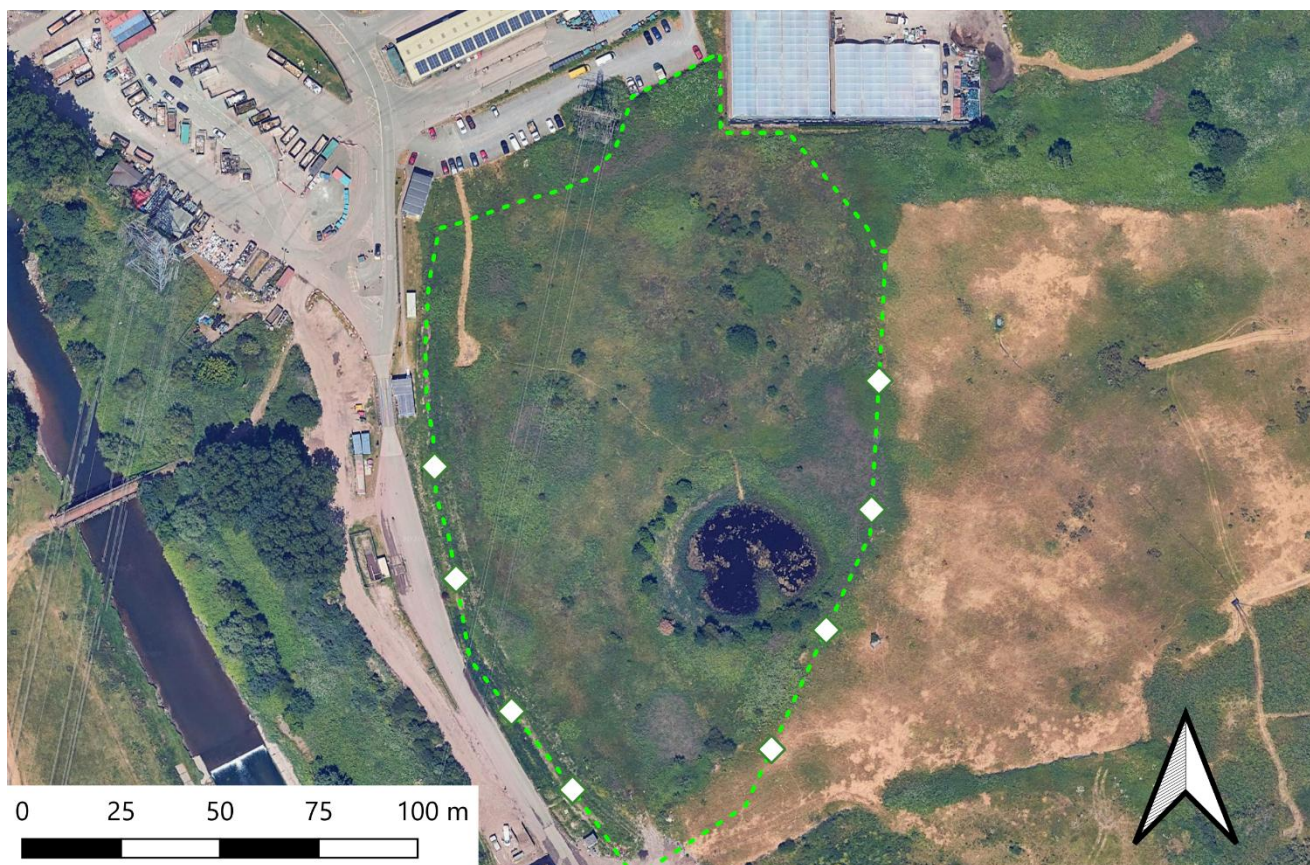
- Proposed fencing
- ◇ Approximate recommended locations of mammal gaps

**Figure 4: Proposed fencing and recommended location of mammal gaps**

It is recommended that created mammal gaps are made intermittently, at least one every 30 metres along the fence line. These will likely be most effective at the south of the site closest to pond and dense scrub habitats. At both eastern and western sides to allow access/ egress for any otters travelling from the river Ebbw to the west of the site and the River Usk to the east of the site. The north of the site is the most developed landscape surrounding the site, and includes car parks. Therefore, it would not be ideal to encourage mammals to enter or leave the site from this direction.

Gaps must be created either within or below proposed fencing in order to allow otters access to, and across, the site. These gaps must be at least 20 x 20cm, and not have sharp or jagged edges that may injure any animals passing through them. Gaps should ideally be positioned at the eastern and western boundaries of the site, to allow access to the river Usk and the river Ebbw. Gaps should not be created at the northern boundary of the site, as this may encourage otters leaving the site to travel through car parking areas.
