## **Boundary Treatment Context Assessment Oakfields, Lighthouse Road**

This document presents a photographic record of 28 different boundary treatments along Lighthouse Road, mapped for clarity to illustrate the existing character of the street scene and local context within the Wentlooge Special Landscape Area.

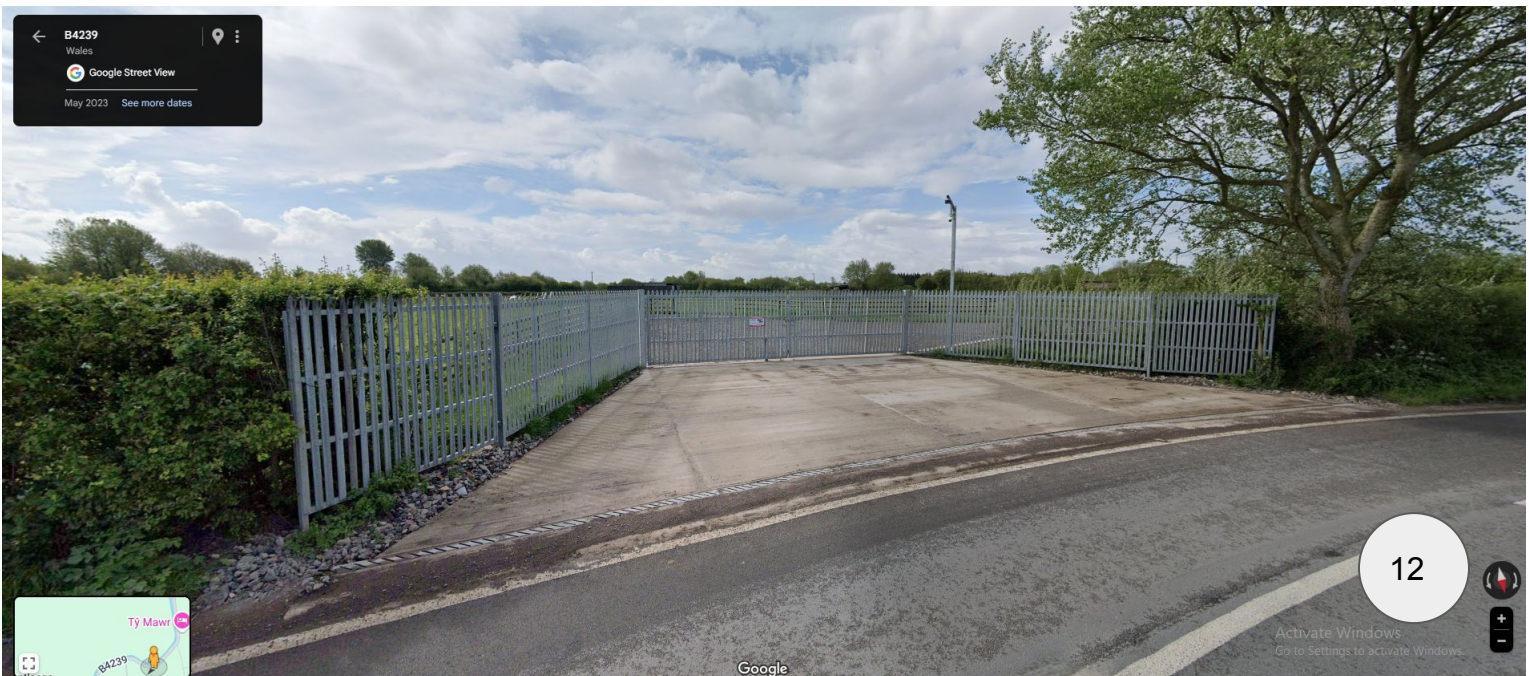
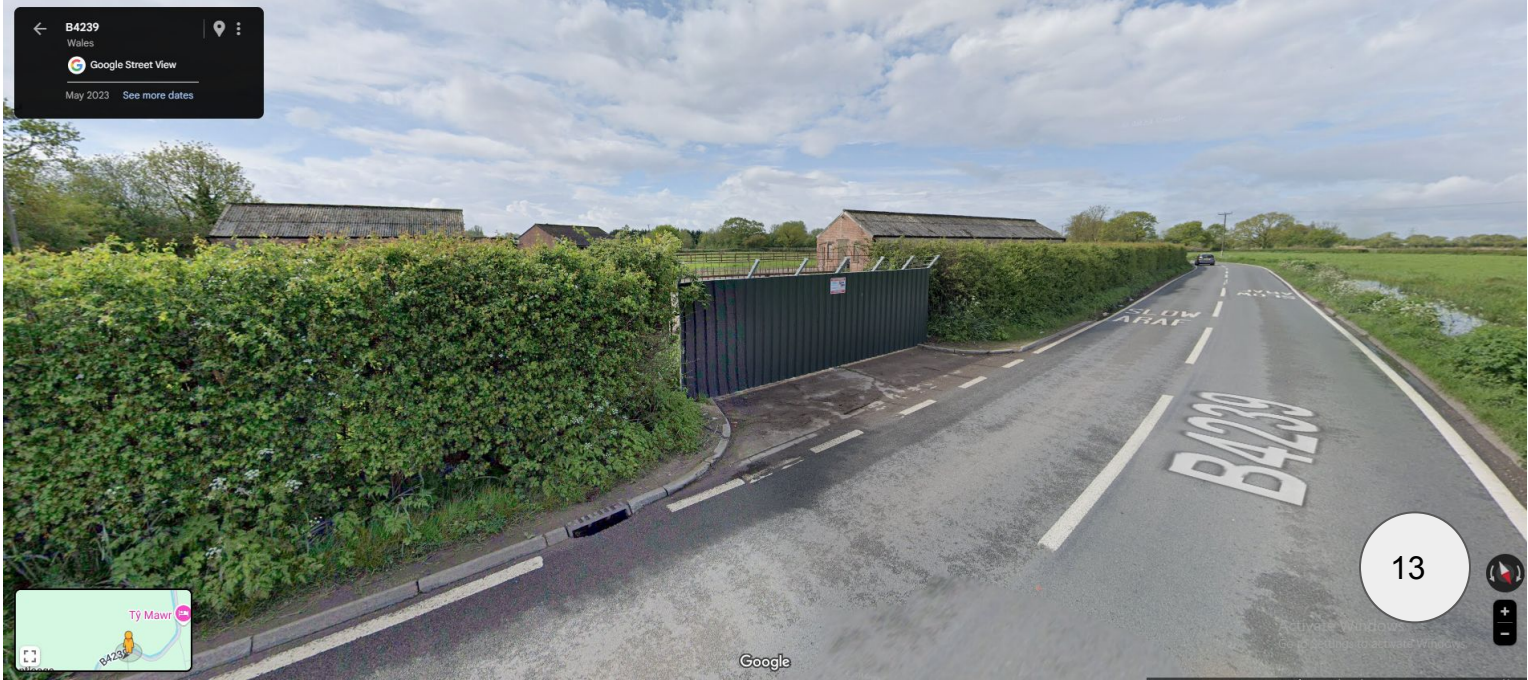
It is also an important consideration that Images 12 and 13, which are the two boundary treatments closest to the north of our site, comprise large and prominent metal fences and gates. These boundary features are visually prominent and by their nature not sympathetic to the wider landscape character. However, their presence is read as part of the existing visual context when travelling along Lighthouse Road, which means that our proposed wall would appear considerably more sympathetic and visually cohesive by comparison. In effect, the prominence of these adjacent boundary treatments helps to soften the impact of our proposal, as it would be understood as one element within a varied and already developed landscape.
