**HILL & SMITH COMPOUND OFFICE DEVELOPMENT**

**GROUND INVESTIGATION REPORT**

**DATE ISSUED:** 17/06/2025  
**JOB NUMBER:** CA13057  
**REPORT NUMBER:** 0005  
**VERSION:** V2.0  
**STATUS:** FINAL

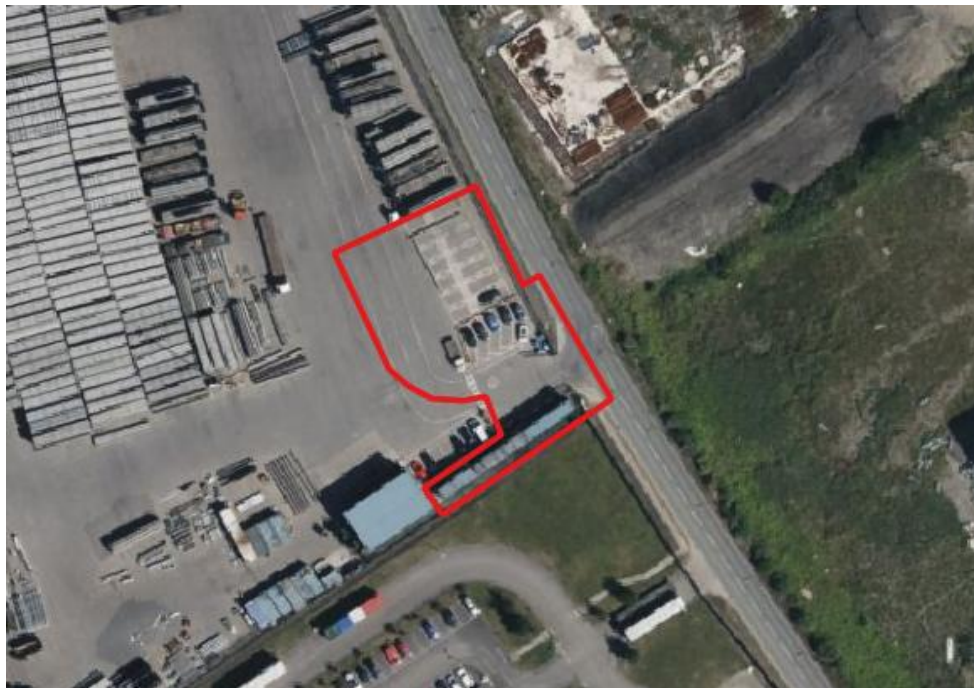
- 1.3 The Site is located on land off Tom Lewis Way at the Alexandra Docks in Newport, NP20 2WF. The Site is 0.163 Ha and centred at E 331173, N 184616, shown below in **Figure 1** and on **Drawing CA13057-007**.

**Figure 1 – Site boundary (Bing aerial imagery).**

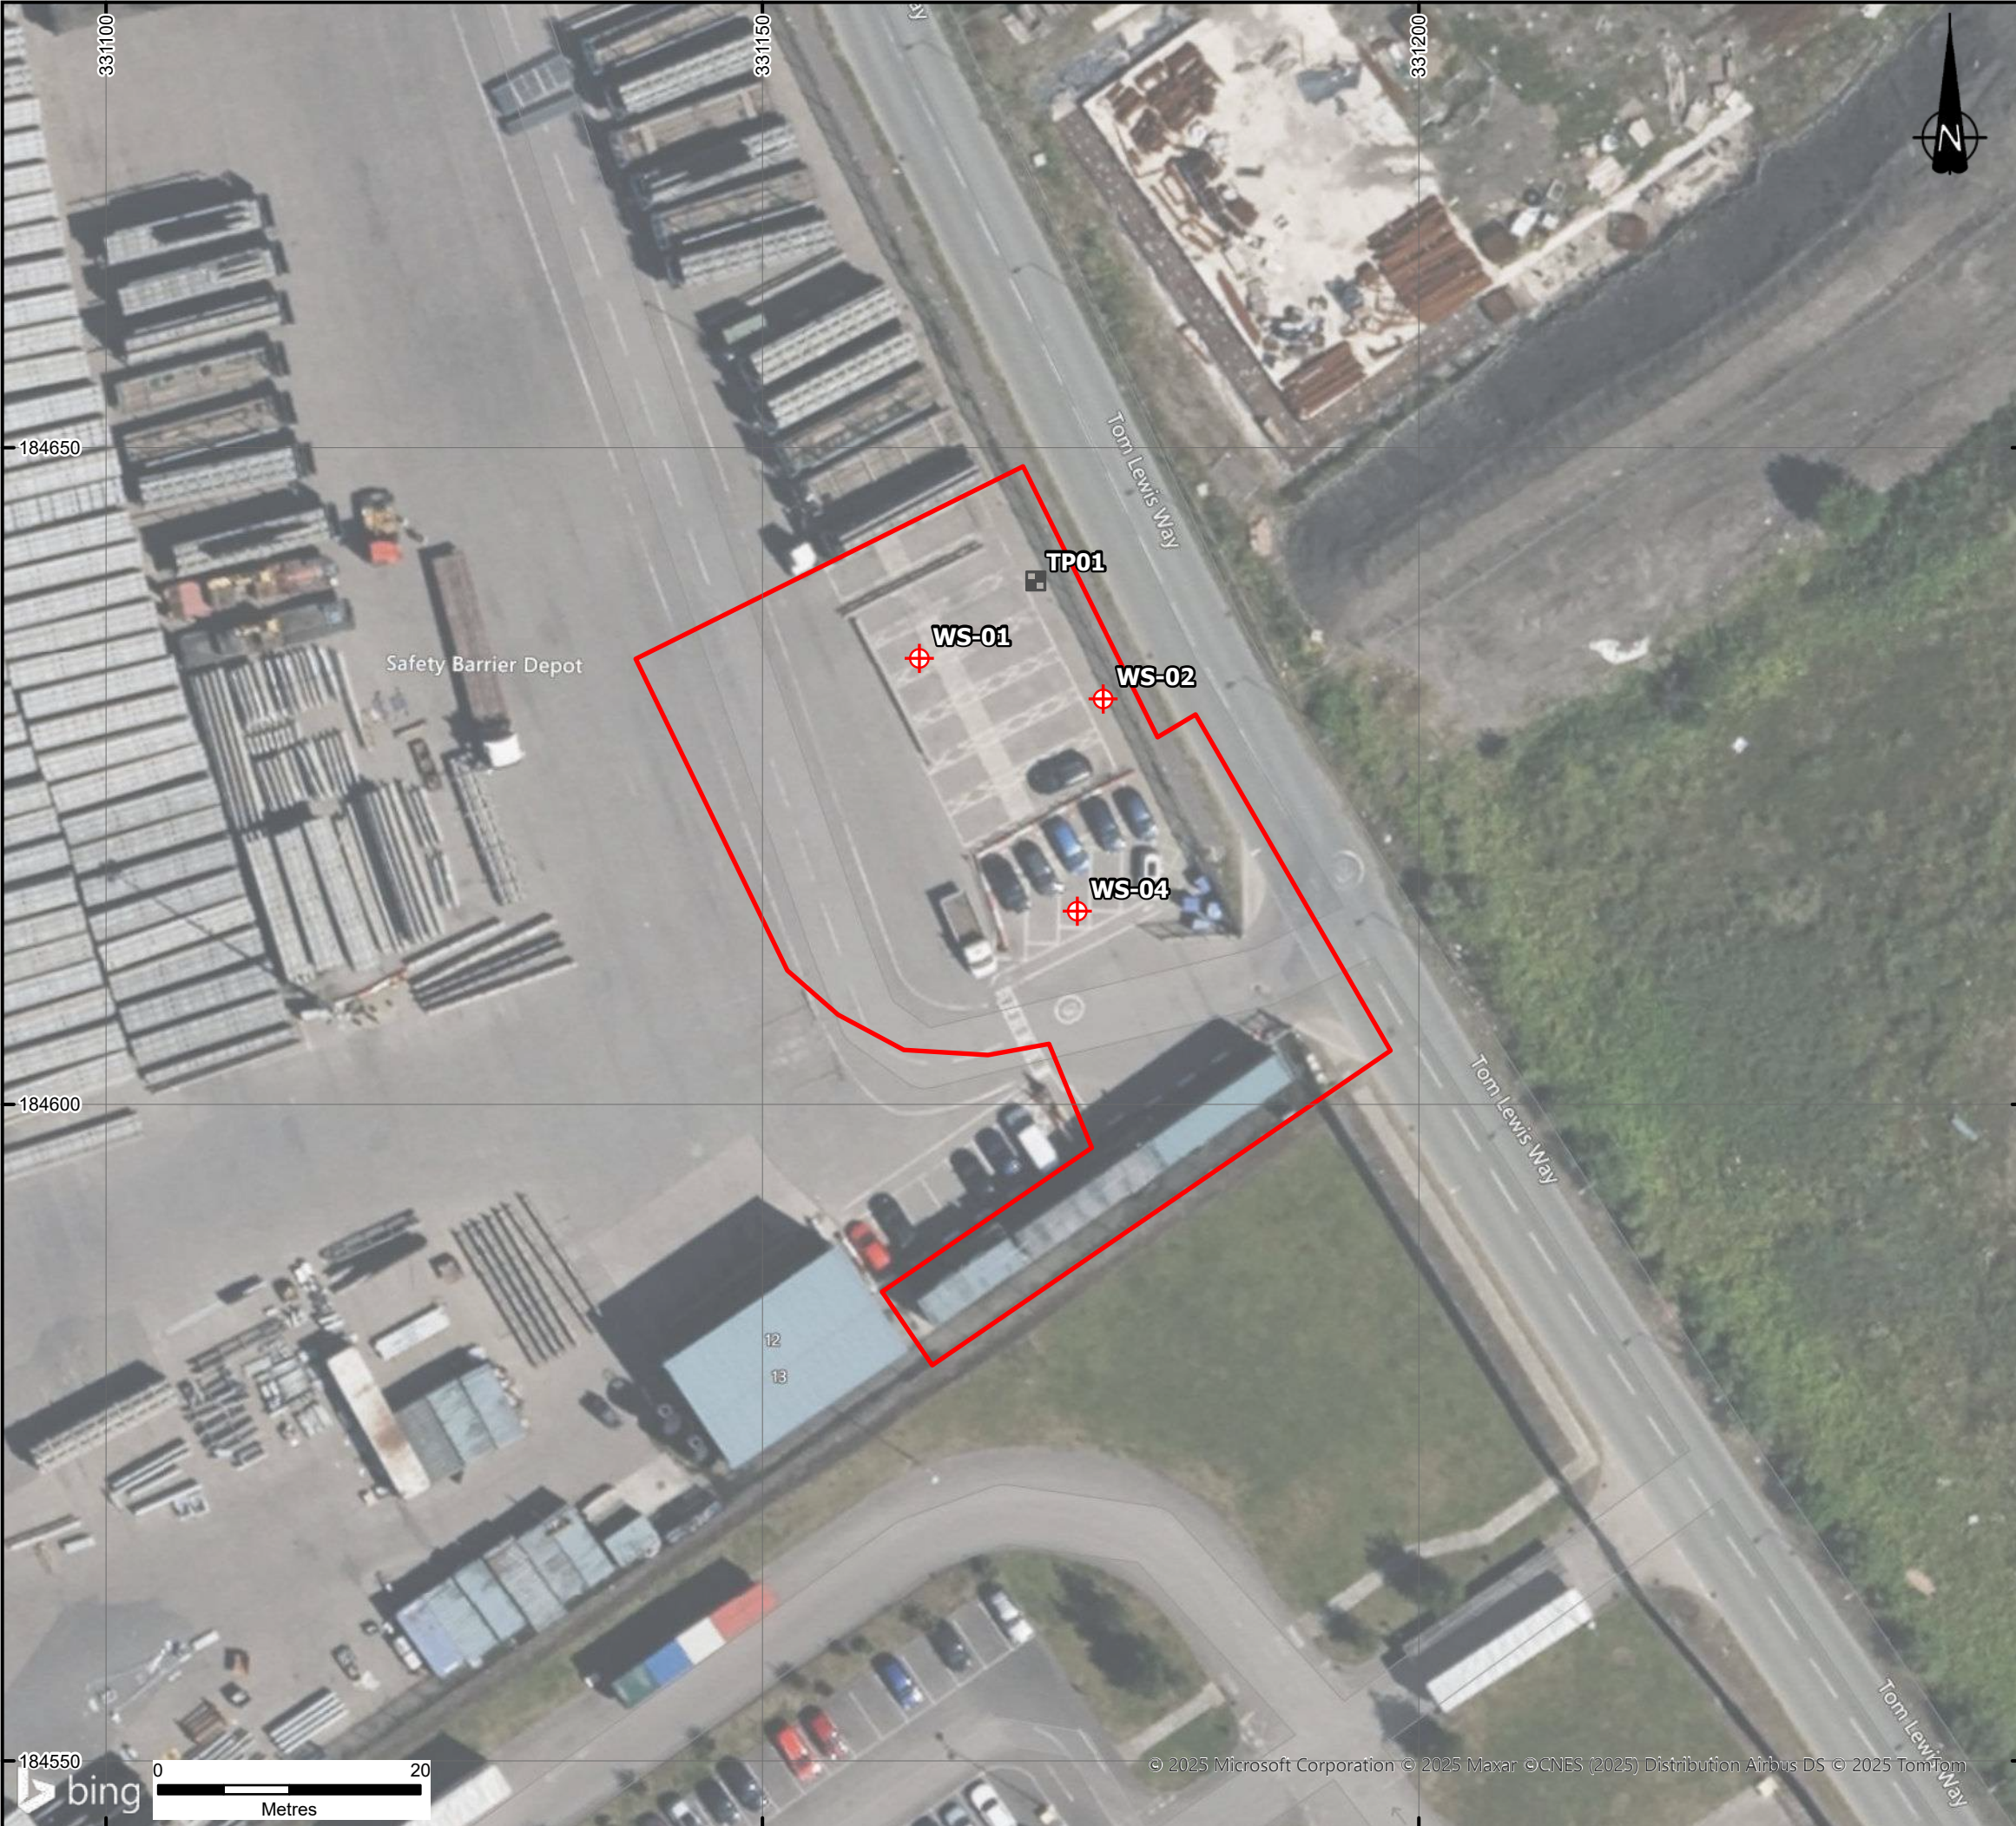
## **Drawing 2**

**CA13057-009 As Built Ground Investigation Locations**
