# **DRAFT** Landscape and Ecological Management Plan Years 6-10

Llanwern Solar, Gwent Levels

21 April 2026

| Report Reference | 0419-LEMP-HS |

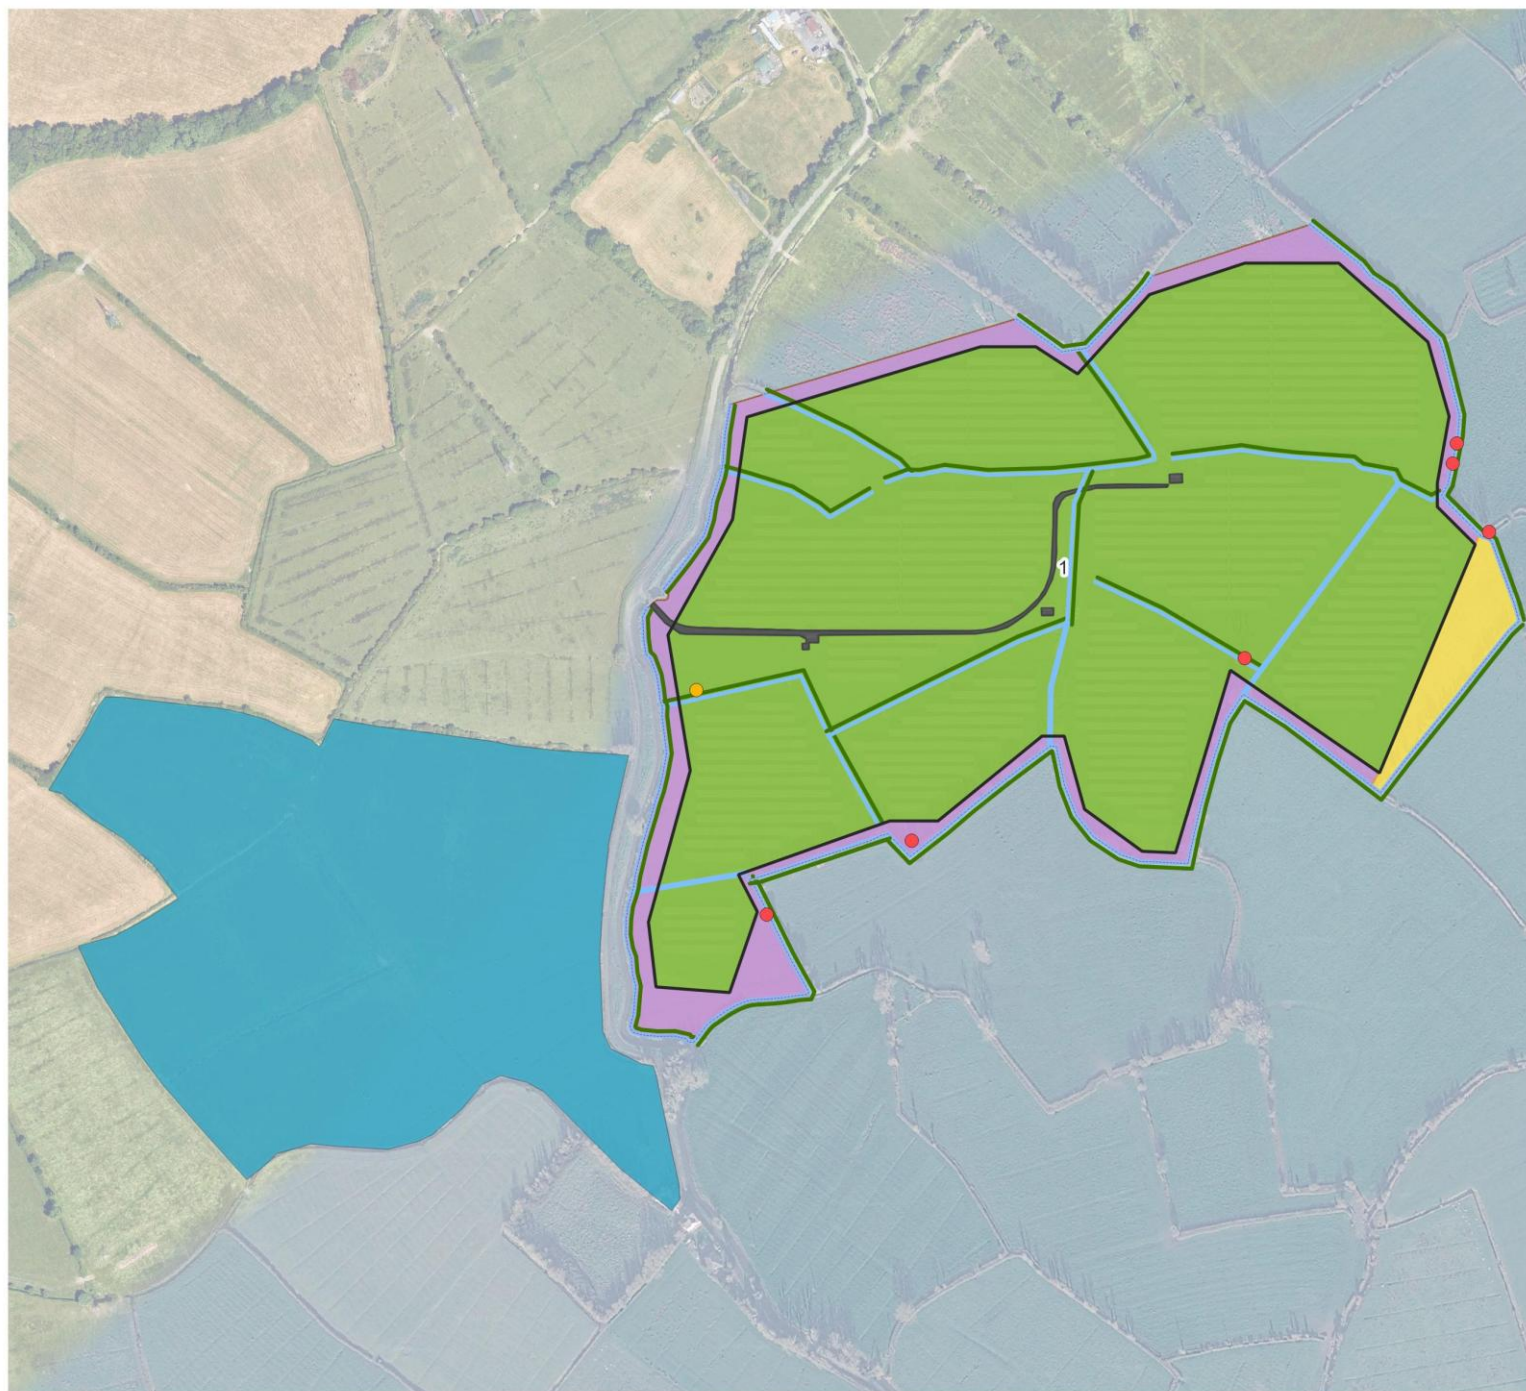
# Key:

- Site Boundary
- Fence Boundary Around Solar Arrays
- Original bat box
- Bug Hotels
- Retained Grassland (Solar Array Area)
- Dedicated Common Crane and Shril Carder Bee Mitigation Areas
- Grassland Outside of Security Fencing
- Lapwing Mitigation Fields
- Hardstanding
- Hedgerow and Reen/ Ditch
- Reens and Ditches

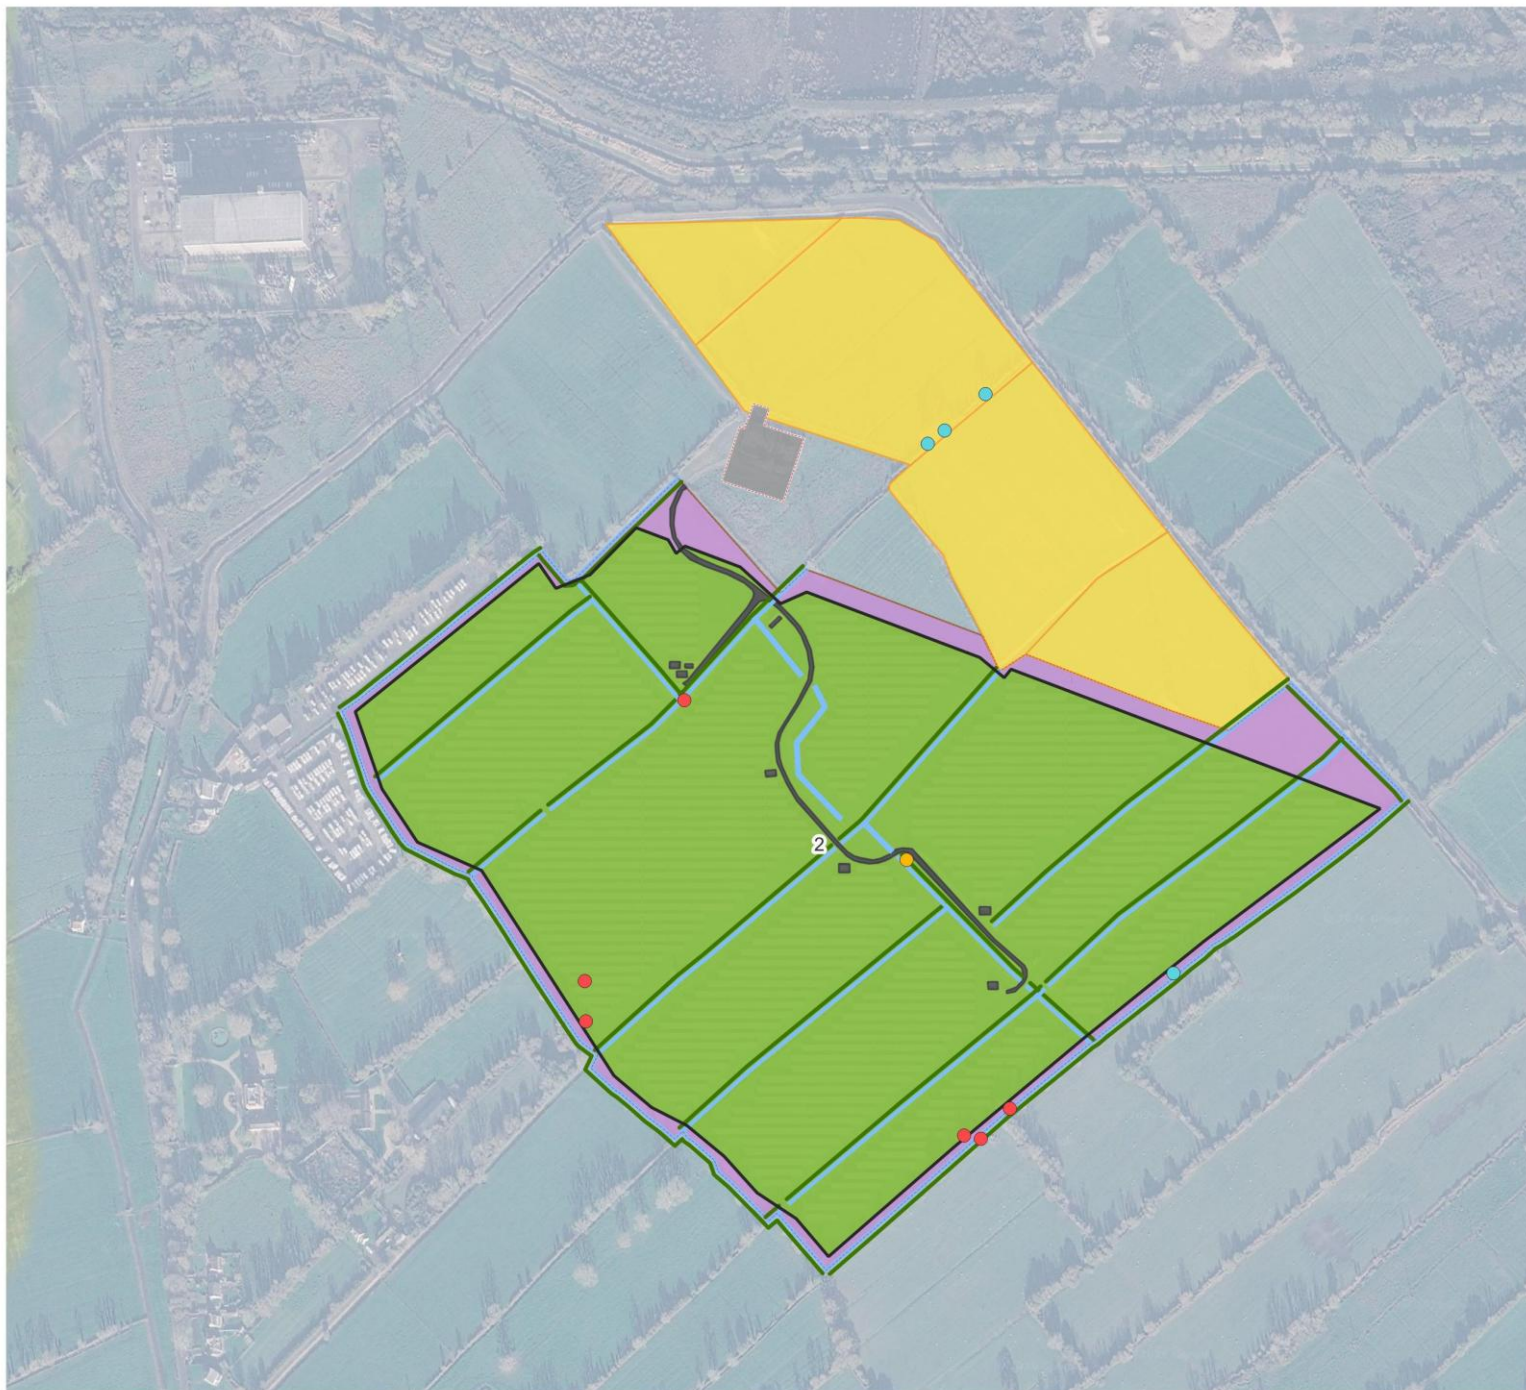
### Key:

- Site Boundary
- Fence Boundary Around Solar Arrays
- 2024 new bat box
- Original bat box
- Bug Hotels
- Retained Grassland (Solar Array Area)
- Dedicated Common Crane and ShriII Carder Bee Mitigation Areas
- Grassland Outside of Security Fencing
- Substation
- Hardstanding
- Hedgerow and Reen/ Ditch
- Reens and Ditches

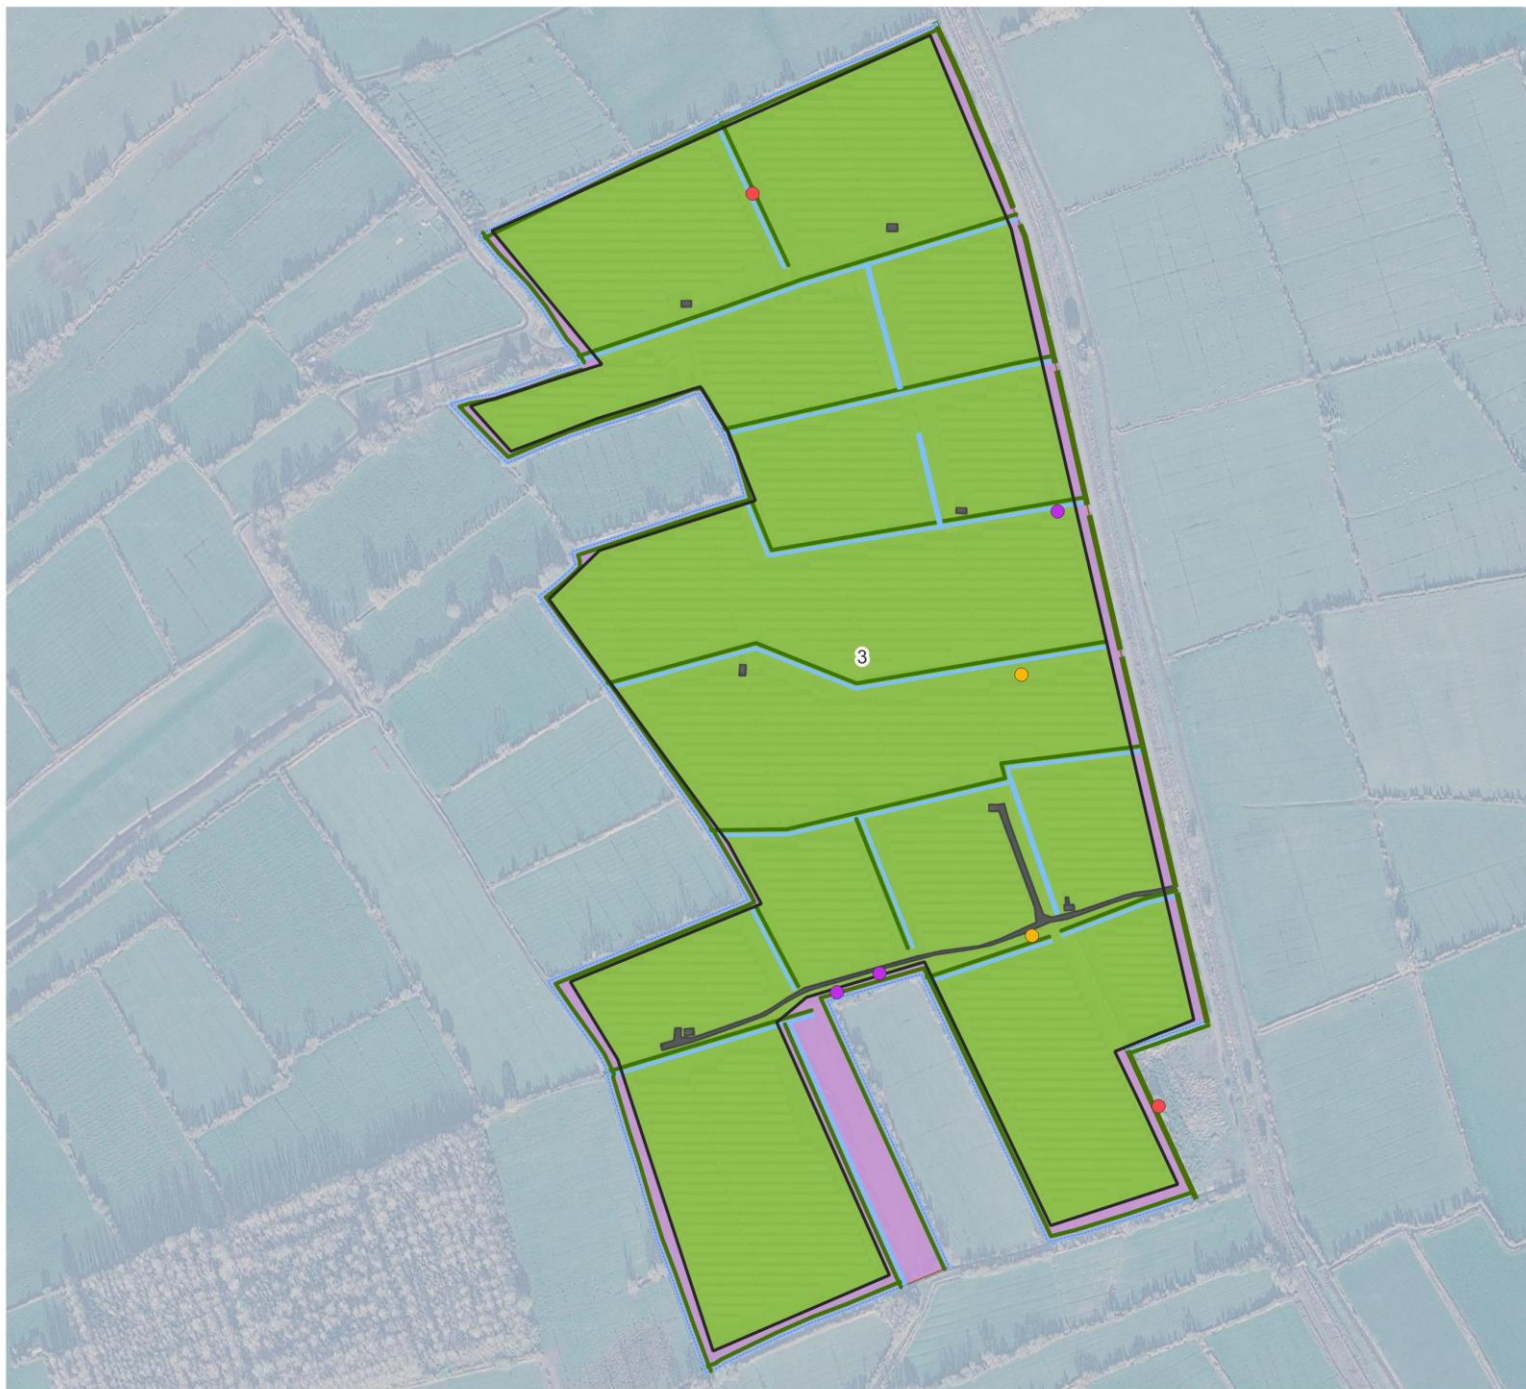
### Key:

- Site Boundary
- Fence Boundary Around Solar Arrays
- 2024 relocated bat box
- Original bat box
- Bug Hotels
- Retained Grassland (Solar Array Area)
- Grassland Outside of Security Fencing
- Hardstanding
- Hedgerow and Reen/ Ditch
- Reens and Ditches
- Hedgerow

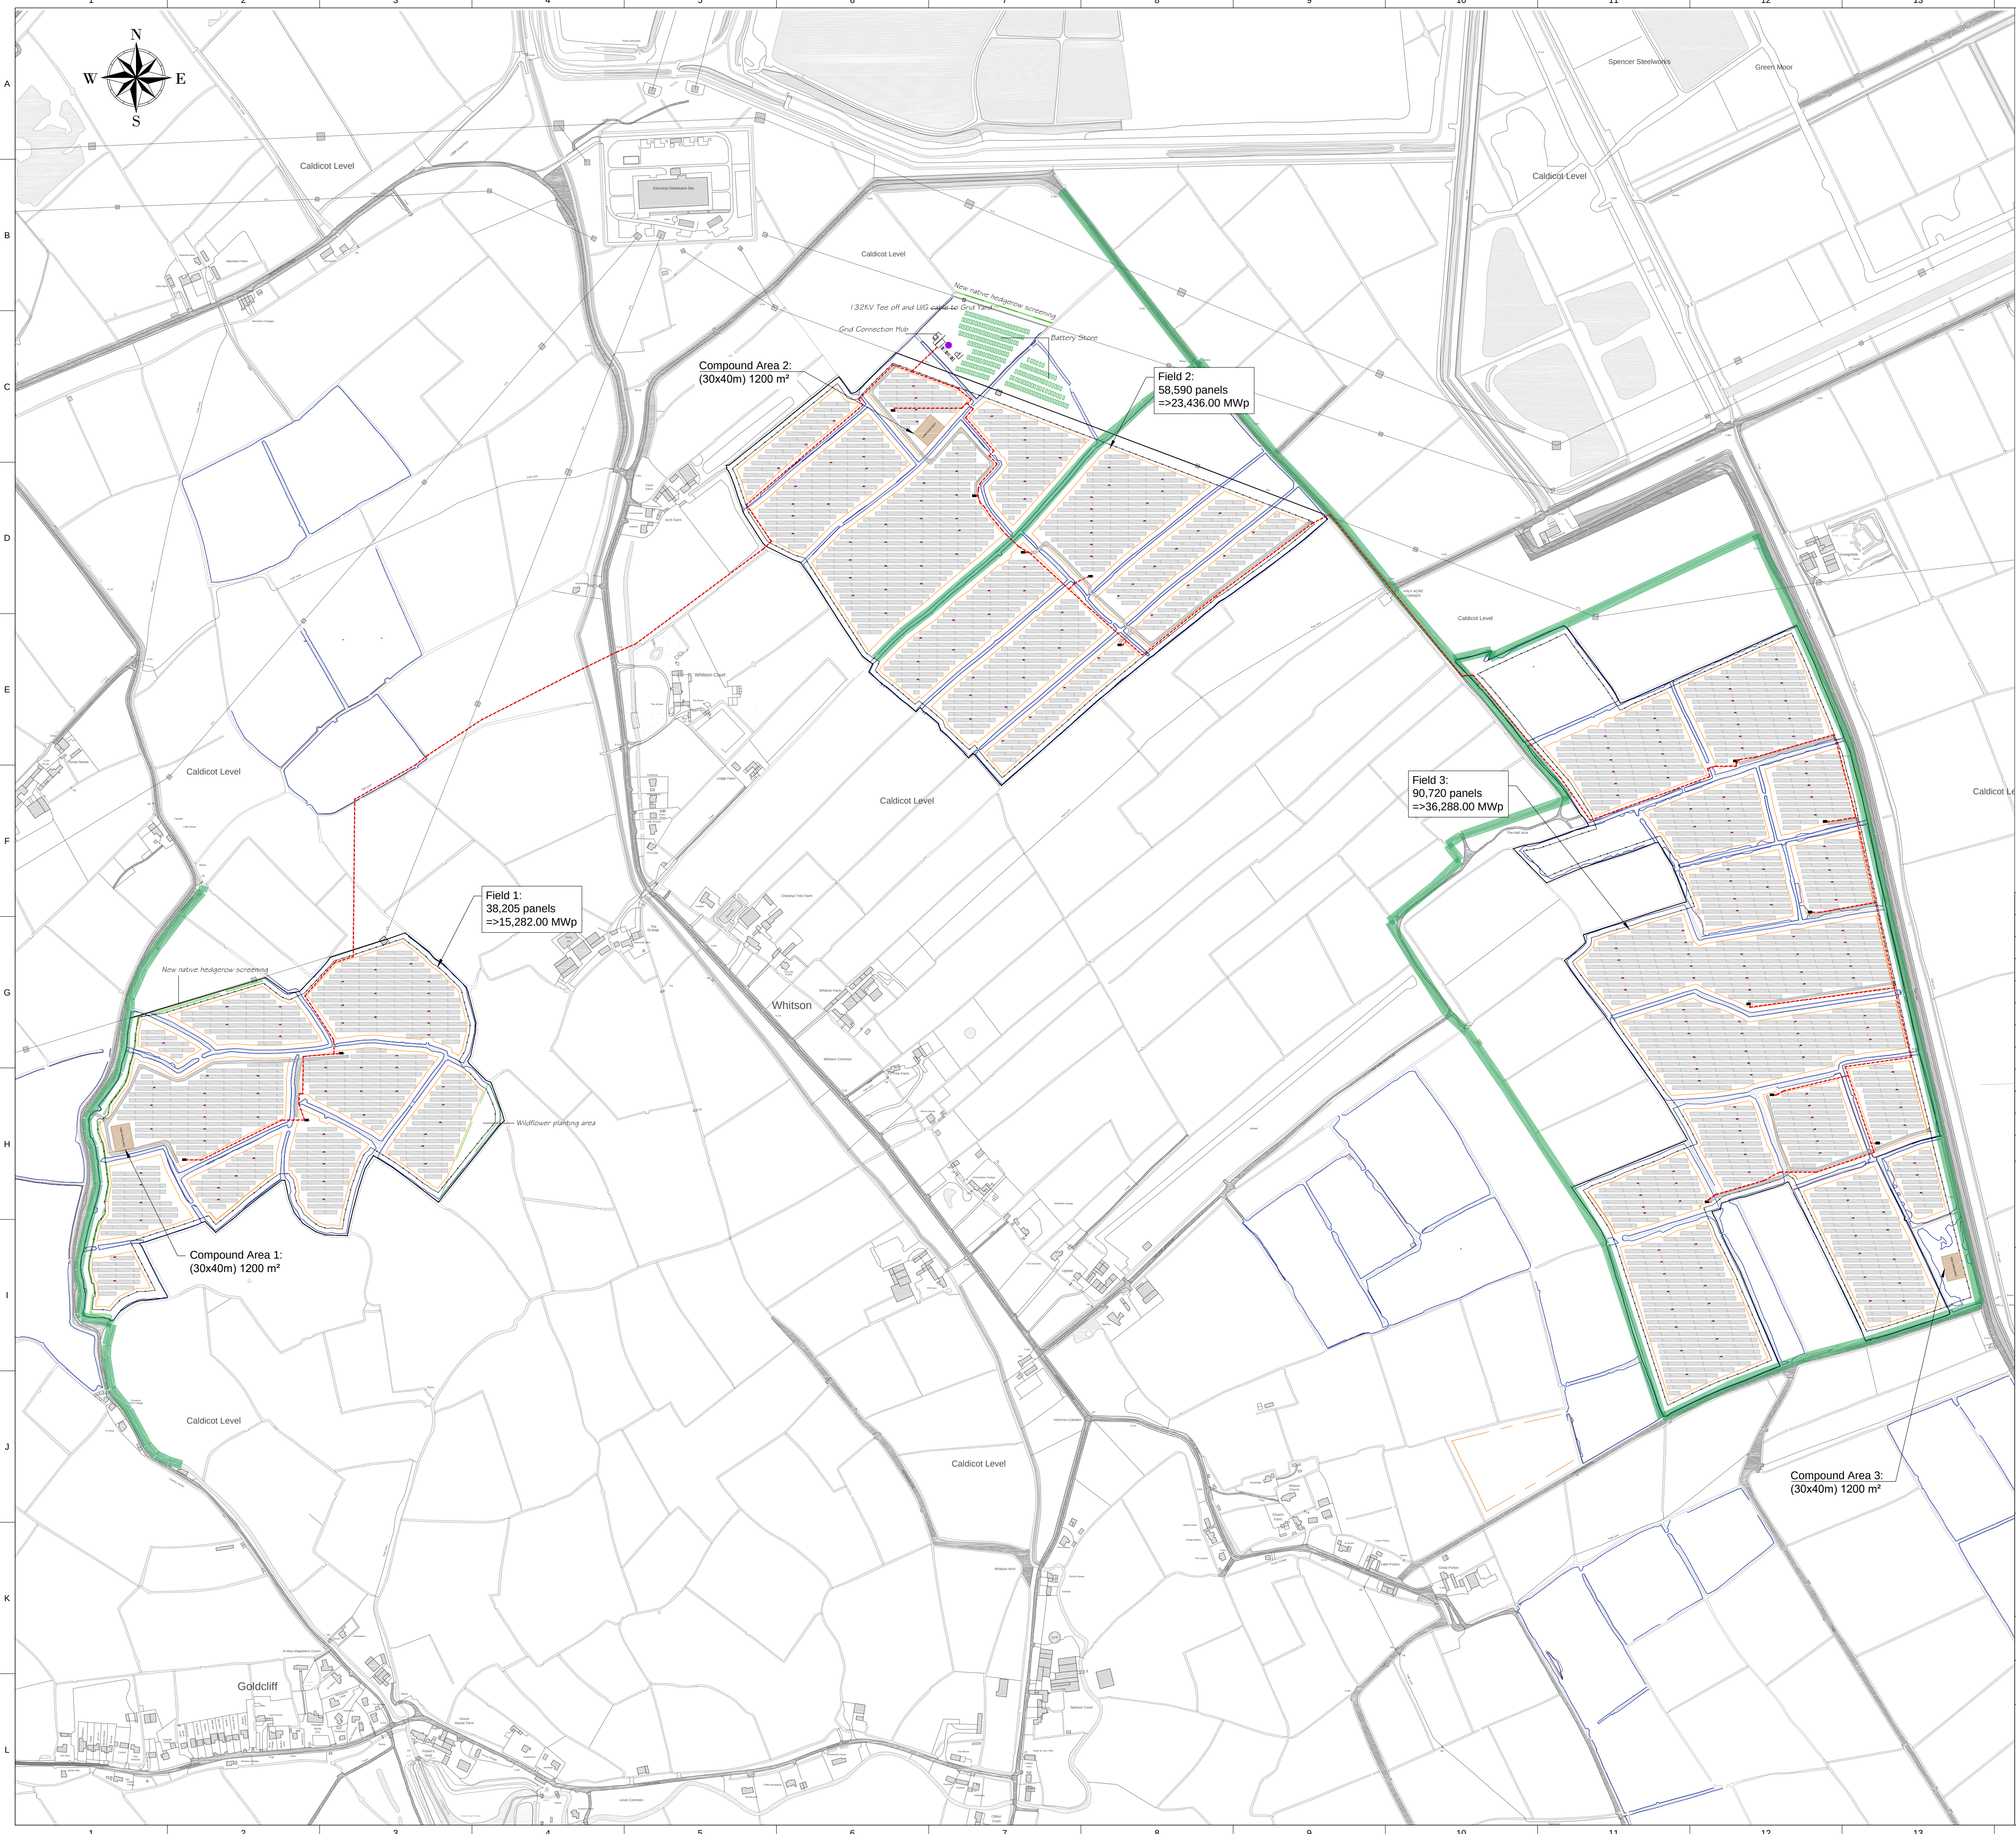
## **Appendix 1 – Landscape Proposals**

- Legend
- Site Boundary
  - Fence
  - PV Area
  - Gate
  - Transformer Station
  - Internal Road
  - Rack 3V27
  - Rack 3V18
  - Rack 3V9
  - Costumer Substation
  - Drainage
  - Main Drainage
  - MV Cable Trench
  - DC Combiner Box

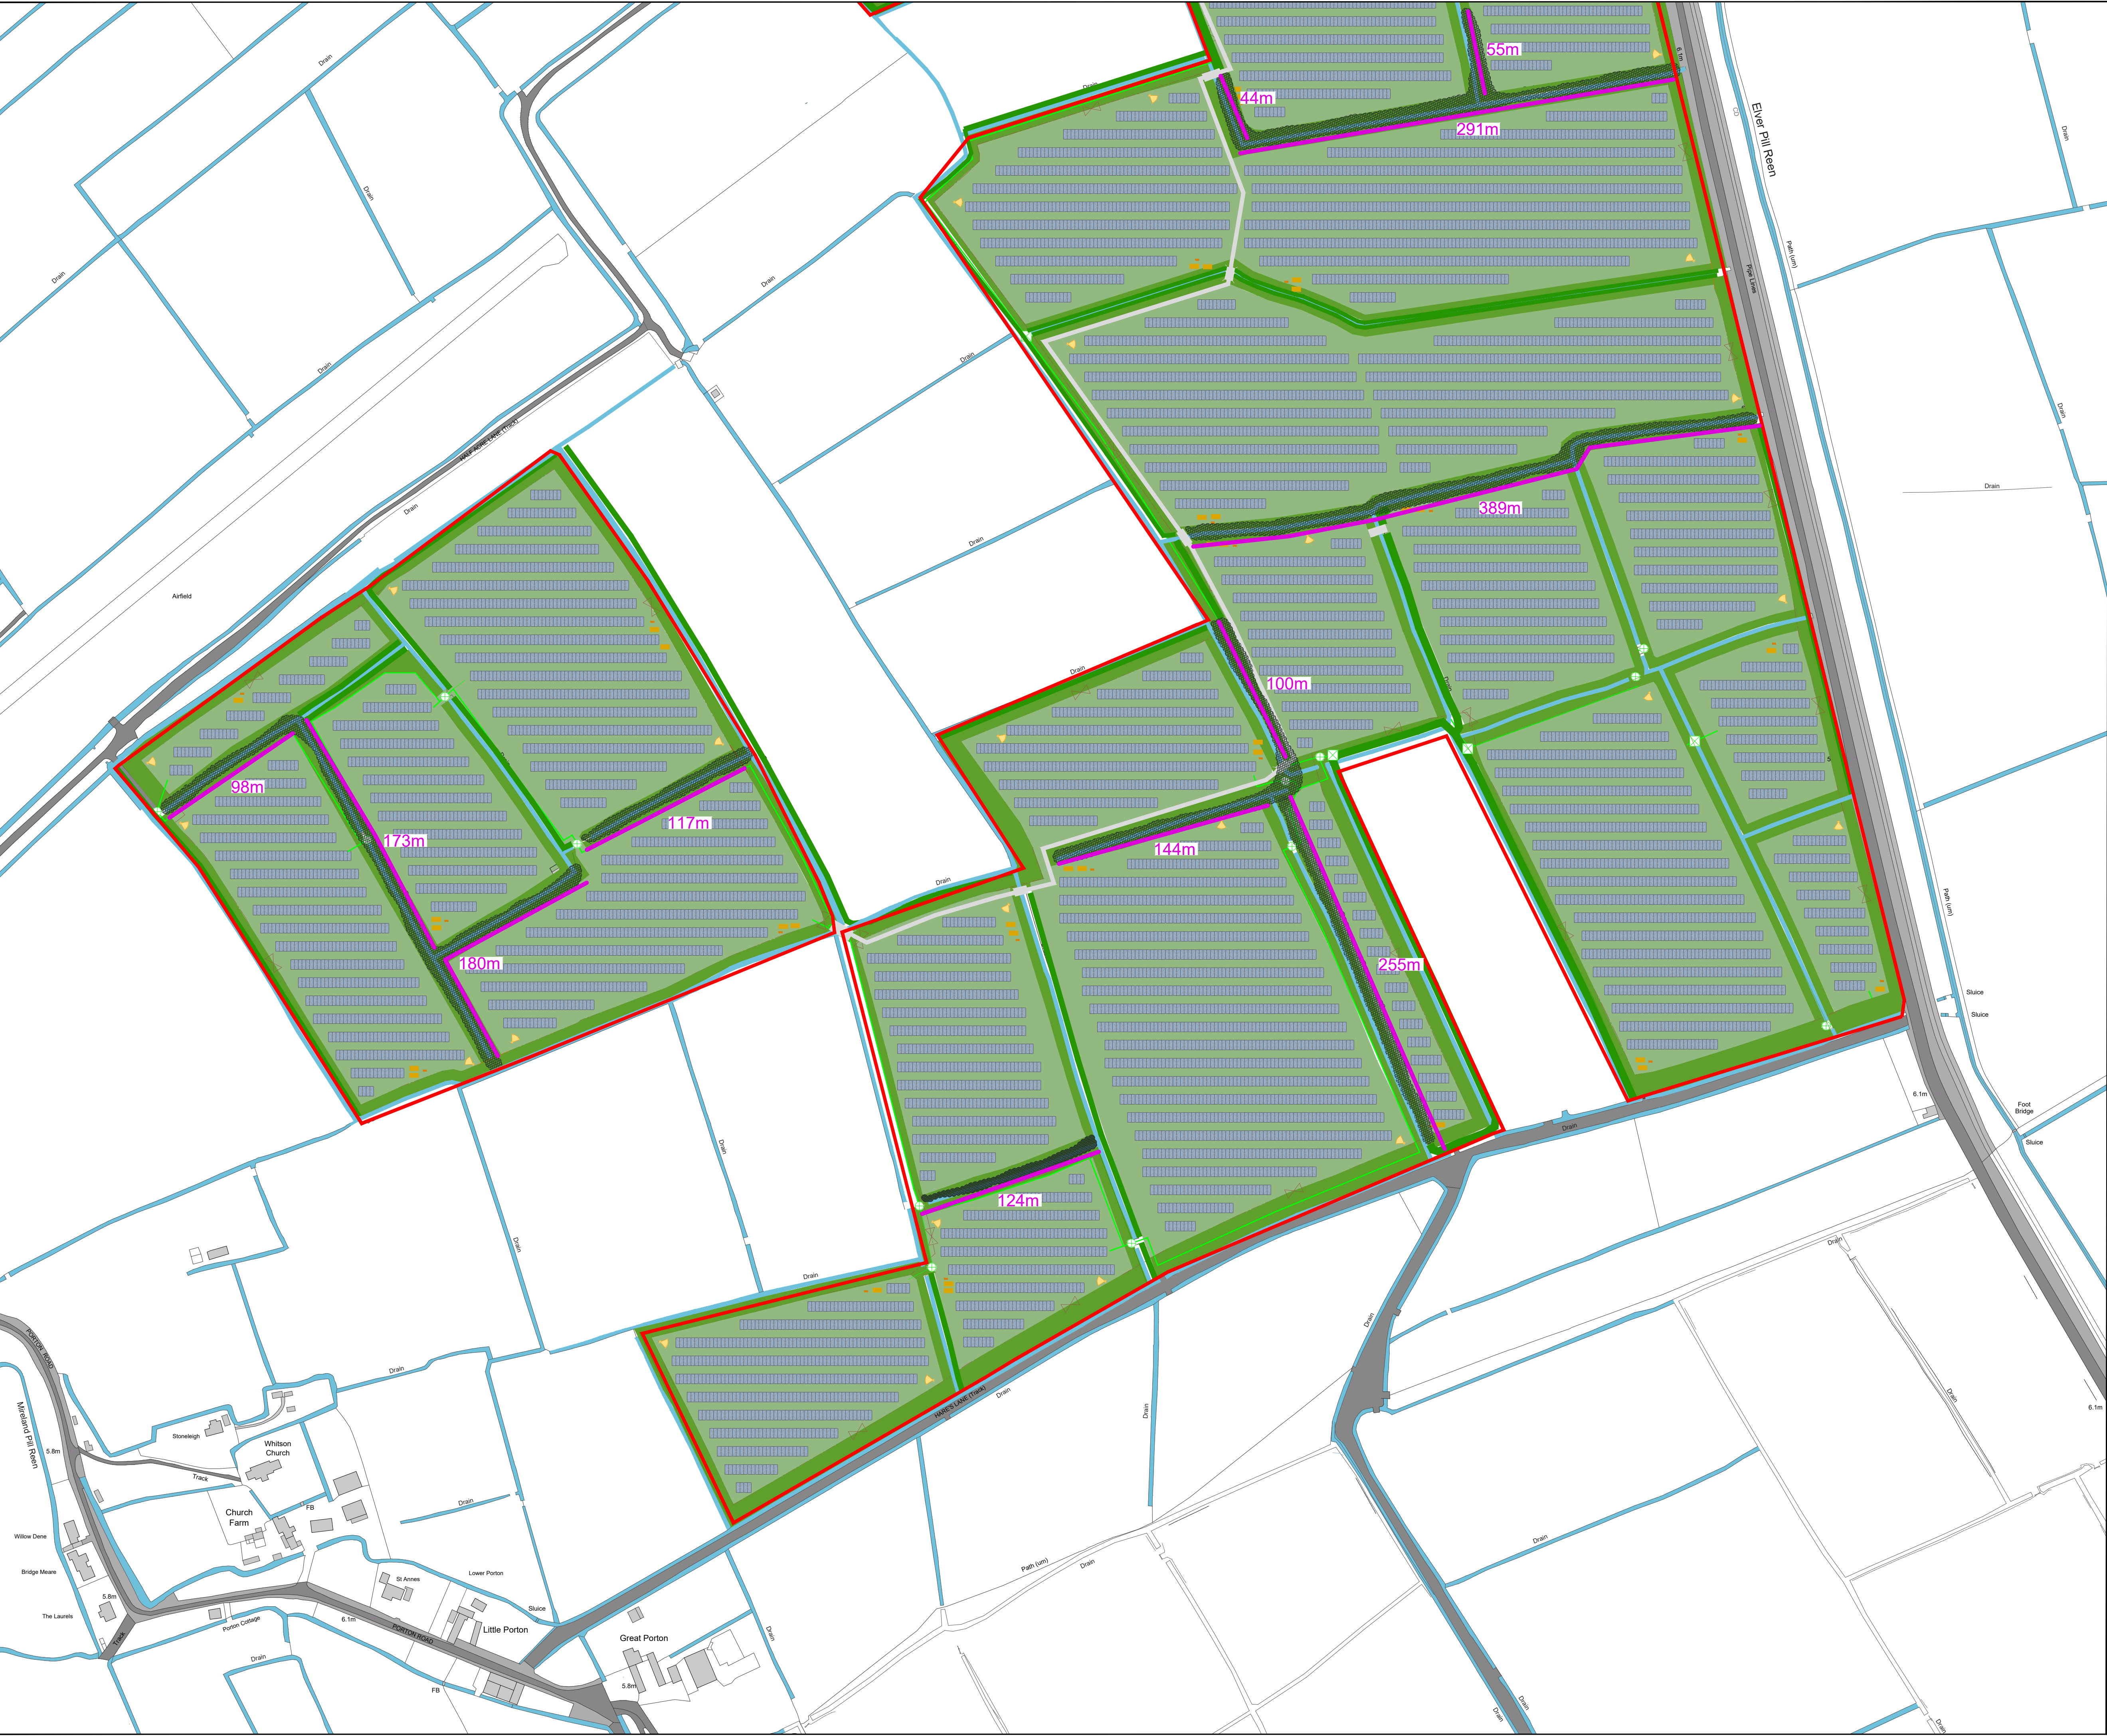
| 19/06/2019 | Sheet: 3 of 5 | Ref: 0419/HRP | Scale (A1): 1:500 |

**Key**

- Red Line Boundary
- Retained Grass areas
- Retained hedgerow
- Existing reen network
- Existing track
- Proposed Battery storage units
- Proposed Grid connection area
- Proposed telecommunications tower
- Proposed transformer units/connection point
- Proposed solar panels
- Proposed 2.0m high stock fence
- Proposed access track
- Proposed gate
- Existing Grass areas
- Double hedgerow to be managed
- Hedgerow to be coppiced
- Proposed grass buffers

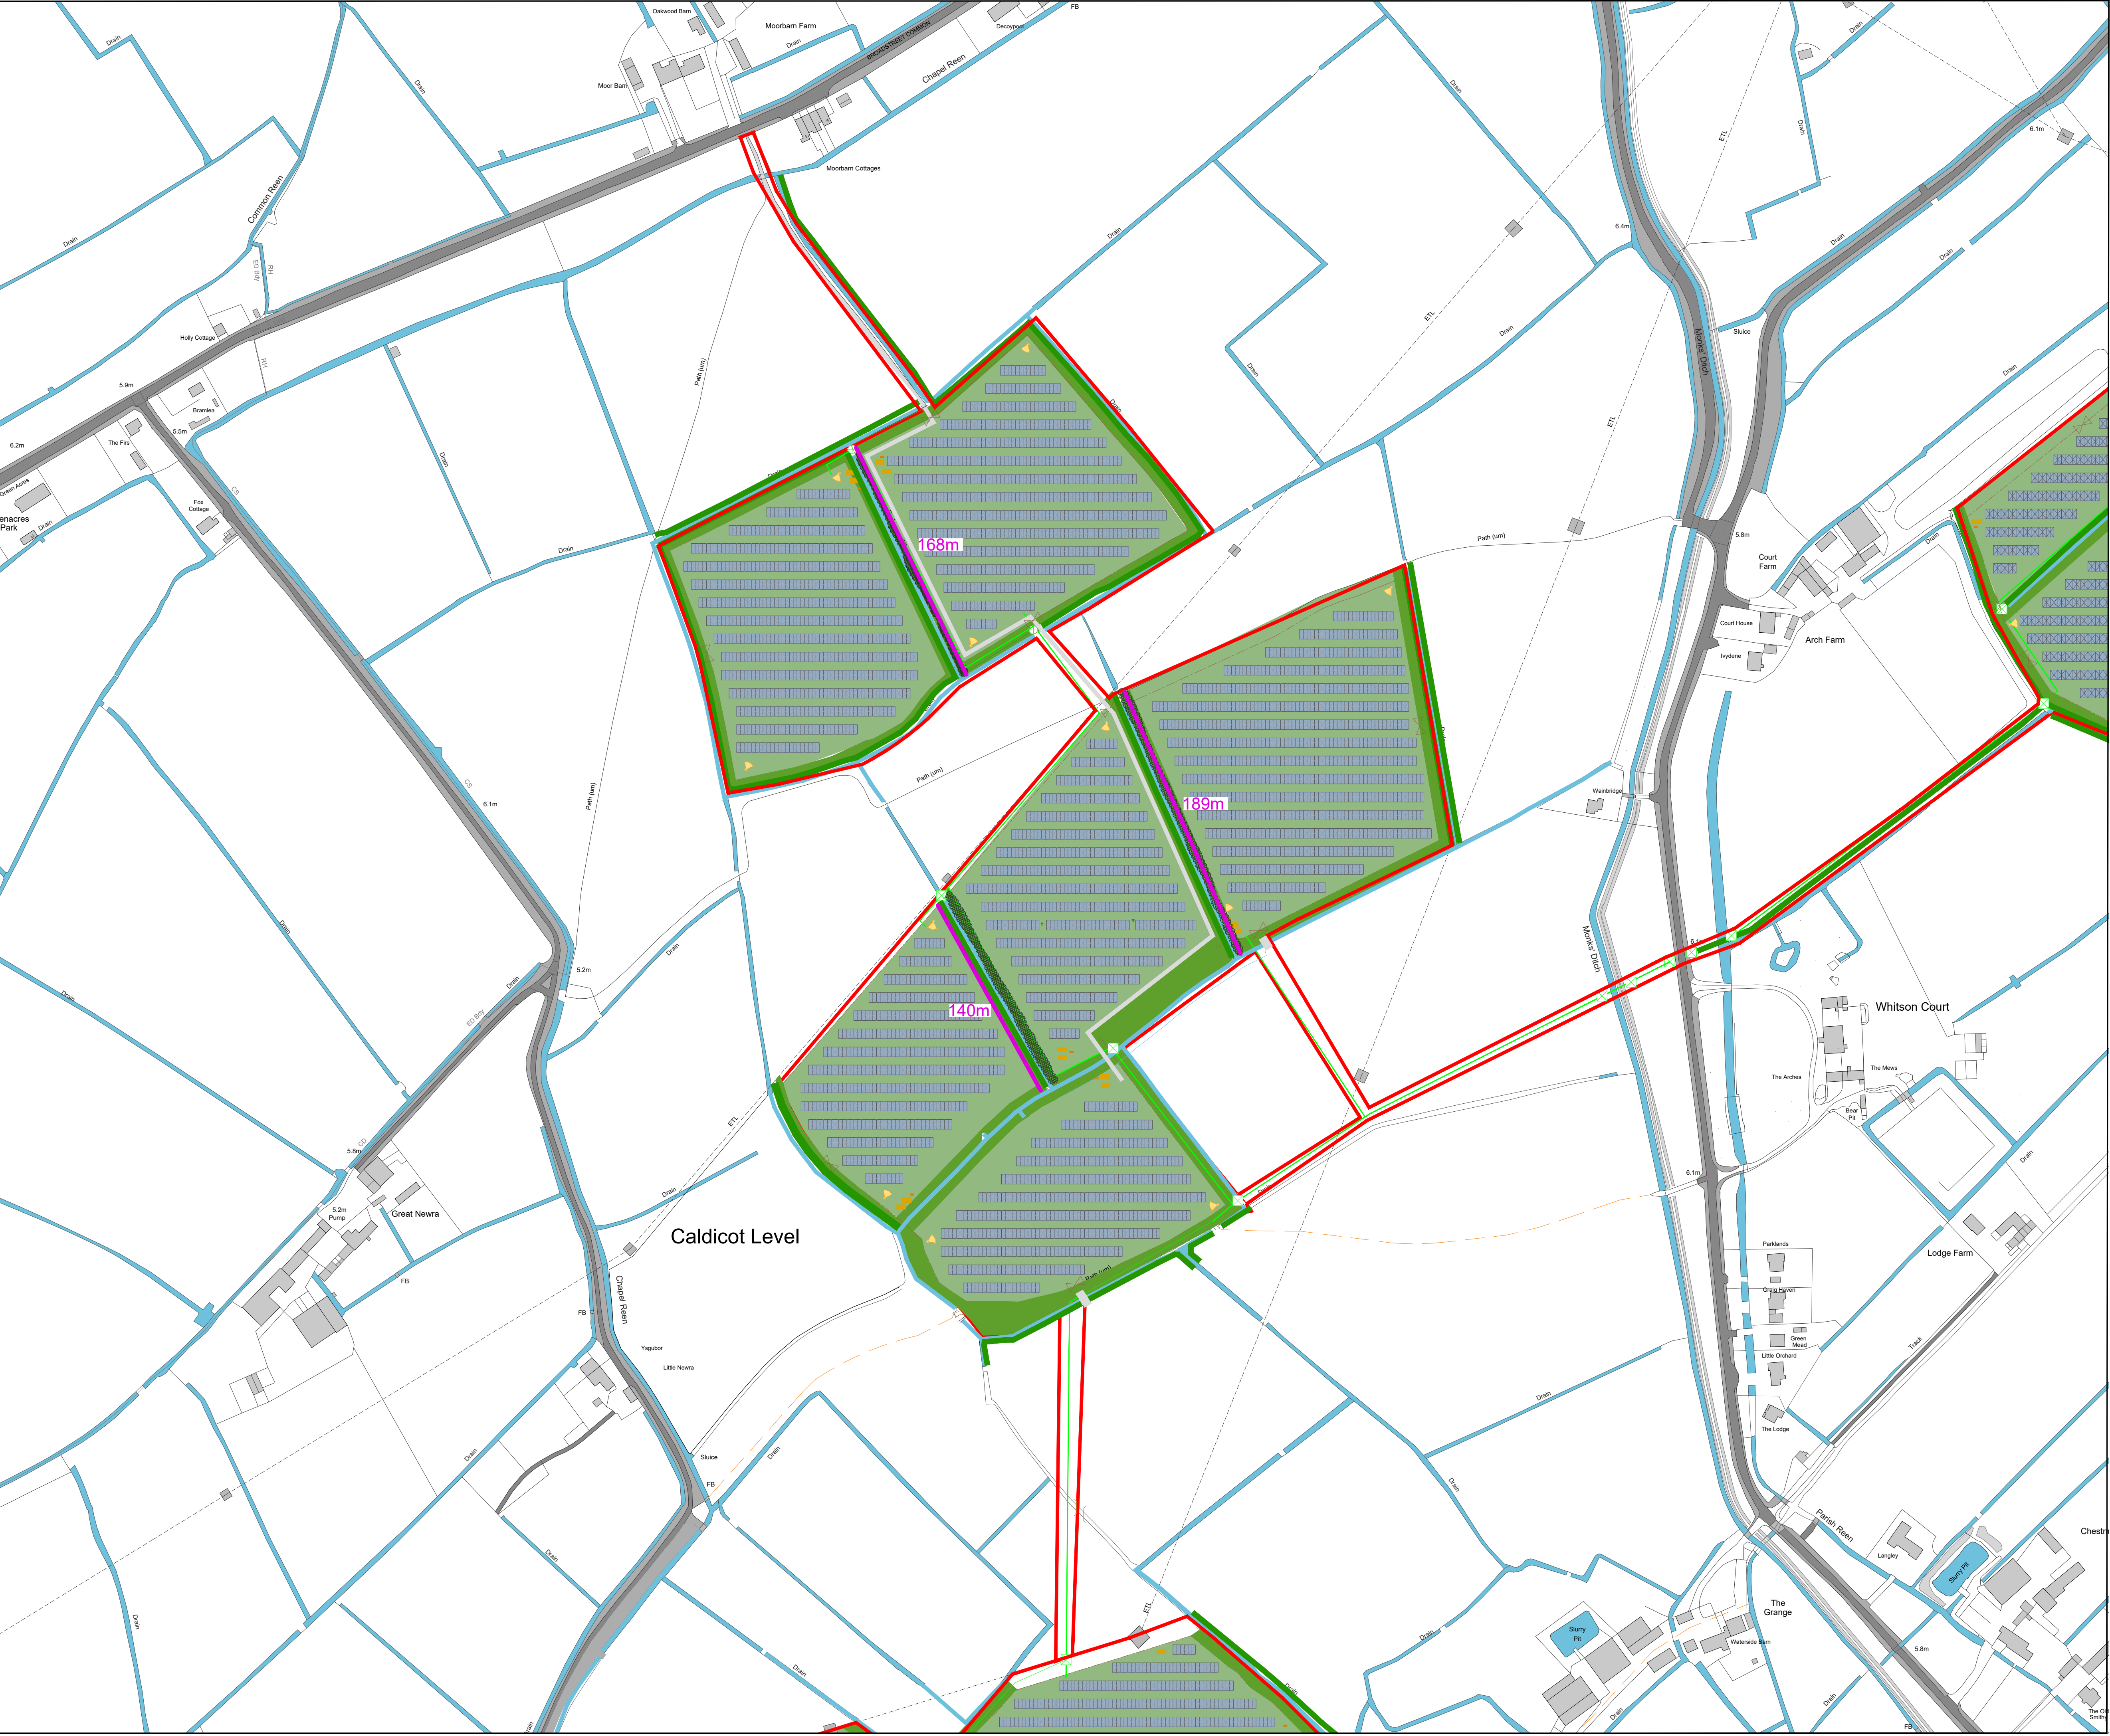
19/06/2019 Sheet: 4 of 5 Ref: 0419/HRP Scale (A1): 1:500

**Key**

- Red Line Boundary
- Retained Grass areas
- Retained hedgerow
- Existing reen network
- Existing track
- Proposed Battery storage units
- Proposed Grid connection area
- Proposed telecommunications tower
- Proposed transformer units/connection point
- Proposed solar panels
- Proposed 2.0m high stock fence
- Proposed access track
- Proposed gate
- Existing Grass areas
- Double hedgerow to be managed
- Hedgerow to be coppiced
- Proposed grass buffers

Drawing prepared using Landscape Management Plan reference A091650 by WYG 2018

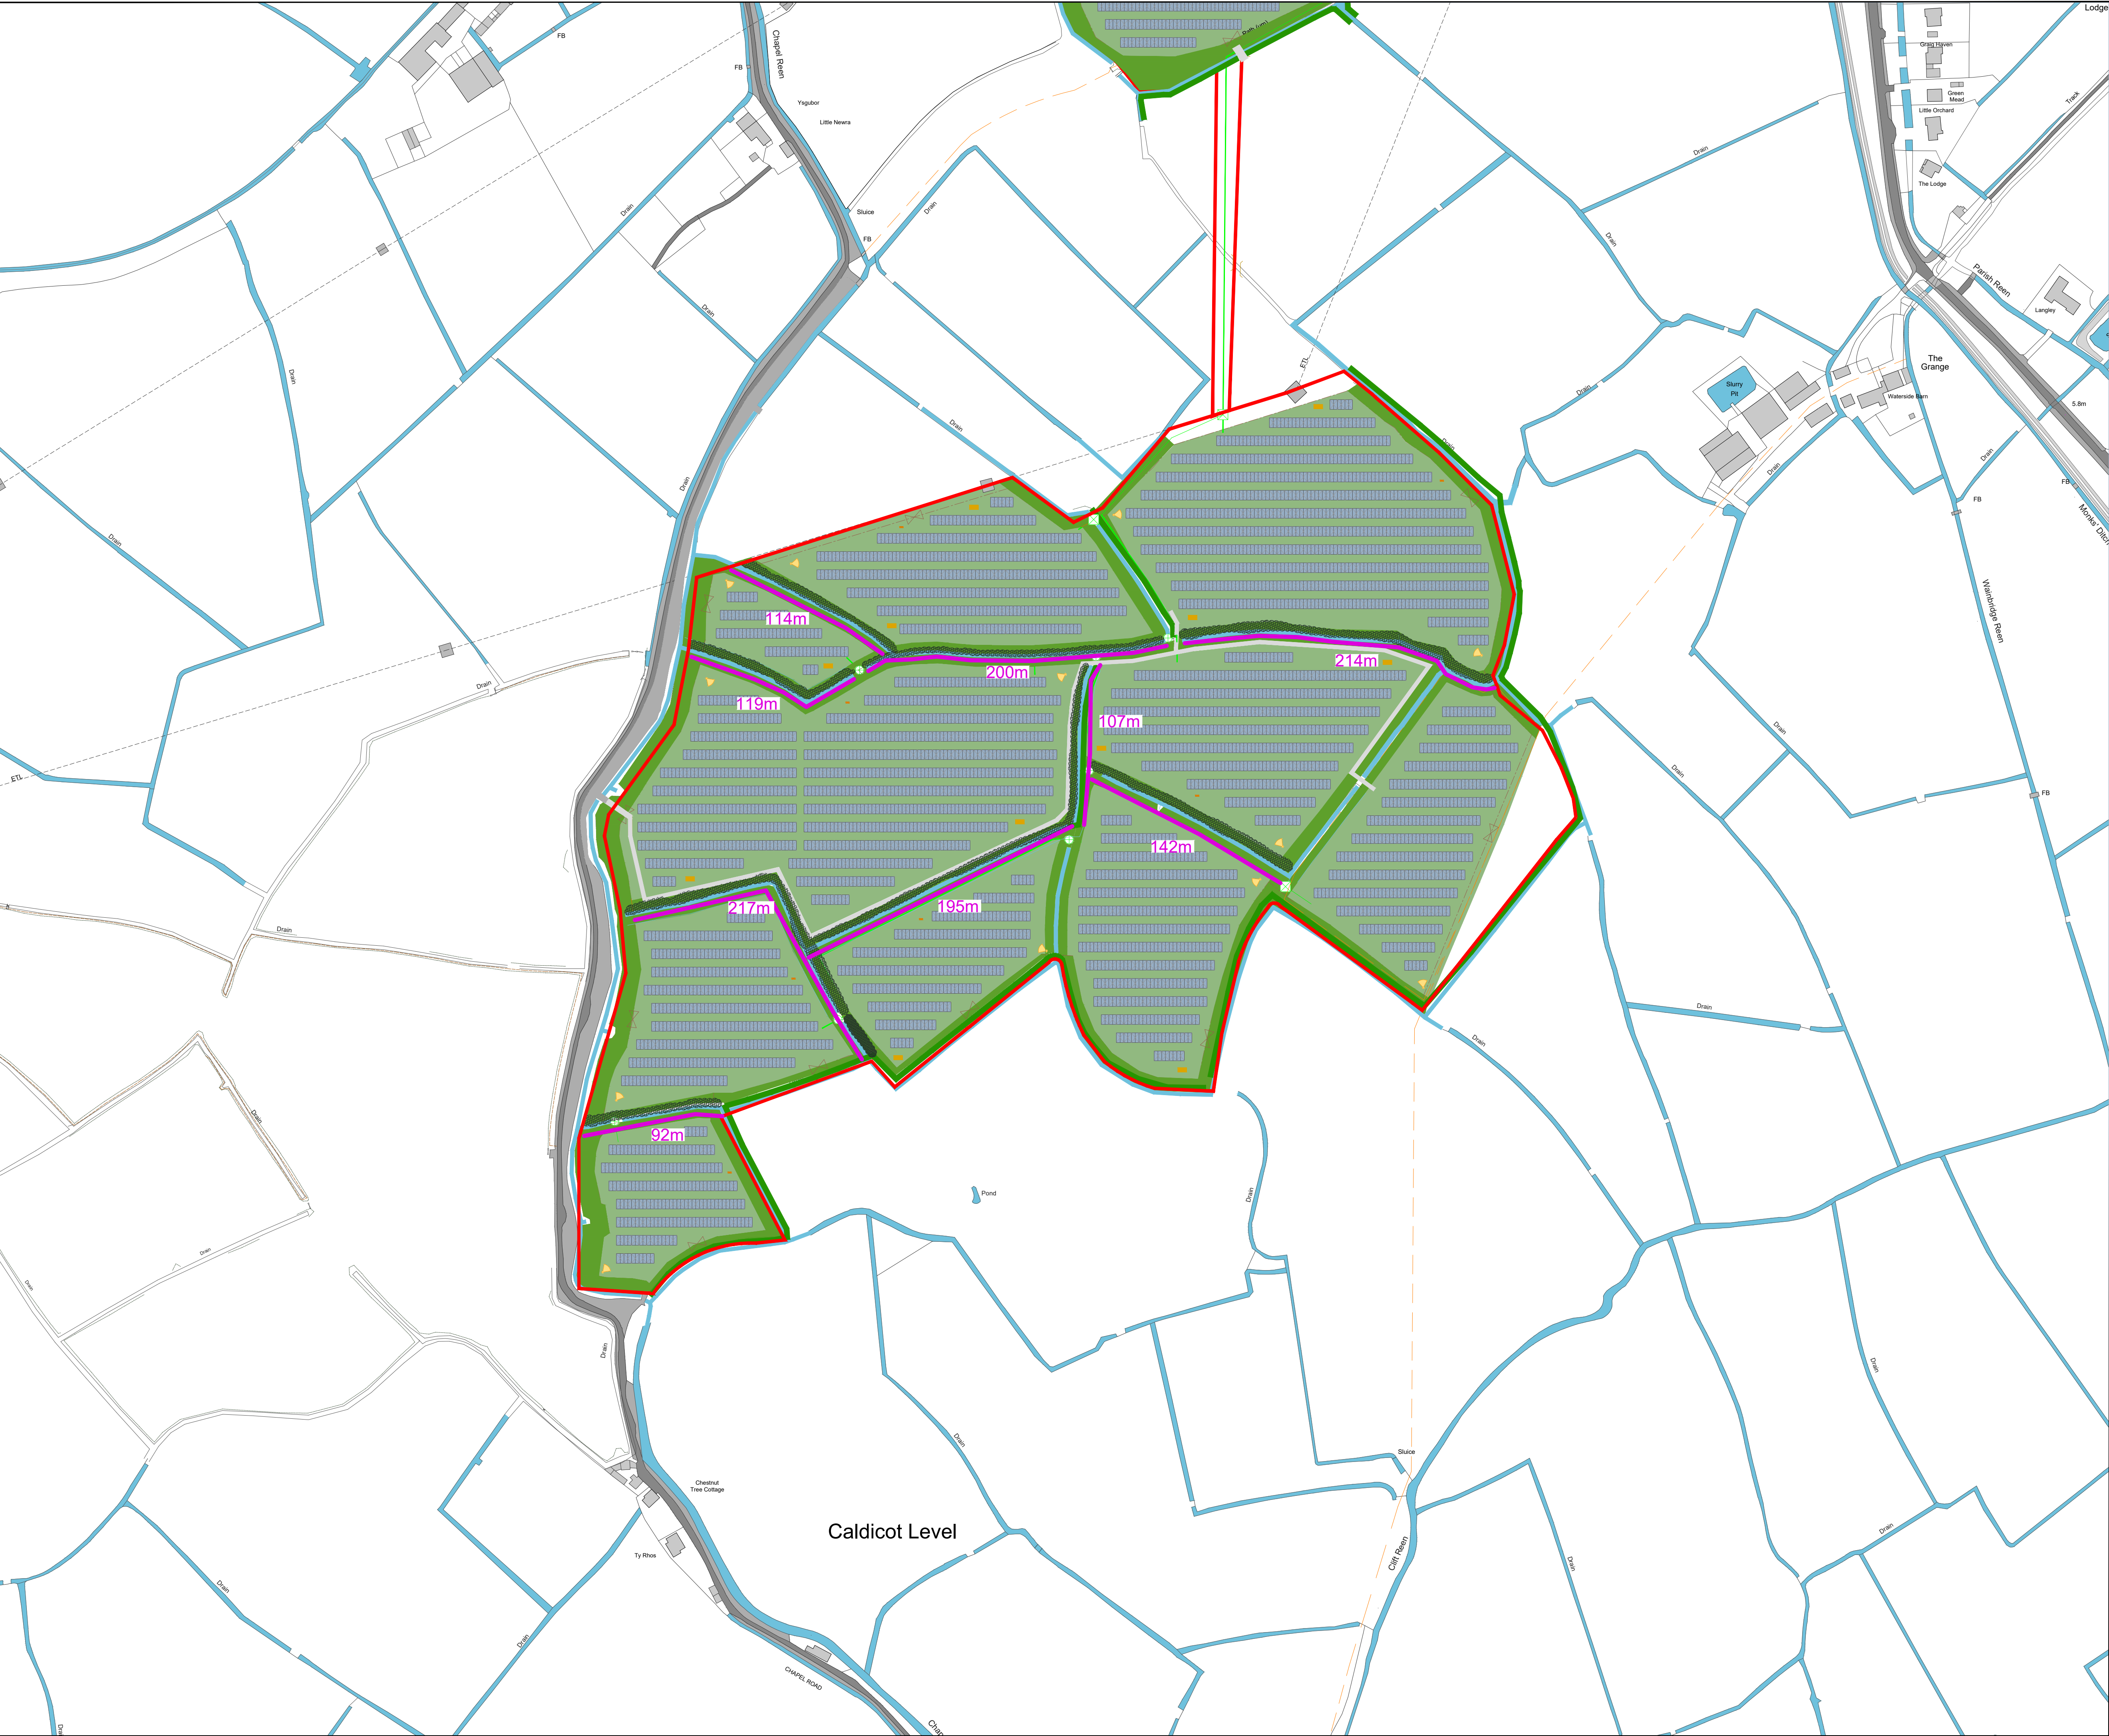
19/06/2019    Sheet: 5 of 5    Ref: 0419/HRP    Scale (A1): 1:500

**Key**

- Red Line Boundary
- Retained Grass areas
- Retained hedgerow
- Existing reen network
- Existing track
- Proposed Battery storage units
- Proposed Grid connection area
- Proposed telecommunications tower
- Proposed transformer units/connection point
- Proposed solar panels
- Proposed 2.0m high stock fence
- Proposed access track
- Proposed gate
- Existing Grass areas
- Double hedgerow to be managed
- Hedgerow to be coppiced
- Proposed grass buffers

Drawing prepared using Landscape Management Plan reference A091650 by WYG 2018

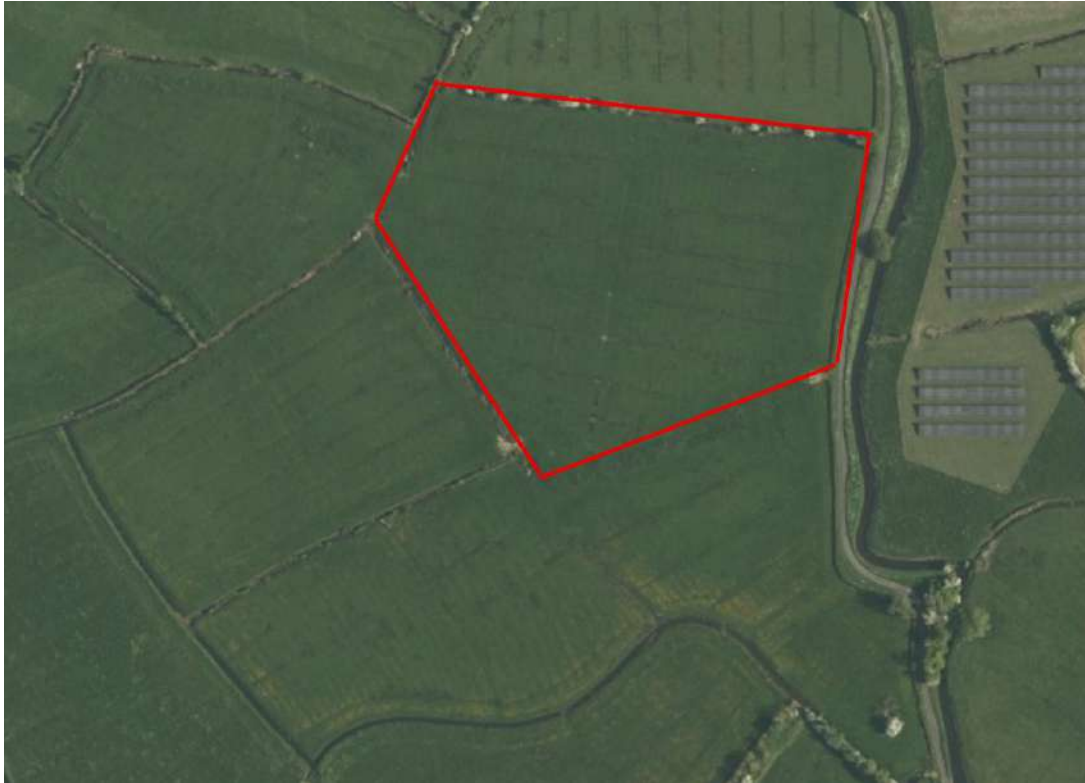
Grip Reinstatement works will take place within the red pentagon shaped field as suggested by NRW, shown below:
