# **DRAFT** Landscape and Ecological Management Plan Years 6-10

Llanwern Solar, Gwent Levels

21 April 2026

| Report Reference | 0419-LEMP-HS |

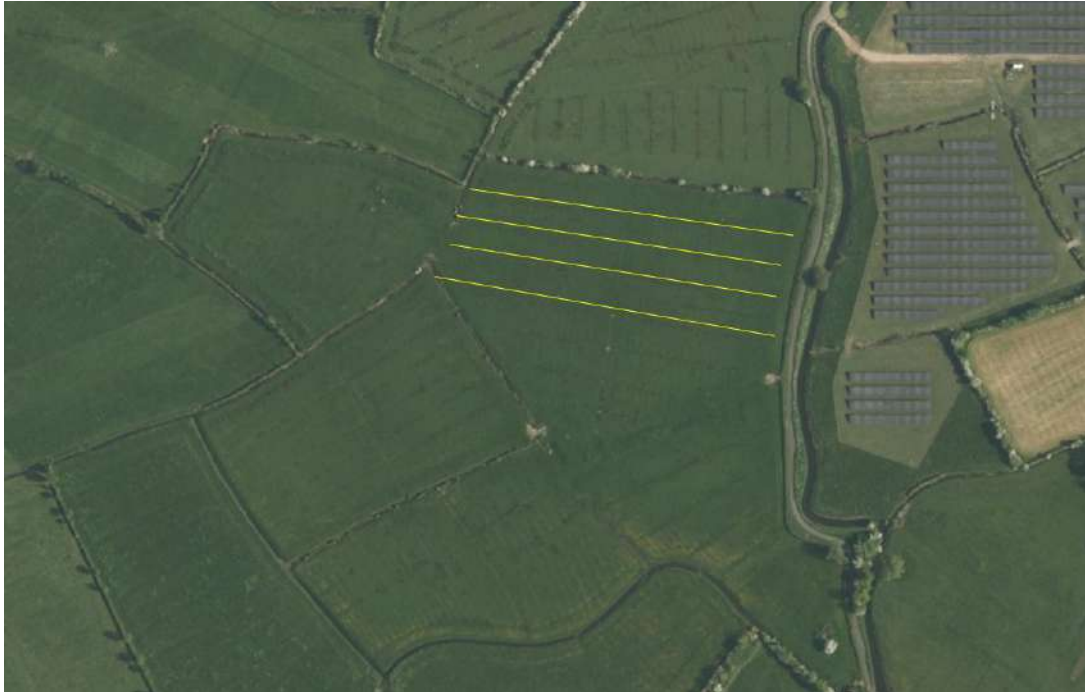
The proposed locations of the four grips are marked below in yellow:

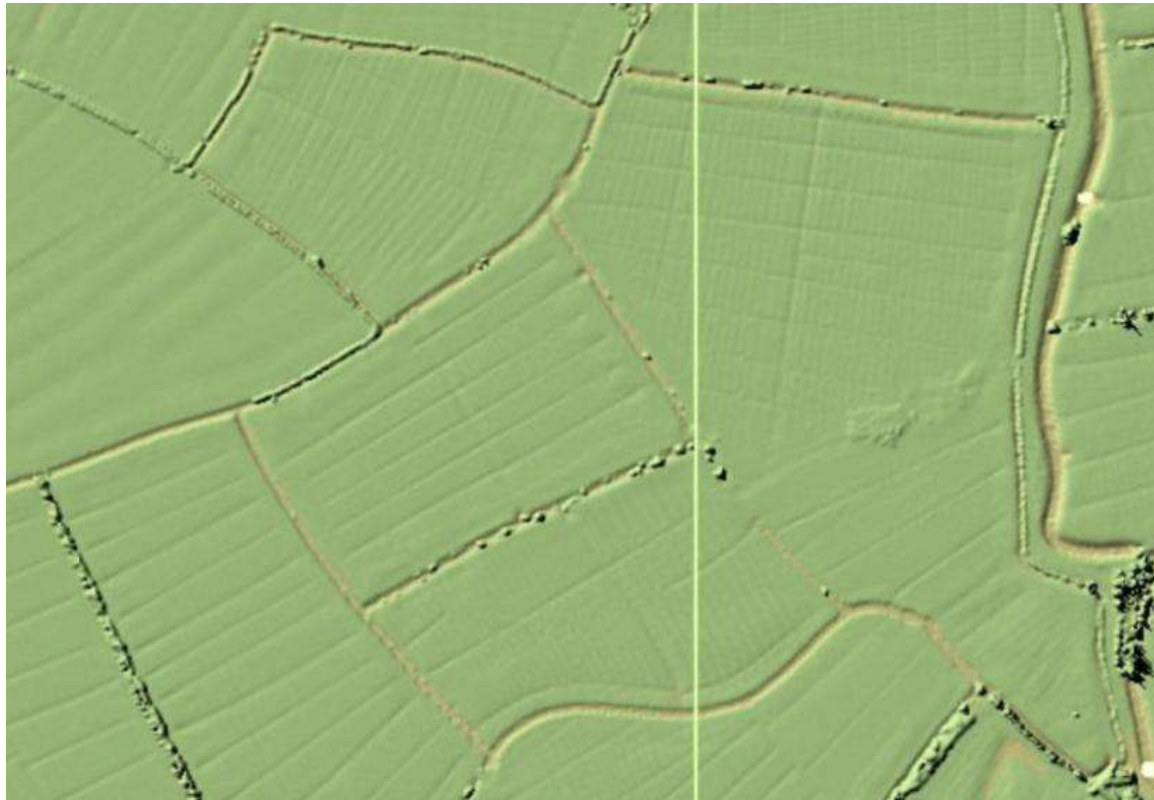
Using the LiDAR Viewer on DataMap Wales, we have been able to visualise the locations of the existing grips clearer. The top four grips on the northern pentagon shaped field are the grips proposed to be reinstated:

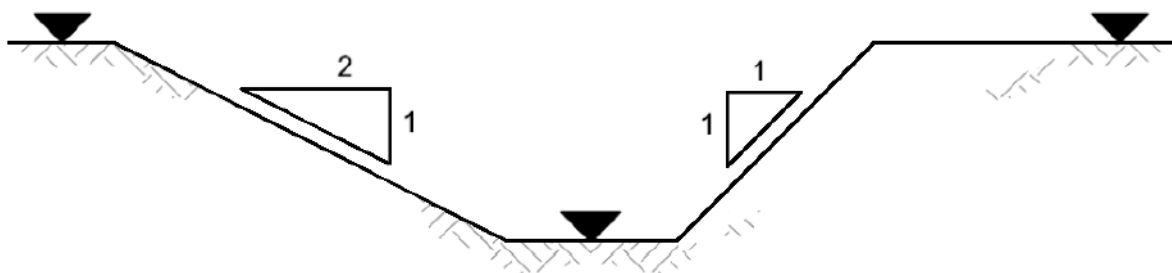
### **Ditch Profile**

10. Spoil is to be spread and levelled on top of bank within 7m of the watercourse.
11. Decommission site, remove all machinery and waste.
12. Ensure that the site is left in a neat and tidy condition.
