Ref: LBC/19/00686 – TSD04

## **MATERIAL SAMPLES CONDITION: CONDITION 2 APPLICATION – SHIREHALL REF: LBC/2019/00686**

Please find below photographs taken of the samples of materials proposed for the CRACK REPAIRS TO STONES of the grins hill / witton fell (buff sandstone colour) on all facades at the above applicant site:

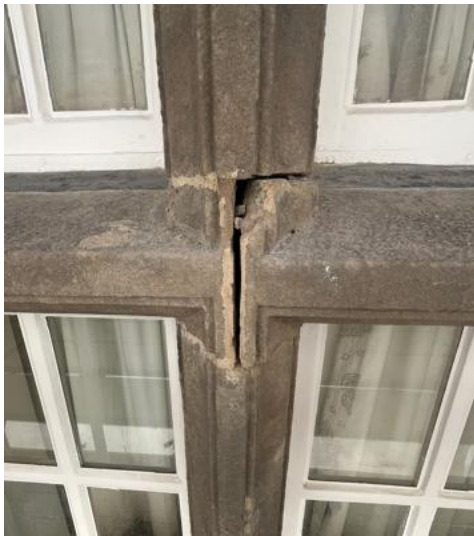
Plate 1: Existing stone cracking / parting

Cracks or partings to pennant / lias stones and Buff sandstones (all elevations) of Shirehall repaired using stone stitching methods utilising 8mm diameter threaded stainless steel 316 grade rods; with a polyester resin mortar fill (colour to match individual stones repaired)

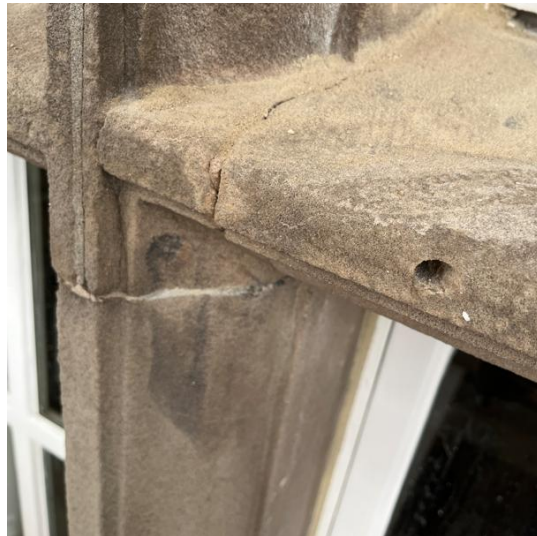
Plate 2: Trial sections of stone stitching to stabilise transom crack / parting.

(8mm dia threaded stainless steel rods in resin mortar  
Drilled at angle into good stone mullion hole filled with lime mortar mix for matching stone colour)
