Ref: LBC/19/00686 – TSD05

## **MATERIAL SAMPLES CONDITION: CONDITION 2 APPLICATION – SHIREHALL REF: LBC/2019/00686**

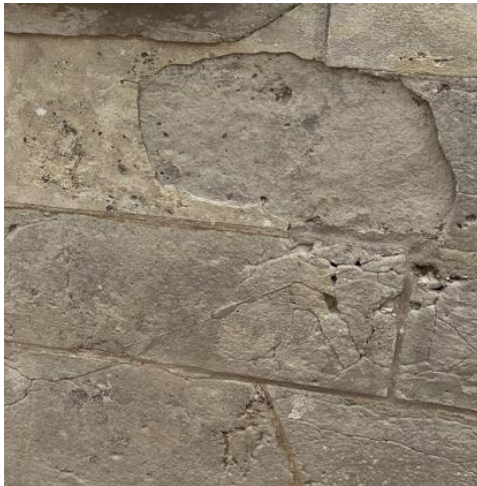
Plate 1: Existing stone face delaminations

Cleaved and delaminated Buff sandstones faces (all elevations) of Shirehall repaired using stone stabilising lime mortars / sheltercoats methods utilising Lime mortar mix - NHL 3.5; washed sharpsand; Natural goat hair 1:3:1 ratio

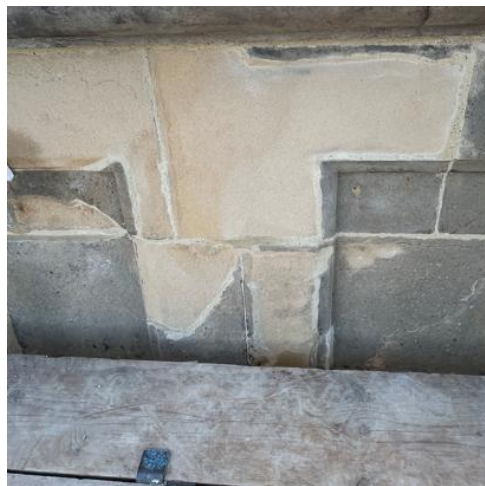
Plate 2: Trial sections of stone stabilisation / shelter  
(Apply behind delaminations and to all cleaved edges to re-bond. NHL 3.5; washed sharpsand; Natural goat hair 1:3:1 ratio)
