Ref: LBC/19/00686 – TSD11

## **MATERIAL SAMPLES CONDITION: CONDITION 2 APPLICATION – SHIREHALL REF: LBC/2019/00686**

Please find below photographs taken of the samples of materials proposed for the REPLACEMENT of rotten timbers within sash and casement windows (reclaimed pitch pine matched exactly to existing), on selected windows to the facades at the above applicant site:

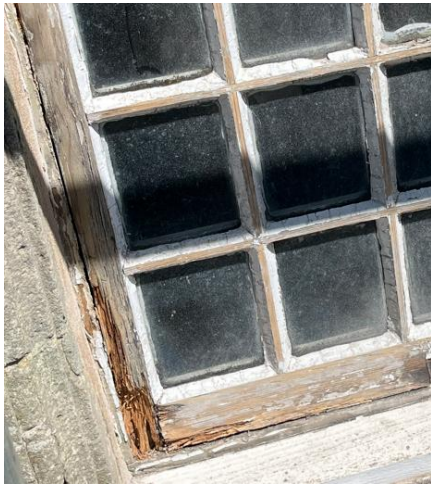
Plate 1: Rotting of existing windows

Rotten or defective TIMBER WINDOWS (all elevations) of Shirehall are to be repaired using scarfed in timbers of RECLAIMED PITCH PINE - to exactly match existing JOINERY in species, specification, dimensions and fit. All sound original timbers remain in situ and are decorated.

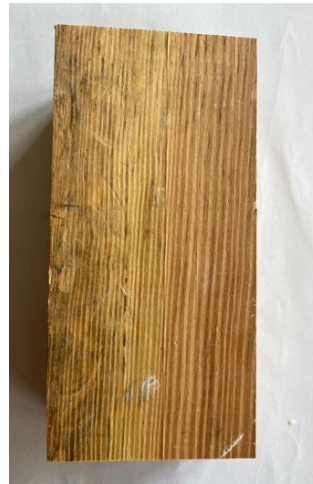
Plate 2: reclaimed pitch pine to scarf in

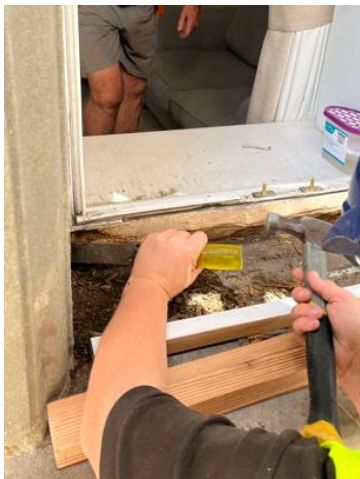
Plate 3: Cutting out rotten timber

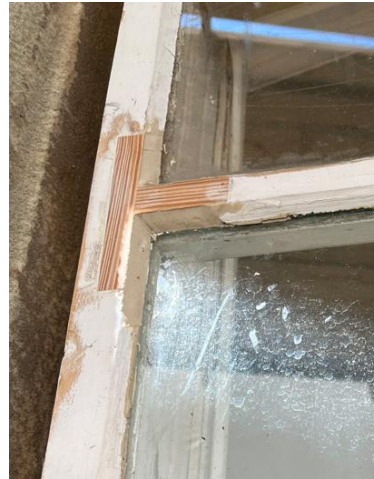
Plate 4: scarfed timber repair made
