Ref: LBC/19/00686 – TSD17

## **MATERIAL SAMPLES CONDITION: CONDITION 2 APPLICATION – SHIREHALL REF: LBC/2019/00686**

Please find below photographs taken of the samples of materials proposed for the REPLACEMENT OF EXISTING LIME MORTAR EDGE SEALS TO WINDOWS WITHIN STONE REVEALS to the facades at the above applicant site:

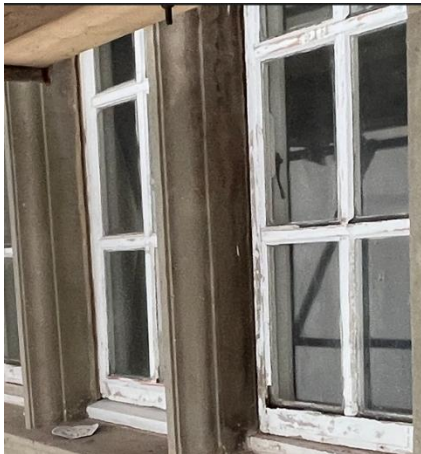
Plate 1: Defective Lime edge seals carefully removed

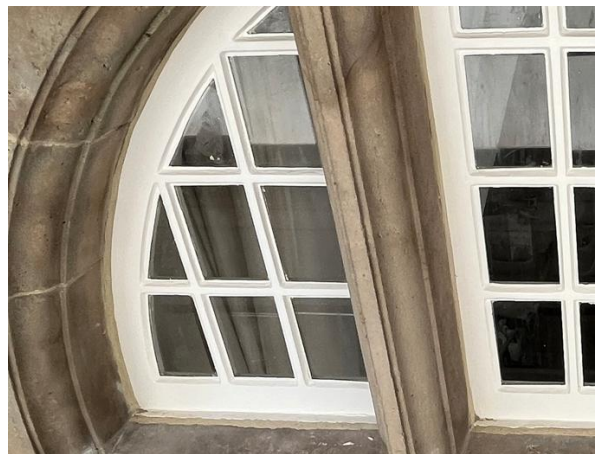
Plate 2: New lime mortar edge seal installed

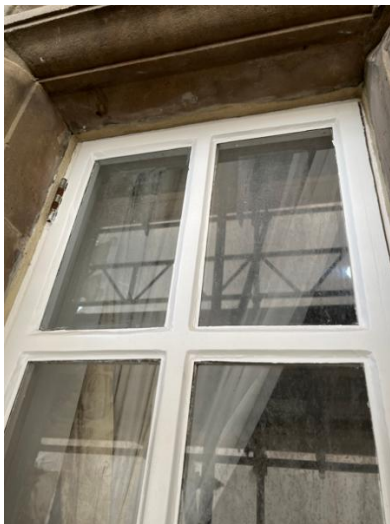
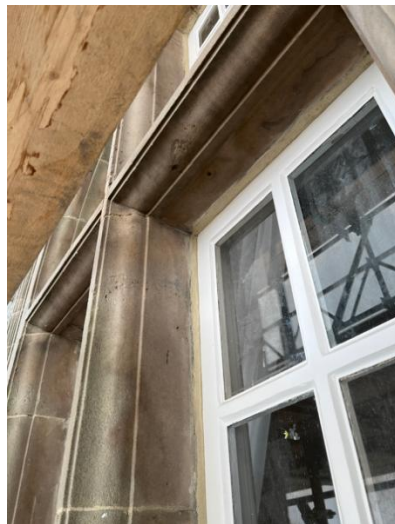
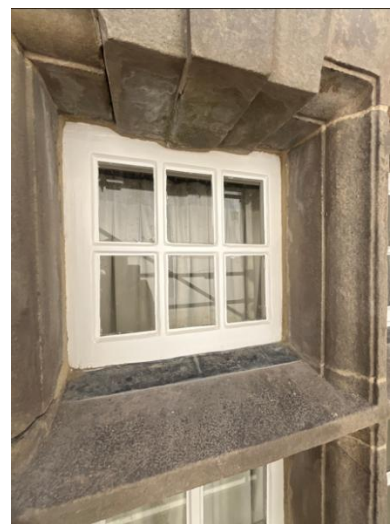
Plates 3,4 & 5: Selection of windows to front façade (all windows within stone reveals to receive) having renewed lime edge seals installed. Lime mortar mix proposed: 3.5NHL; Washed sharpsand; Goat Hair natural; Ratio: 1:3:1. (matched closely to existing).
