Ref: LBC/19/00686 – TSD21

## **MATERIAL SAMPLES CONDITION: CONDITION 2 APPLICATION – SHIREHALL REF: LBC/2019/00686**

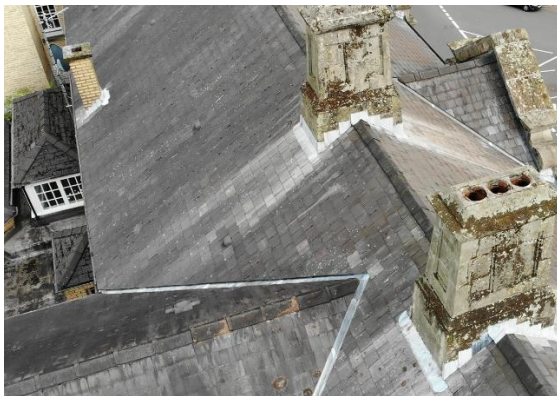
Plate 1: Existing defective slates

SLATES TO BE USED TO REPLACE DEFECTIVE SECTIONS : SIZE, COLOUR AND FIT IN WELSH (salvaged from reclamation retailer) NATURAL SLATE TO EXACTLY MATCH EXISTING, adding copper tingles where necessary to secure slipped slates.

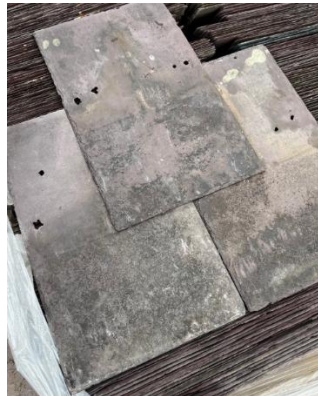
Plate 2: Welsh RECLAIMED natural slate proposed to replace

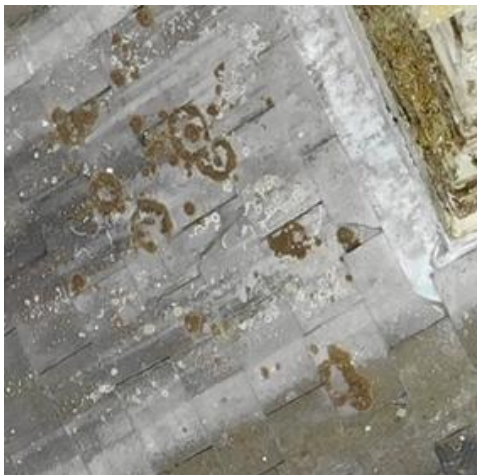
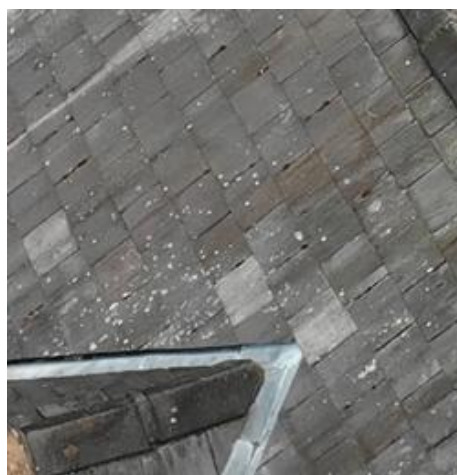
Plates 3 & 4: Selection of photographs of defective slates found existing (main duo pitched roof is welsh slate, rear roofs are combination of man -made slates, with some asbestos containing older man- made slates, and fewer natural Welsh slates).
